**Re: 2015 Annual Report for Lakewood Subdivision Sewage System
Municipality of Northern Bruce Peninsula**

Project Title:	<u>Lakewood Subdivision</u>	Inspection Date:	<u>Dec. 15, 2015</u>
Inspector:	<u>Laura Swanson, P.Eng</u>	Inspection Time:	<u>10:40 am</u>
Location:	<u>Lakewood Subdivision</u>	File No.:	<u>M09010</u>

Lakewood Subdivision – Sewage System

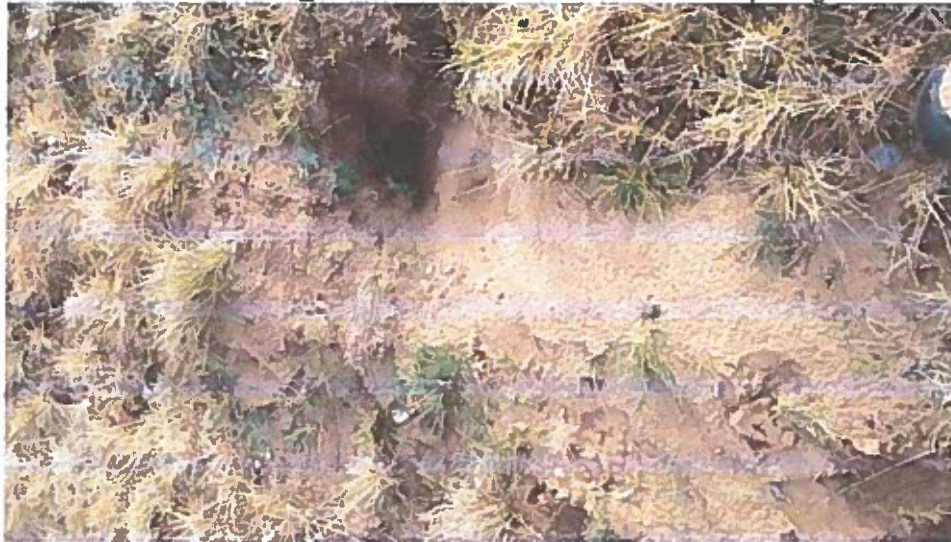
DMRC's inspector walked around the tile field and septic tank area during the inspection. Bare spots were observed on the surface of the tile bed. There also appeared to be evidence of rodent infestation. Evidence of turtle nesting was also visible on the north side of the tile bed. There were also signs of erosion on the north side of the tile bed. It is suggested that these areas be top soiled and seeded in the spring. Please refer to the attached photos.

Photo ID: IMG_20151215-114217: Potential Rodent Opening

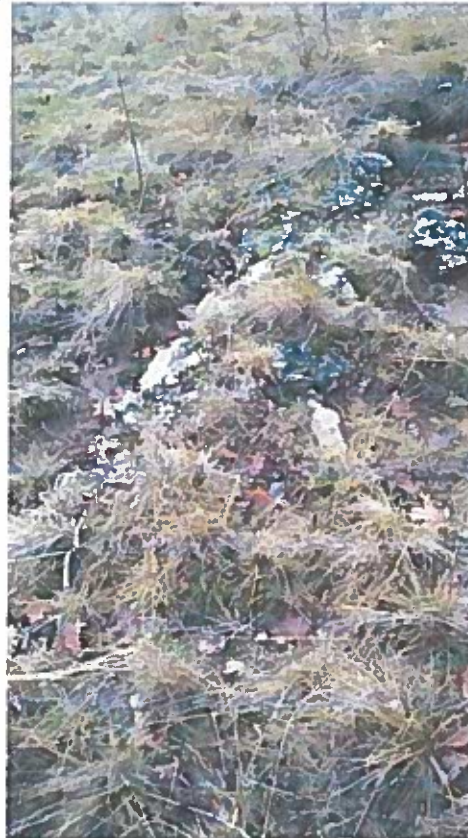
Photo ID IMG_20151215-114437: Erosion at the north side of the tile bed

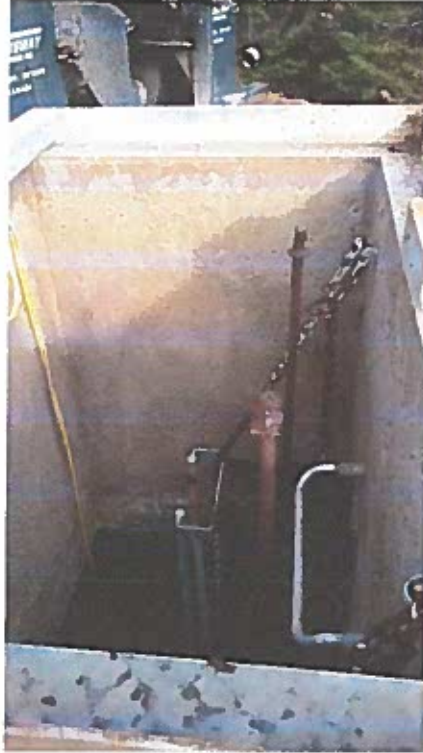
There was no detectable septic odour encountered except within the vicinity of the access opening of the dosing chamber. Both of the two (2) valve stem handles have disintegrated due to corrosion. Please see the attached photo. It is recommended that the valve stems be replaced.

- The discharge control valve stems (dosing chamber) that control discharge to the tile fields were not operable, the handles are rusted and in poor condition.

Photo ID IMG_20151215-114645: Discharge Control Valve Stems (Dosing Chamber)

1. OCWA and the Municipality should replace the effluent discharge control valve stems.
2. The "Dosing Pump Elapsed Time Weekly Record Sheets" provided in the Updated Operations and Maintenance Manual should be used by operations staff. Operators should continue to keep a project-specific journal of their site visits, alarm conditions, maintenance, repairs and observations.
3. Operations staff should continue to monitor the air relief valve at SANMH2. There had been maintenance issues with the air relief valve in the past.

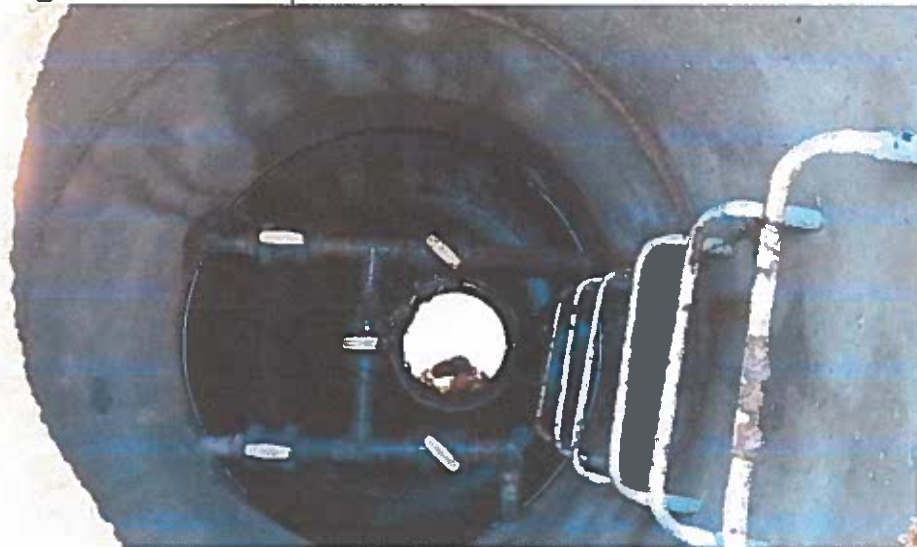
The splitter valve chamber was inspected and although the chamber did contain some water, there appears to be no need for concern and the valves are above the water level.

- An inspection of the splitter valve chamber to the tile fields was conducted. There were no deficiencies noted. The chamber did contain some water, but the valves were above the water level. The water was clear and was assumed to be from infiltration. A poly-seal (bowl) had been installed.

Photo ID IMG_20151215-113223: Splitter Valve Chamber
