MUNICIPALITY OF NORTHERN BRUCE PENINSULA

2020 STRUCTURE INSPECTION REPORT

FINAL
PROJECT NO.: 201-01605-00
DATE: MARCH 10, 2021

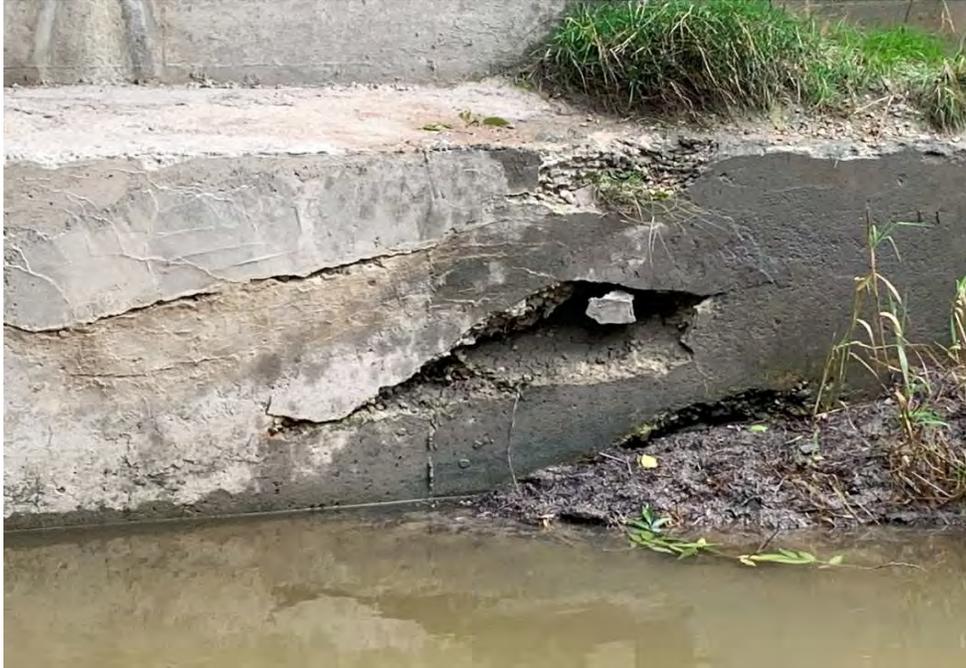
Photo 1-2: S. Abutment and footing with spalling

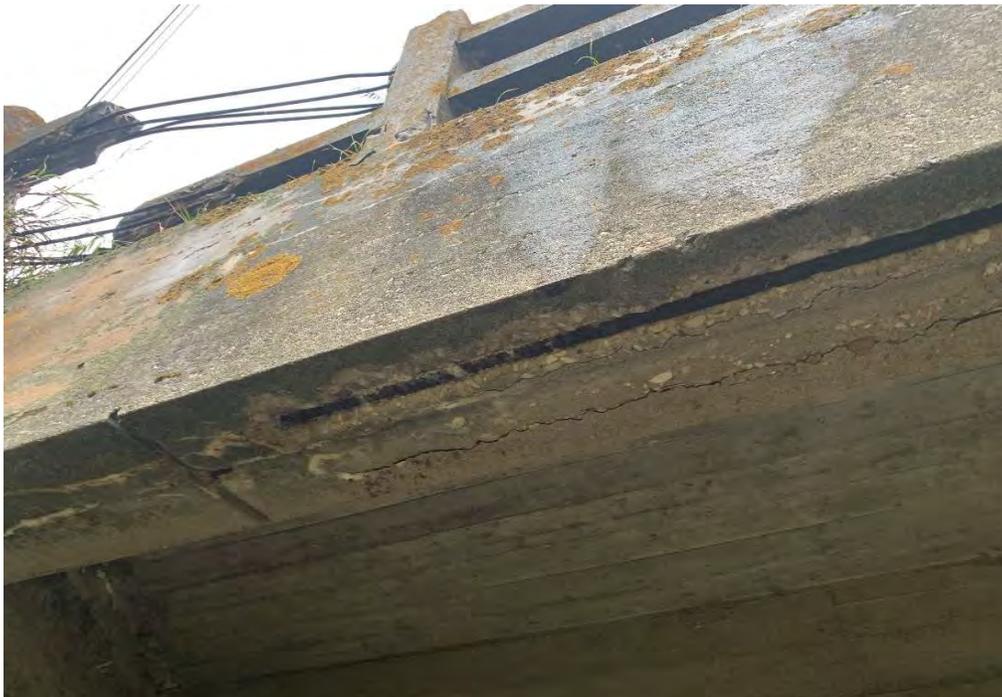
Photo 1-3: North Abutment girders and soffit with spalling and delamination

Element Group:	Beam/MLE's		Length:	7.6 m			
Element Name:	Floor Beams		Width:	0.41 m			
Location:			Height:	0.61 m			
Material:	Concrete		Count:	4			
Element Type:			Total Quantity:	49.55 m ²			
Environment:	Moderate		Limited Insp'n:				
Protection System:							
Condition Data:	Units	Exc.	Good	Fair	Poor	Perform. Deficiencies	Maint. Needs
	m ²			14.87	34.68		
Comments:	Four concrete girders were poured with the deck on top of each abutment wall. The exterior beam concrete has spalled exposing the rebar. The interior beams have exposed rebar and cracking at the abutments.						
Recommended Work:	None 6-10 Years <input checked="" type="checkbox"/> 1-5 Years < 1 Year Urgent Repair all poor concrete, clean reinforcing steel, and replace concrete.

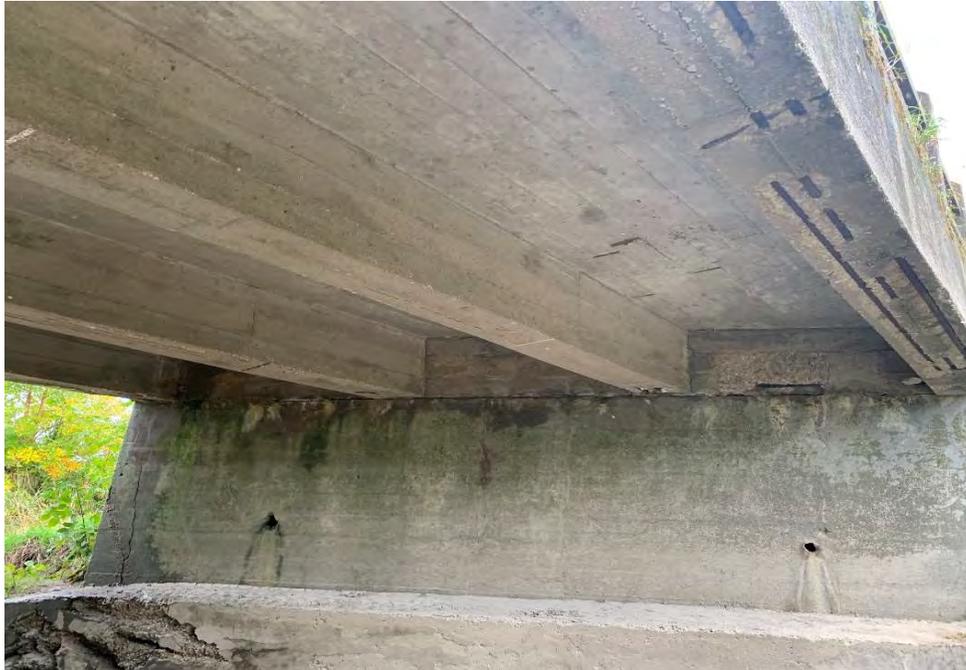
Photo 1-4: South abutment, soffit and foundation

Element Group:	Foundations		Length:				
Element Name:	Foundation (below ground level)		Width:				
Location:			Height:				
Material:	Concrete		Count:				
Element Type:			Total Quantity:				
Environment:	Moderate		Limited Insp'n:	√			
Protection System:							
Condition Data:	Units	Exc.	Good	Fair	Poor	Perform. Deficiencie	Maint. Needs
Comments:	A previous repair to the south side (under water) was observed. The exposed south footing sounds hollow when walking across it. Investigate the extent of the voids and fill with concrete grout.						
Recommended Work:	None 6-10 Years <input checked="" type="checkbox"/> 1-5 Years < 1 Year Urgent Repair all poor concrete and place erosion protection south side. Further investigation required.

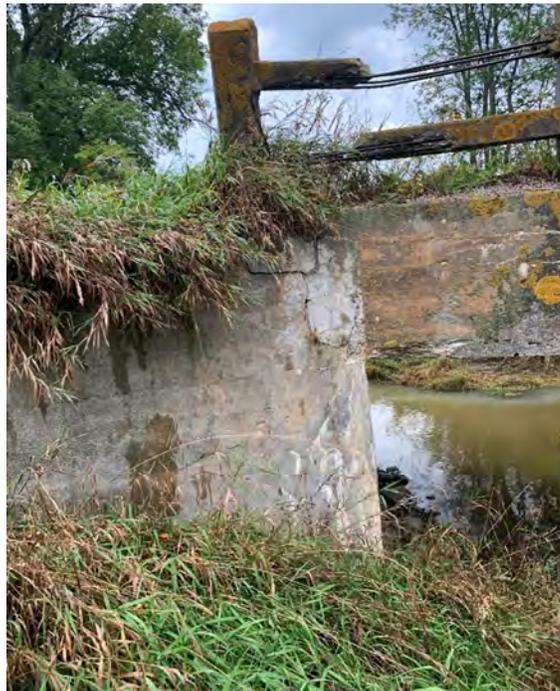
Photo 1-5: Wingwall deterioration (typ)

Element Group:	Abutments		Length:	3.05			
Element Name:	Wingwalls		Width:				
Location:			Height:	1.83			
Material:	Concrete		Count:	4			
Element Type:			Total Quantity:	22.32 m ²			
Environment:	Moderate		Limited Insp'n:				
Protection System:							
Condition Data:	Units	Exc.	Good	Fair	Poor	Perform. Deficiencie	Maint. Needs
	%			11.16	11.16		
Comments:	Surface spalling & cracking was observed at each wingwall.						
Recommended Work:	None 6-10 Years <input checked="" type="checkbox"/> 1-5 Years < 1 Year Urgent Repair all poor concrete, clean reinforcing steel, and replace concrete.

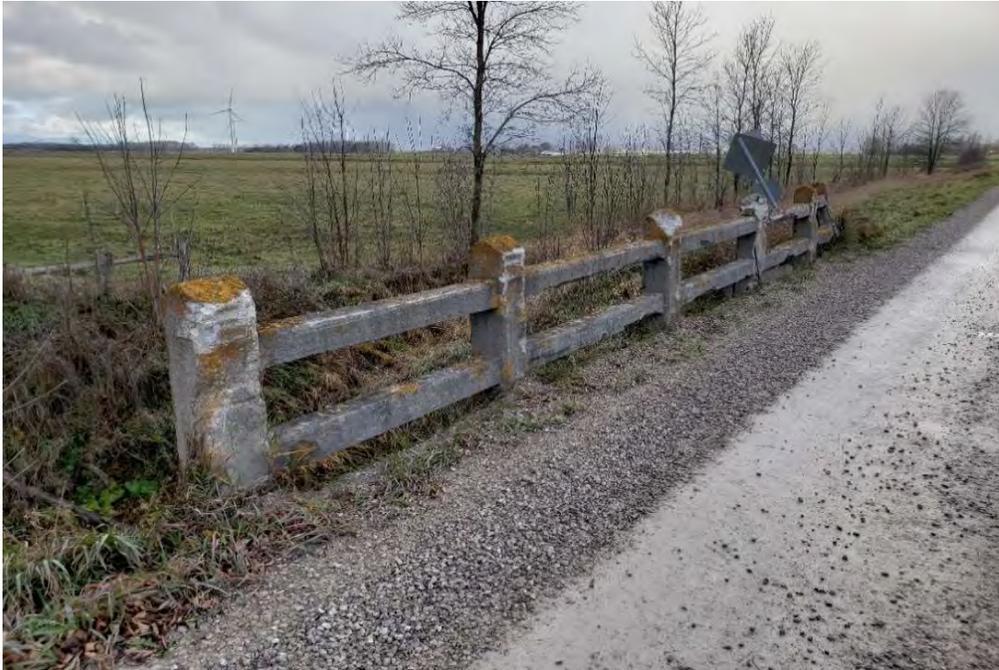
Photo 1-6 - Structure barrier and excessive granular fill on deck

Element Group:	Decks		Length:	9.1 m			
Element Name:	Deck Top		Width:	5.8 m			
Location:			Height:				
Material:	Concrete		Count:				
Element Type:			Total Quantity:	52.78 m ²			
Environment:	Moderate		Limited Insp'n:	Yes			
Protection System:							
Condition Data:	Units	Exc.	Good	Fair	Poor	Perform. Deficiencies	Maint. Needs
	m ²			52.78		Yes	
Comments:	Limited inspection of the top deck condition due to cover with granular wearing surface. The thickness of the granular surface is excessive and creates a high dead load on the structure.						
Recommended Work:	None 6-10 Years		1-5 Years	<input checked="" type="checkbox"/> < 1 Year	Urgent		
	Grade out excess gravel and inspect the condition of the concrete deck top.

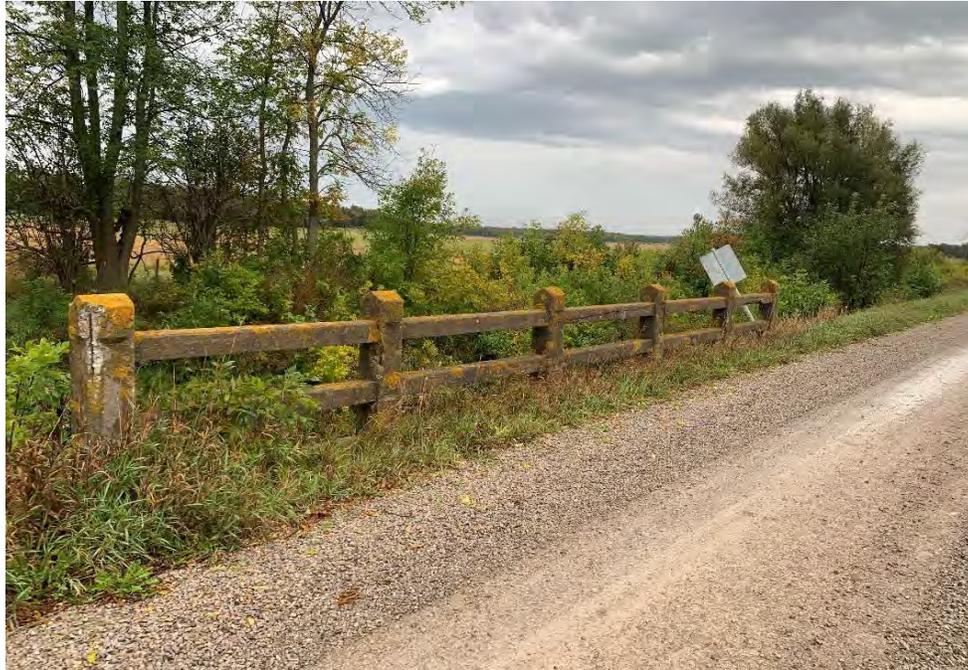
Photo 1-8 - Vegetation and debris accumulation along shoulders, potholes in wearing surface, load limit reduction sign not plumb

Element Group:	Approaches		Length:	5 m			
Element Name:	Wearing Surface		Width:	5 m			
Location:			Height:				
Material:	Gravel		Count:	2			
Element Type:			Total Quantity:	50 m ²			
Environment:	Moderate		Limited Insp'n:				
Protection System:							
Condition Data:	Units	Exc.	Good	Fair	Poor	Perform. Deficiencies	Maint. Needs
	m ²			50			Yes
Comments:	Shoulder vegetation has started to encroach on the roadway. Large potholes and wheel path rutting have developed at each approach.						
Recommended Work:	None 6-10 Years 1-5 Years <input checked="" type="checkbox"/> < 1 Year Urgent Grade the shoulders and clear the encroaching vegetation.

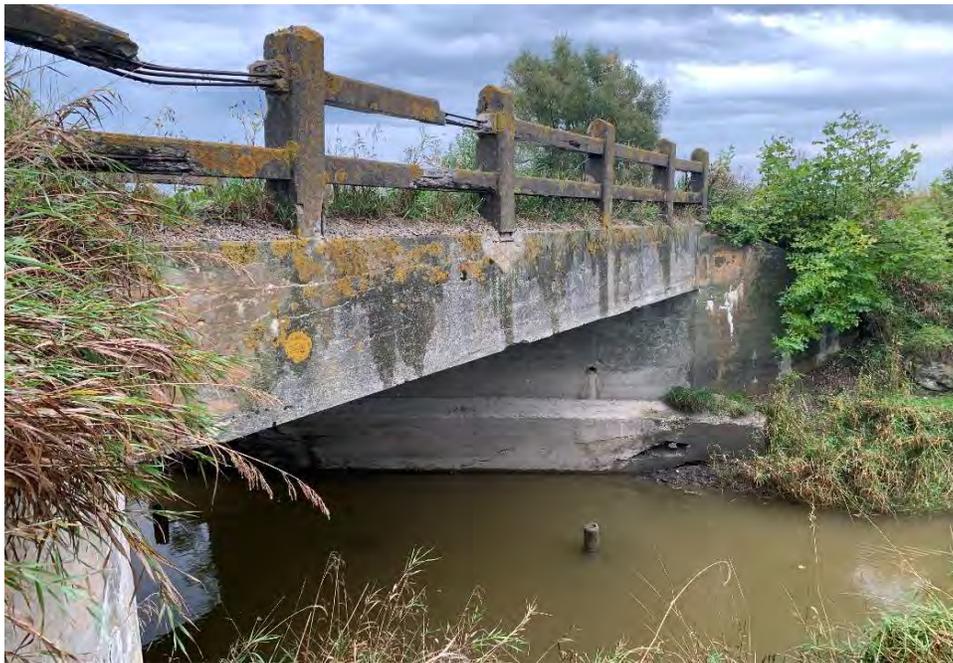
Photo 1-9 - Structure elevation, exterior soffit, curb and barrier

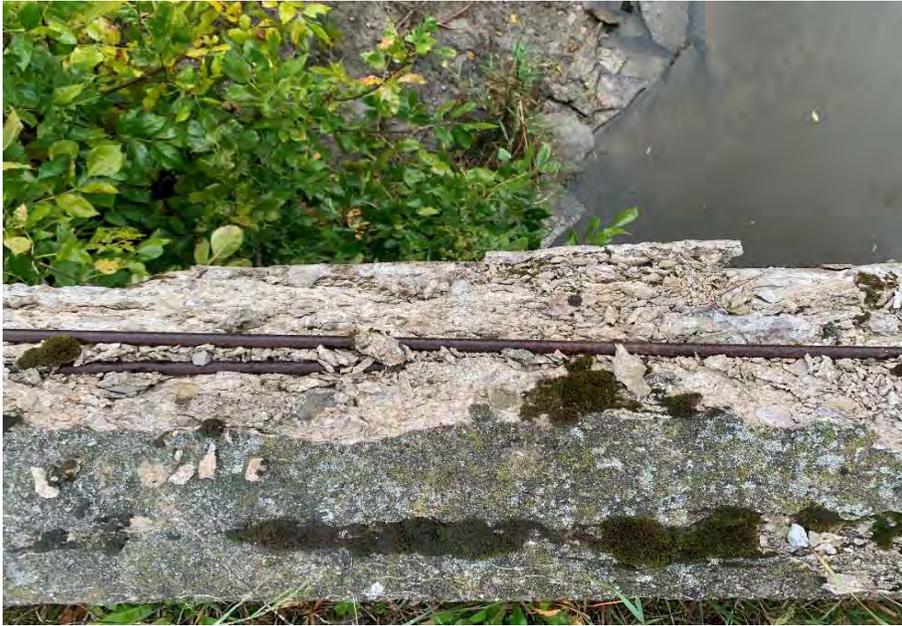
Photo 2-2: Spalling of exterior curb

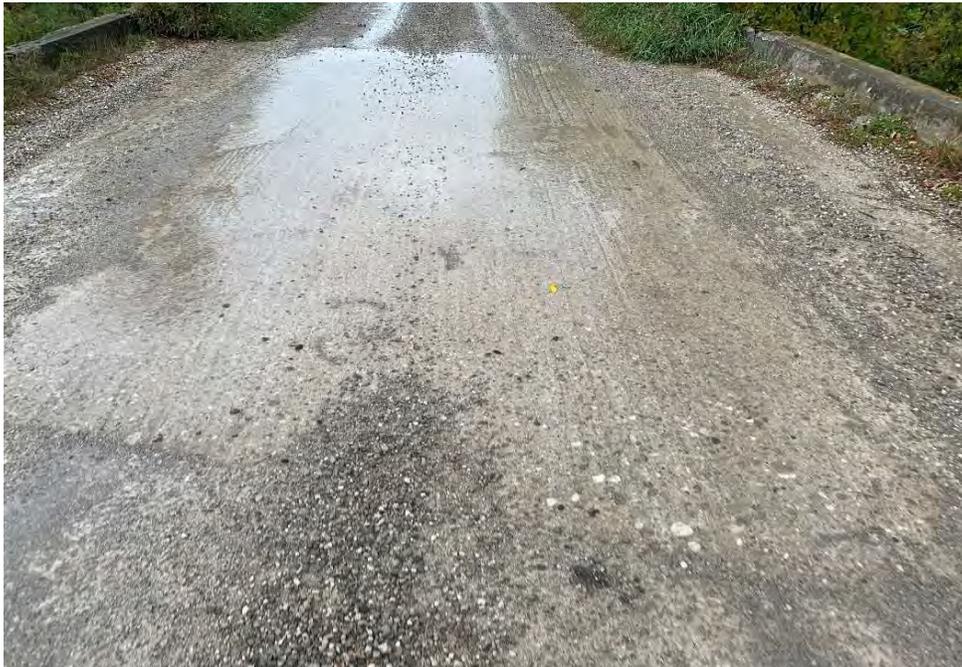
Photo 2-3: Structure deck

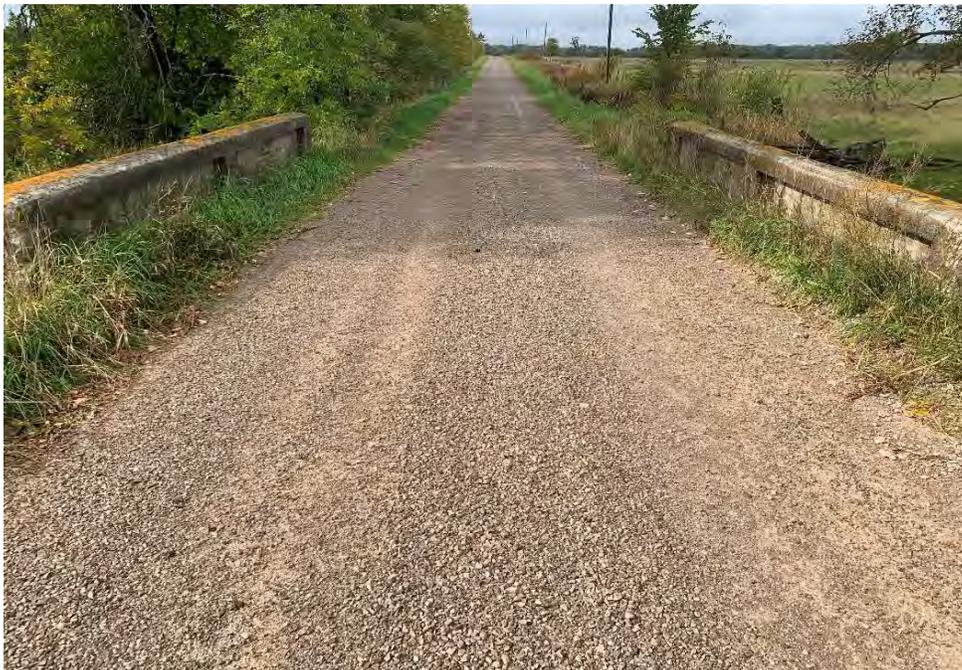
Photo 3-5: Structure and approach wearing surface with wheel path rutting and encroaching vegetation

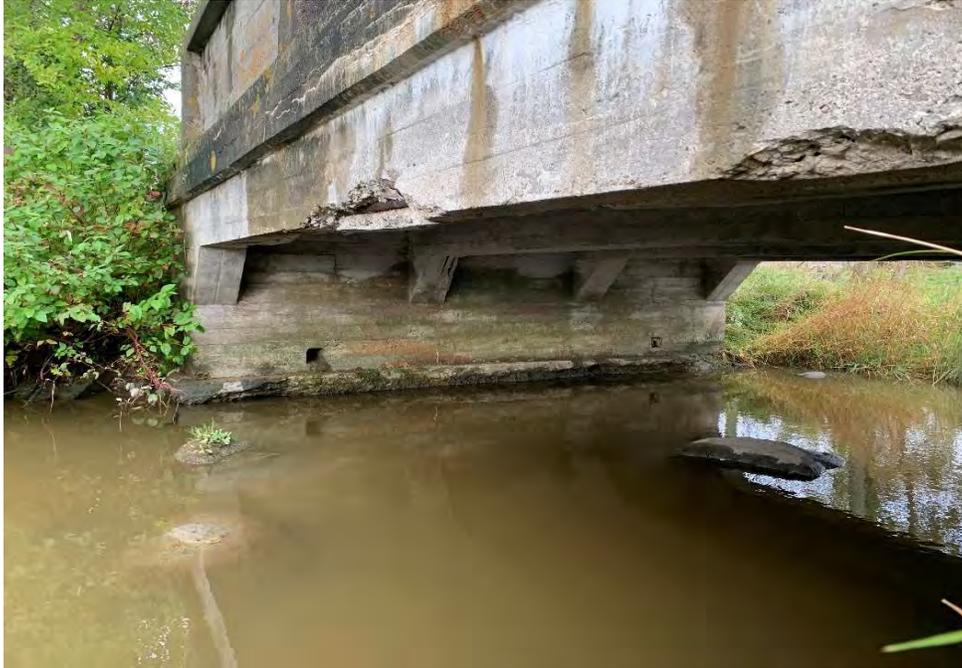
Photo 3-8: Exterior girder delamination and spalling

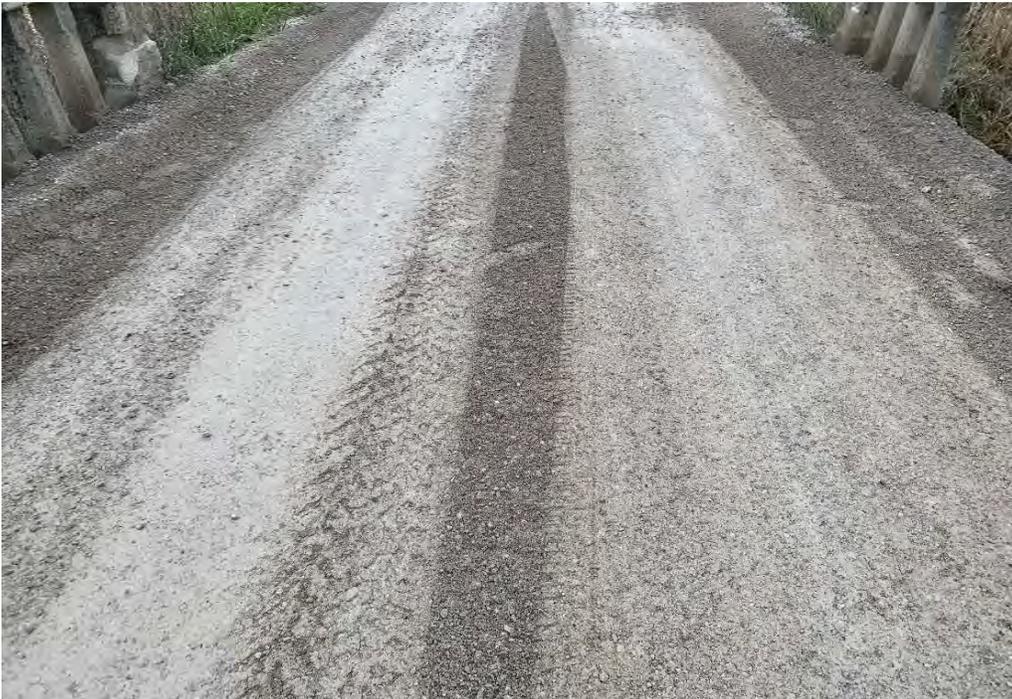
Photo 4-5: Wearing surface deterioration

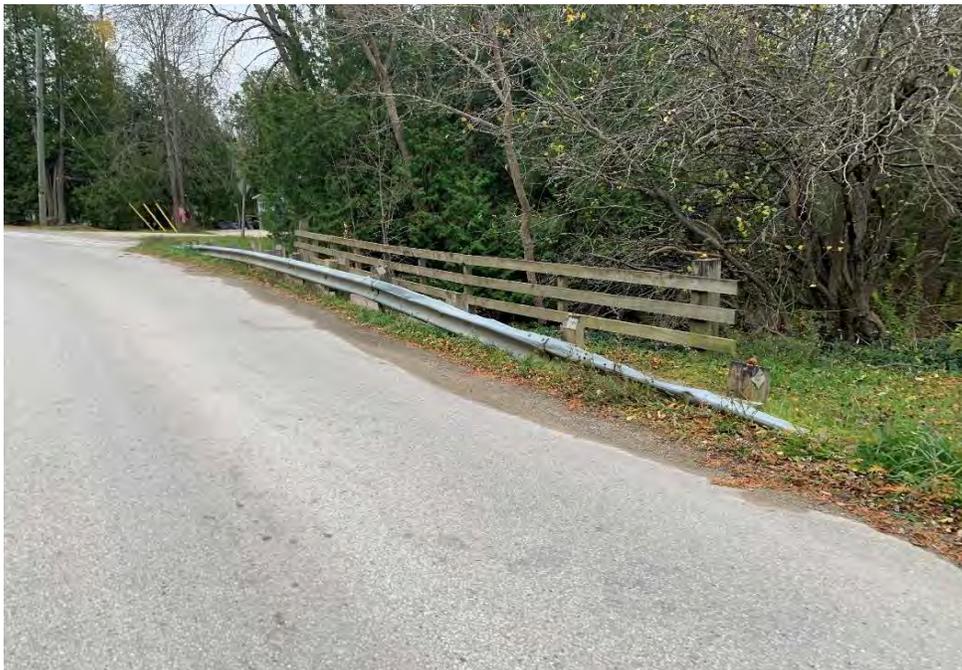
Photo 5-3: Impact damage to southeast barrier protection

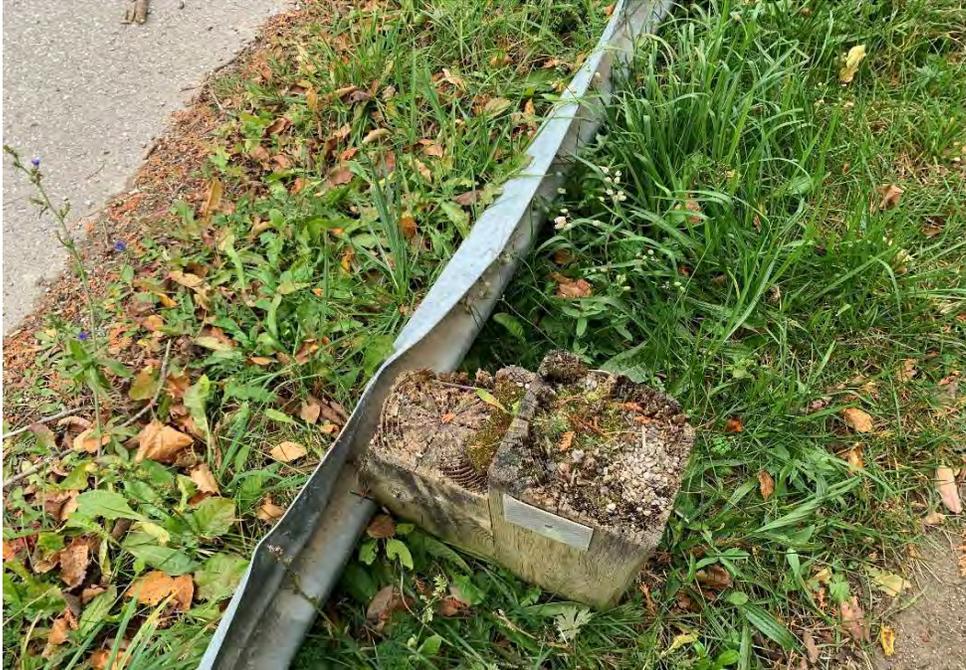
Photo 5-4: Wooden barrier post rot (typical)

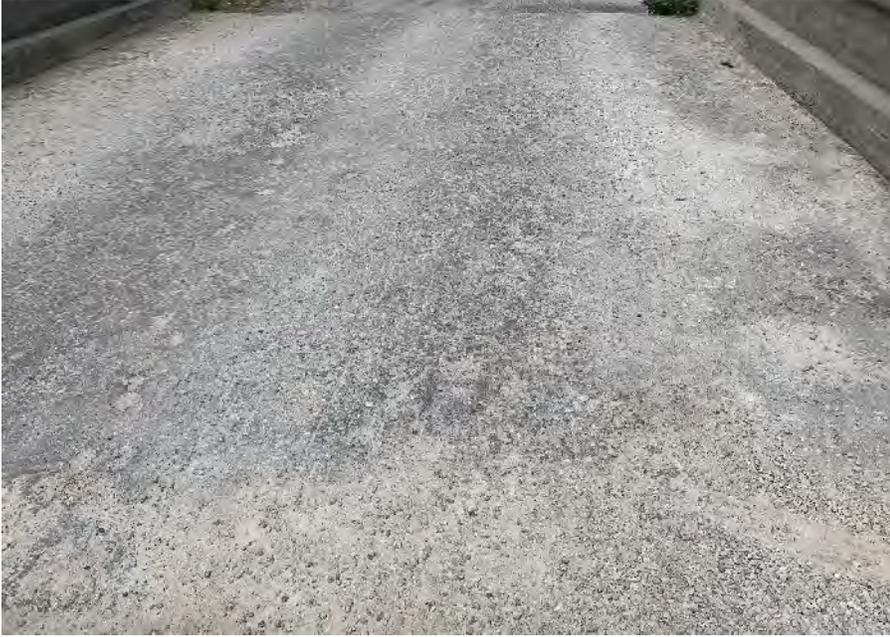
Photo 6-2: View of structure deck with delaminations

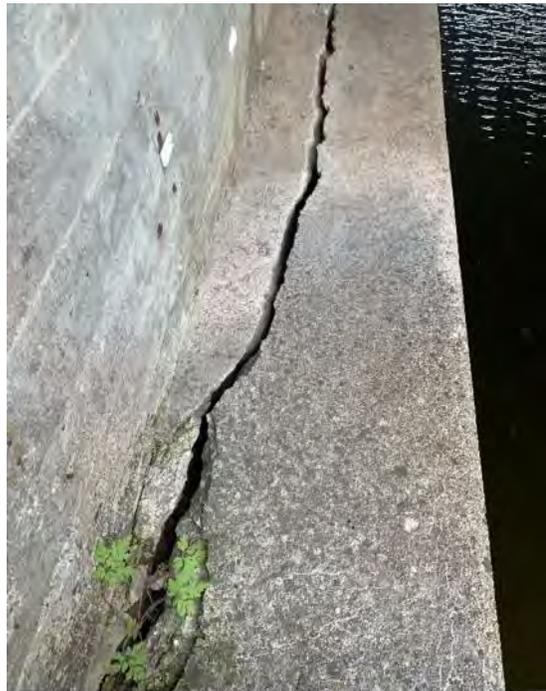
Photo 6-9: Differential foundation settlement

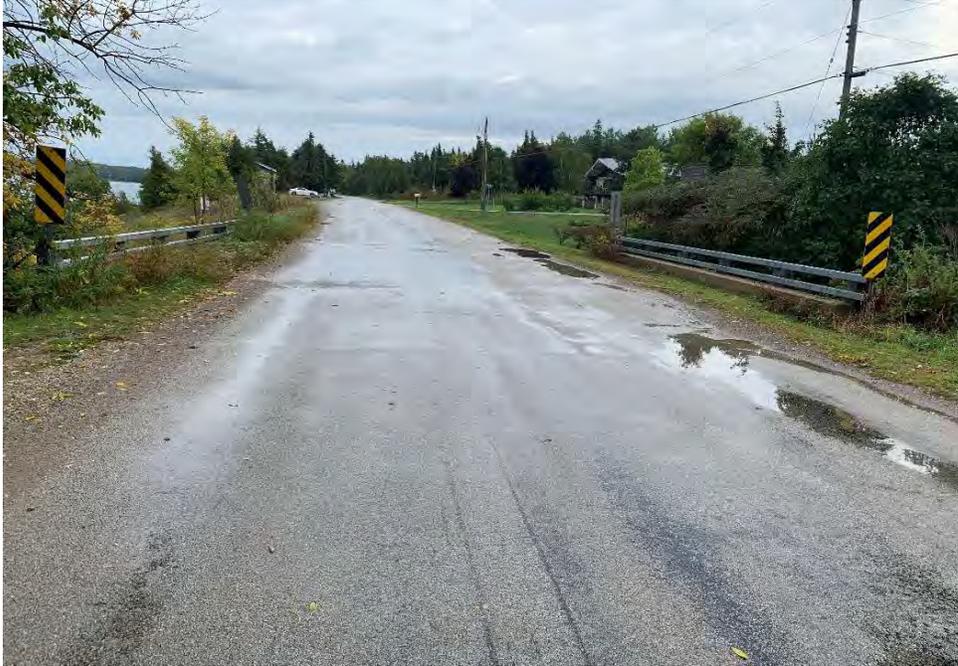
Photo 8-2: View of structure barrier, signage (typ) and encroaching vegetation

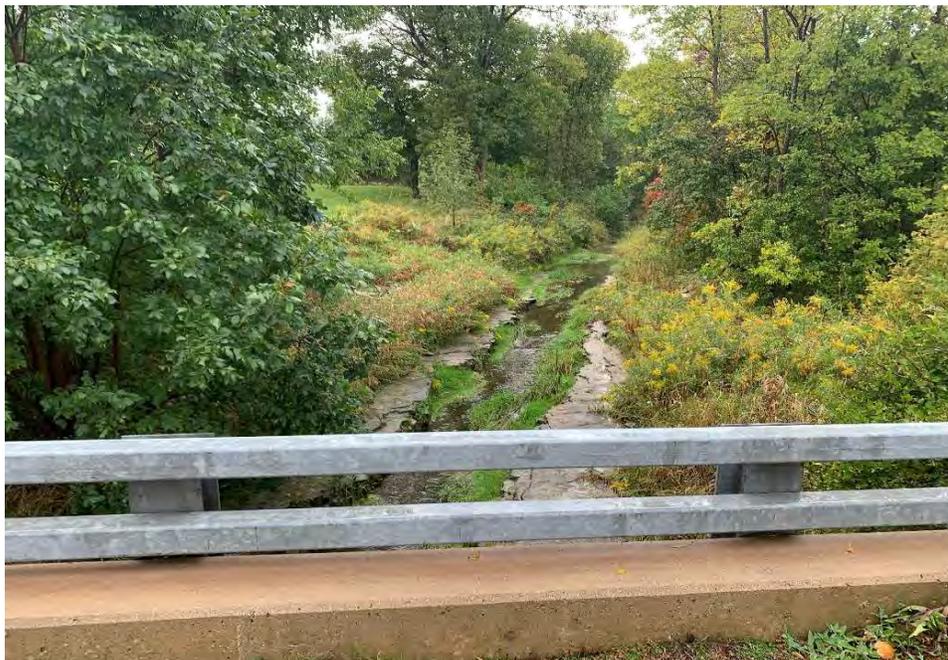
Photo 8-3: View of watercourse upstream and deficient barrier protection

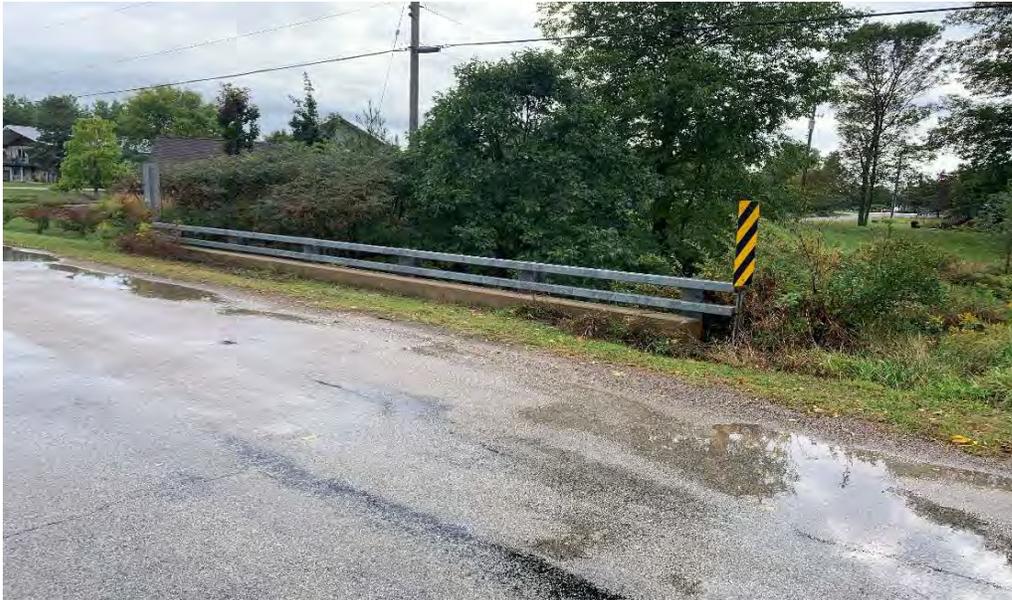
Photo 8-4: Deficient barrier termination and hazard signage

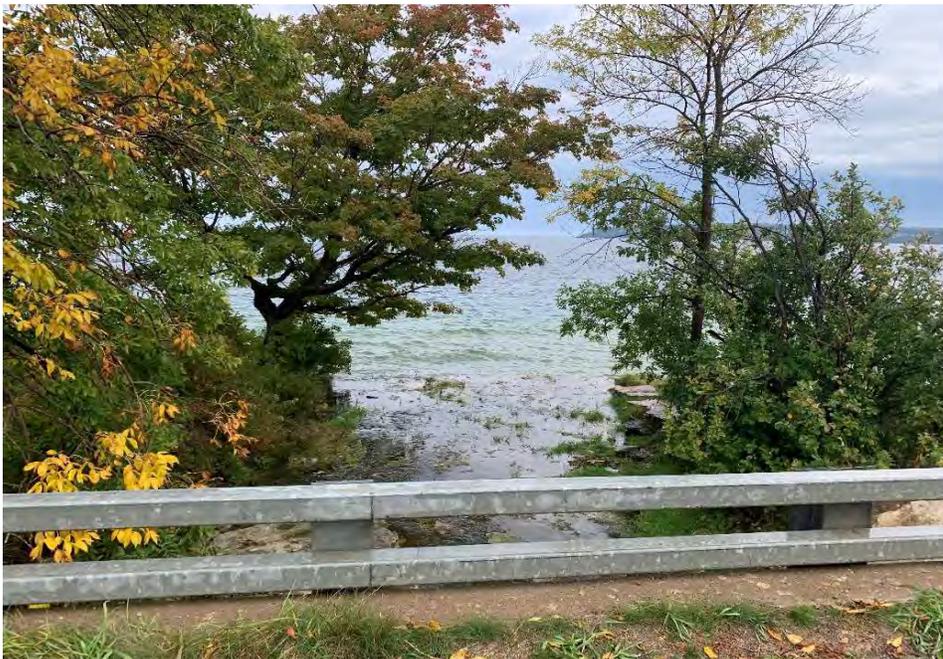
Photo 8-5: View of watercourse downstream and deficient barrier protection

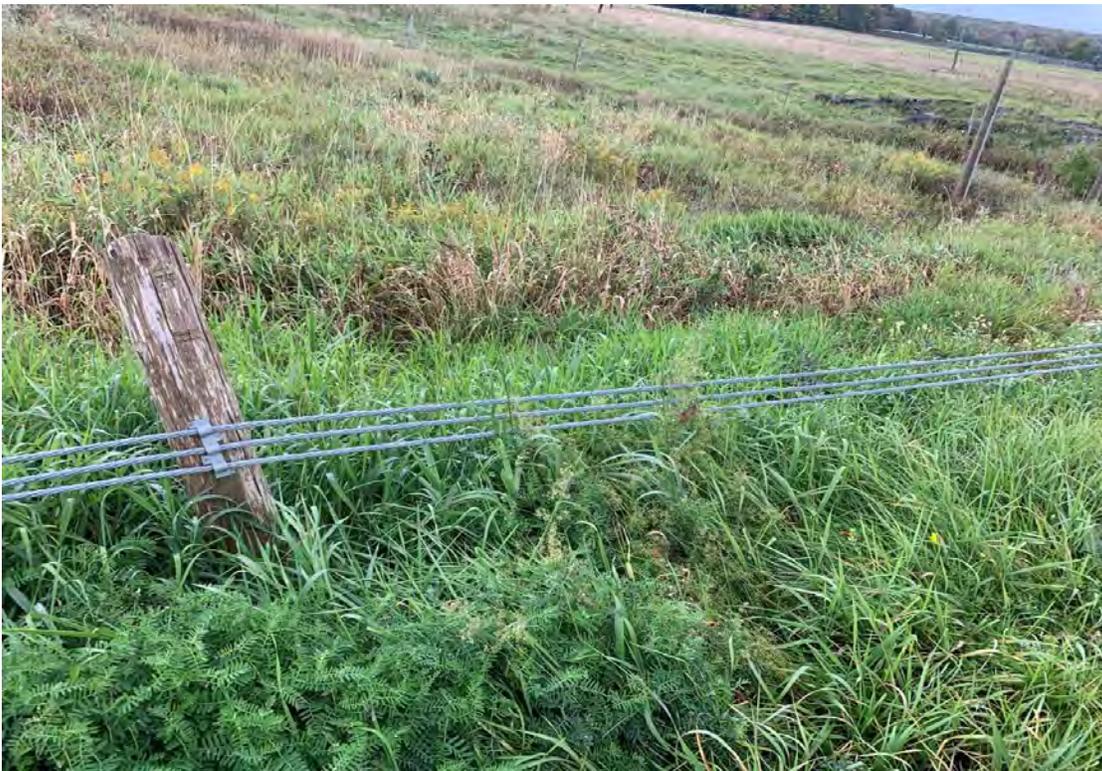
Photo 9-5 - View of west 3 cable guiderail barrier protection with loose cable

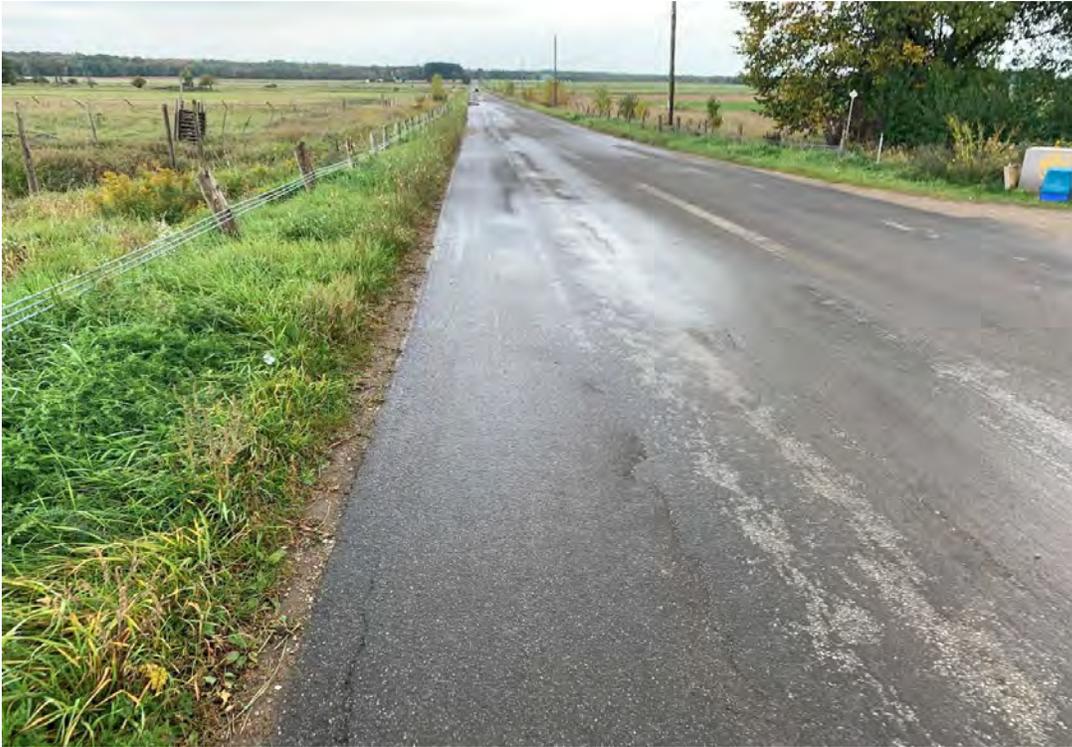
Photo 9-8 - View of northeast deficient section of 3 cable guiderail (impact damage)

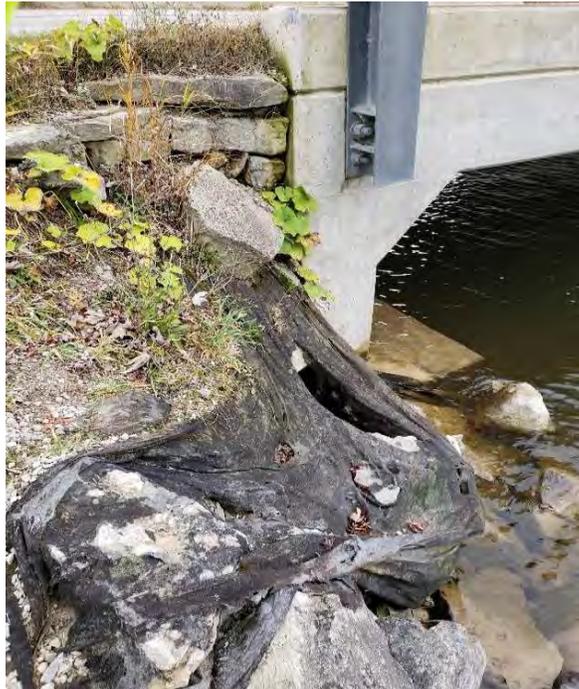
11-5: Rock slope protection and geotextile failure at the southeast quadrant

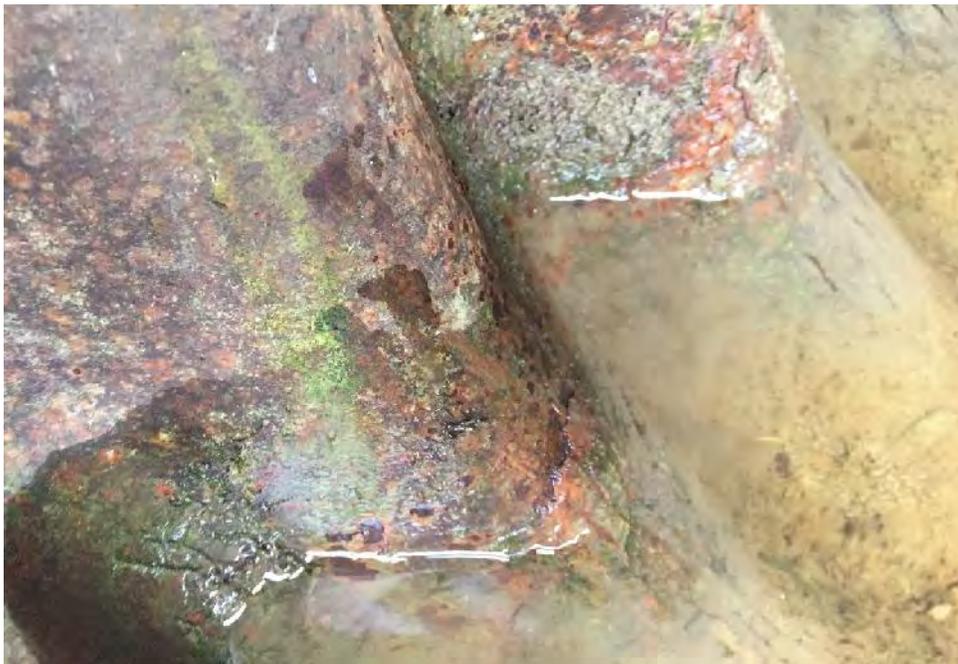
Photo 12-9: View of culvert barrel corrosion at the waterline (typical)

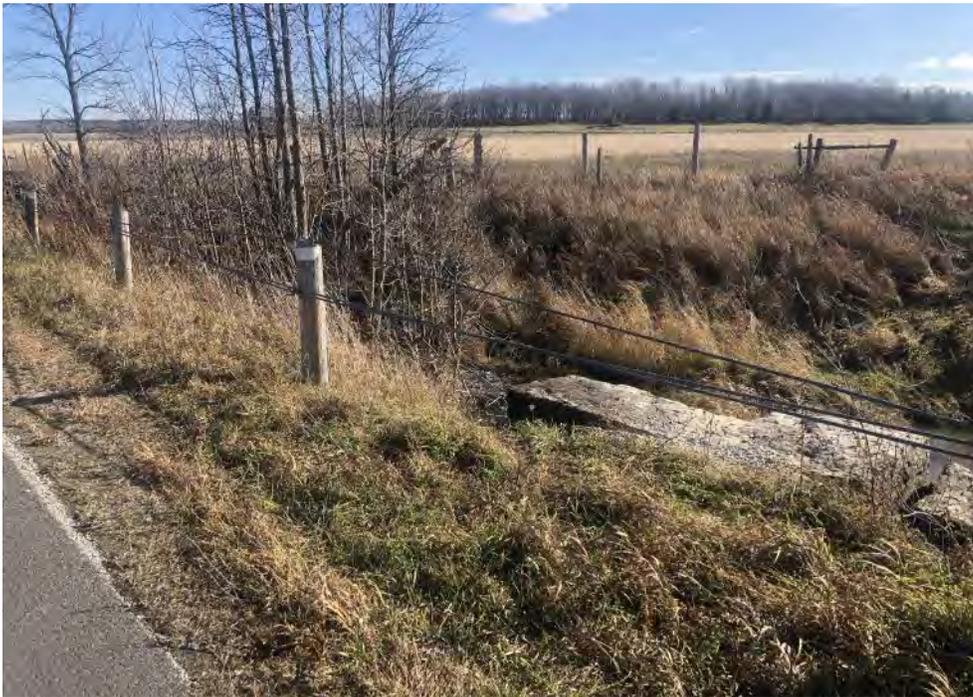
Photo 16-8: Loose cable on barrier protection

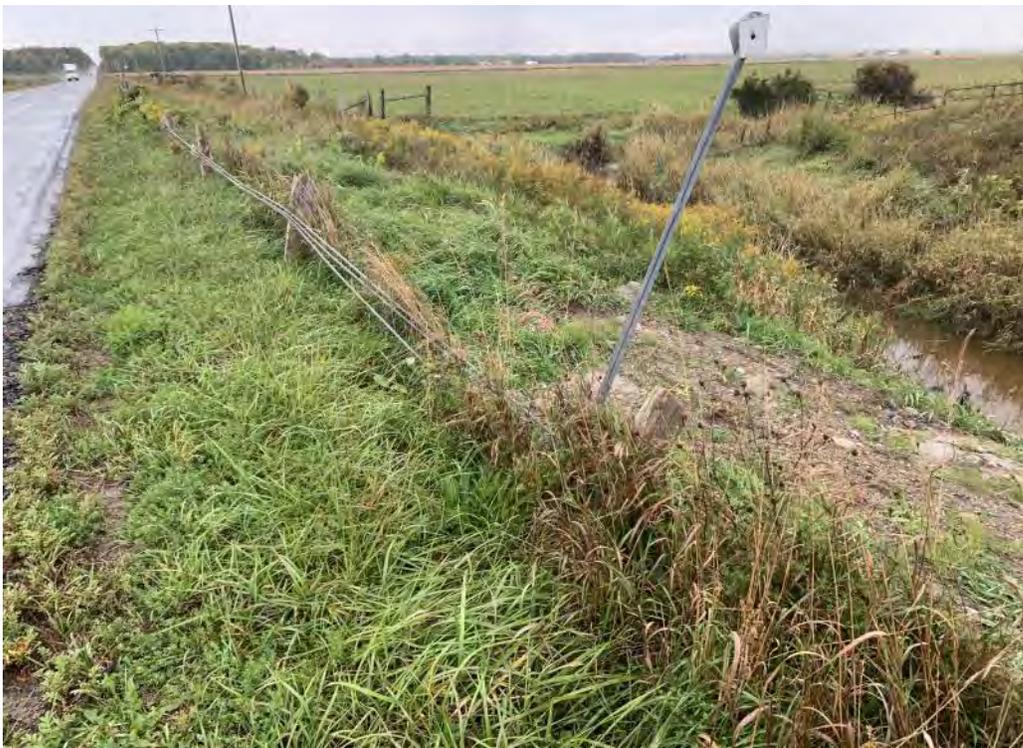
Photo 19-5: Impact damage to the northeast barrier protection post

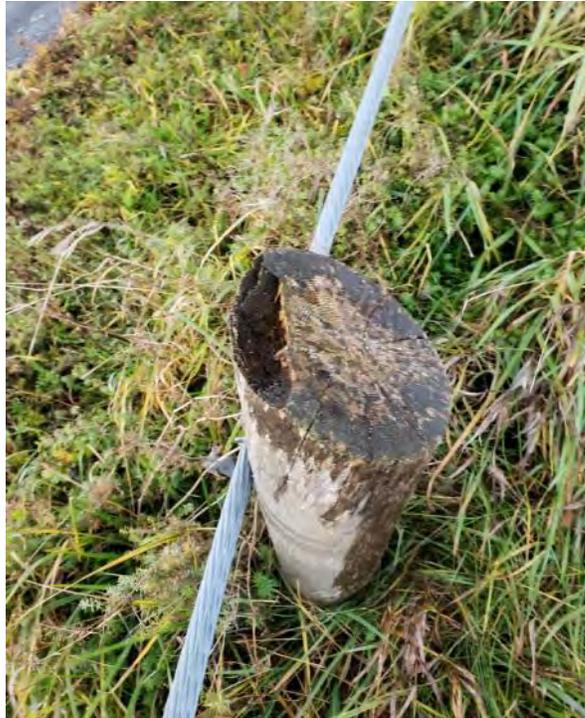
Photo 19-6: Typical wooden post rot (2018)
