MUNICIPALITY OF NORTHERN BRUCE PENINSULA

2022 STRUCTURE INSPECTION REPORT

FINAL
PROJECT NO.: 201-01605-00
DATE: APRIL 03, 2023

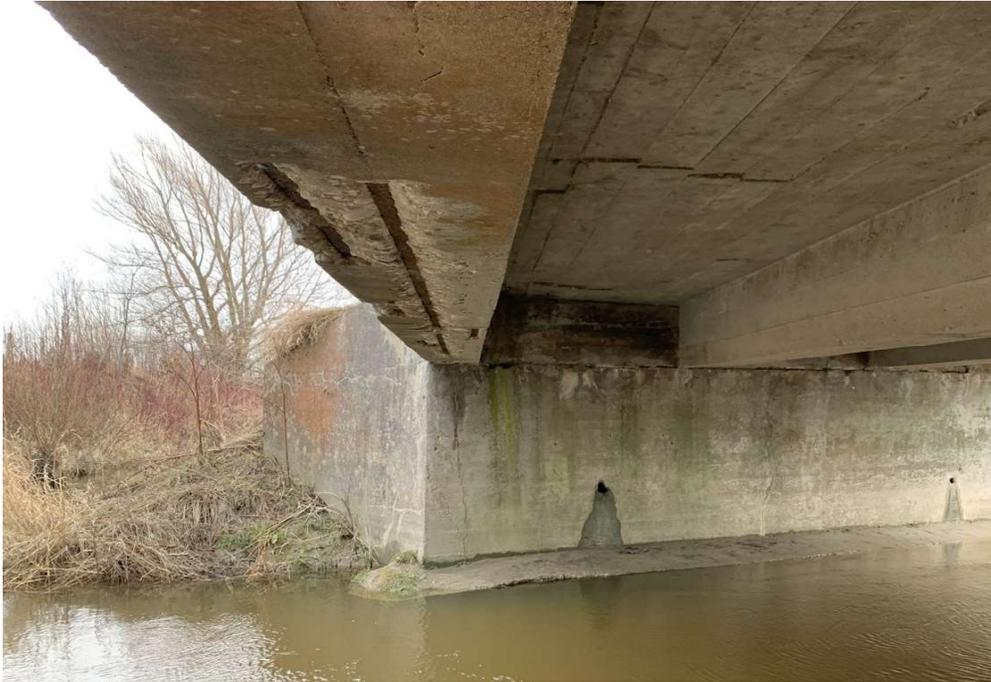
Photo 1-2: South abutment, soffit and exterior girder.

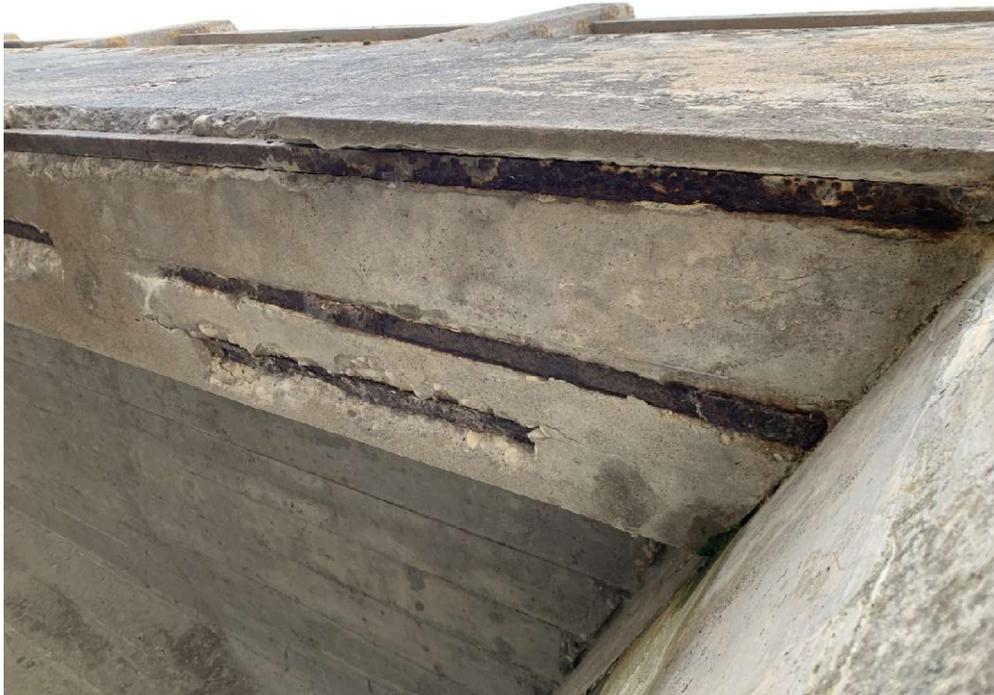
Photo 1-3: North abutment, girders and soffit with spalling and delamination

Element Group:	Decks		Length:	7.6 m			
Element Name:	Soffit - Thick Slab		Width:	6.9 m			
Location:			Height:				
Material:	Concrete		Count:				
Element Type:			Total Quantity:	48.64 m ²			
Environment:	Moderate		Limited Insp'n:				
Protection System:							
Condition Data:	Units	Exc.	Good	Fair	Poor	Perform. Deficiencies	Maint. Needs
	m ²			38.91	9.73	Yes	Yes
Comments:	Exterior soffit concrete loss with exposed rebar was observed.						
Recommended Work:	None 6-10 Years		<input checked="" type="checkbox"/> 1-5 Years	< 1 Year	Urgent		
	Remove delaminated concrete, clean steel and replace concrete.

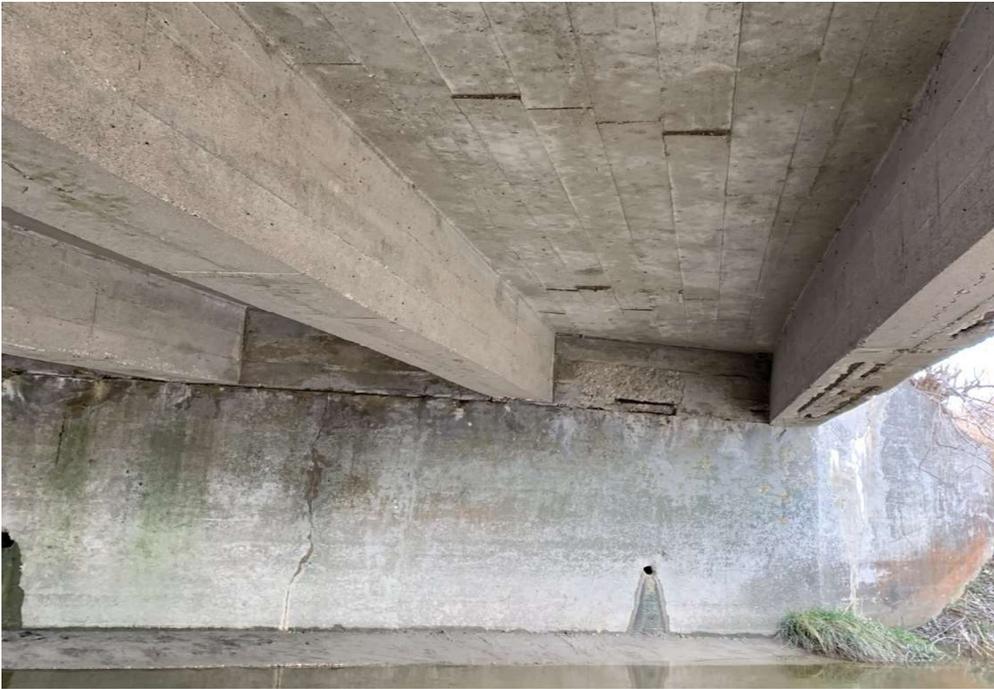
Photo 1-4: South abutment wall, soffit and girders

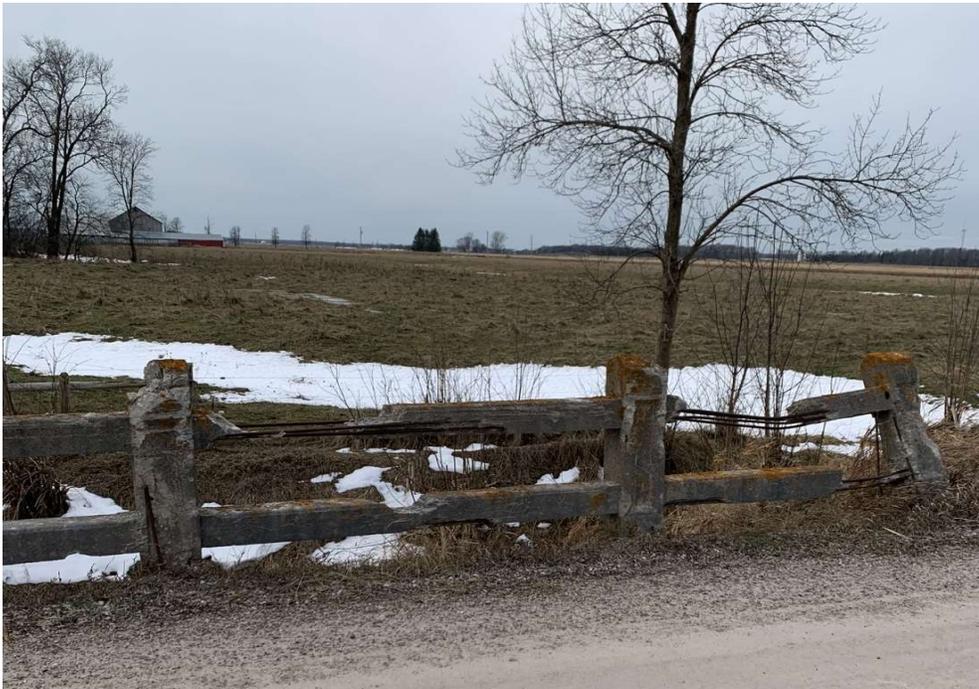
Photo 1-6 - Structure barrier and excessive granular fill on deck

Element Group:	Decks		Length:	9.1 m			
Element Name:	Deck Top		Width:	5.8 m			
Location:			Height:				
Material:	Concrete		Count:				
Element Type:			Total Quantity:	52.78 m ²			
Environment:	Moderate		Limited Insp'n:	Yes			
Protection System:							
Condition Data:	Units	Exc.	Good	Fair	Poor	Perform. Deficiencies	Maint. Needs
	m ²			52.78			
Comments:	Limited inspection of the top deck condition due to cover with granular wearing surface.						
Recommended Work:	None 6-10 Years		1-5 Years	<input checked="" type="checkbox"/> < 1 Year	Urgent		
	Grade out excess gravel and inspect the condition of the concrete deck top.

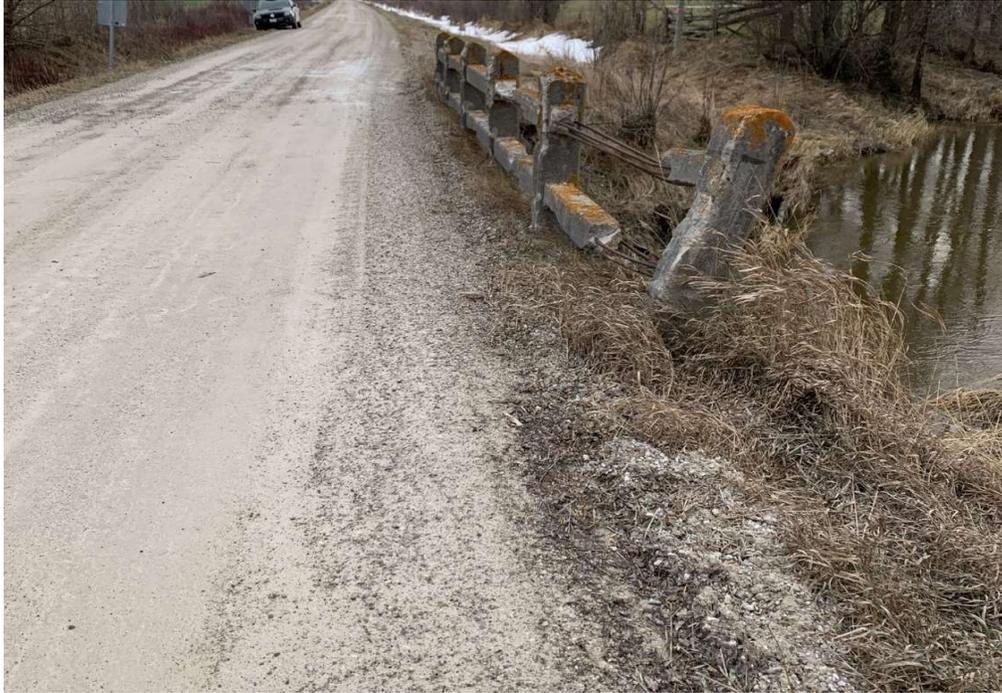
Photo 1-8 - Vegetation and debris accumulation along shoulders, potholes in wearing surface

Element Group:	Approaches		Length:	5 m			
Element Name:	Wearing Surface		Width:	5 m			
Location:			Height:				
Material:	Gravel		Count:	2			
Element Type:			Total Quantity:	50 m ²			
Environment:	Moderate		Limited Insp'n:				
Protection System:							
Condition Data:	Units	Exc.	Good	Fair	Poor	Perform. Deficiencies	Maint. Needs
	m ²			50			Yes
Comments:	Shoulder vegetation has started to encroach on the roadway. Minor potholes and wheel path rutting have developed at each approach.						
Recommended Work:	None 6-10 Years 1-5 Years <input checked="" type="checkbox"/> < 1 Year Urgent Grade the shoulders and clear the encroaching vegetation.

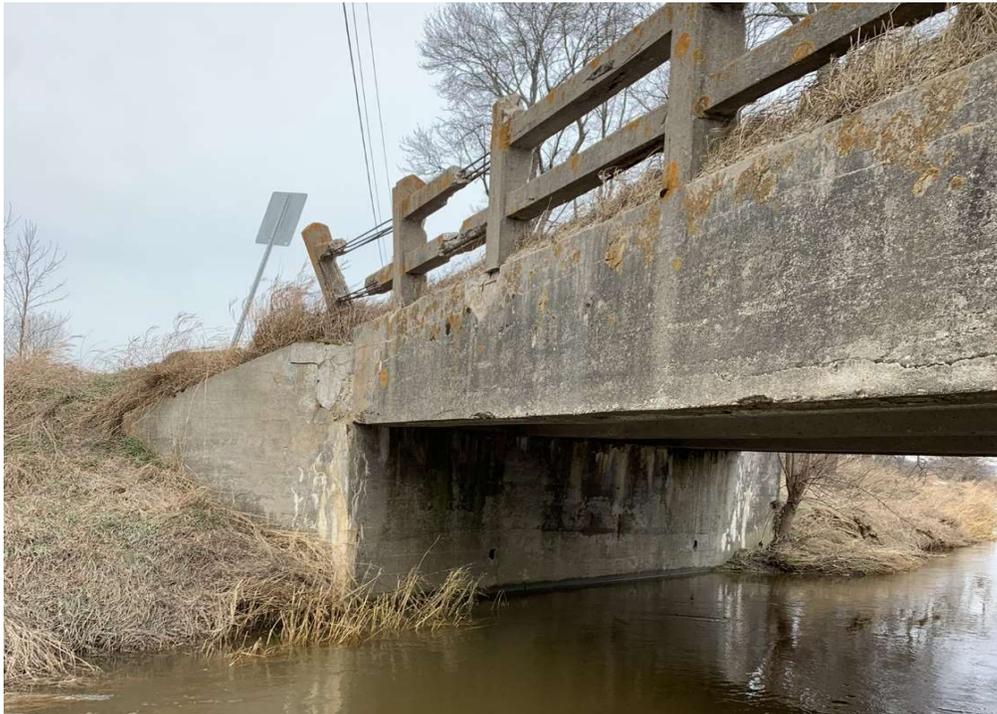
Photo 1-9 - Structure elevation, exterior soffit, curb and barrier

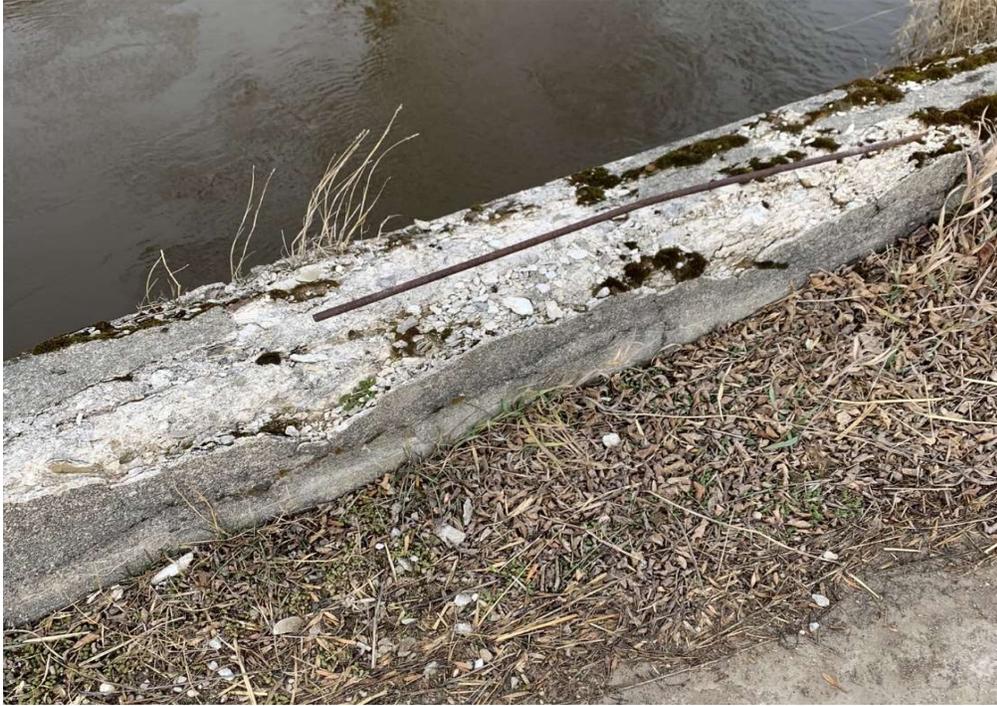
Photo 2-2: Spalling of exterior curb

Element Group:	Curbs/Sidewalk		Length:	14 m			
Element Name:	Curbs		Width:	0.31 m			
Location:	Each Side		Height:	0.31 m			
Material:	Concrete		Count:	2			
Element Type:			Total Quantity:	2.69 m ²			
Environment:	Severe		Limited Insp'n:				
Protection System:	None						
Condition Data:	Units	Exc.	Good	Fair	Poor	Perform. Deficiencies	Maint. Needs
	m ²			1.08	1.61	Yes	Yes
Comments:	No barrier currently in place and the structure is debris covered. The exterior curb (south side) has heavy delaminations, the north side has some delamination. Reduce the speed limit to 35 km/hr until barrier protection is installed to Code.						
Recommended Work:	None	6-10 Years	1-5 Years (Replace)	< 1 Year	Urgent (Barrier Protection)		
	Install barrier to provide required vehicle safety, repair concrete and clear debris.

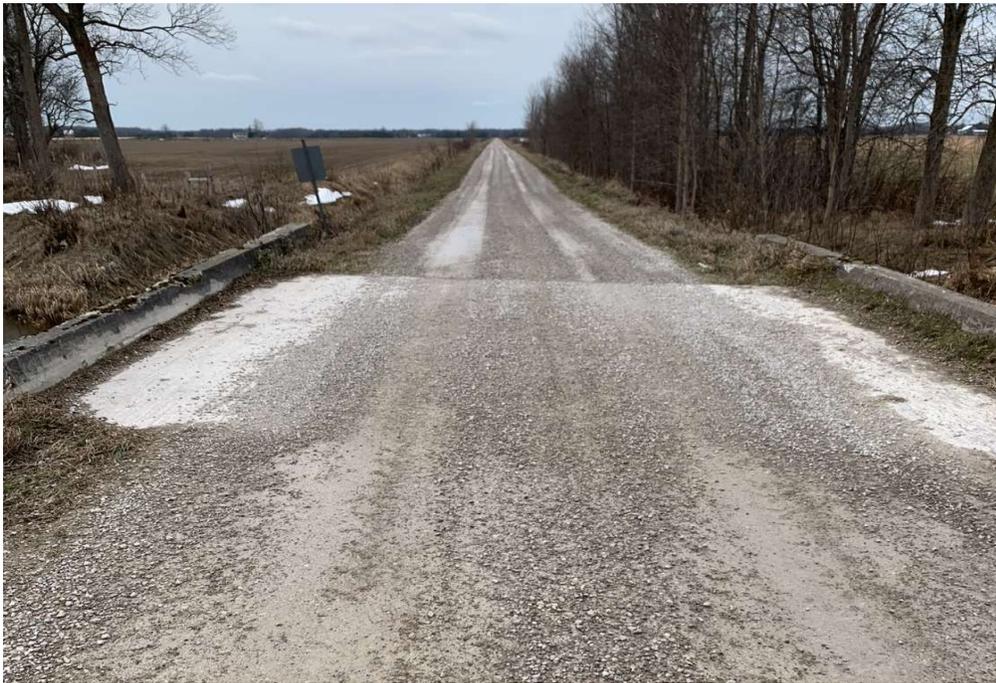
Photo 2-3: Structure deck

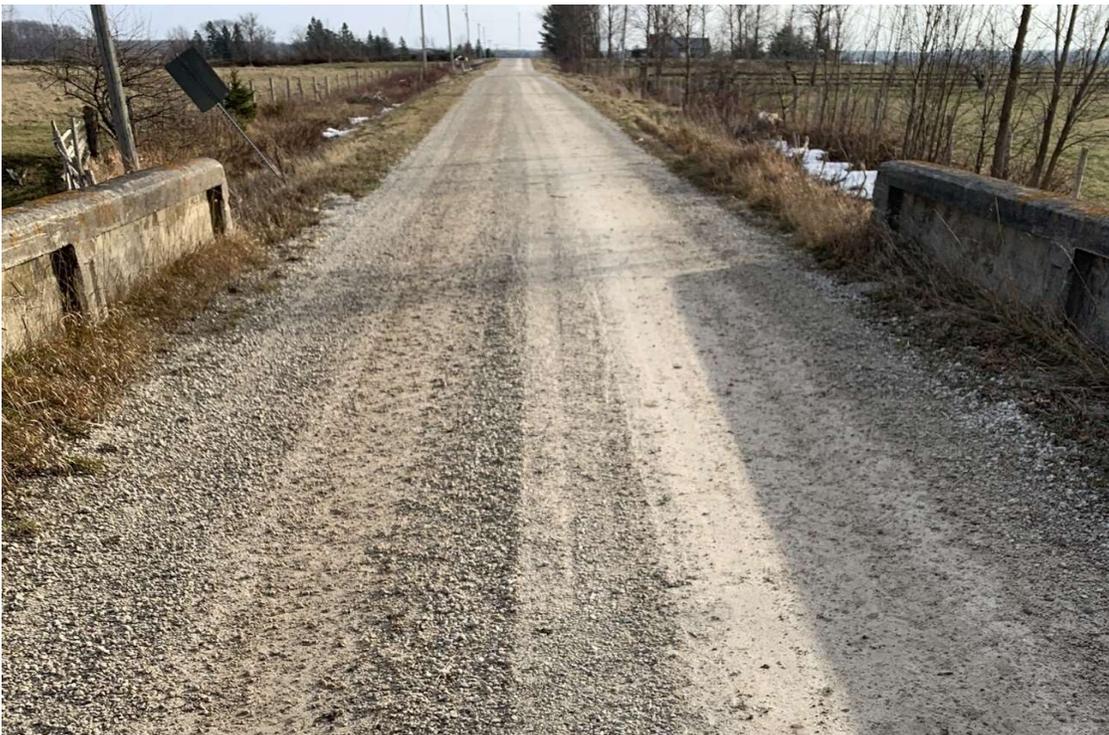
Photo 3-5: Structure and approach wearing surface with wheel path rutting and encroaching vegetation

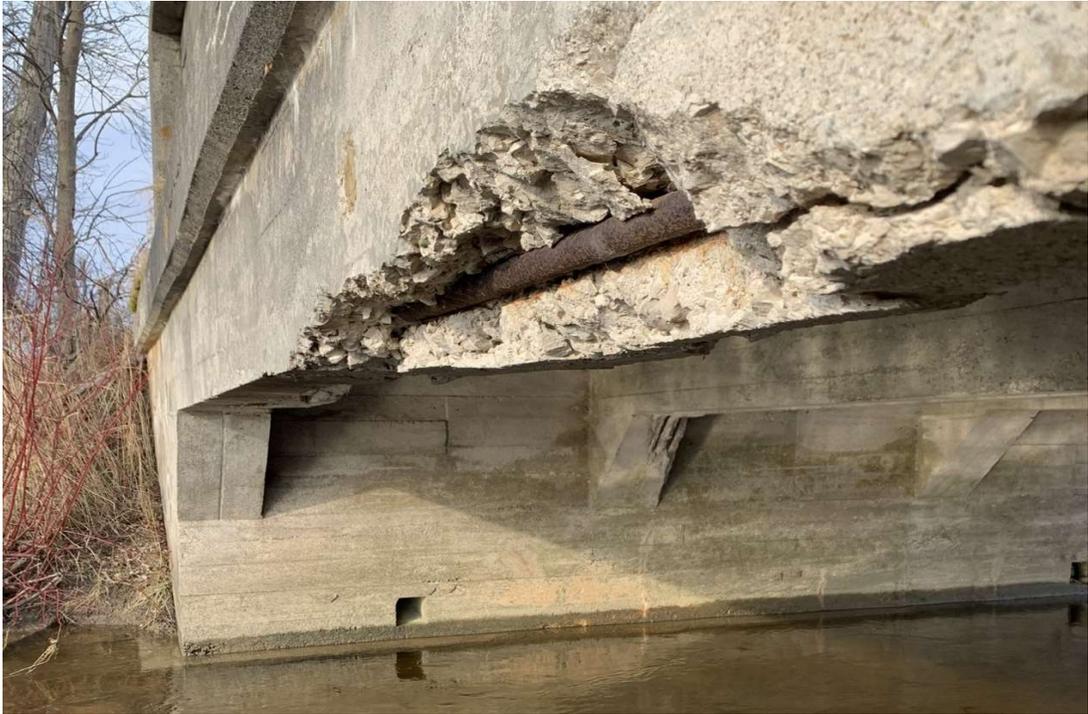
Photo 3-8: Exterior girder delamination and spalling

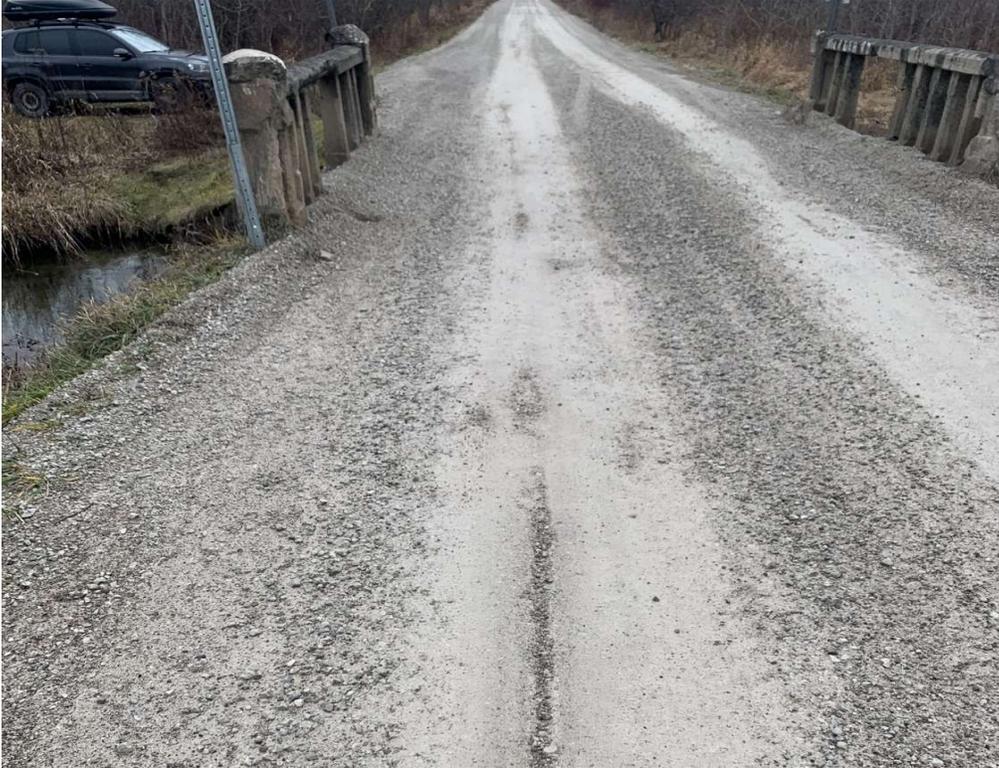
Photo 4-5: Wearing surface deterioration

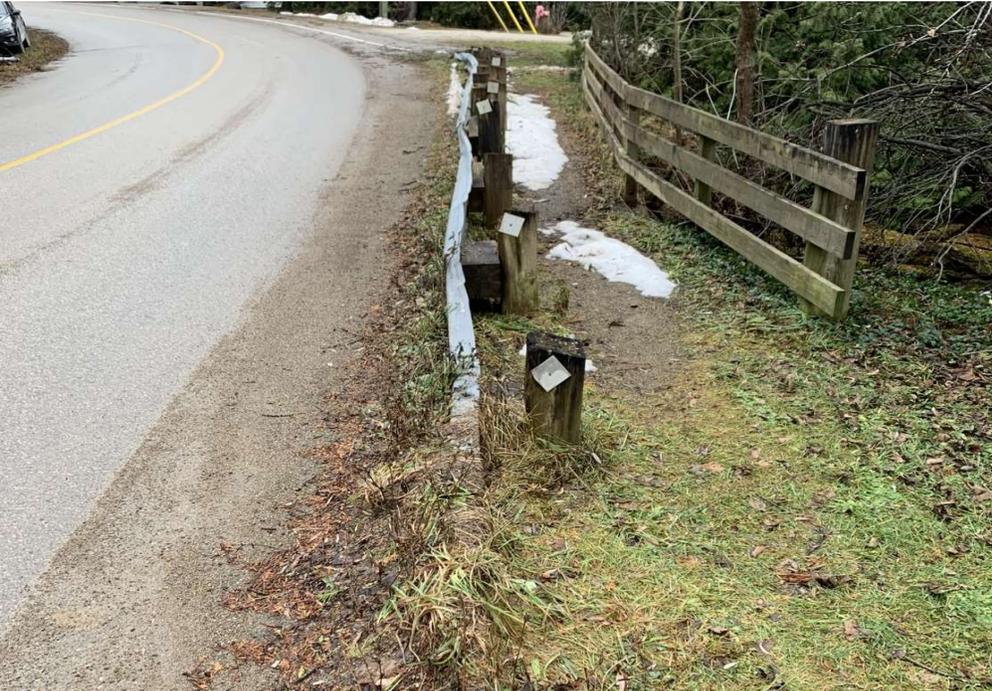
Photo 5-3: Impact damage to southeast barrier protection

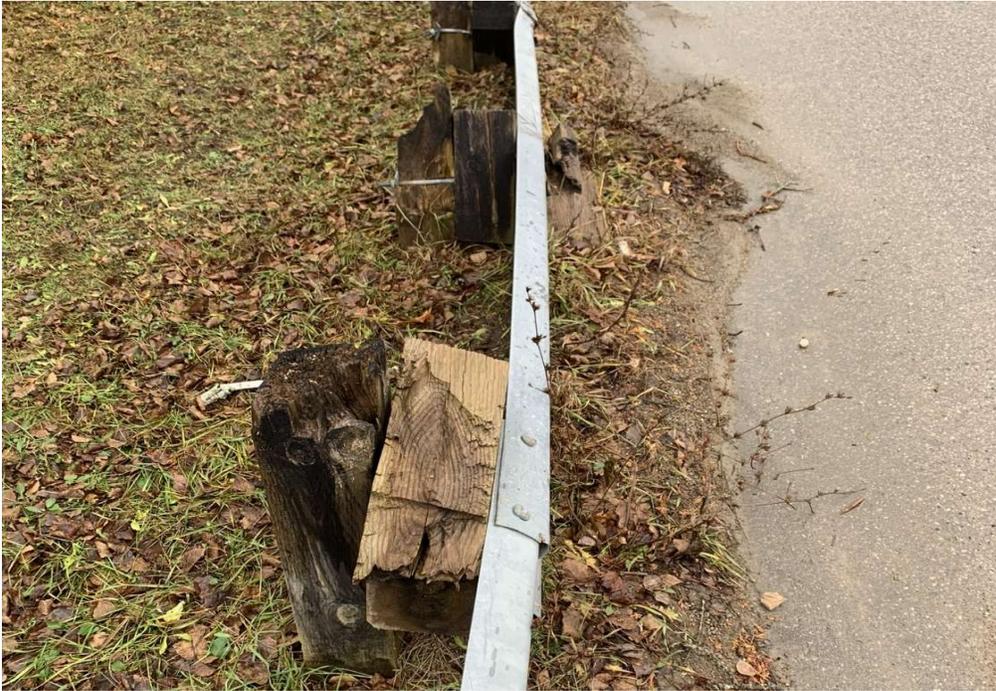
Photo 5-4: Wooden barrier post rot (typical)

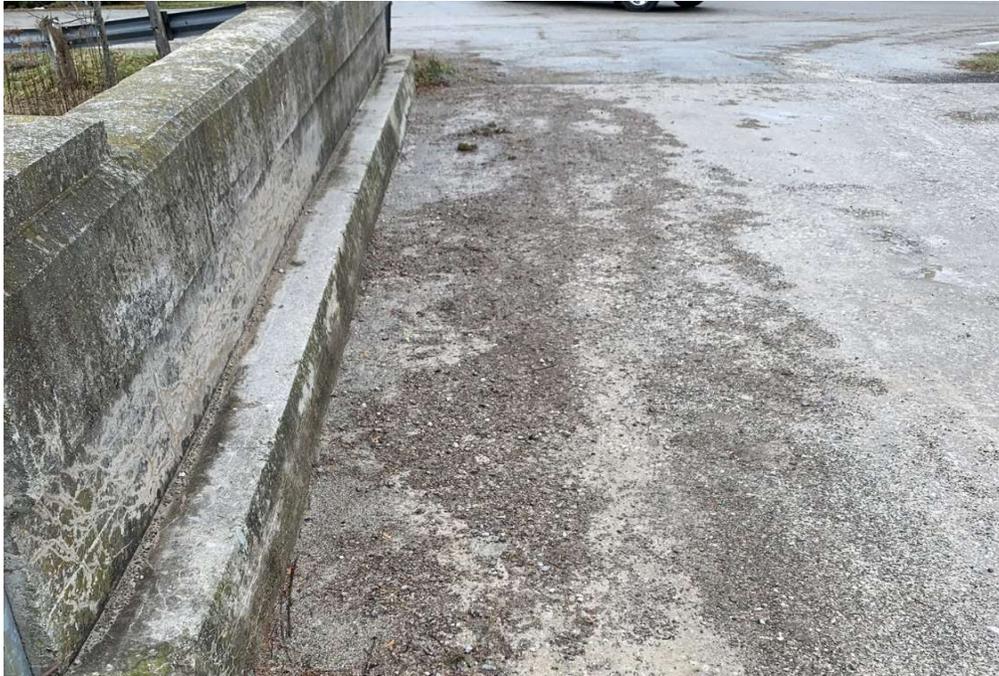
Photo 6-2: View of structure deck with delamination

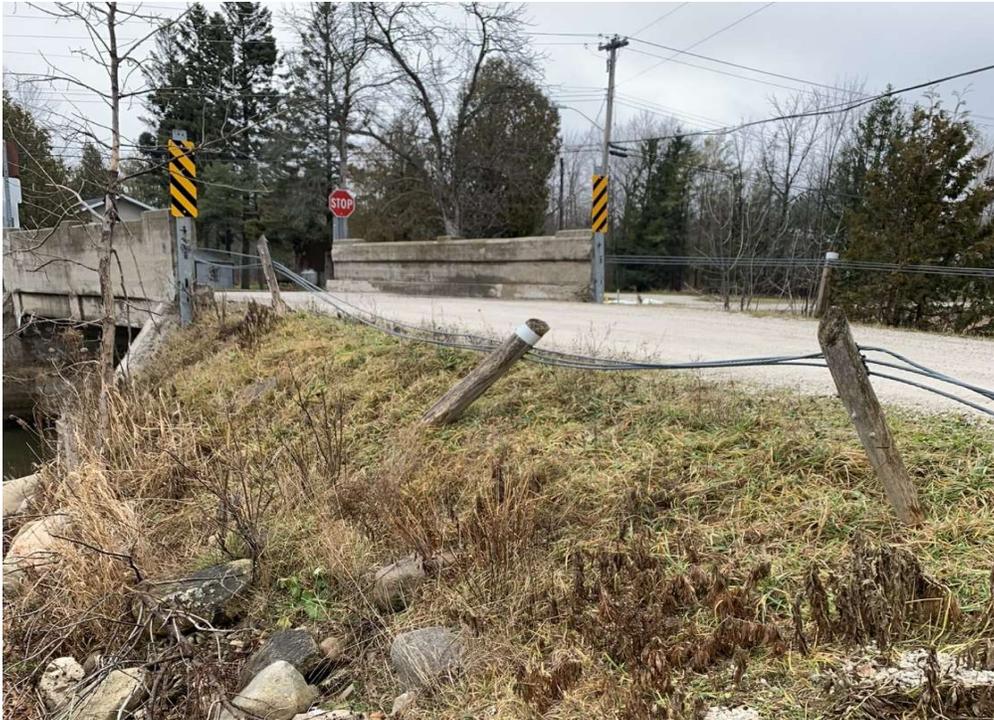
Photo 6-12: Embankment and deficient barrier protection

Element Group:	Approaches		Length:				
Element Name:	Guiderail		Width:				
Location:			Height:				
Material:	Steel/Timber		Count:				
Element Type:	3 - Cable and Flex Beam		Total Quantity:				
Environment:	Severe		Limited Insp'n:				
Protection System:	Galvanized						
Condition Data:	Units	Exc.	Good	Fair	Poor	Perform. Deficiencies	Maint. Needs
	%			25	75	Yes	Yes
Comments:	The configuration of the flex beam on the north side of the structure does not meet Code. There are missing intermediate posts, improper connections to the structure parapet walls, and lack end protection. The 3-cable guiderail on the south approach is set too high, the cable is loose, several posts are broken, and the structure connection is not to code.						
Recommended Work:	None 6-10 Years <input type="checkbox"/> 1-5 Years <input checked="" type="checkbox"/> < 1 Year Urgent Upgrade the north approach barrier protection and structure connection to meet current code. Replace the 3-cable south side barrier with flex beam.

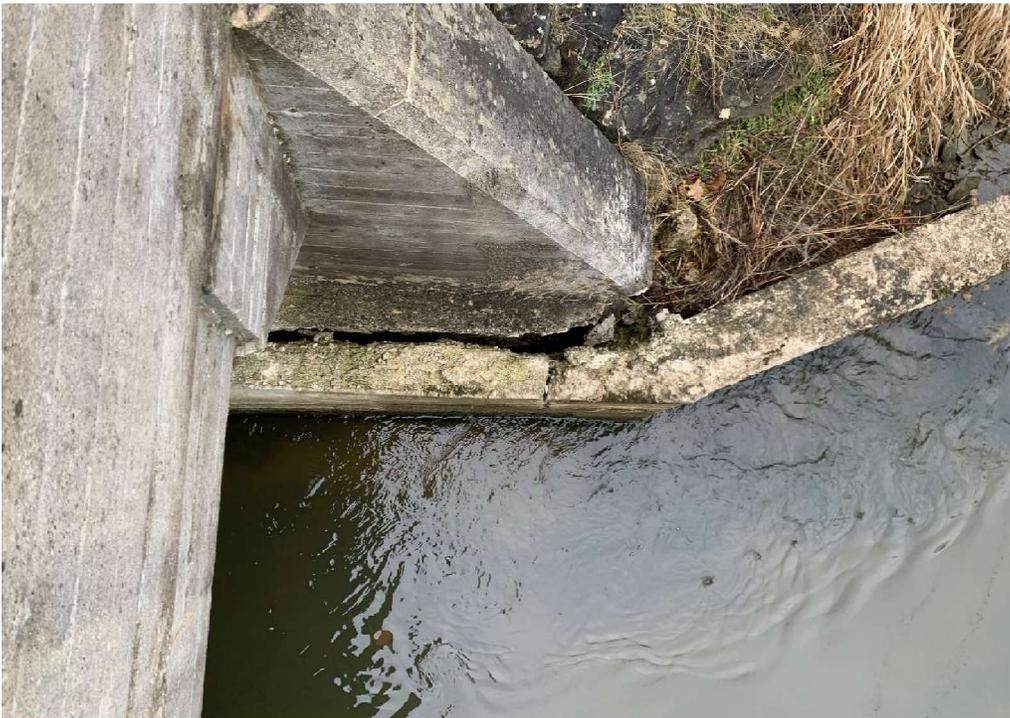
Photo 6-13: Wingwall and footing separation.

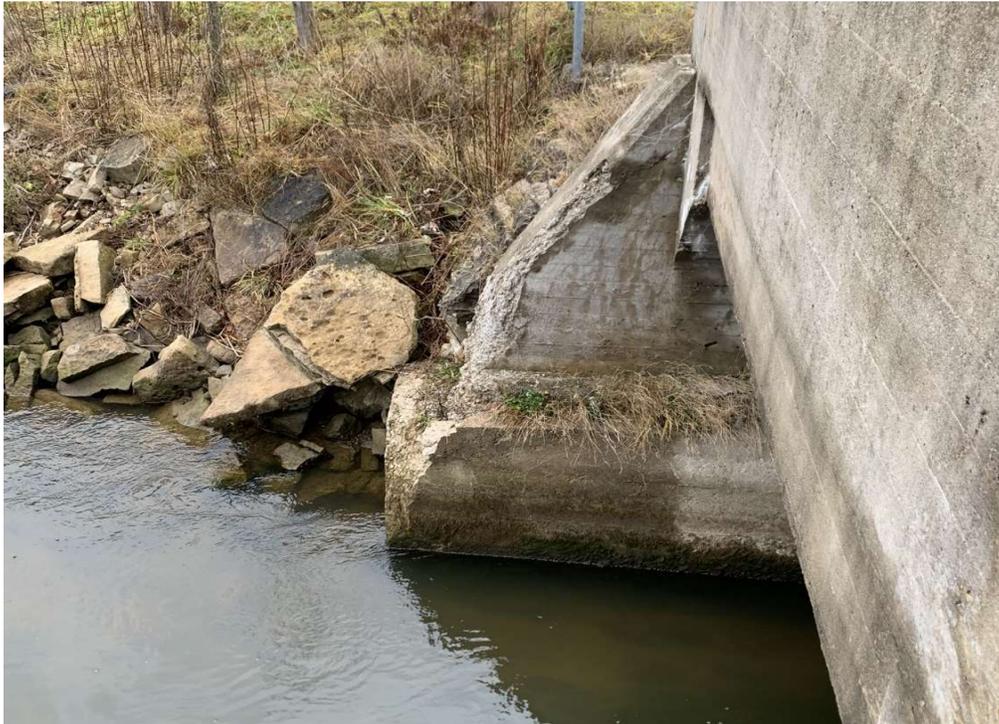
Photo 6-15: View of abutment wall and footing spalling.

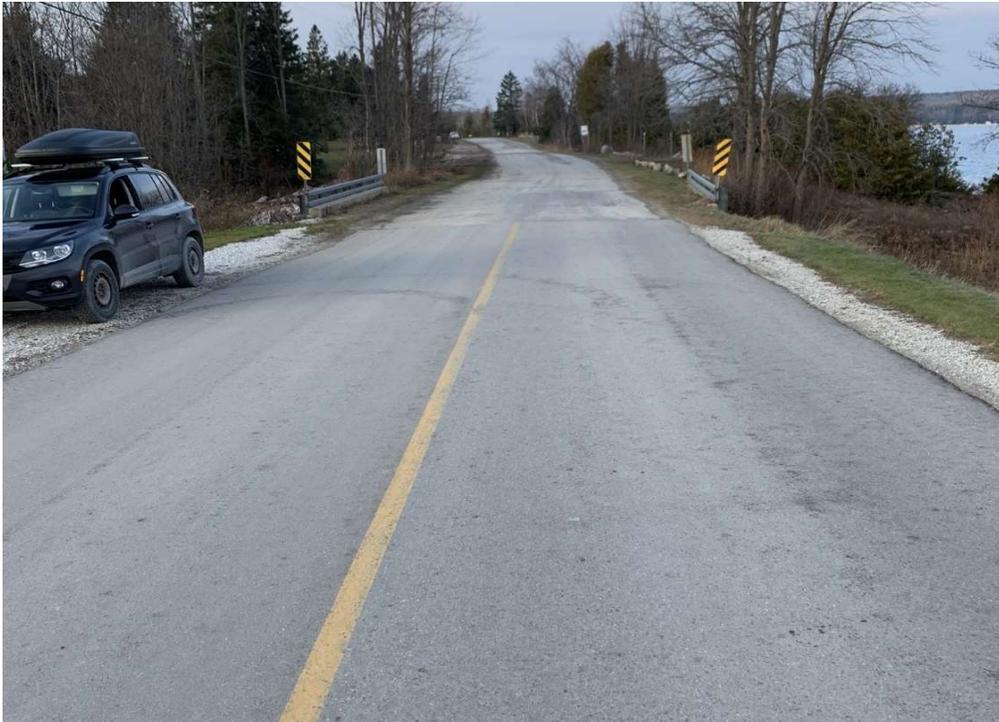
Photo 8-2: View of structure barrier, signage (typ) and encroaching vegetation

Element Group:	Approaches		Length:				
Element Name:	Drainage		Width:				
Location:			Height:				
Material:	Asphalt		Count:				
Element Type:			Total Quantity:				
Environment:	Severe		Limited Insp'n:				
Protection System:							
Condition Data:	Units	Exc.	Good	Fair	Poor	Perform. Deficiencies	Maint. Needs
	%			90	10	Yes	Yes
Comments:	Poor drainage along shoulders signs of water ponding observed.						
Recommended Work:	None 6-10 Years <input checked="" type="checkbox"/> 1-5 Years < 1 Year Urgent Rehab - re-establish adequate platform crossfall during road resurfacing. Maintenance - clear shoulder debris and vegetation and grade for drainage

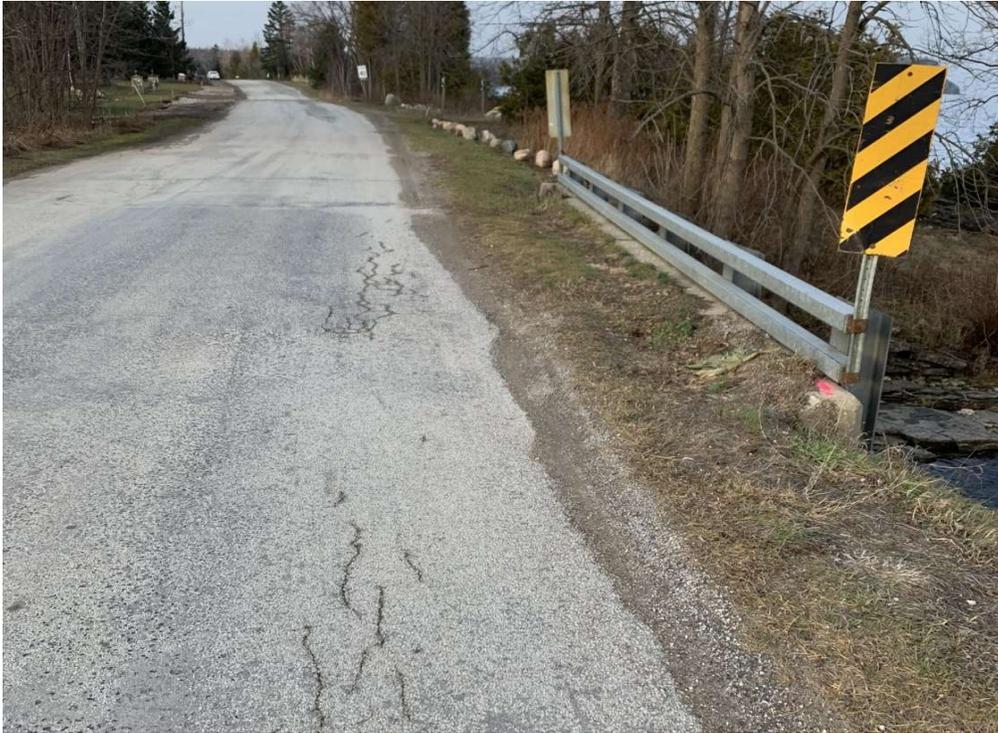
Photo 8-4: Deficient barrier termination and hazard signage

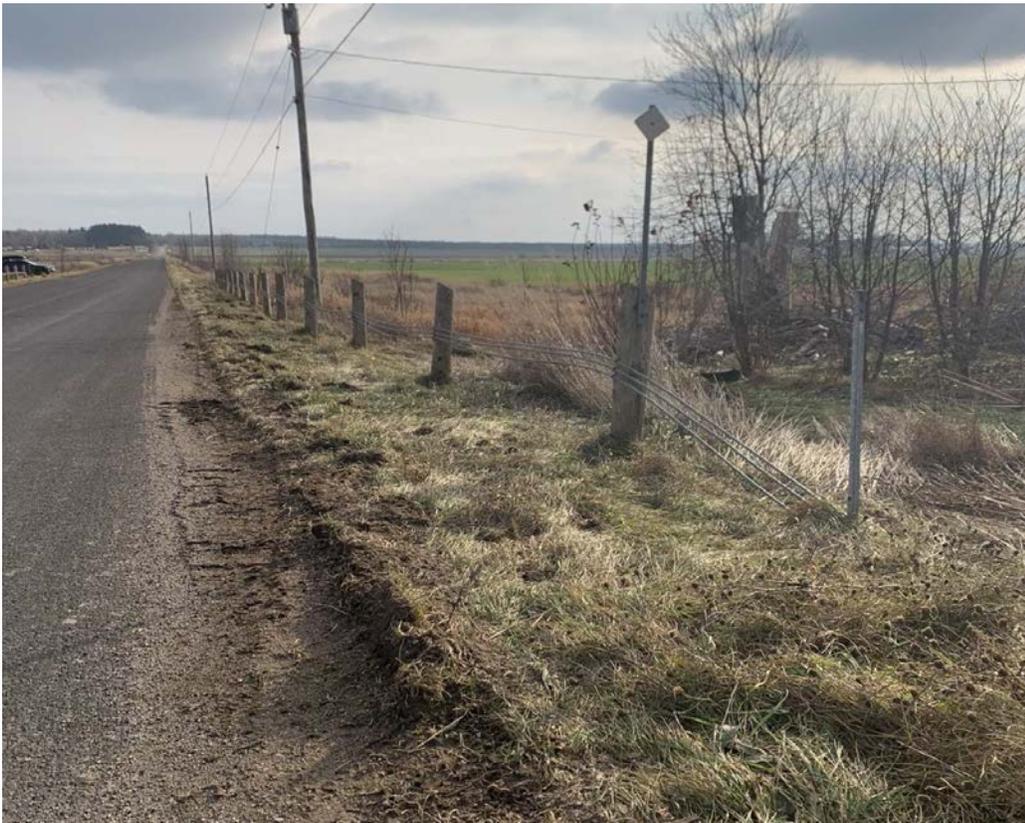
Photo 9-5 - View of 3 cable guiderail barrier protection with loose cable

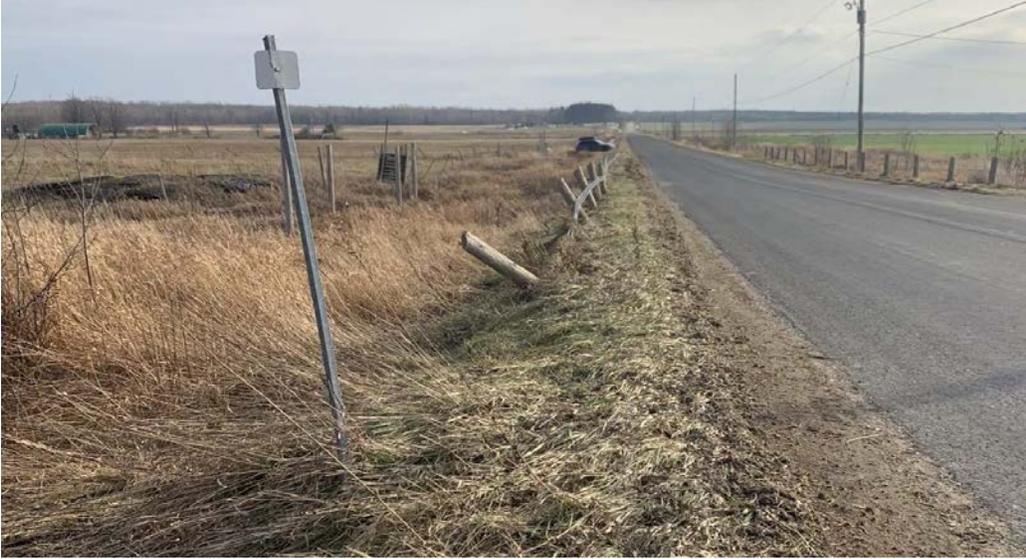
Photo 9-8 - View of northeast deficient section of 3 cable guiderail (impact damage)

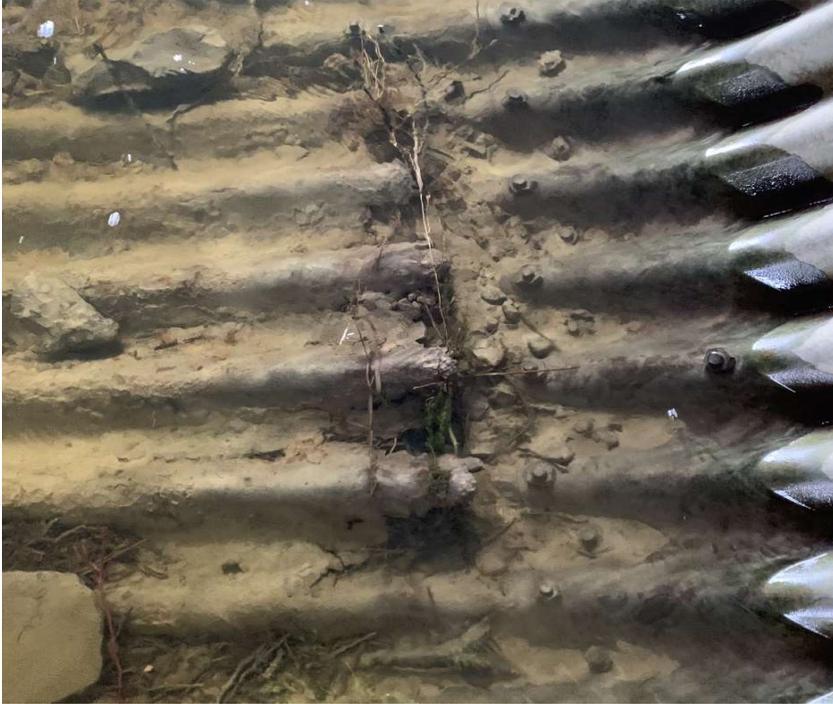
Photo 10-6: Localized failure with complete section loss in base of culvert.

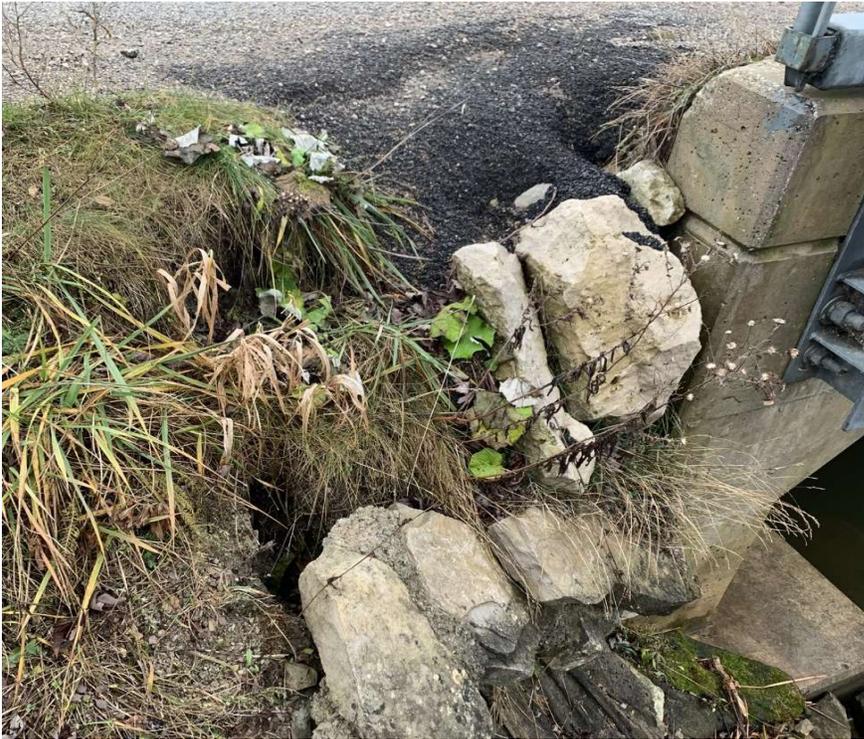
11-5: Rock slope protection and geotextile failure at the southeast quadrant

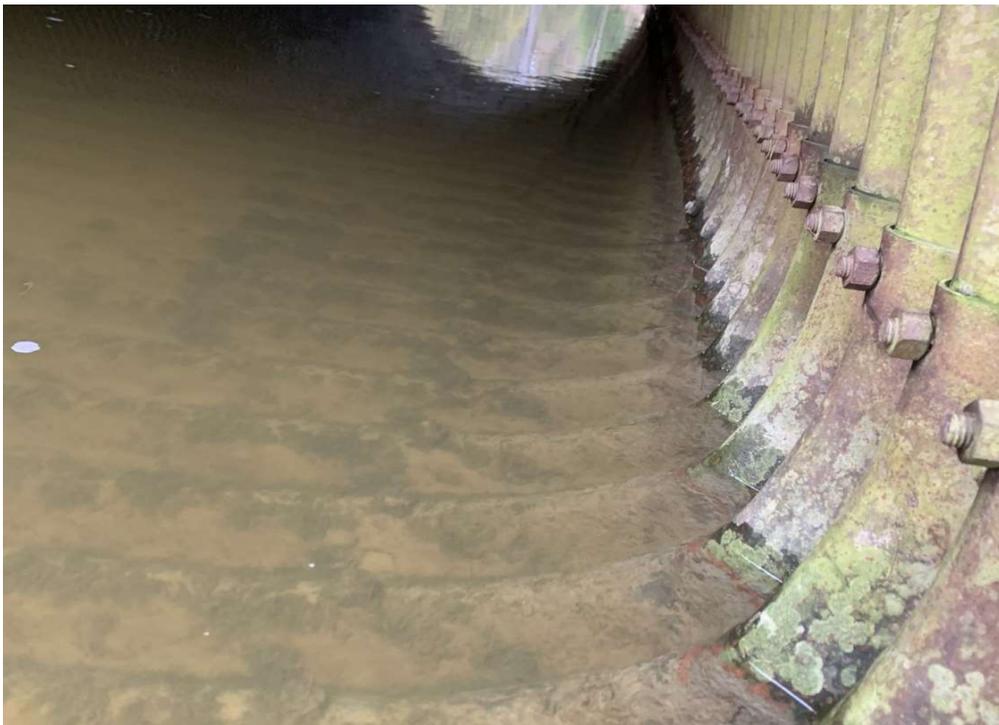
Photo 12-9: View of culvert barrel corrosion at the waterline (typical)

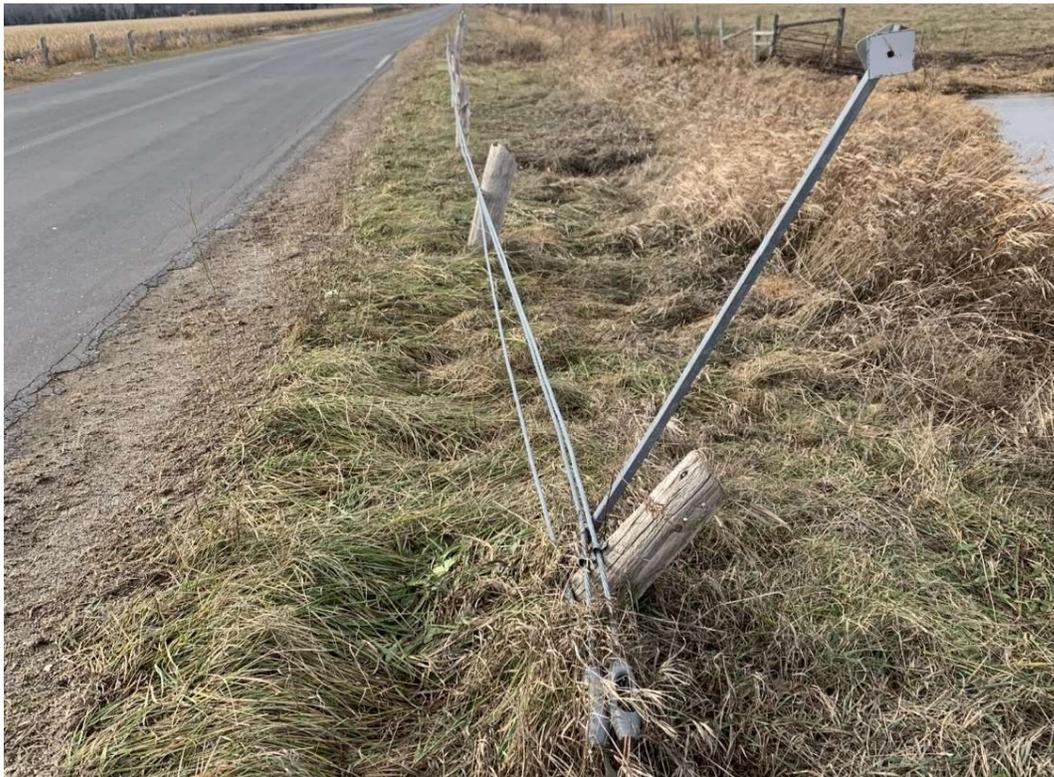
Photo 19-5: Impact damage to the northeast barrier protection post
