#### MUNICIPALITY OF NORTHERN BRUCE PENINSULA

## 2024 STRUCTURE INSPECTION REPORT

FINAL PROJECT NO.: CA0043256.3165 DATE: MARCH 06, 2025

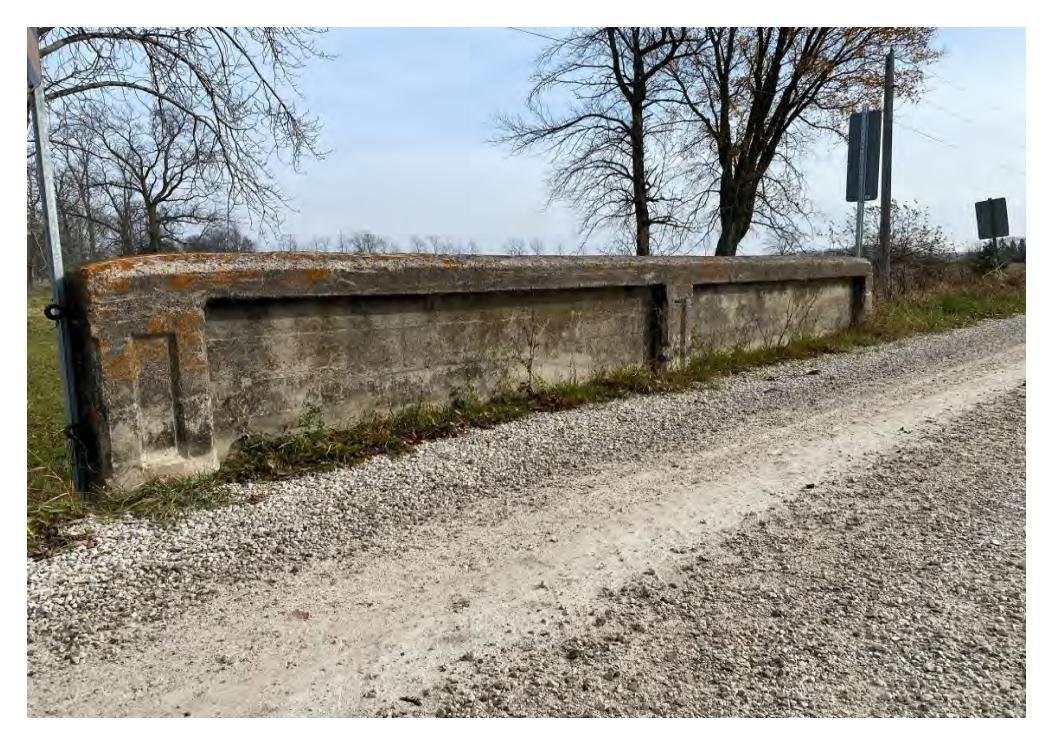
Photo 3-5: Barrier/parapet wall and wearing surface with wheel path rutting and encroaching vegetation

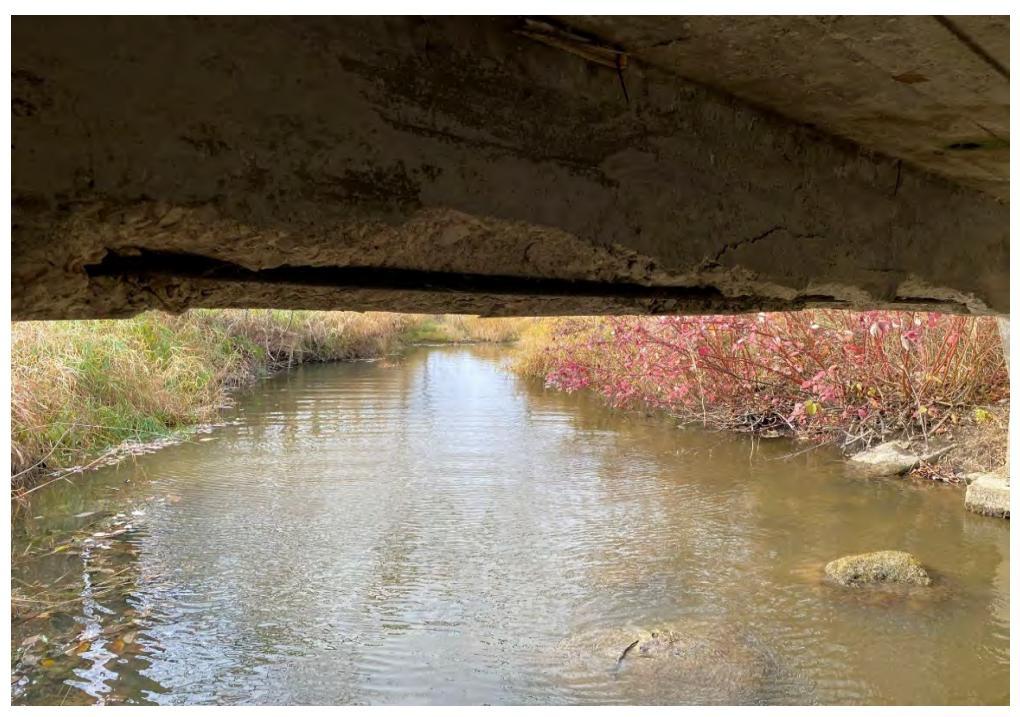
Photo 3-8: Exterior girder delamination and spalling

Element Group:	Beams/MLE	's	Length:	7			
Element Name:	Girders		Width:	0.33			
Location:			Height:	0.48			
Material:	Concrete		Count:	4			
Element Type:			Total Quantity:		3	6.12	
Environment:	Moderate		Limited Insp'n:				
Protection System:							
Condition Data:	Units	Exc.	Good	Fair	Poor	Perform. Deficiencies	Maint. Needs
	m <sup>2</sup>			25.284	10.836	Yes	Yes
Comments:       Severe spalling with exposed rebar observed on both exterior girders. Moderate cracking and severe spalling with exposed rebar observed on interior girders.         Recommended Work:       None       6-10 Years       1-5 Years       < 1 Year       Urgent Remove delaminated/unsound concrete, clean the rebar and pour new concrete.						and

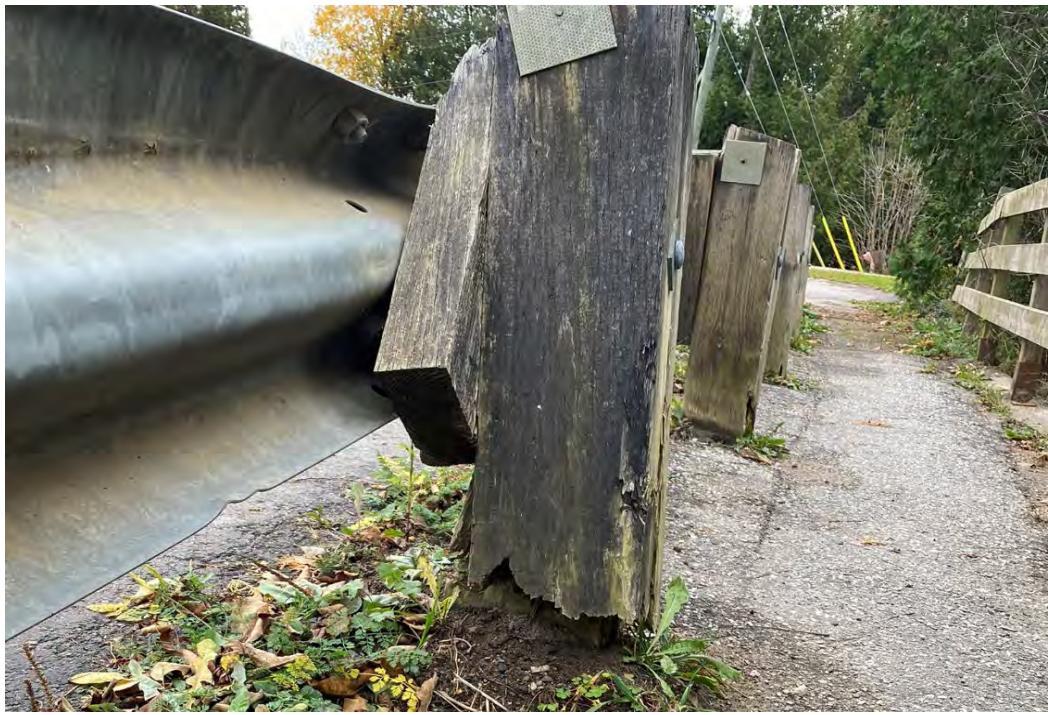
Photo 5-6: Wooden structure barrier post rot (typ.)

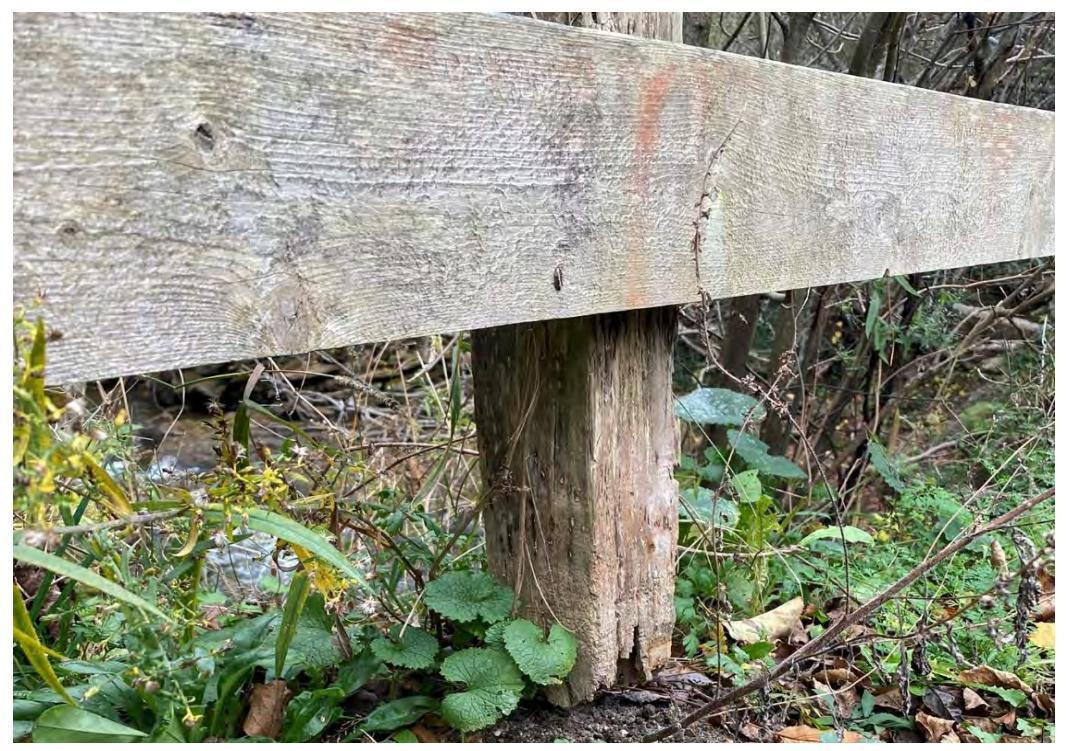
Photo 5-7: Wooded pedestrian barrier post rot

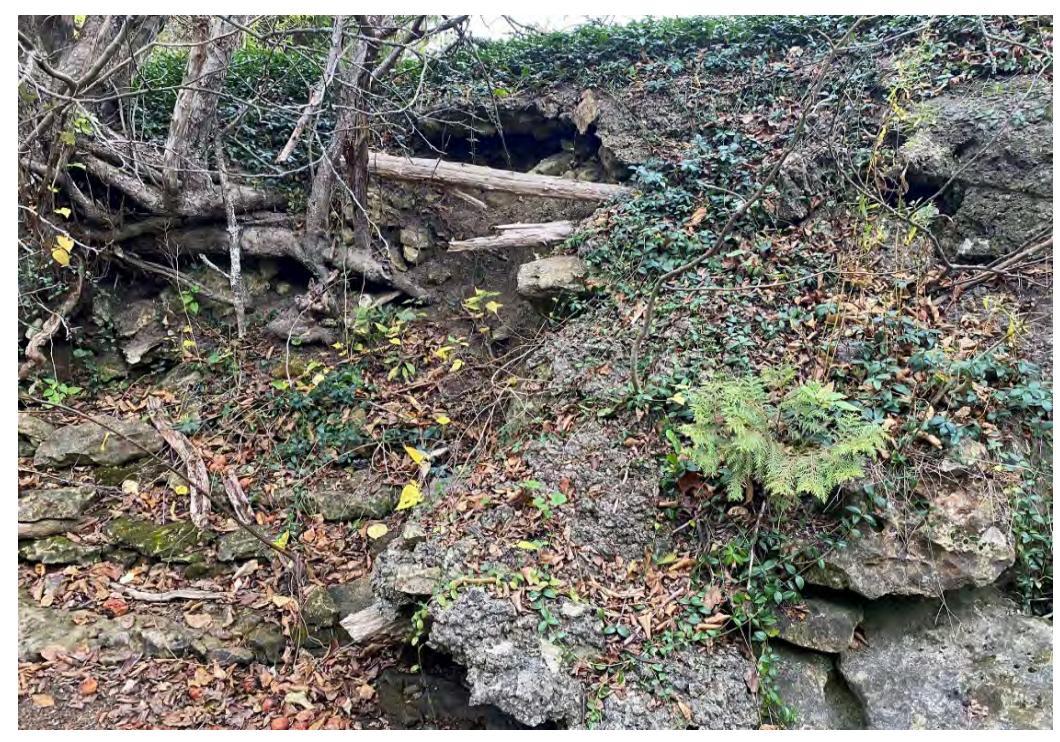
Photo 5-8: View of southwest embankment erosion

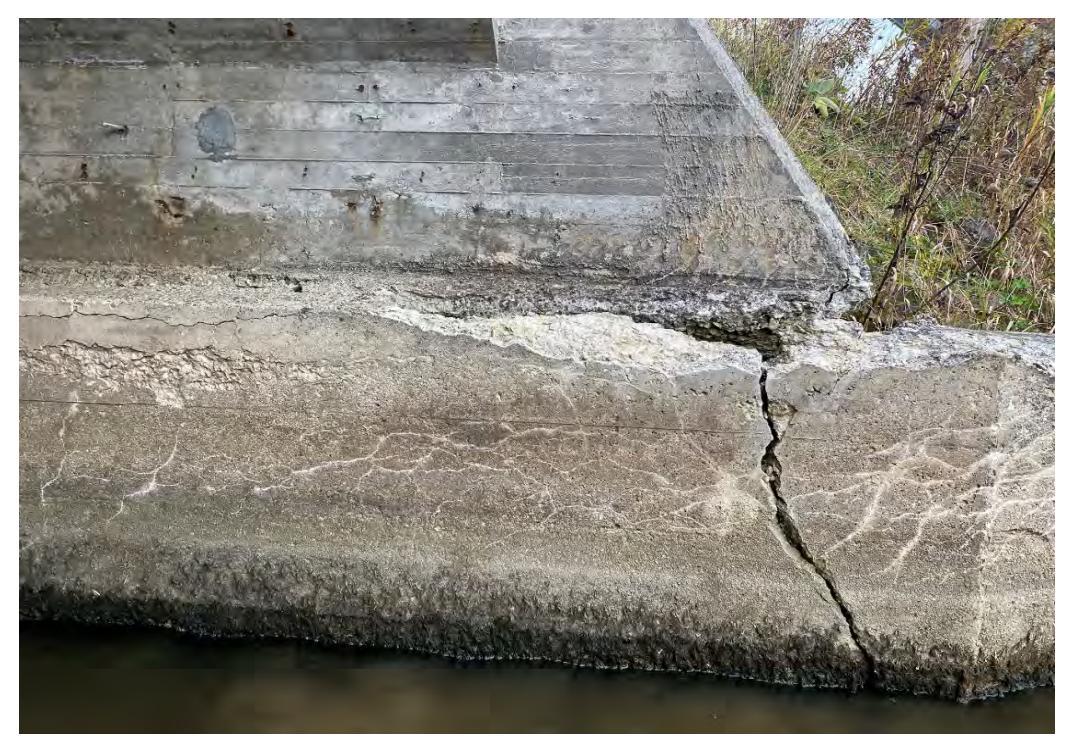
Photo 6-11: View or northeast wingwall cracking and separation from abutment wall

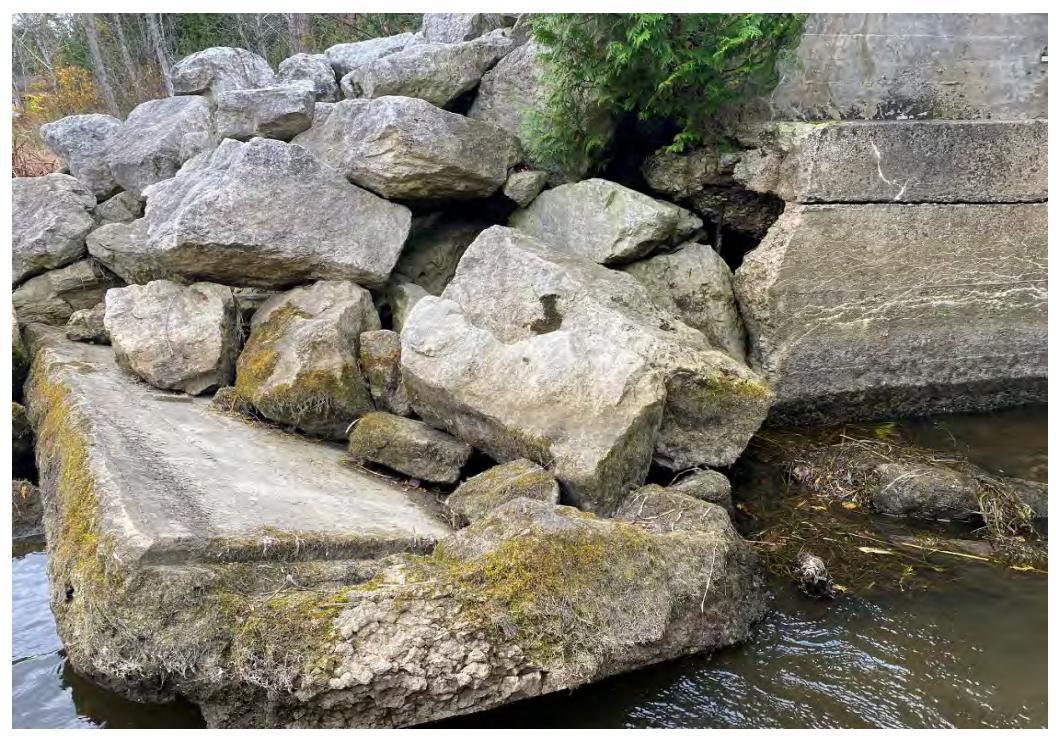
Photo 6-12: View of scour and exposed bar behind south abutment wall

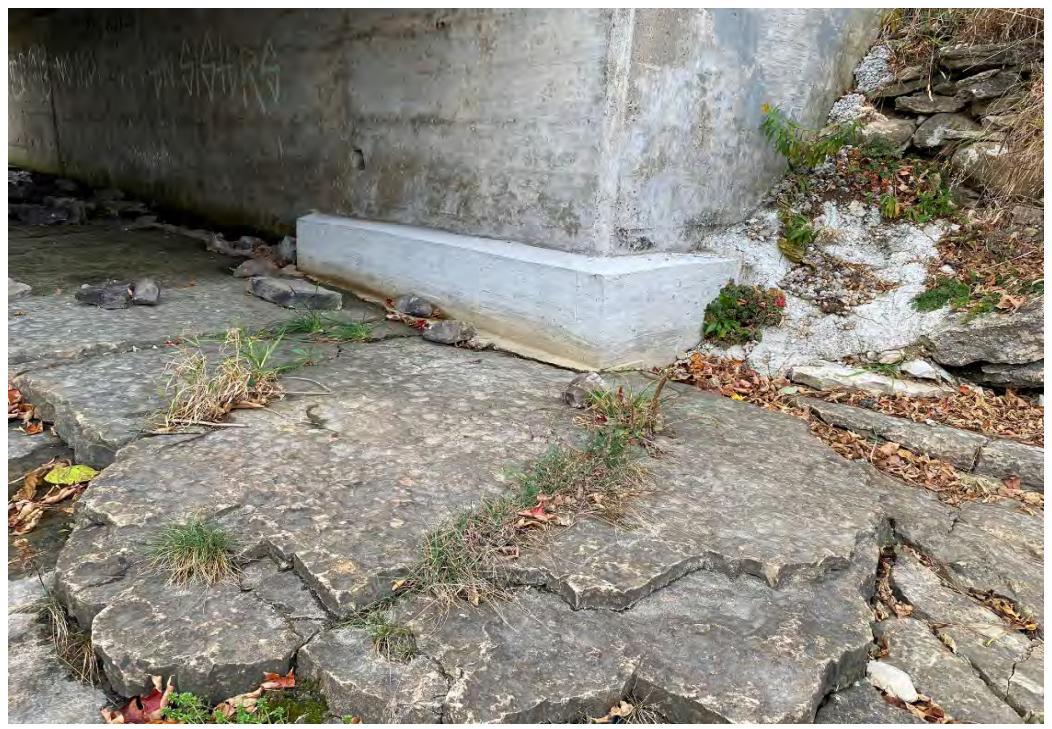
Photo 8-8: View of east foundation/wingwall concrete repairs

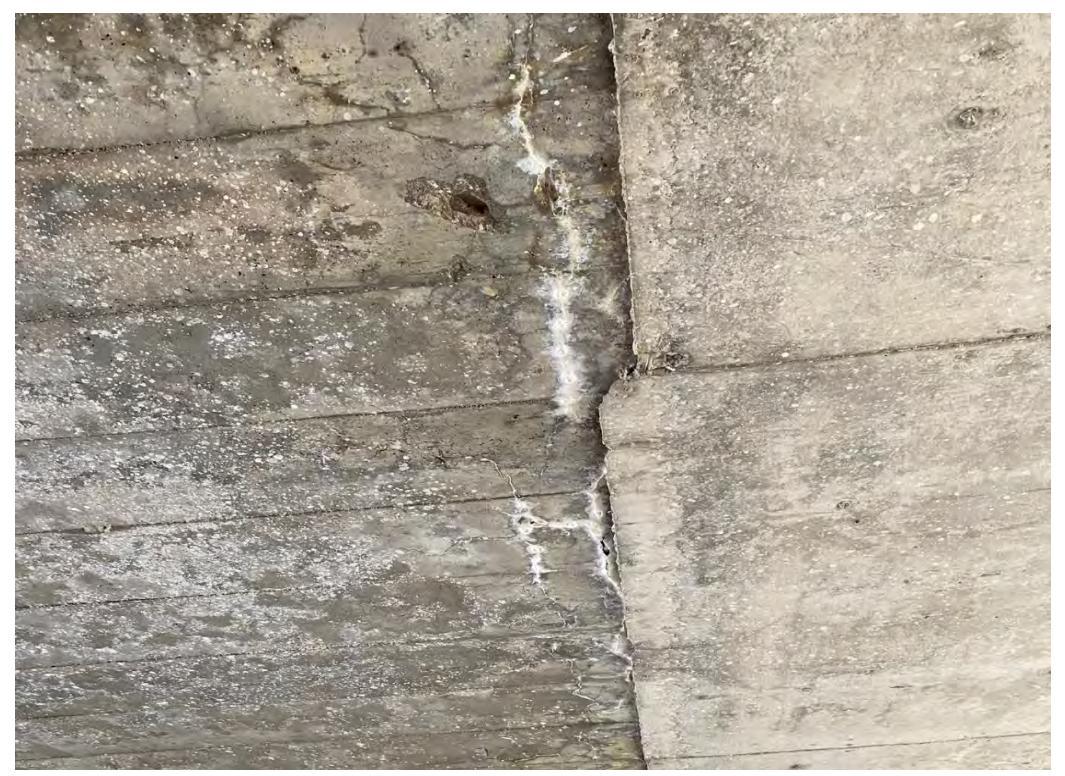
Photo 8-9: View of soffit cracking with efflorescence

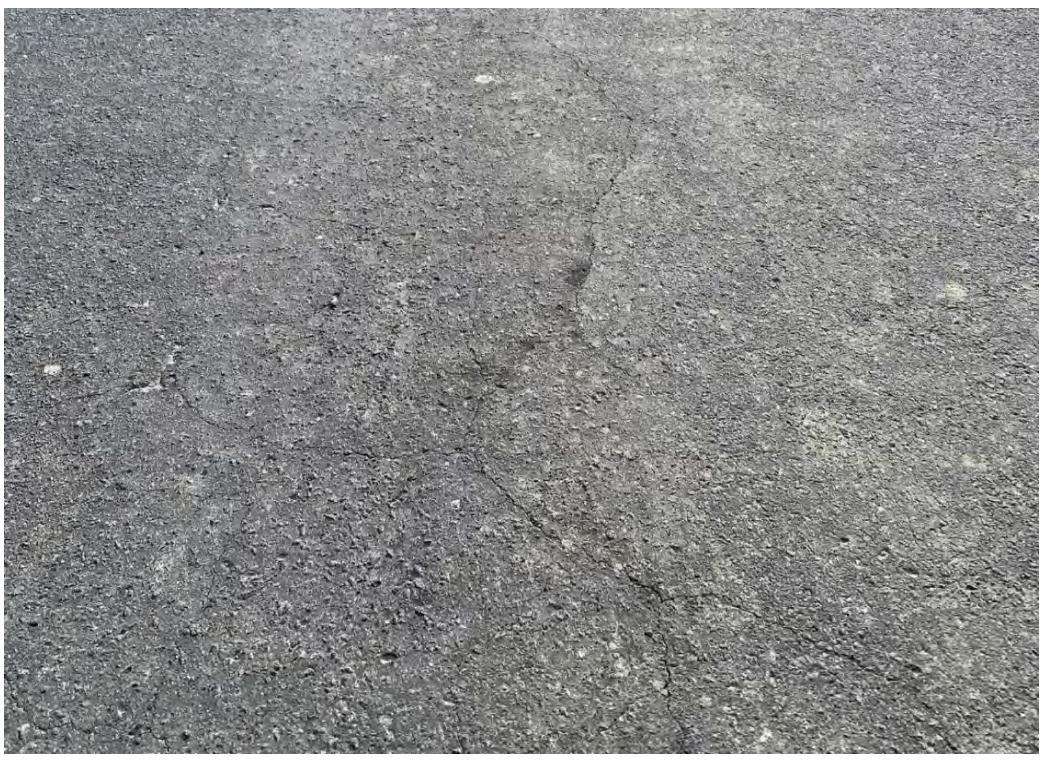
Photo 9-4 - View of wearing surface cracking

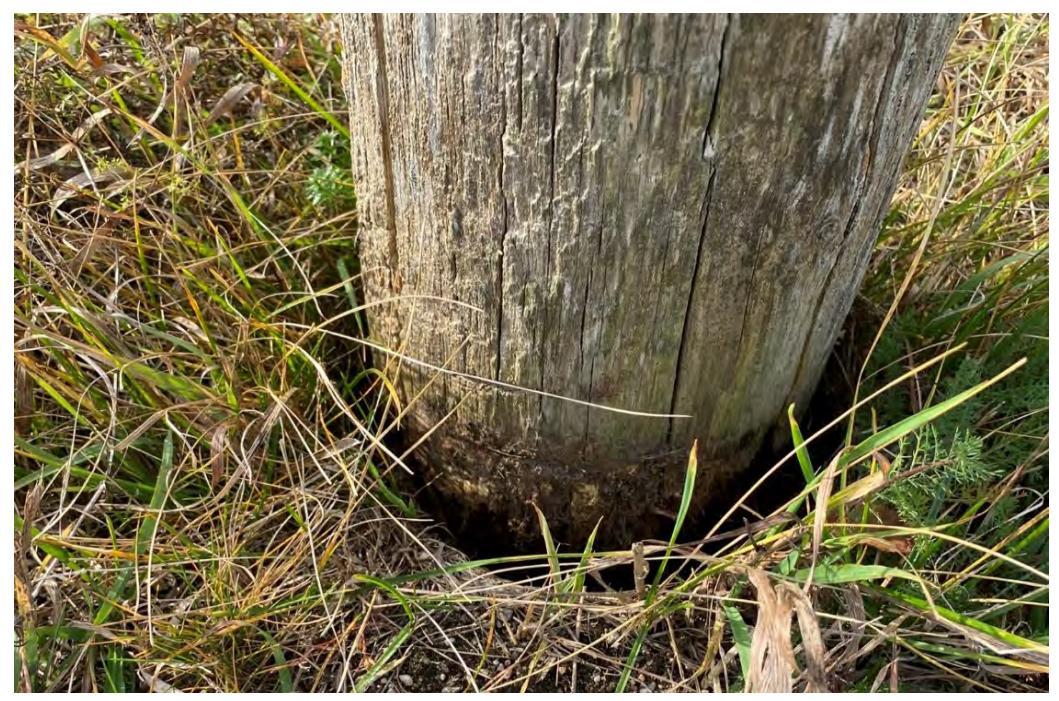
Photo 9-5 - View of rotten/loose barrier post base

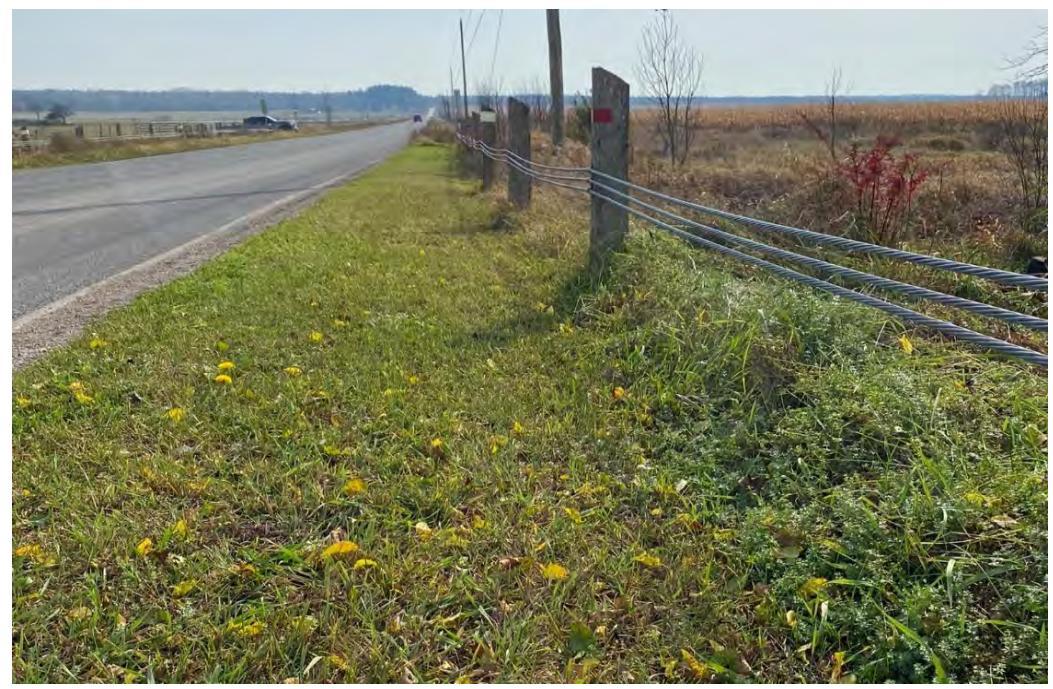
Photo 9-6 - View of loose guiderail cable

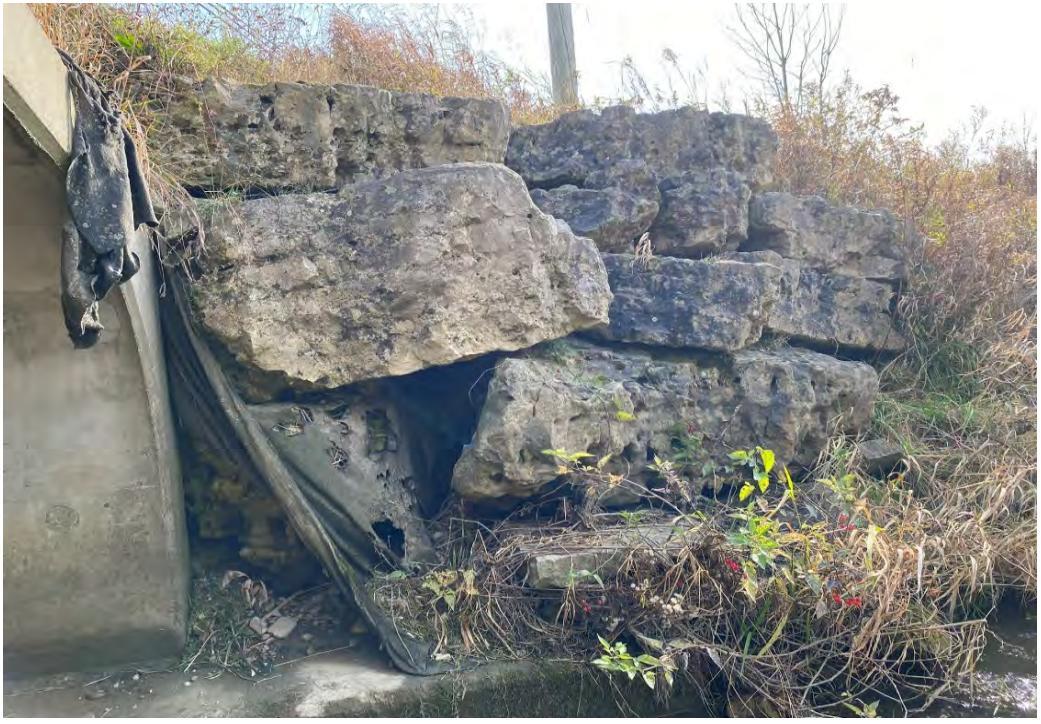
Photo 9-7 - View of erosion between rock protection

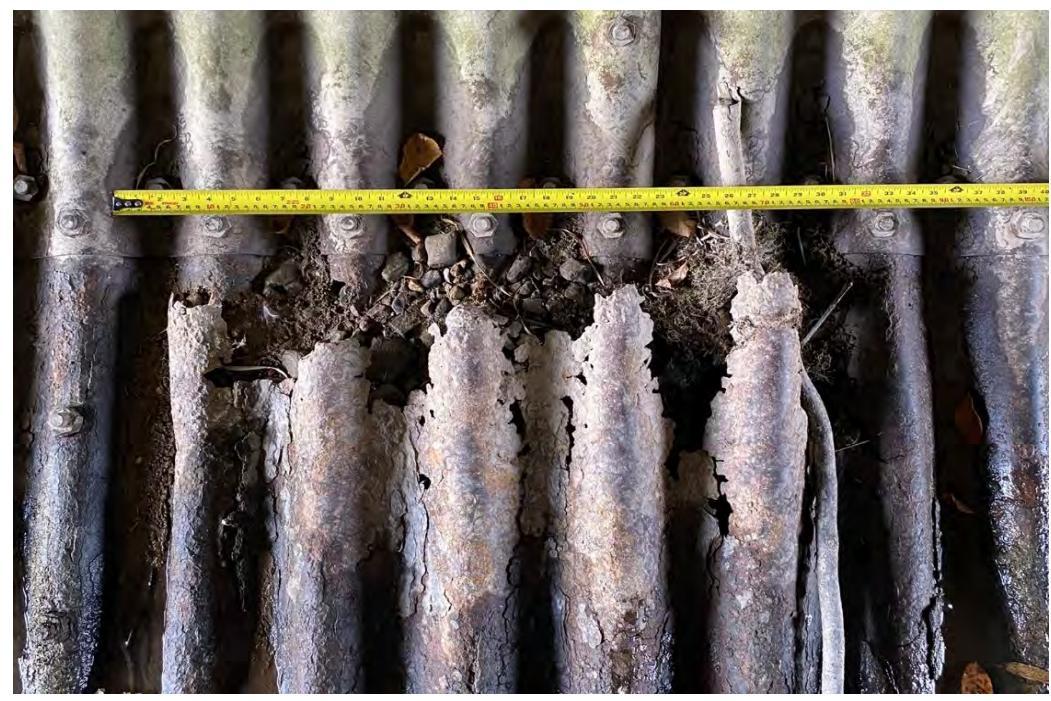
Photo 10-6: Localized failure with complete section loss in base of culvert.

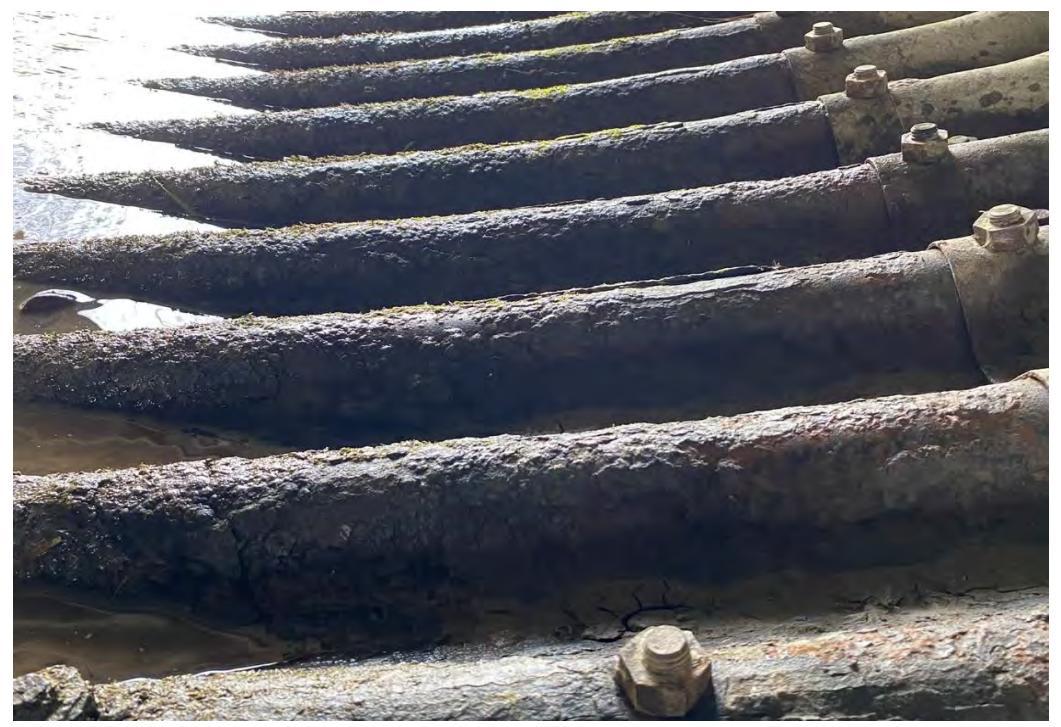
Photo 10-7: Corrosion and section loss at base of culvert

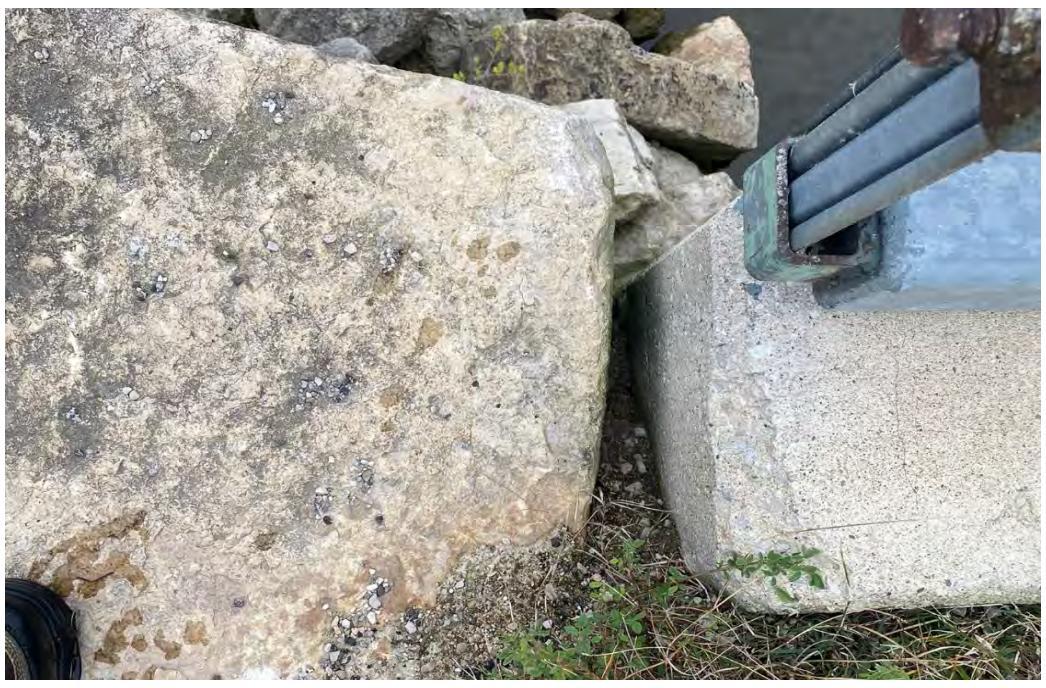
11-8: View of erosion at curb termination (typ.)

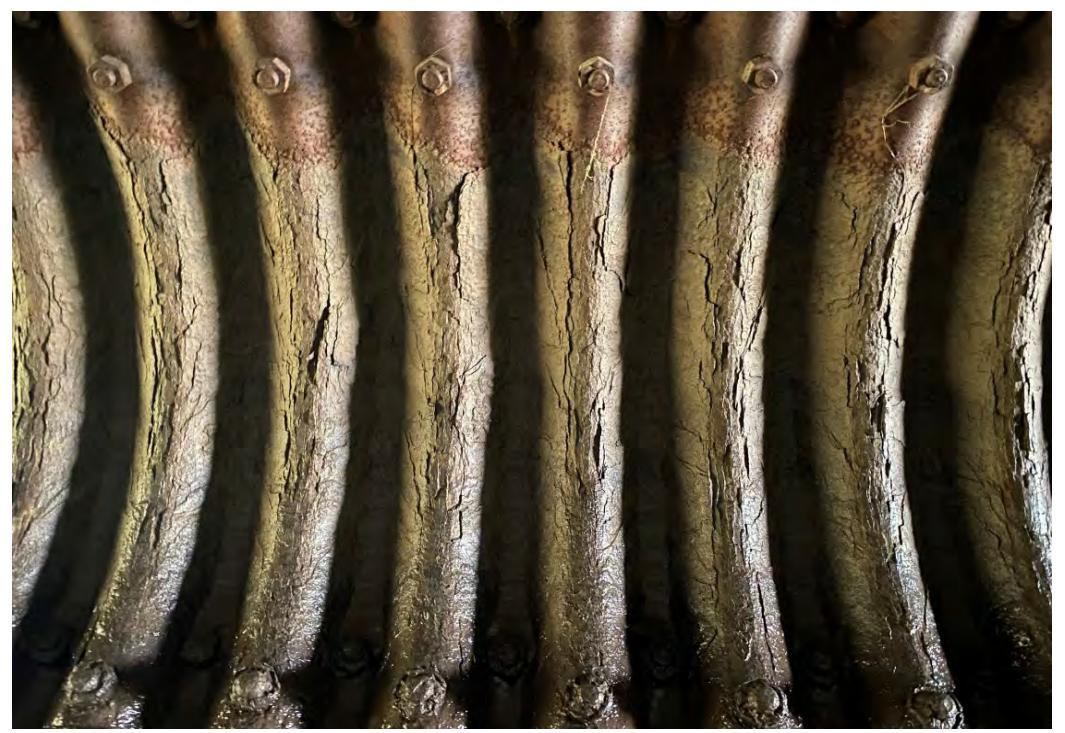
Photo 12-5: View of corrosion / swelling in the haunches (typ.)

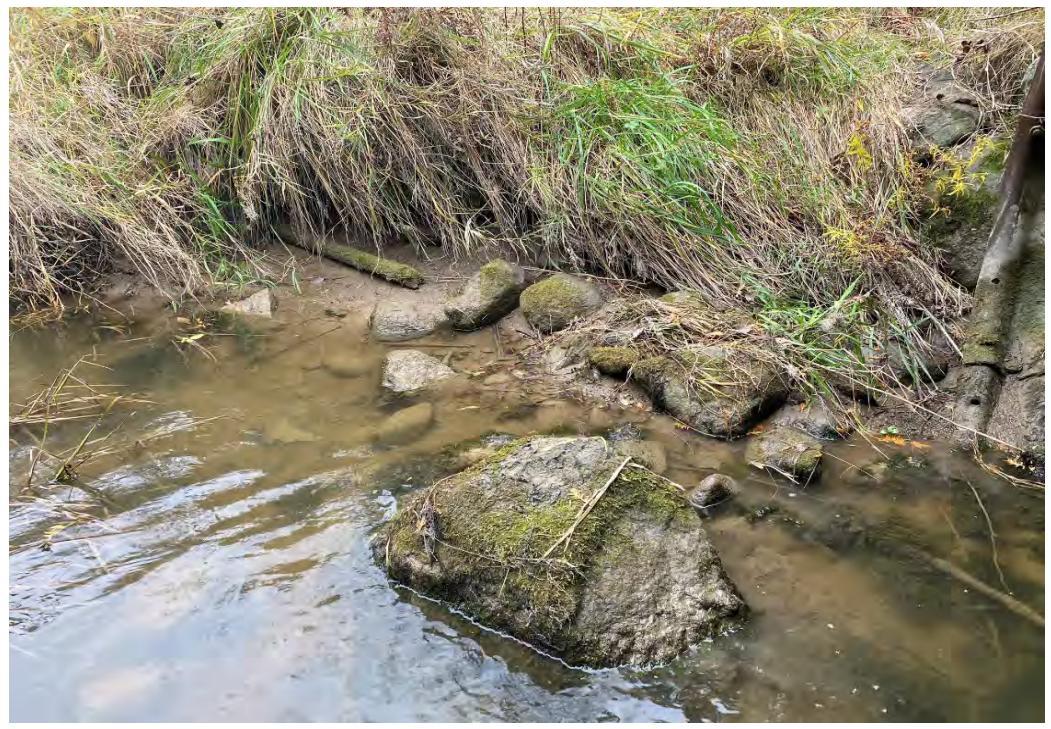
Photo 12-6: View of embankment scour at the inlet.

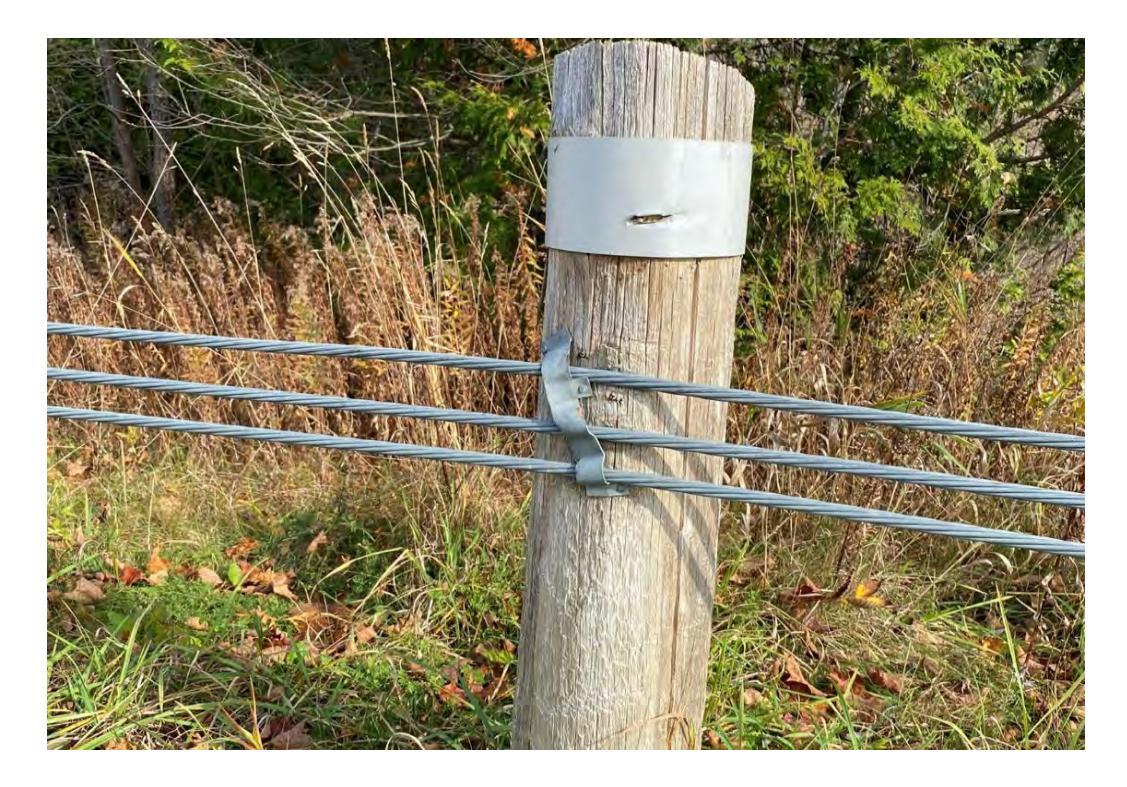
Photo 14-3: View of damaged guiderail post

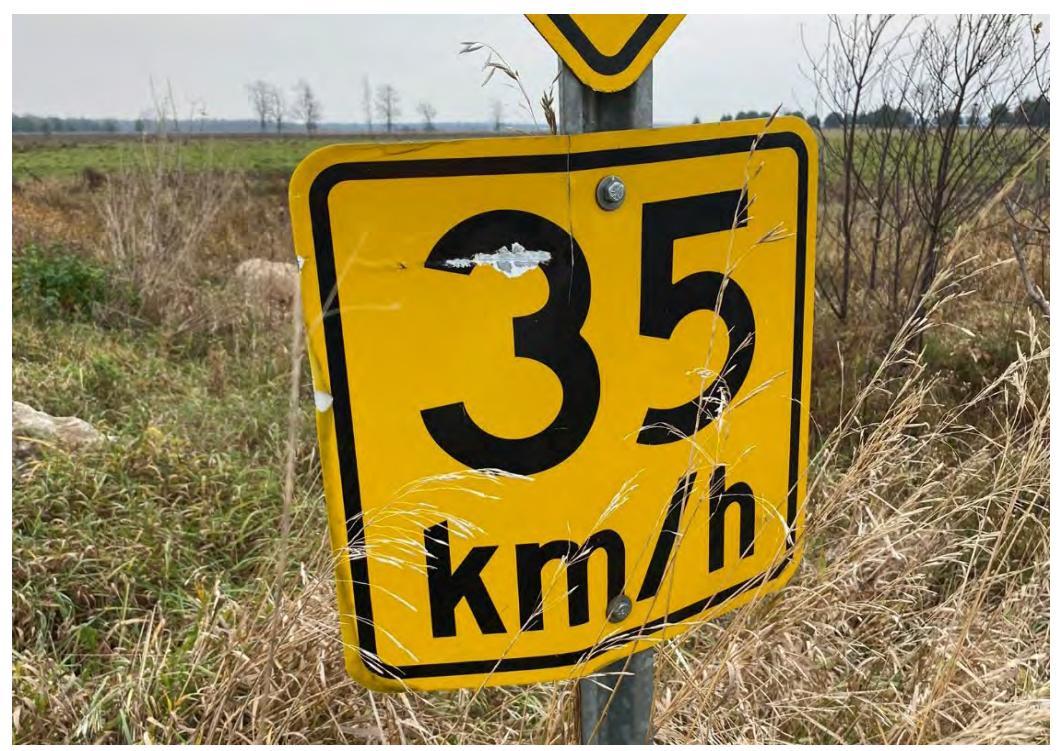
Photo 15-3: View of damaged sign

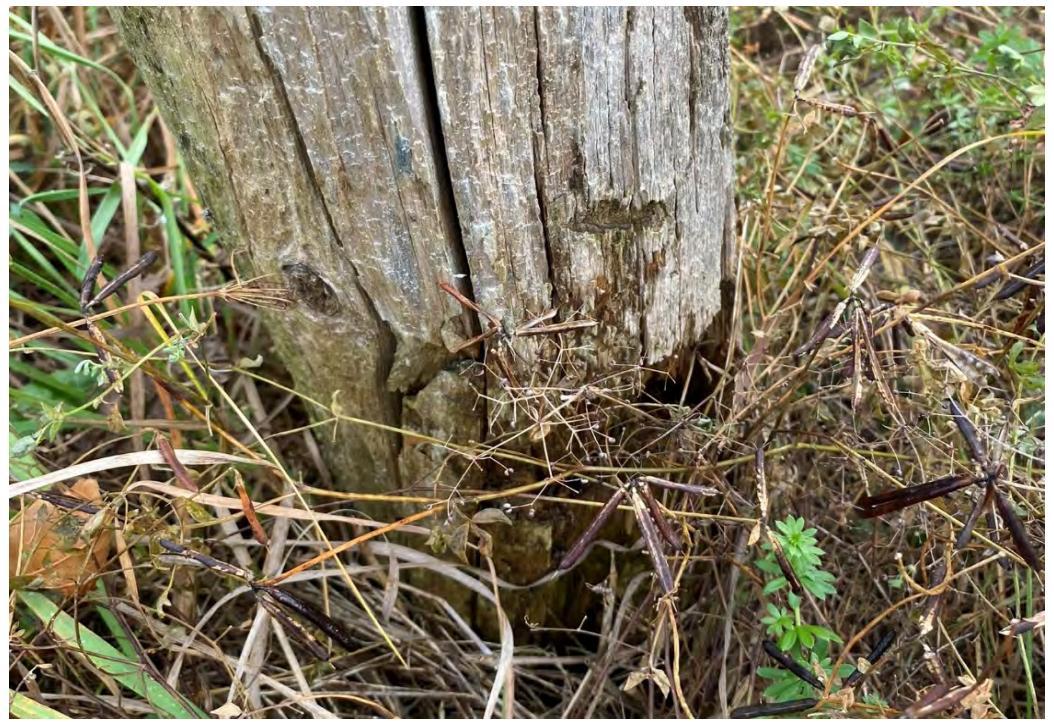
Photo 16-9: View of rotten guiderail post base

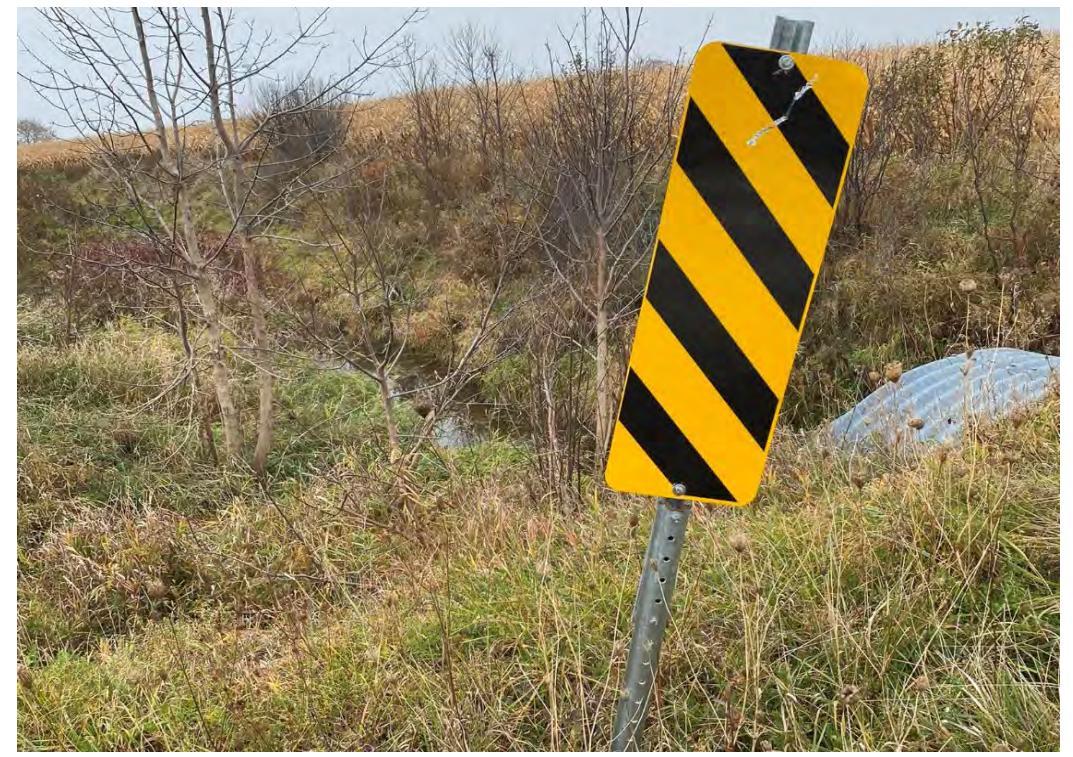
Photo 17-3: View of damaged hazard sign

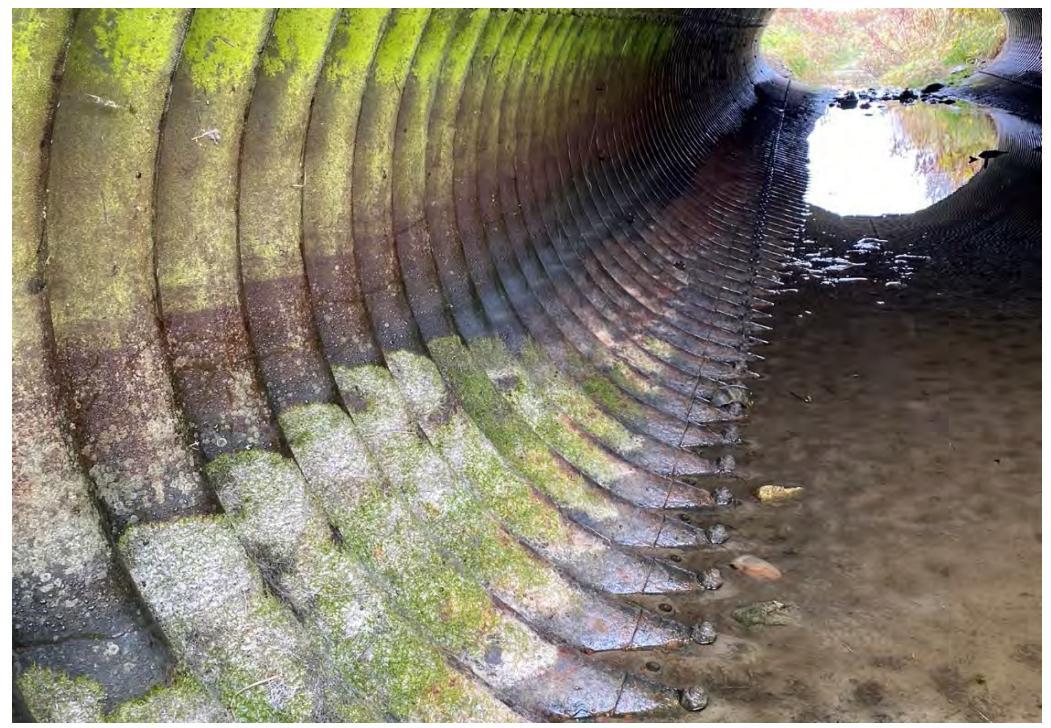
Photo 17-7: View of corrosion at haunches (typ.)
