**Re: 2017 Annual Report for Lakewood Subdivision Sewage System
Municipality of Northern Bruce Peninsula**

INSPECTOR'S REPORT:

Project Title:	<u>Lakewood Subdivision</u>	Inspection Date:	<u>Jan 18, 2018</u>
Inspector:	<u>Laura Swanson, P.Eng</u>	Inspection Time:	<u>1:00 PM</u>
Location:	<u>Lakewood Subdivision Sewage System</u>	File No.:	<u>M09010</u>

Project Title:	<u>Lakewood Subdivision</u>	Inspection Date:	<u>May 22, 2018</u>
Inspector:	<u>Laura Swanson, P.Eng</u>	Inspection Time:	<u>5:00 PM</u>
Location:	<u>Lakewood Subdivision Sewage System</u>	File No.:	<u>M09010</u>

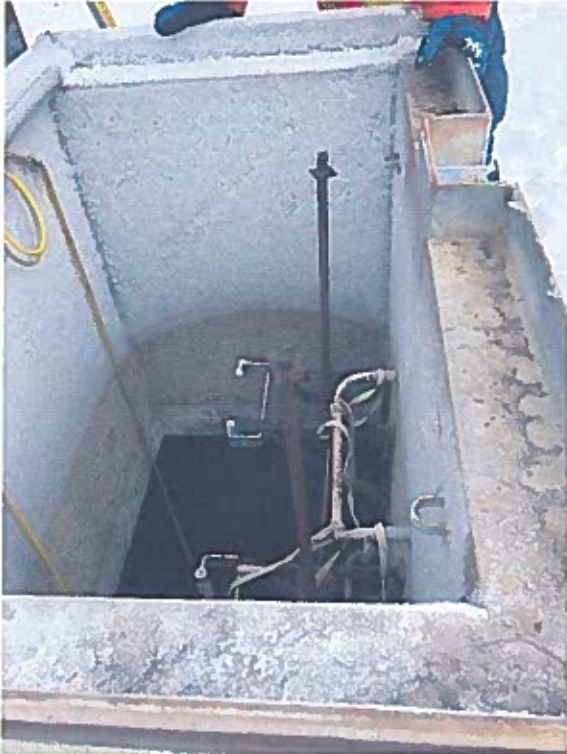
- The discharge control valve stems (dosing chamber) that control discharge to the tile fields were not operable, the handles and support brackets are severely rusted and in poor condition. Please see the attached photo below.

Dosing Chamber – Discharge Control Valve Stems (not operable)

There was no detectable septic odour encountered except within the vicinity of the access opening of the dosing chamber. Both of the two (2) valve stem handles and brackets have disintegrated due to corrosion. It is recommended that the valve stems and brackets be replaced as soon as possible.

1. OCWA and the Municipality should replace the effluent discharge control valve stems and brackets as soon as possible.
2. The "Dosing Pump Elapsed Time Weekly Record Sheets" provided in the Updated Operations and Maintenance Manual should continue to be used by operations staff. Operators should continue to keep a project-specific journal of their site visits, alarm conditions, maintenance, repairs and observations.

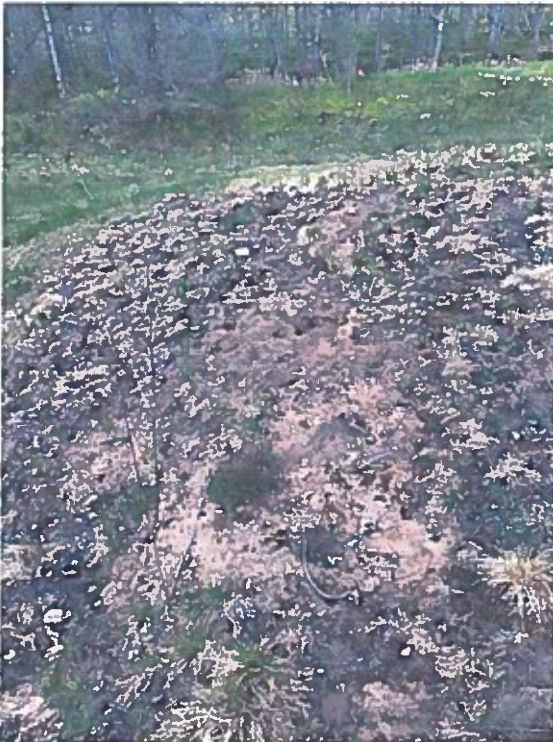
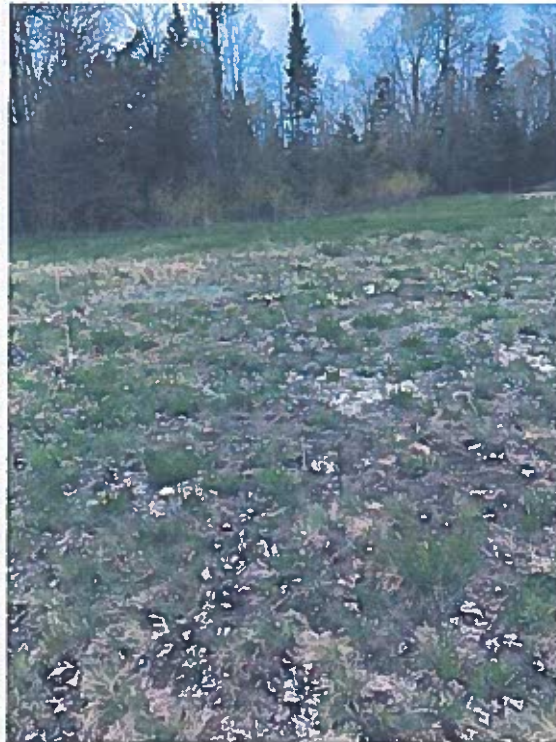
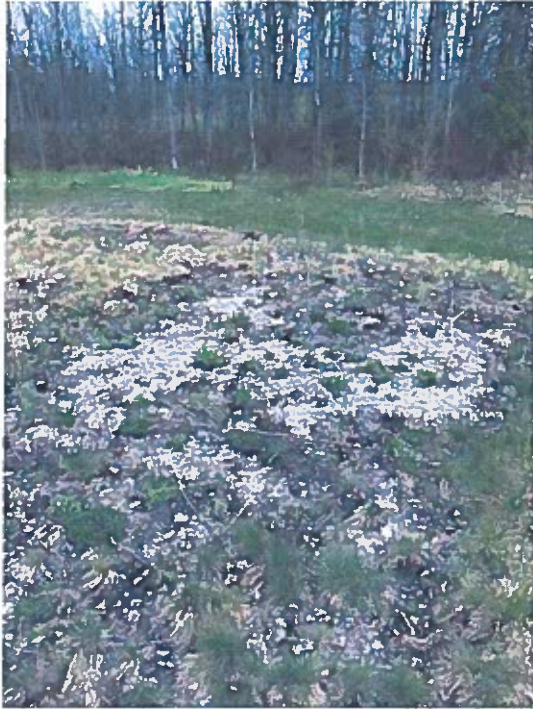
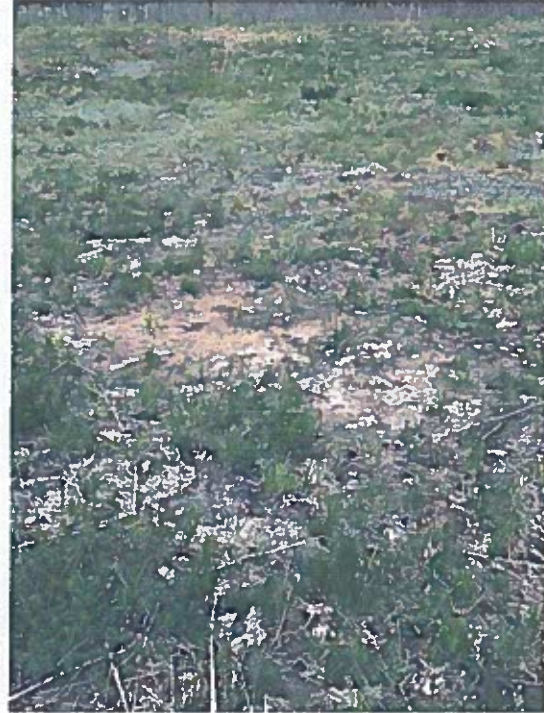
DMRC's inspector walked around the tile field and septic tank area during a separate inspection on May 22, 2018 due to the snow cover in January. More significant bare spots were observed on the slopes and the top of the tile bed. There were also signs of erosion on the top of slope at the southeastern and southwestern corners of the tile bed. It is suggested that these areas be topsoiled and seeded in the spring. Please refer to the attached photos in the inspectors report.

- The writer visited the site to complete the inspection of absorption bed, since there was snow at the time of the original inspection.
- Photos were taken are attached below. Grass cover appears to be sparse in some areas of the absorption bed. It is recommended that the absorption bed be topsoiled (50mm) and cast seeded.

4. The tile bed should be topsoiled and seeded.
5. The hole in the dosing chamber lid for the safety chain attachment is corroded and the hole should be relocated and redrilled to ensure that there is adequate strength to support the weight of the lid structure.
