2025 ANNUAL SEWAGE & COLLECTION SYSTEM PERFORMANCE REPORT

TOBERMORY
SEWAGE TREATMENT PLANT &
COLLECTION SYSTEM

For the period of
JANUARY 1, 2025 TO DECEMBER 31, 2025

Shallow Underwater Hydrographic Acoustic Sonar
Sediment Profiling - Volume Modeling and Distribution Survey

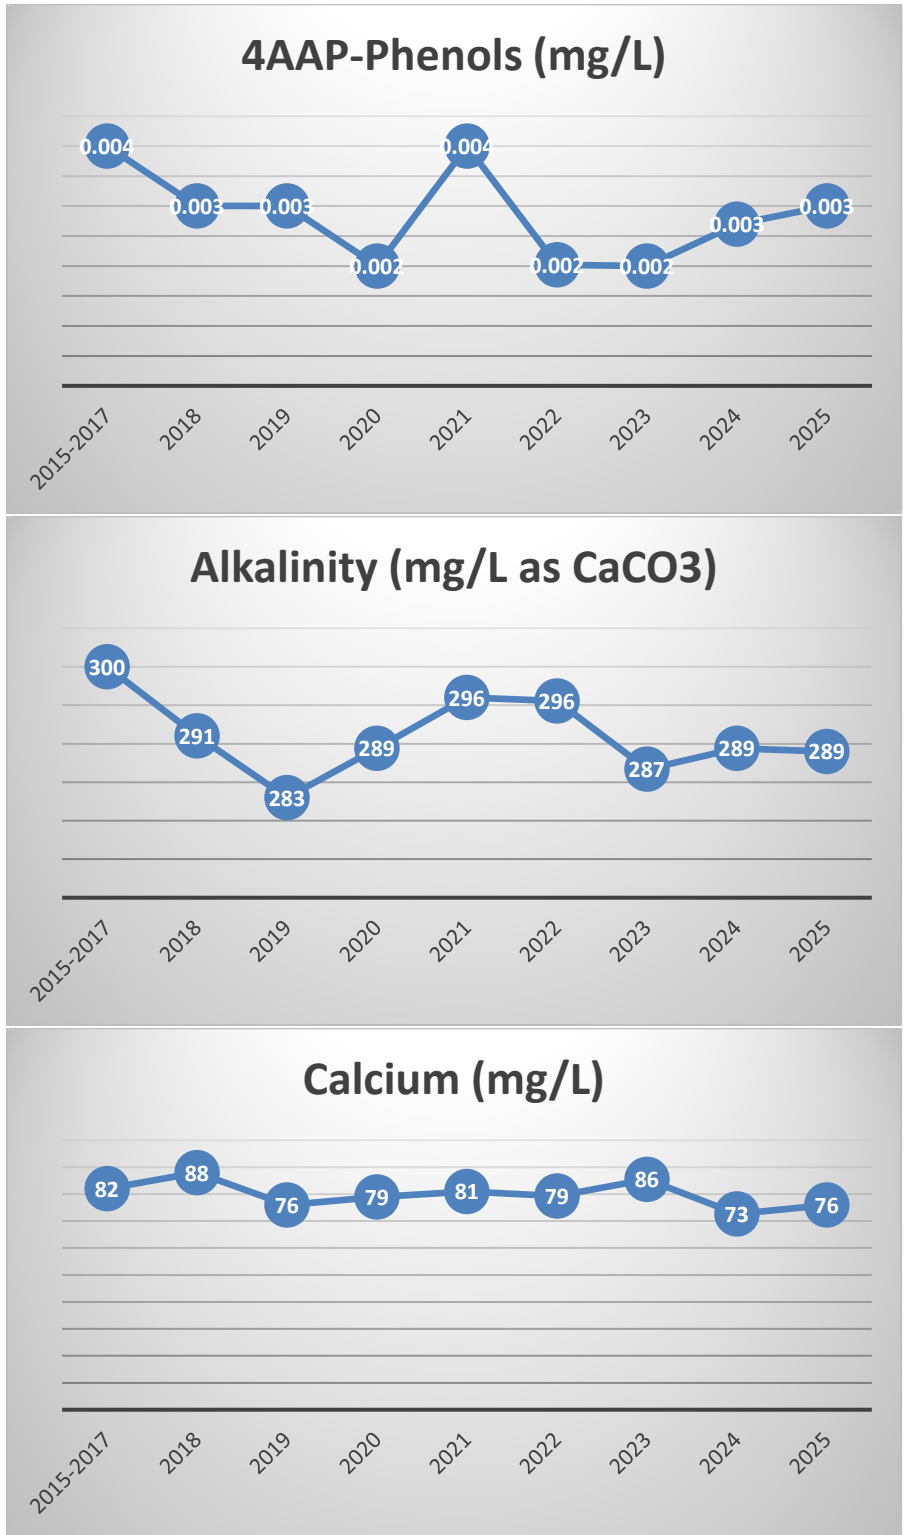
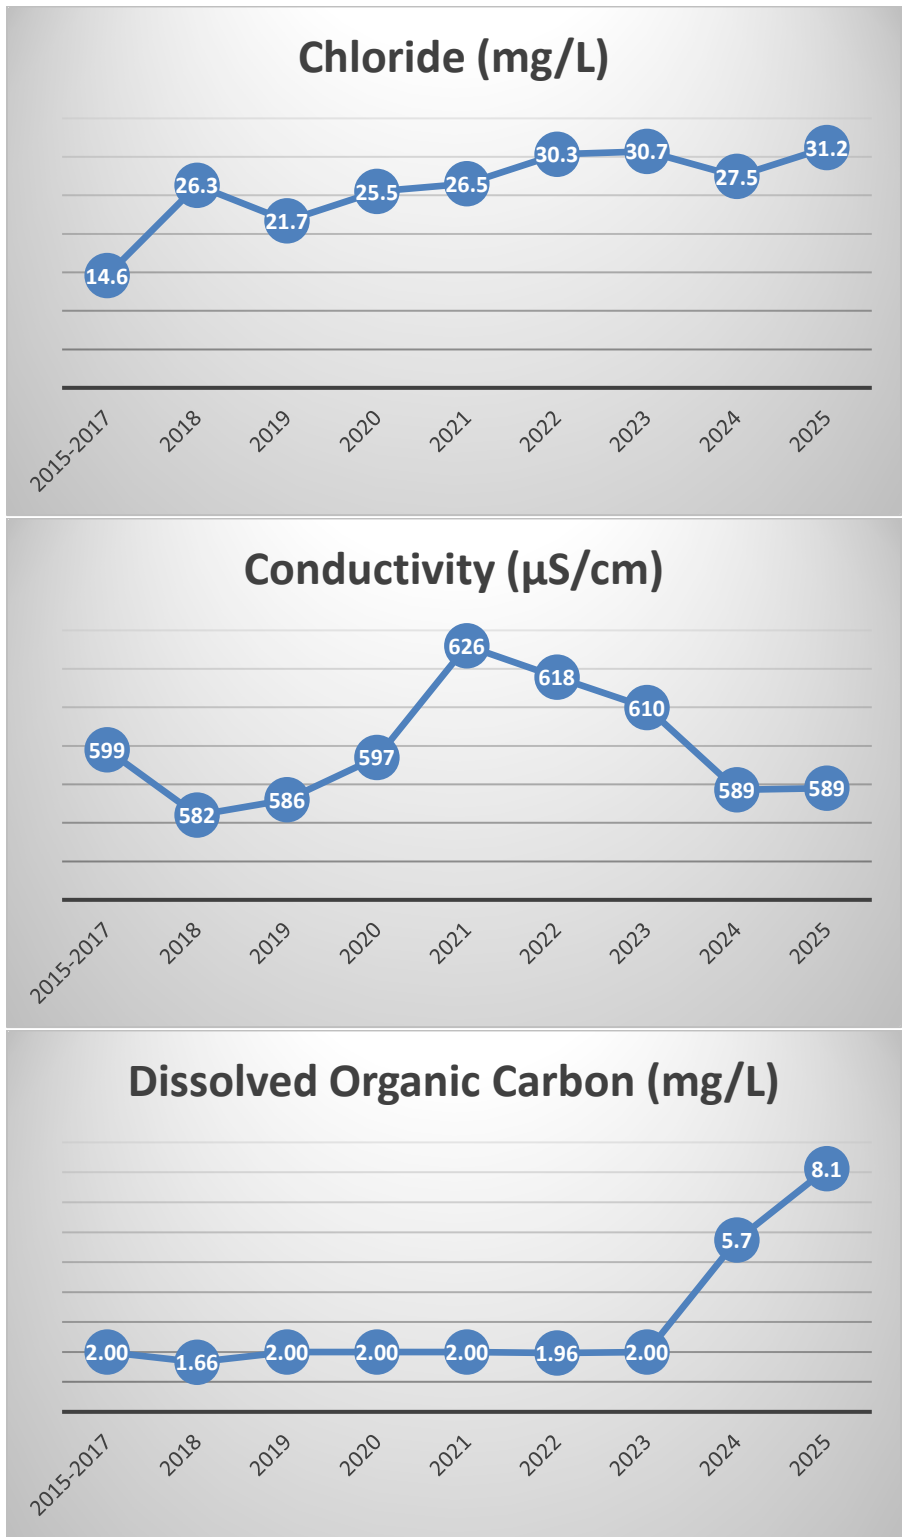
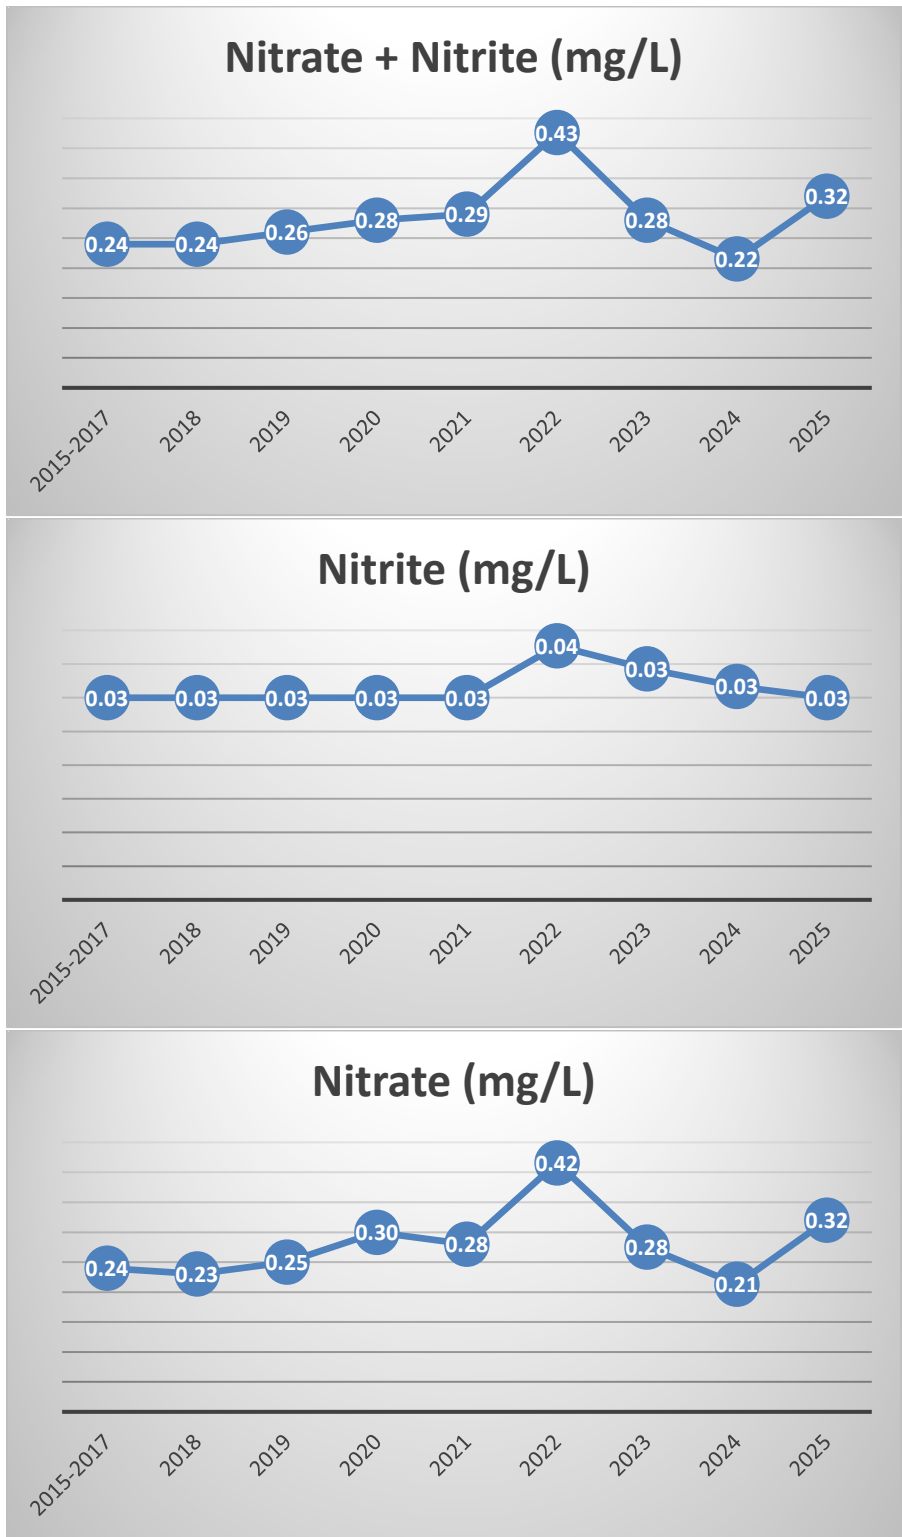
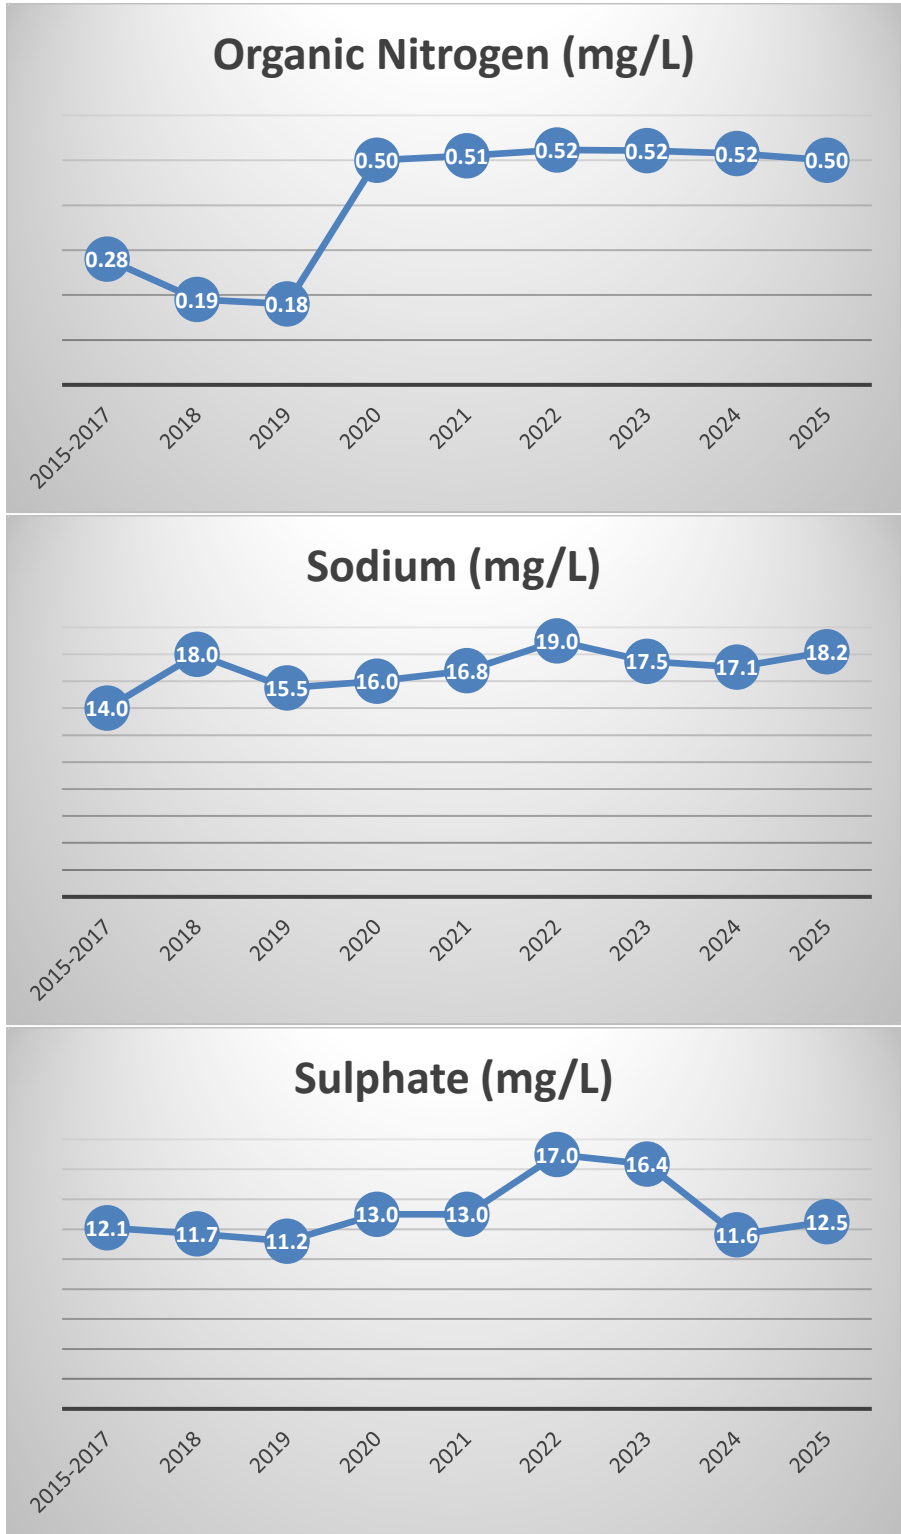
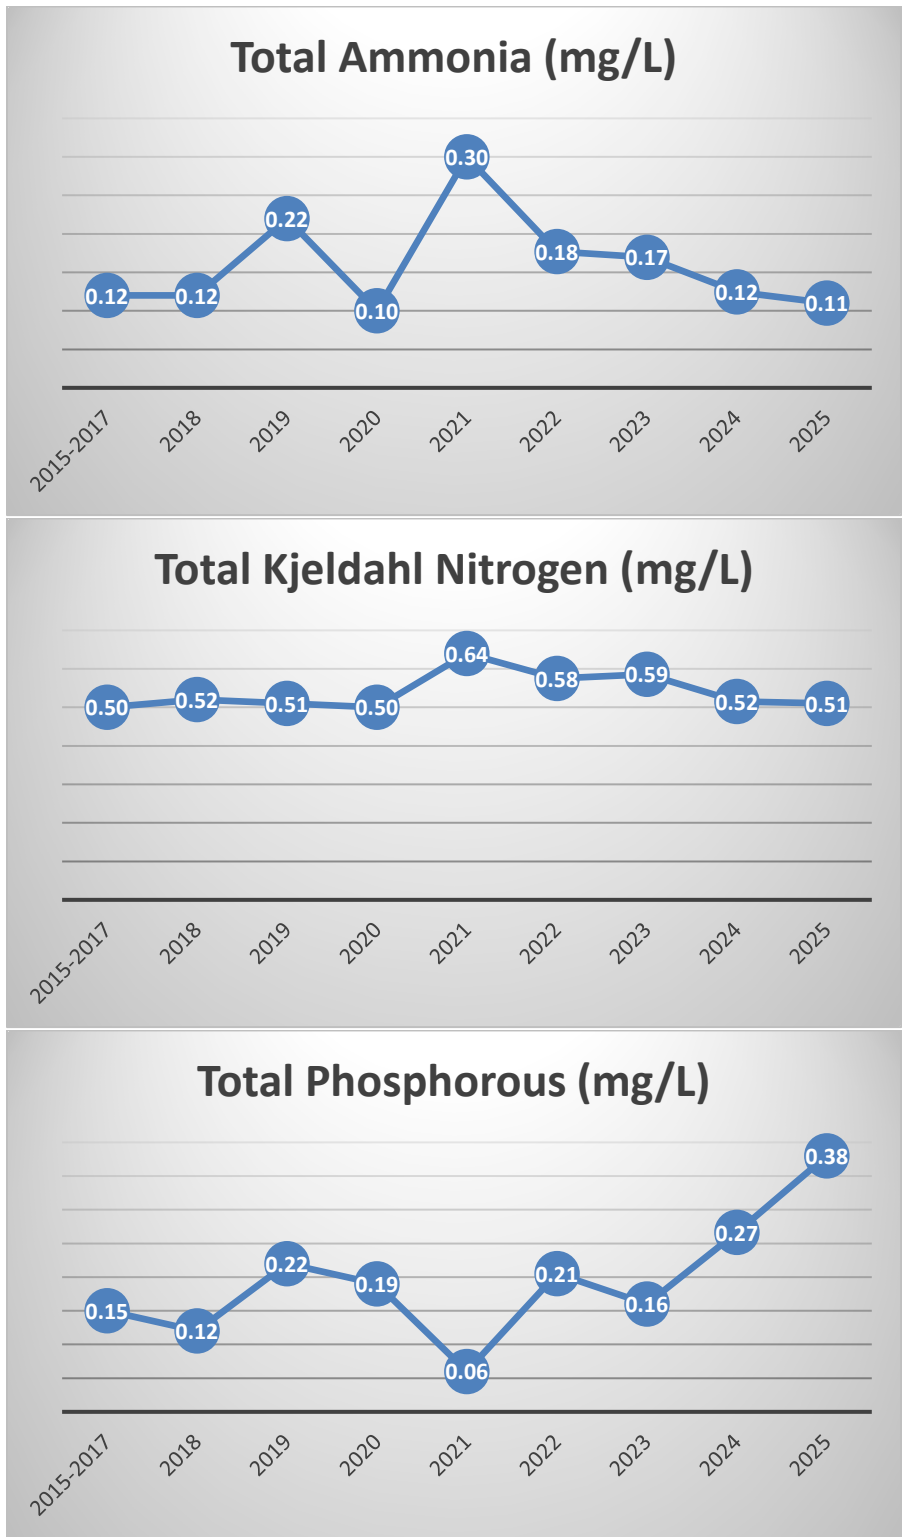
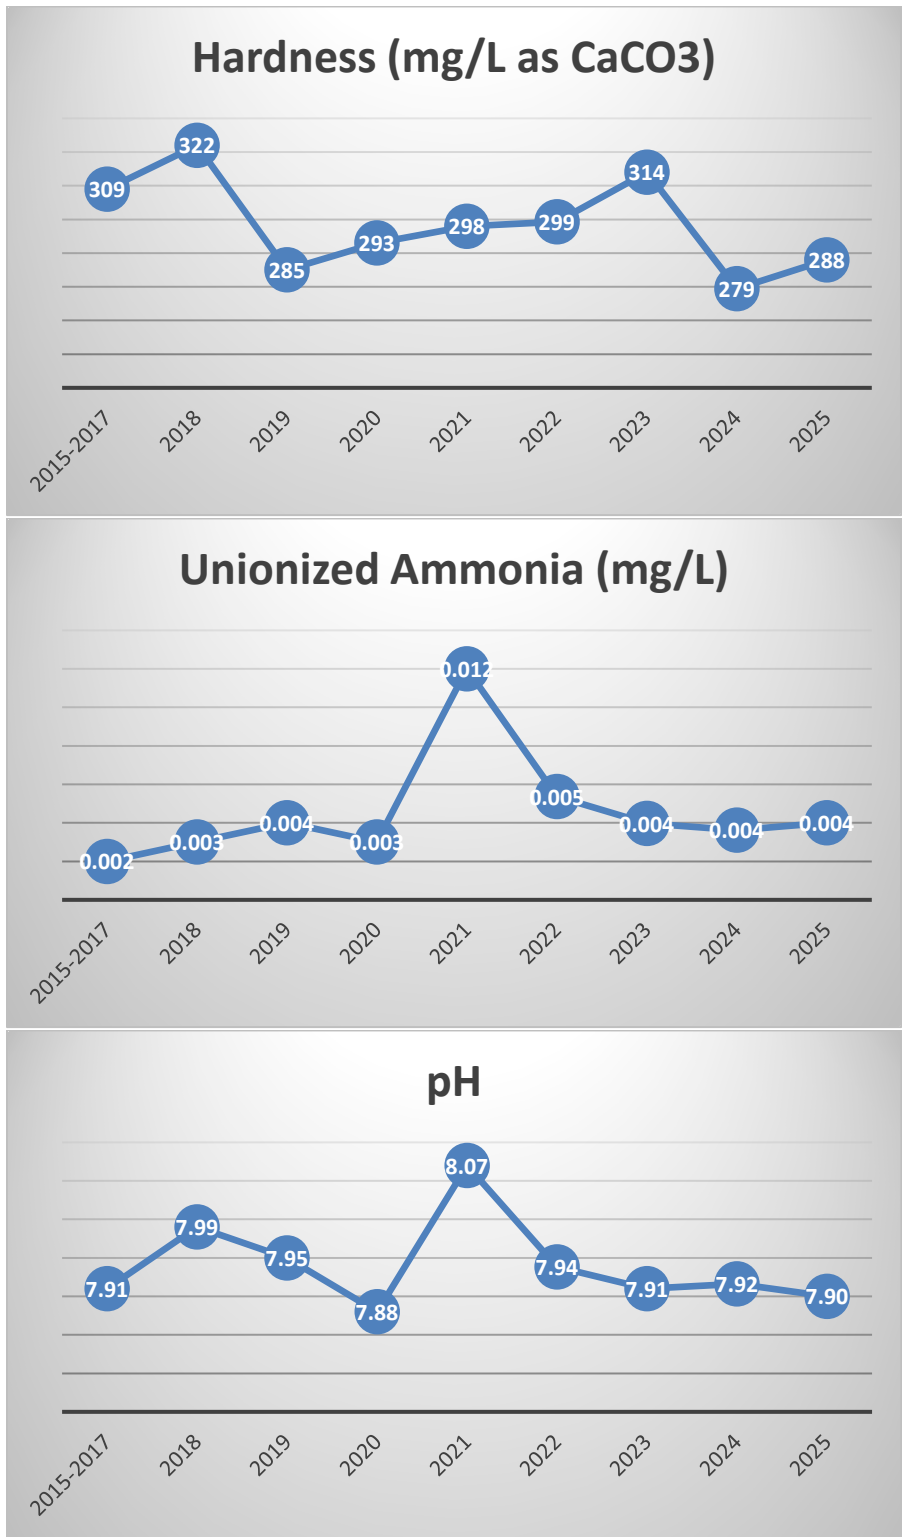
Ground Water Sampling graphs were made for every parameter, please see below. Further comprehensive interpretation of groundwater monitoring data is required in order to determine proximity of sites that produced parameter changes and if relation exists with other monitoring sites.

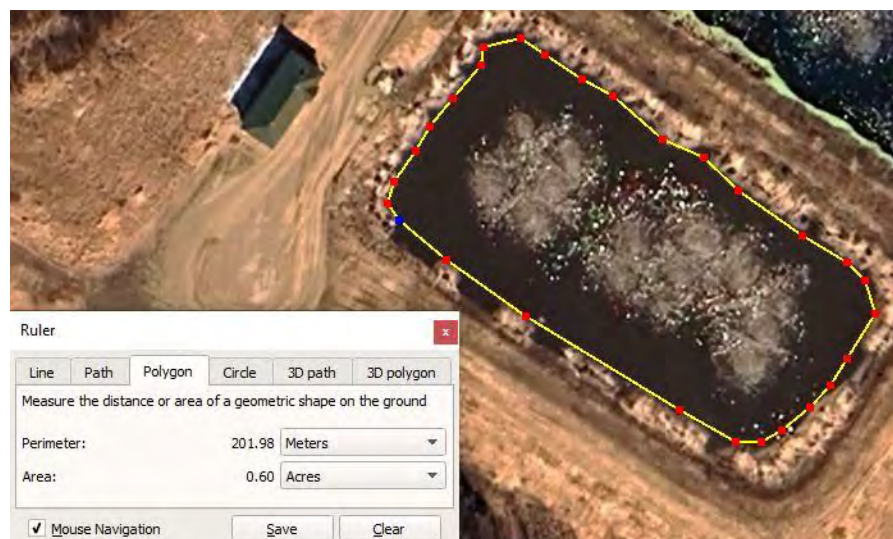
2.4.2

Figure 1. A water table area reference qualifier was conducted by a polygon measurement made in Google Earth to a 03/30/2024 image of the Tobermory West Primary Cell 1, the water table area was found to be approximately 0.60 Acres.¹

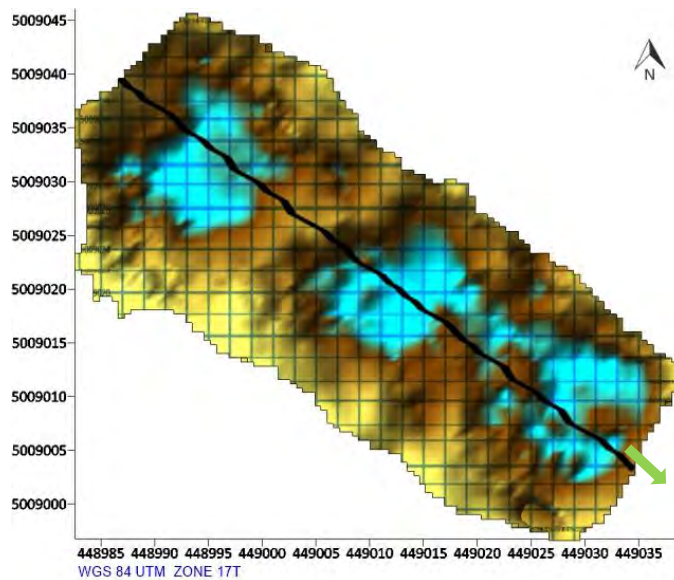
Visual Representation of the Sediment Layer Along a Random Vector Line

The average depth of sediment in the Tobermory West Primary Cell 1 is approximately 0.667 m or 667 mm or 26.25 in or 2.19 ft.

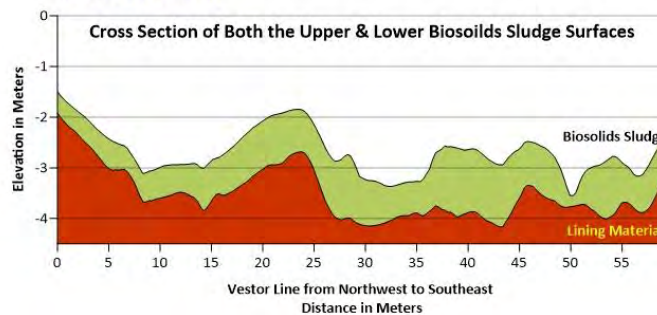
Visual Representation of a Sediment Layer Sliced Randomly from North to South

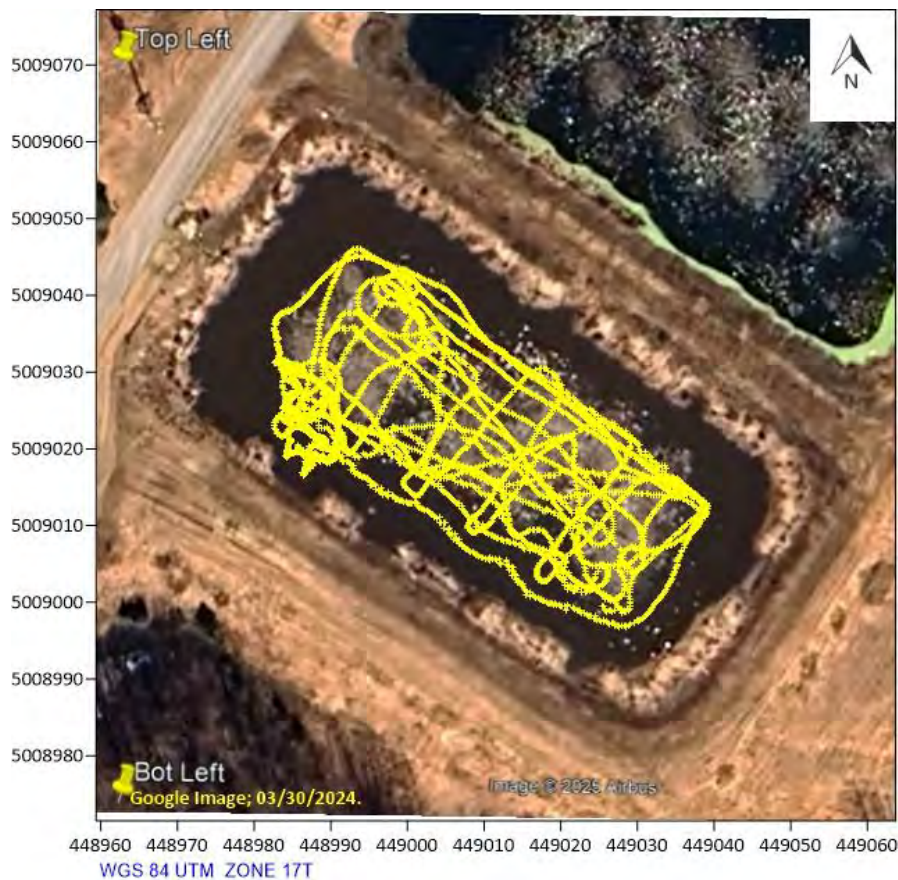
Georeferencing Image and Hydrographic Survey Vessel Tracking Lines	
Municipality of Northern Bruce Peninsula Bruce County, Ontario	
Plot 2	
Survey Date: October 29, 2025

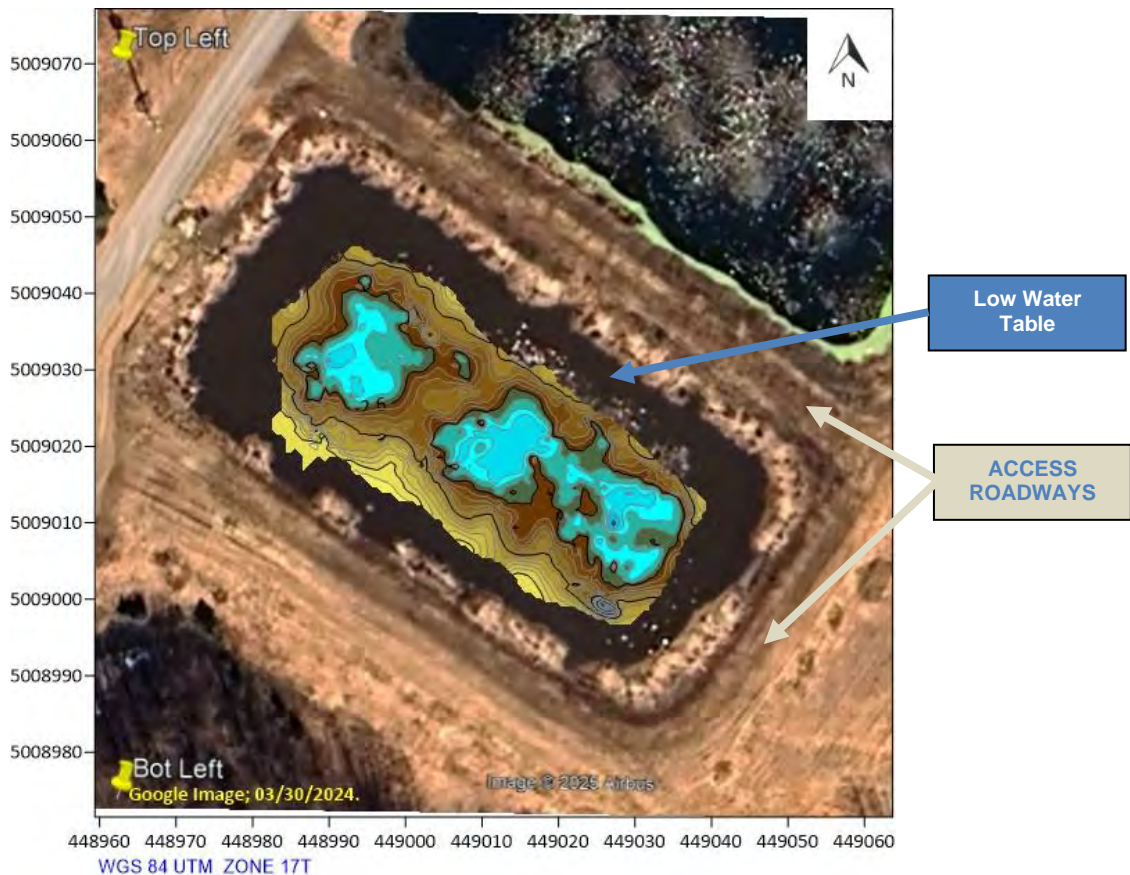
Georeferencing Image and Hydrographic Survey Site Description	
Municipality of Northern Bruce Peninsula Bruce County, Ontario	
Survey Date: October 29, 2025	Plot 3

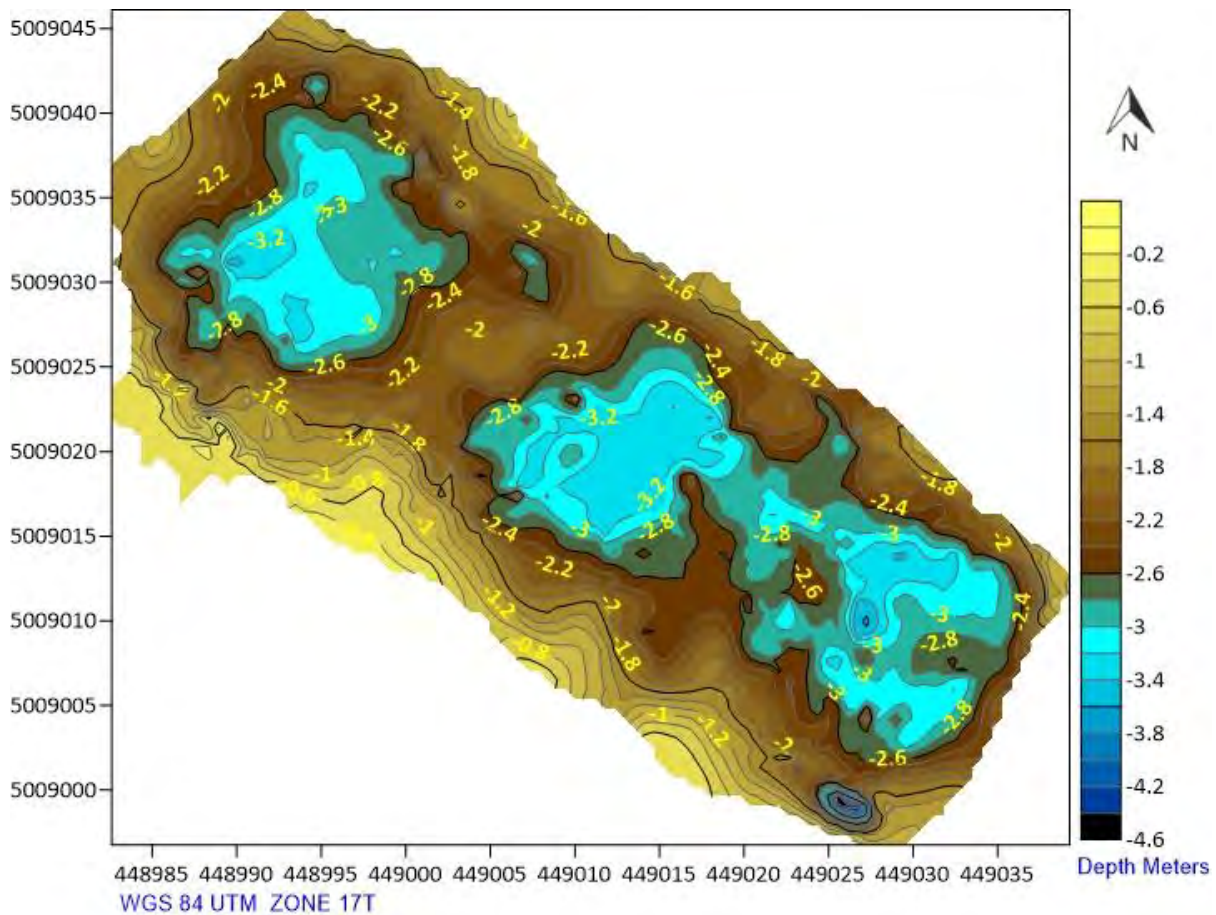
Bathymetric (Upper Surface) Sediment Distribution – Contour Map

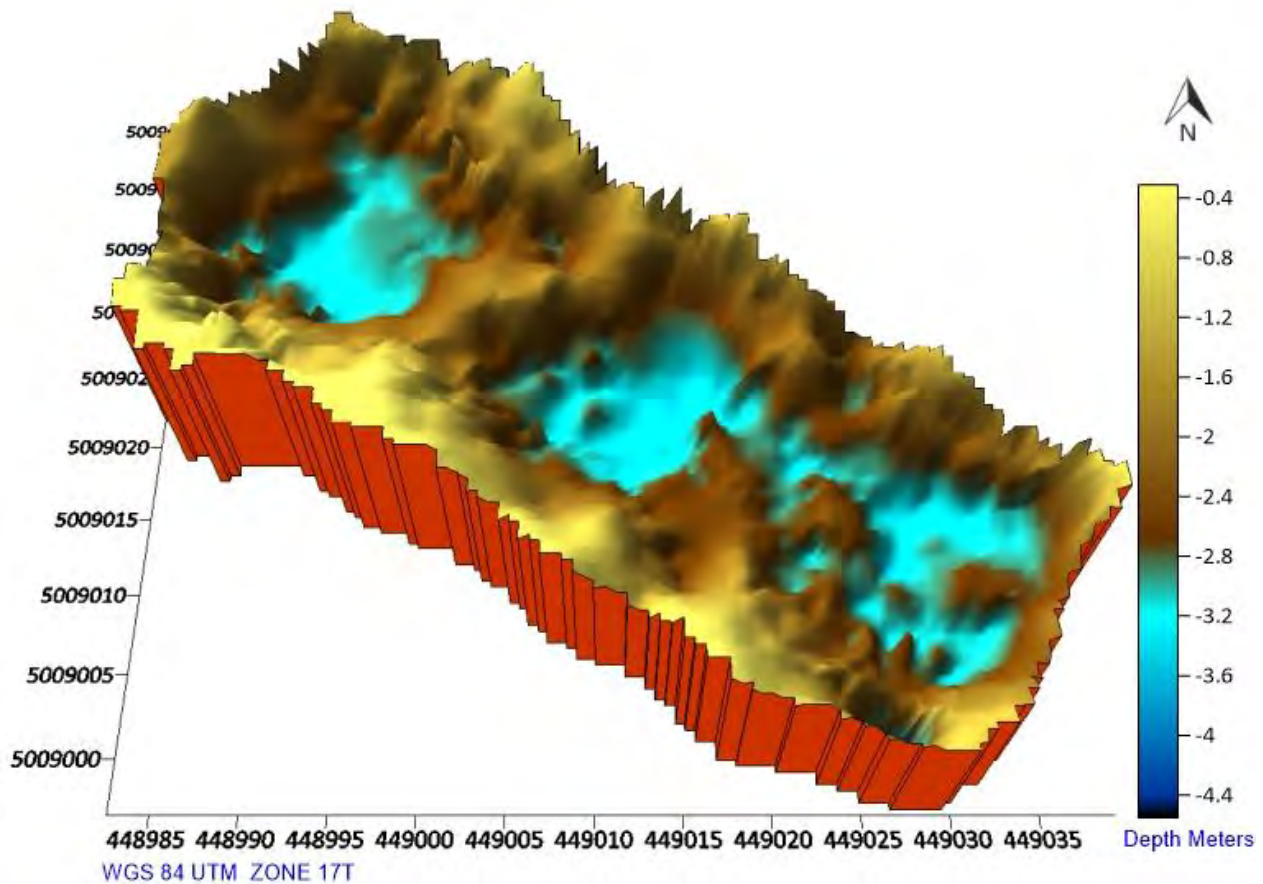
PLOT 5

Bathymetric (Upper Surface) Sediment Distribution – 3D Contour Map
Municipality of Northern Bruce Peninsula
Bruce County, Ontario

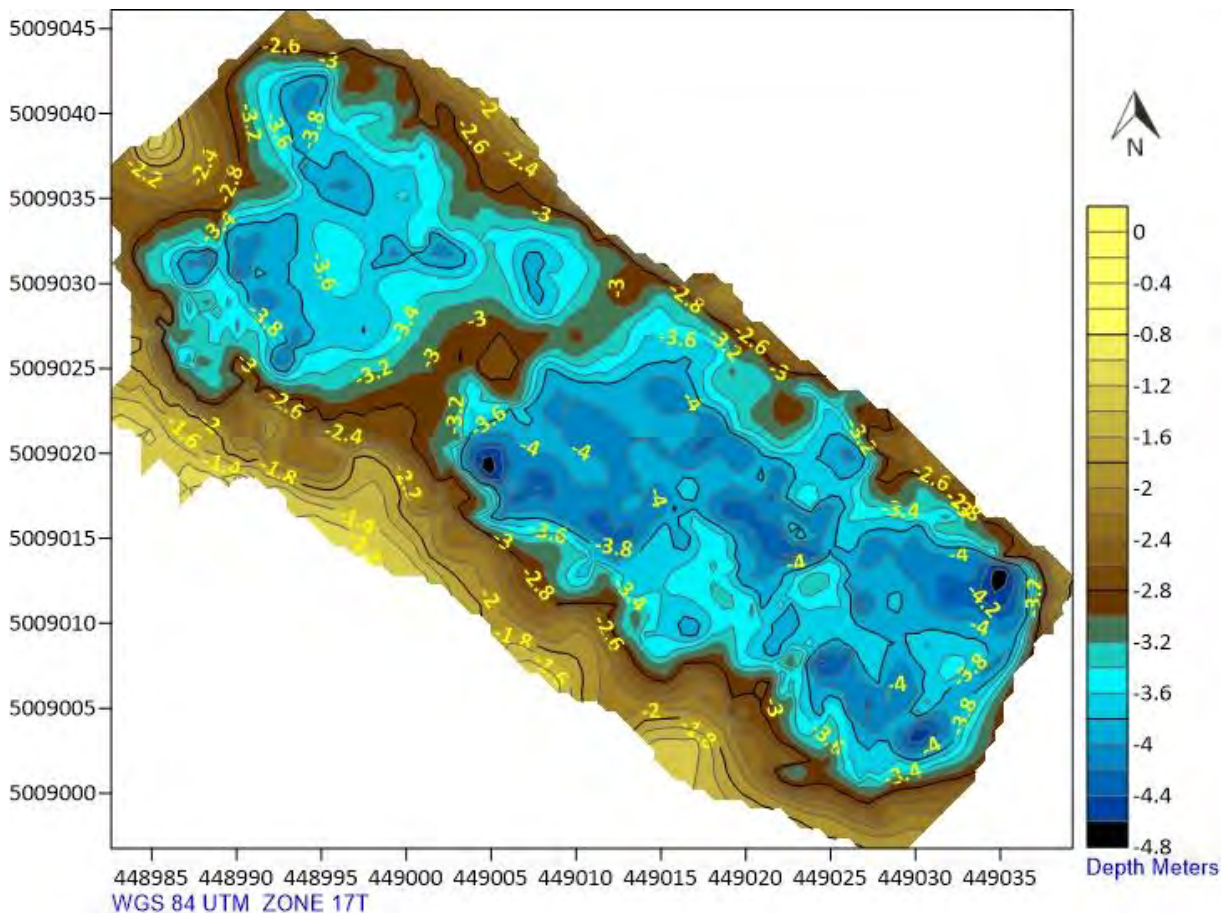
Lower Sub-Bottom (Liner/Clay/Hard Packed Soil) – Contour Map

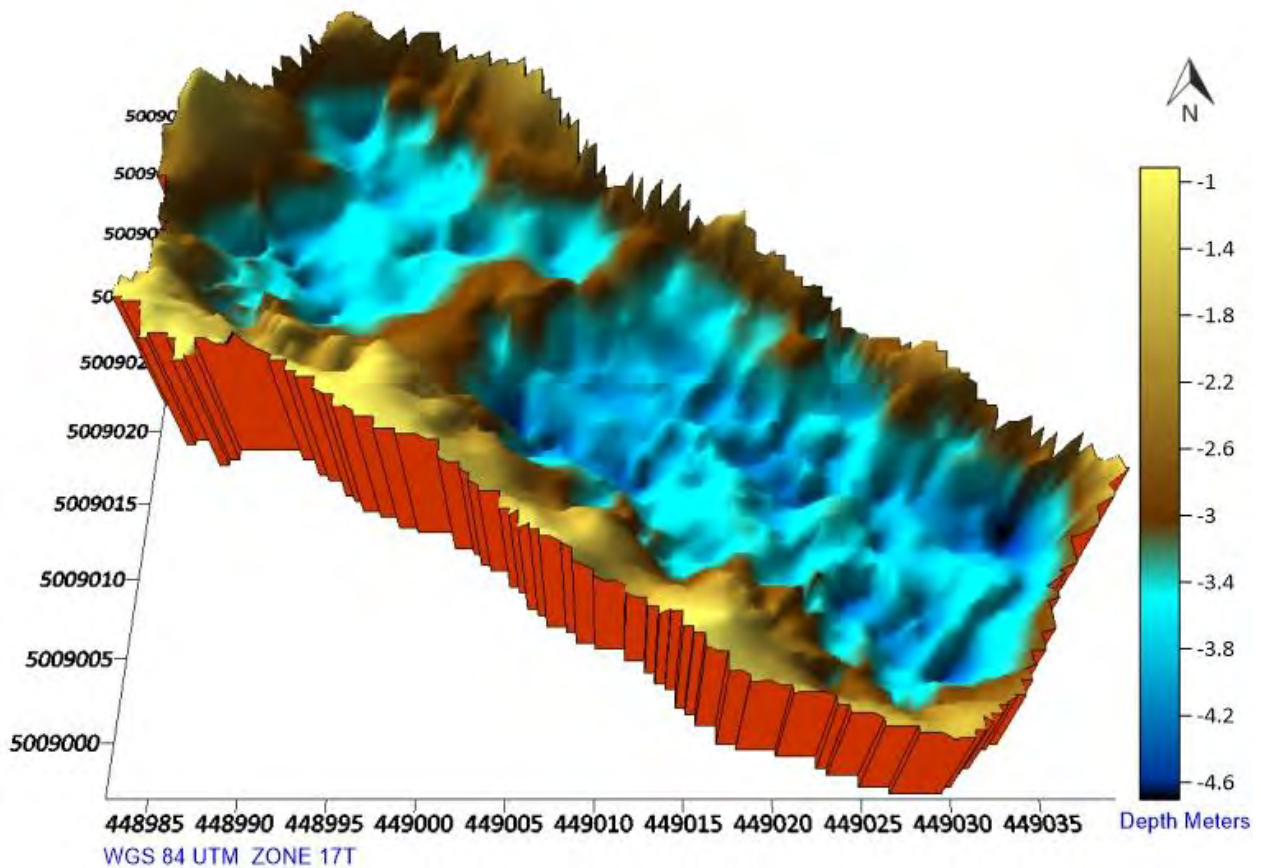
Lower Sub-Bottom (Liner/Clay/Hard Packed Soil) – 3D Contour Map

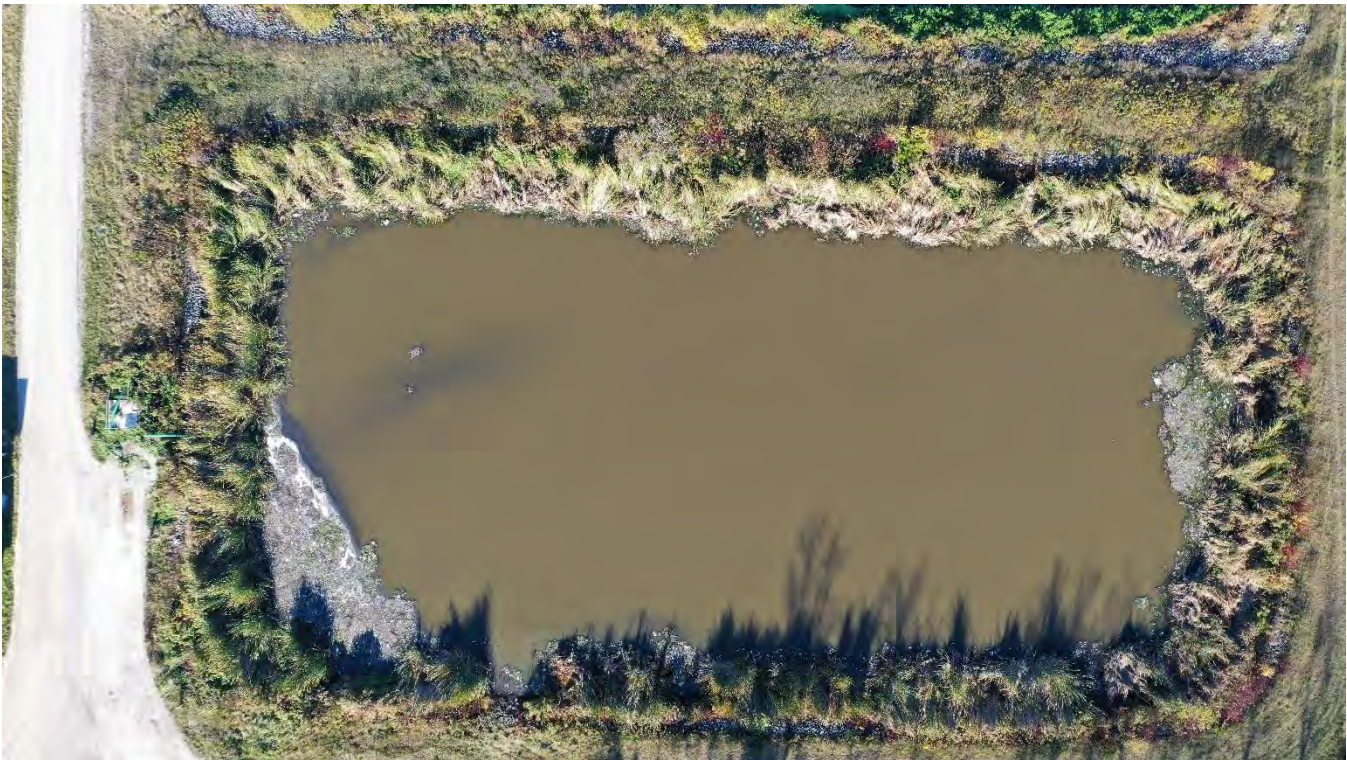
Aerial Digital Image 1. Tobermory West Primary Cell 1. Low Water Table.

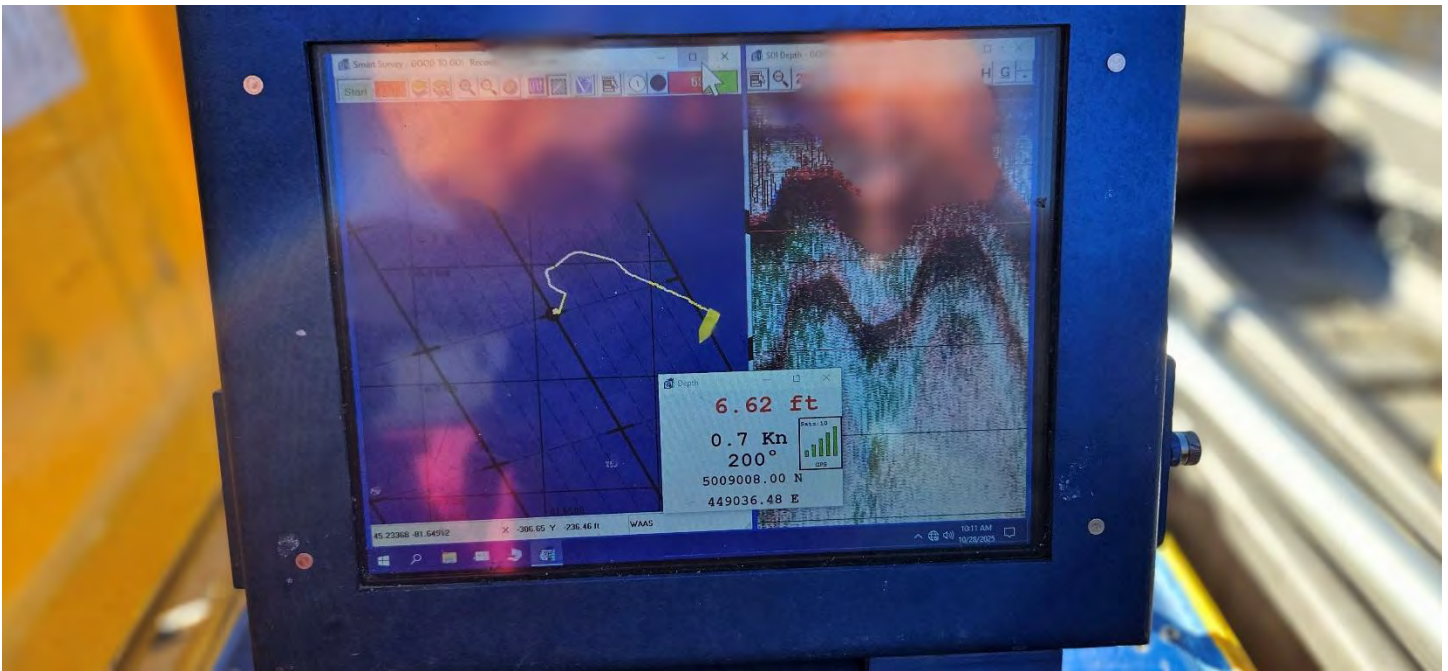
Digital Image 4. Tobermory West Primary Cell 1. Raw Sonar Data during hydrographic surveying.

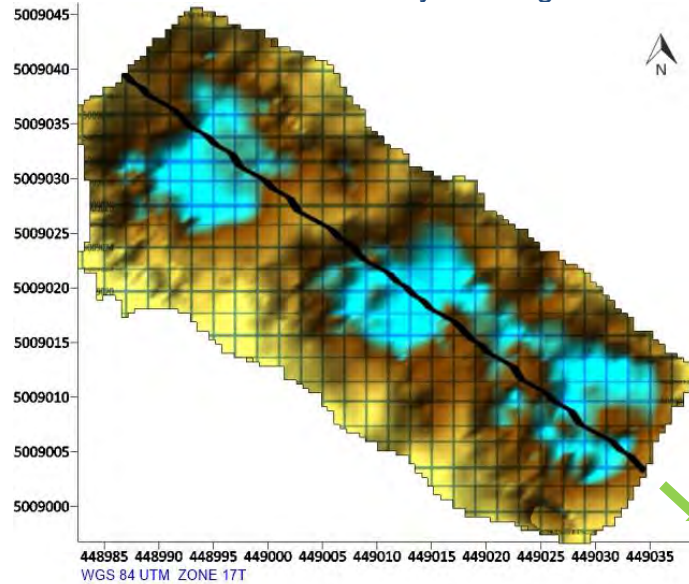
Visual Representation of the Sediment Layer Along a Random Vector Line

The average depth of sediment in the Tobermory East Secondary Cell 2 is approximately 0.461 m or 461 mm or 18.14 in or 1.5 ft.

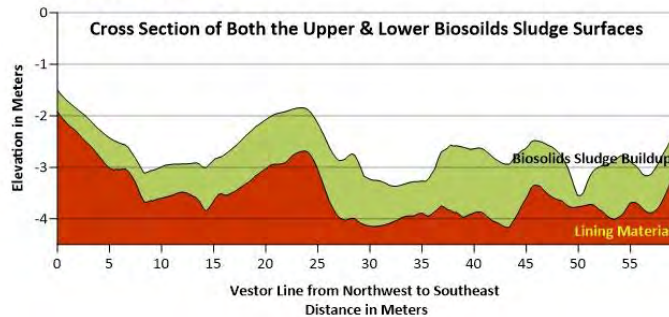
Visual Representation of a Sediment Layer Sliced Randomly from North to South

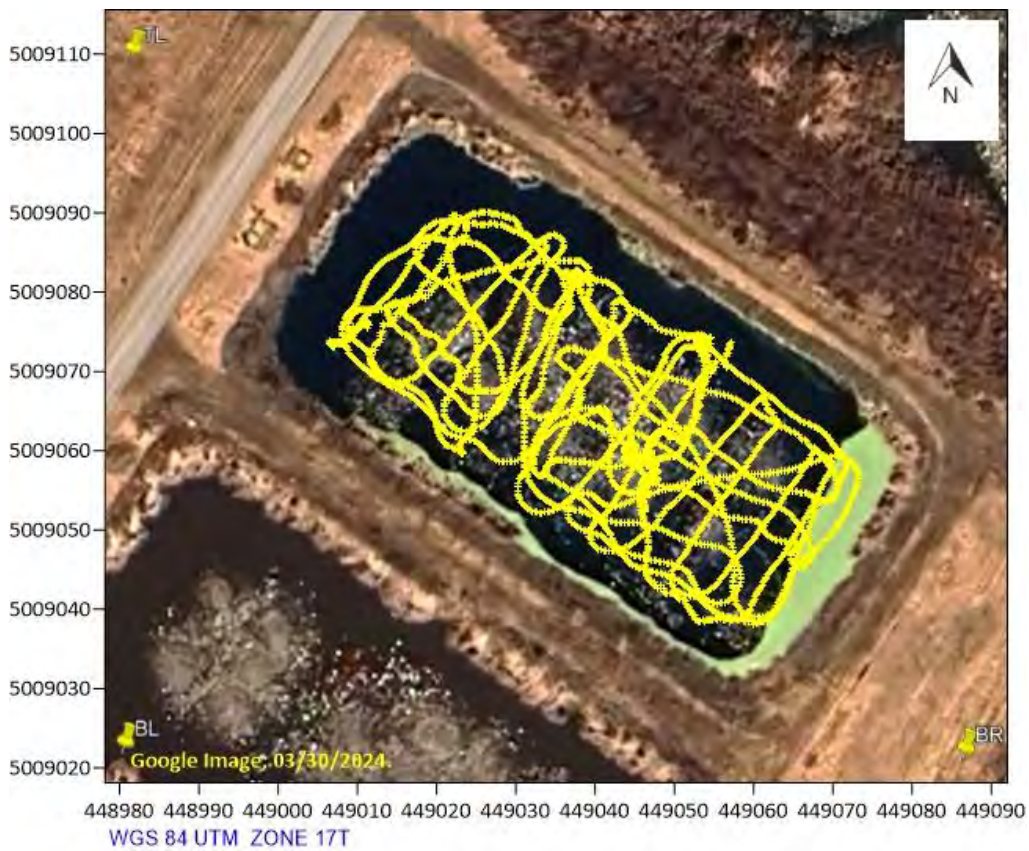
Georeferencing Image and Hydrographic Survey Vessel Tracking Lines	
Municipality of Northern Bruce Peninsula Bruce County, Ontario	
Survey Date: October 29, 2025	Plot 2

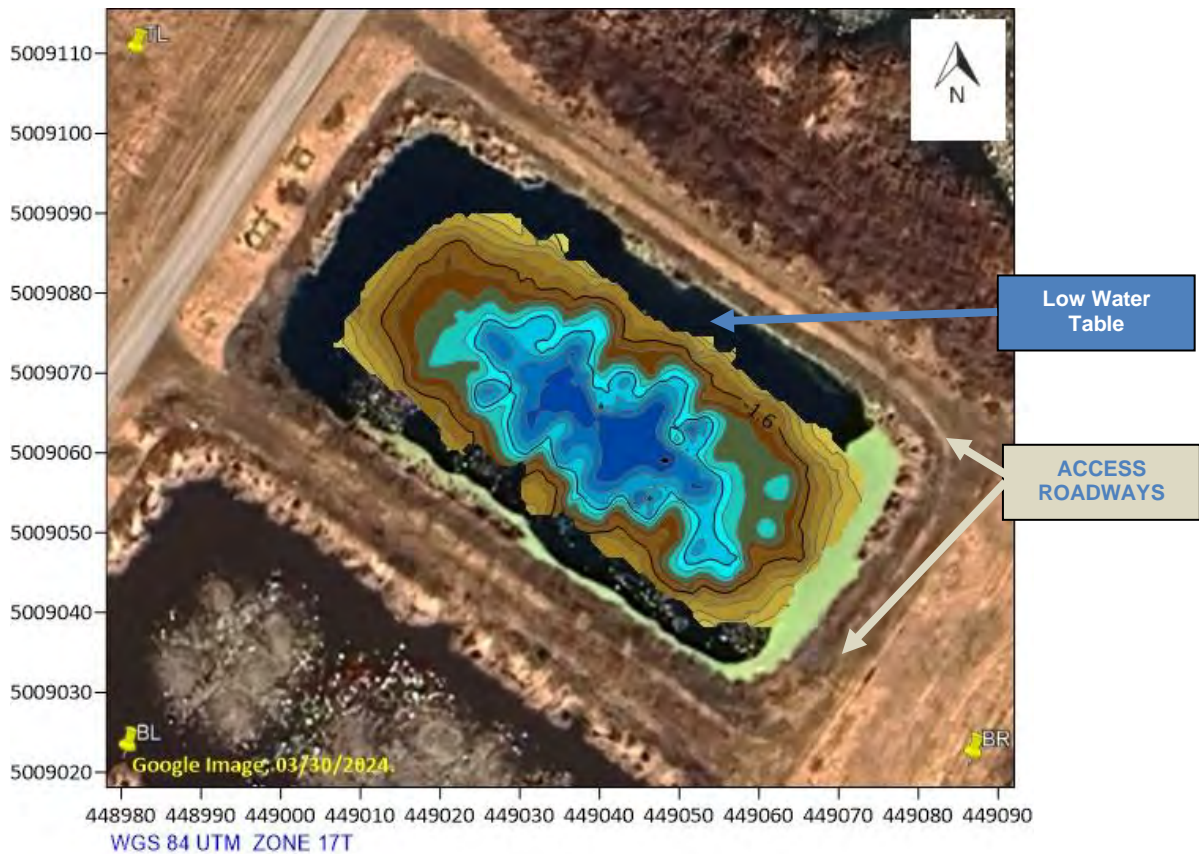
Georeferencing Image and Hydrographic Survey Site Description	
Municipality of Northern Bruce Peninsula Bruce County, Ontario	
Survey Date: October 29, 2025	Plot 3

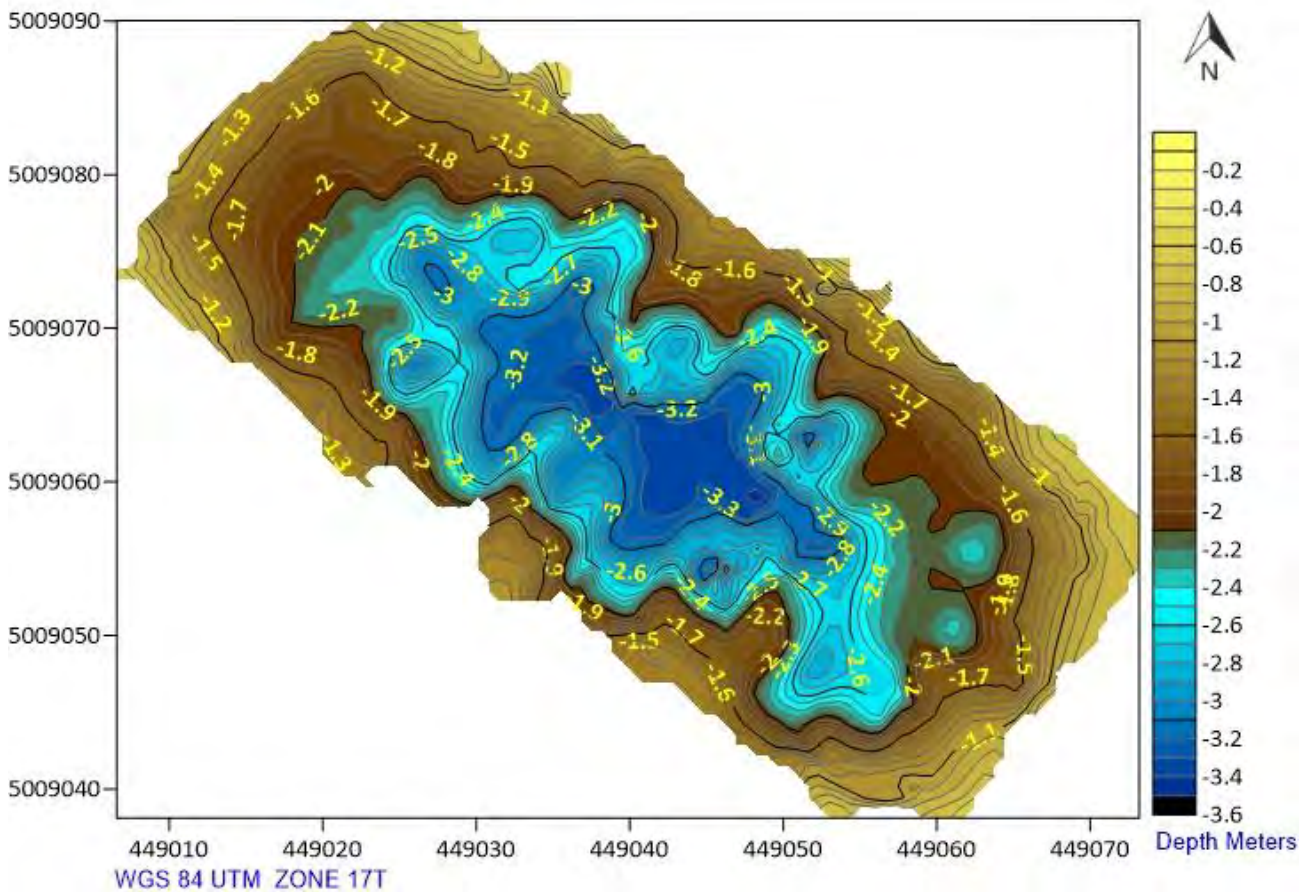
Bathymetric (Upper Surface) Sediment Distribution – Contour Map

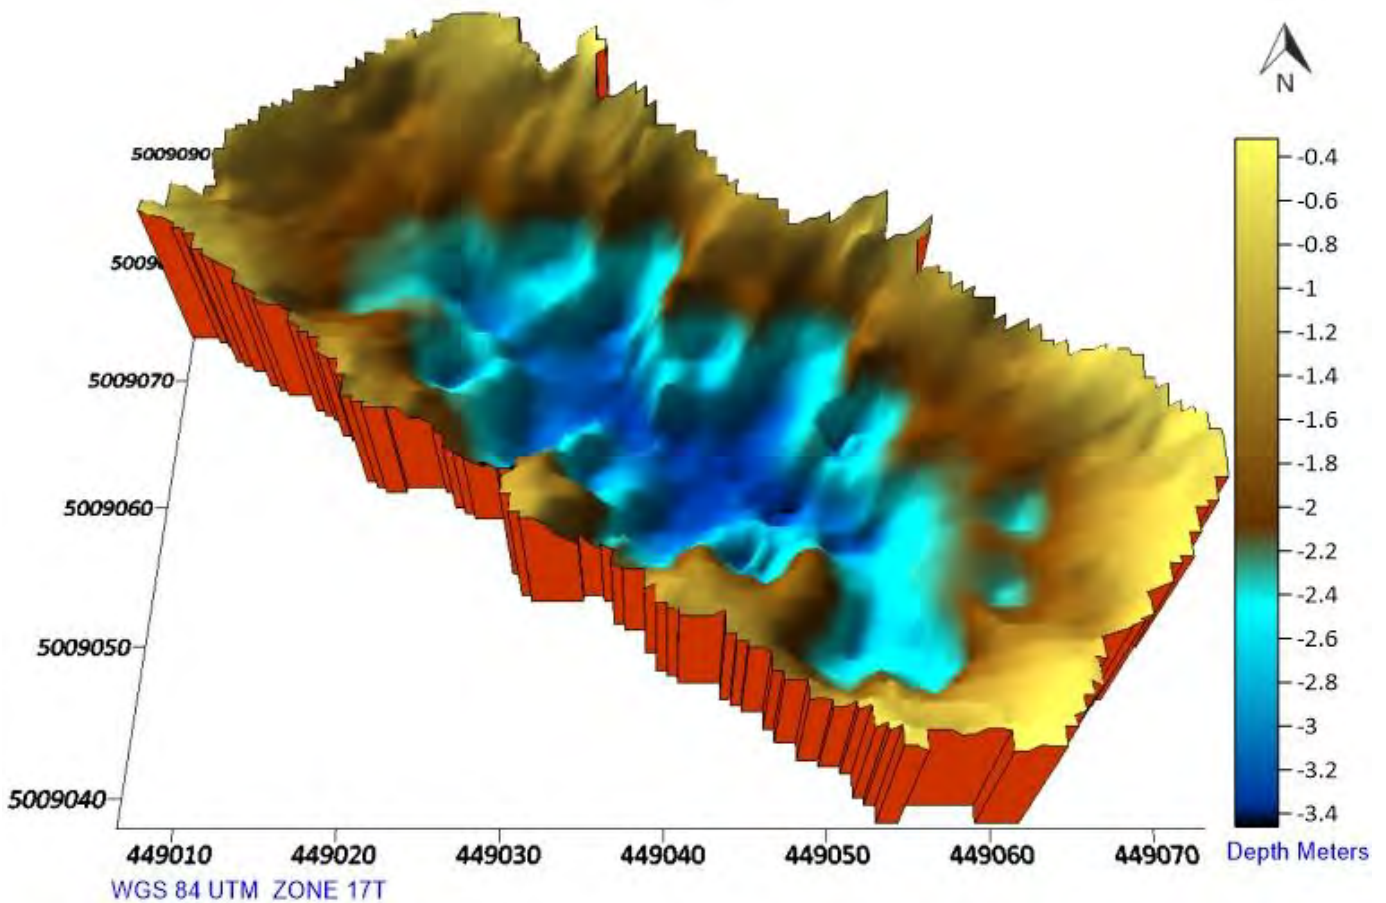
Bathymetric (Upper Surface) Sediment Distribution – 3D Contour Map
