2025 ANNUAL SEWAGE & COLLECTION SYSTEM PERFORMANCE REPORT

TOBERMORY
SEWAGE TREATMENT PLANT &
COLLECTION SYSTEM

For the period of
JANUARY 1, 2025 TO DECEMBER 31, 2025

Shallow Underwater Hydrographic Acoustic Sonar
Sediment Profiling - Volume Modeling and Distribution Survey

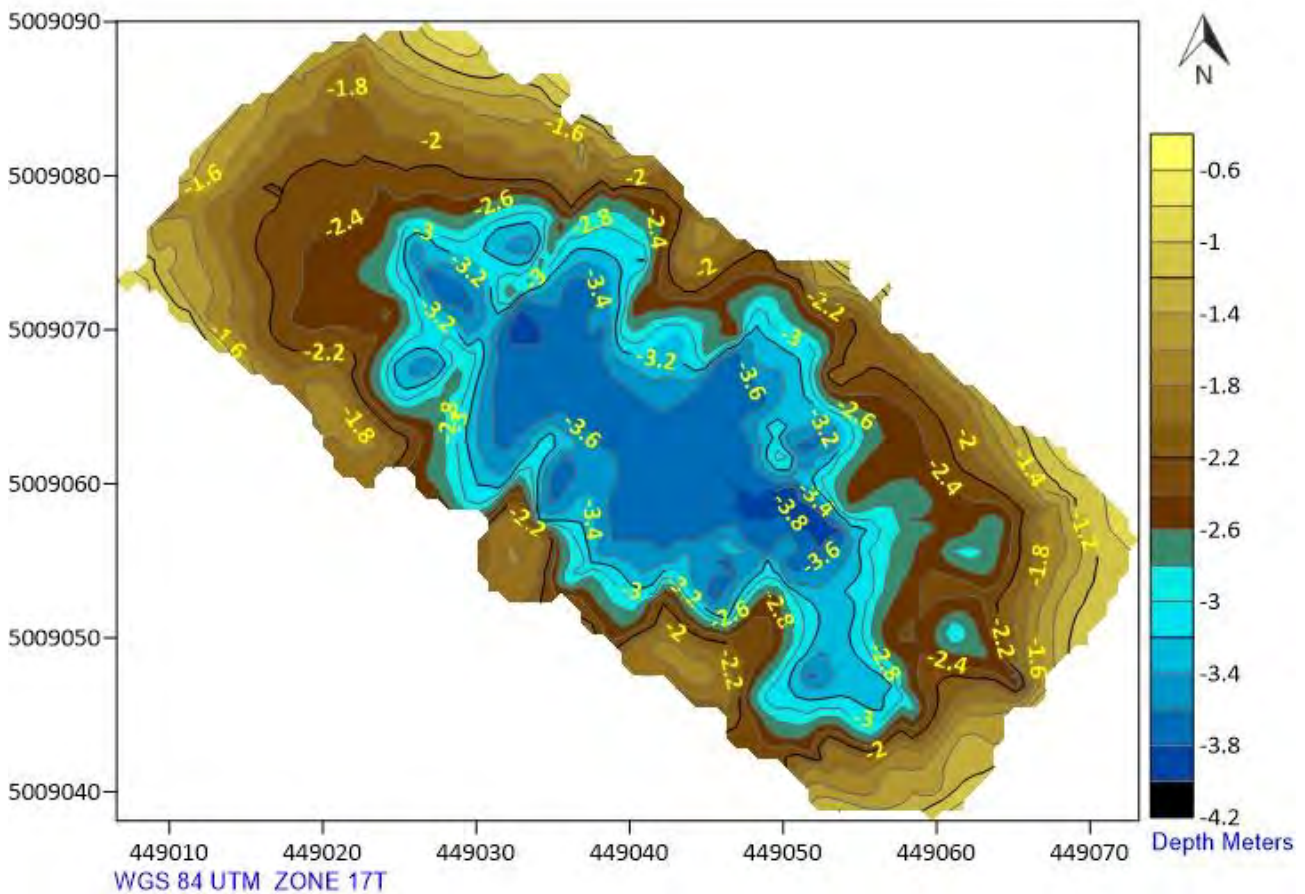
Lower Sub-Bottom (Liner/Clay/Hard Packed Soil) – Contour Map

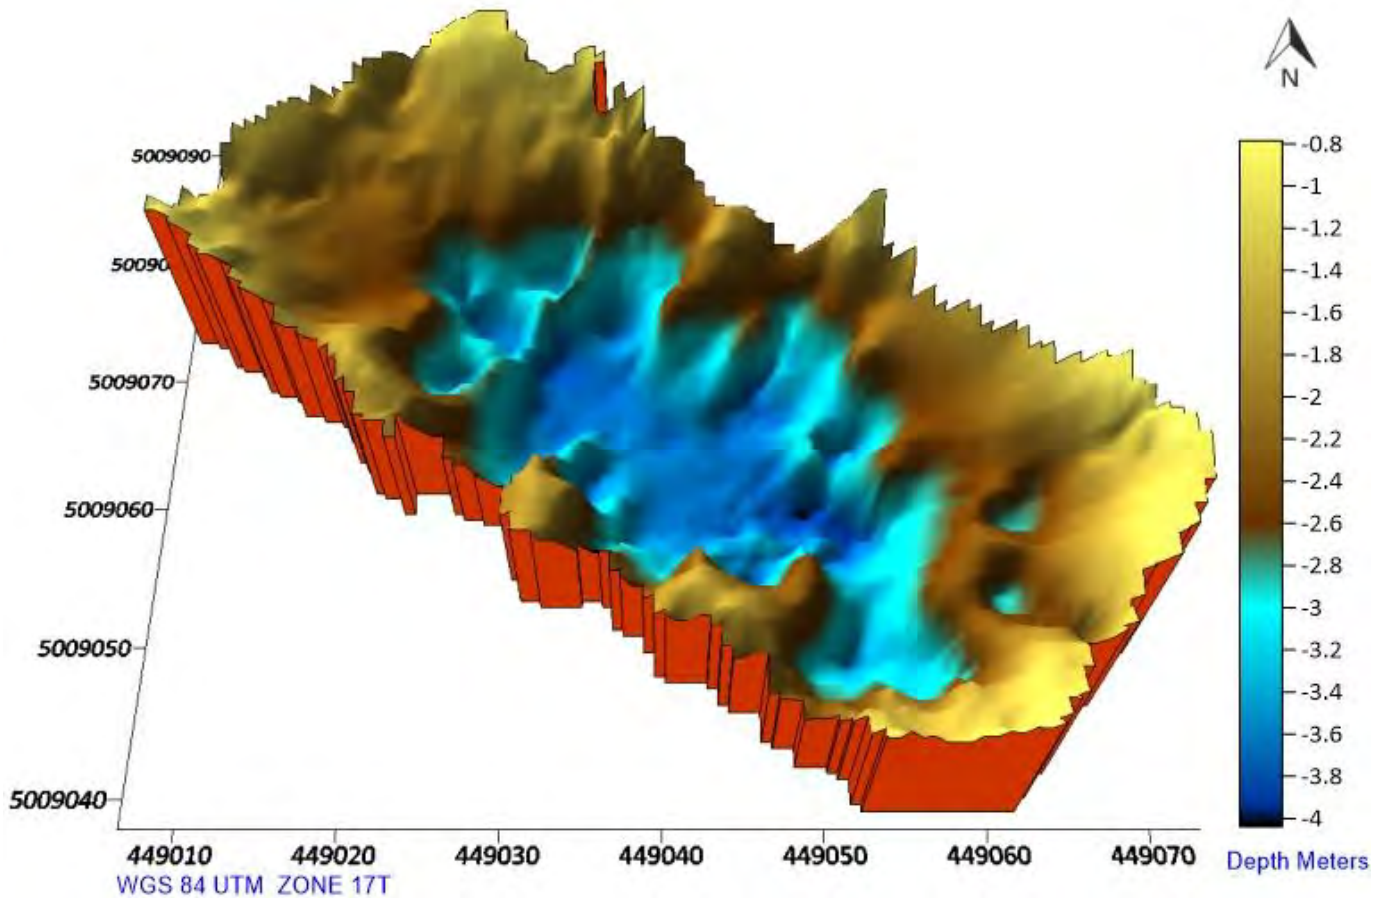
Lower Sub-Bottom (Liner/Clay/Hard Packed Soil) – 3D Contour Map

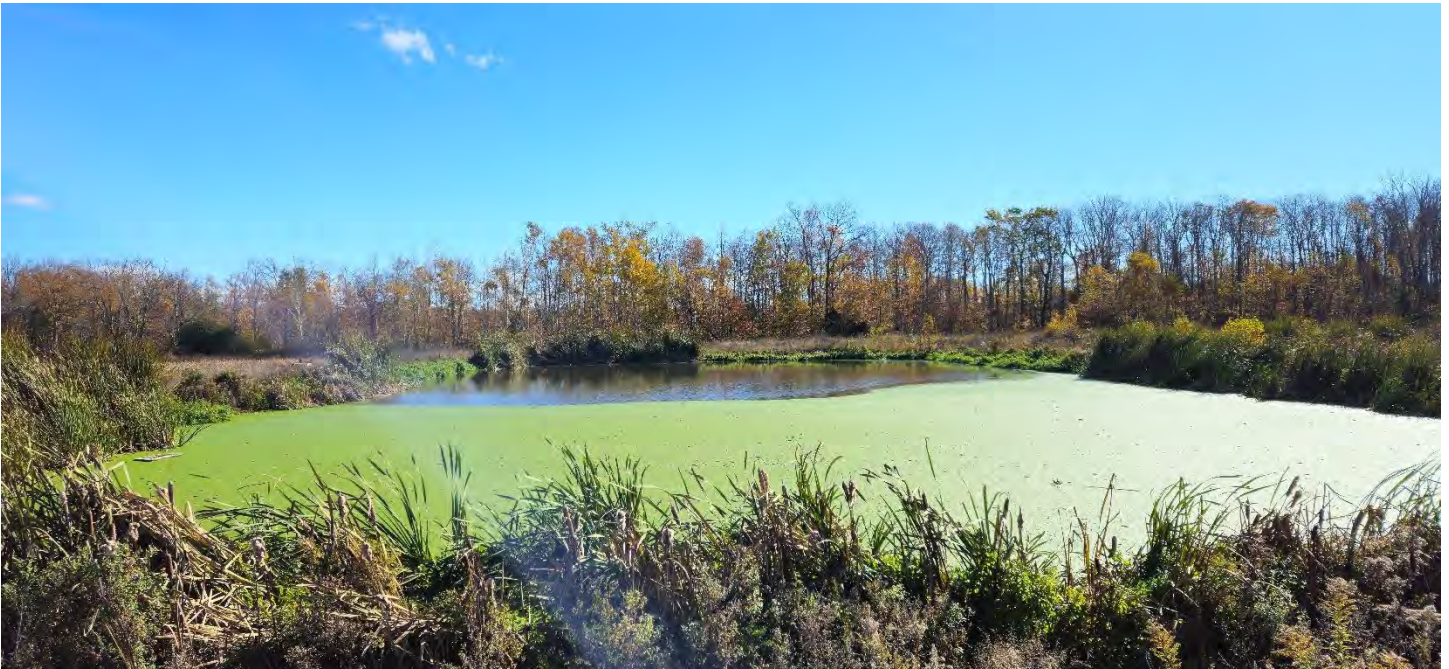
Aerial Digital Image 2. Tobermory East Secondary Cell 2. High level of duck weed floating on the water surface, but navigation of the sonar vessel was still manageable.

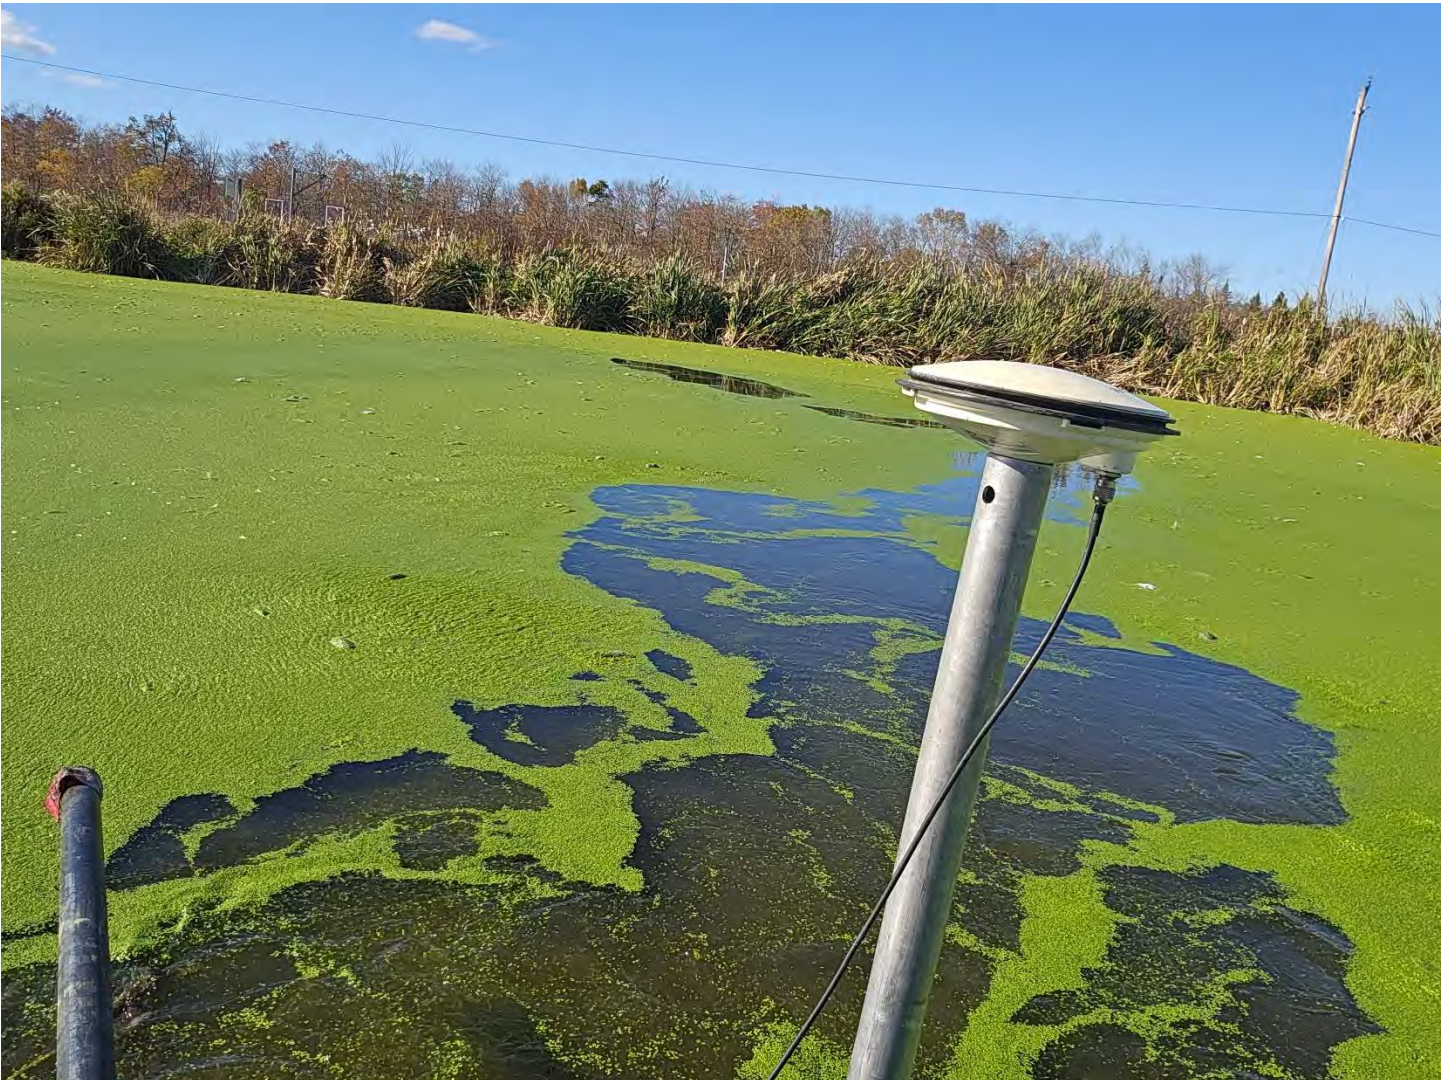
Digital Image 4. Tobermory East Secondary Cell 2. Conducting baseline sludge sub-bottom/liner and bathymetry, sludge blanket depths for post-processing validation.

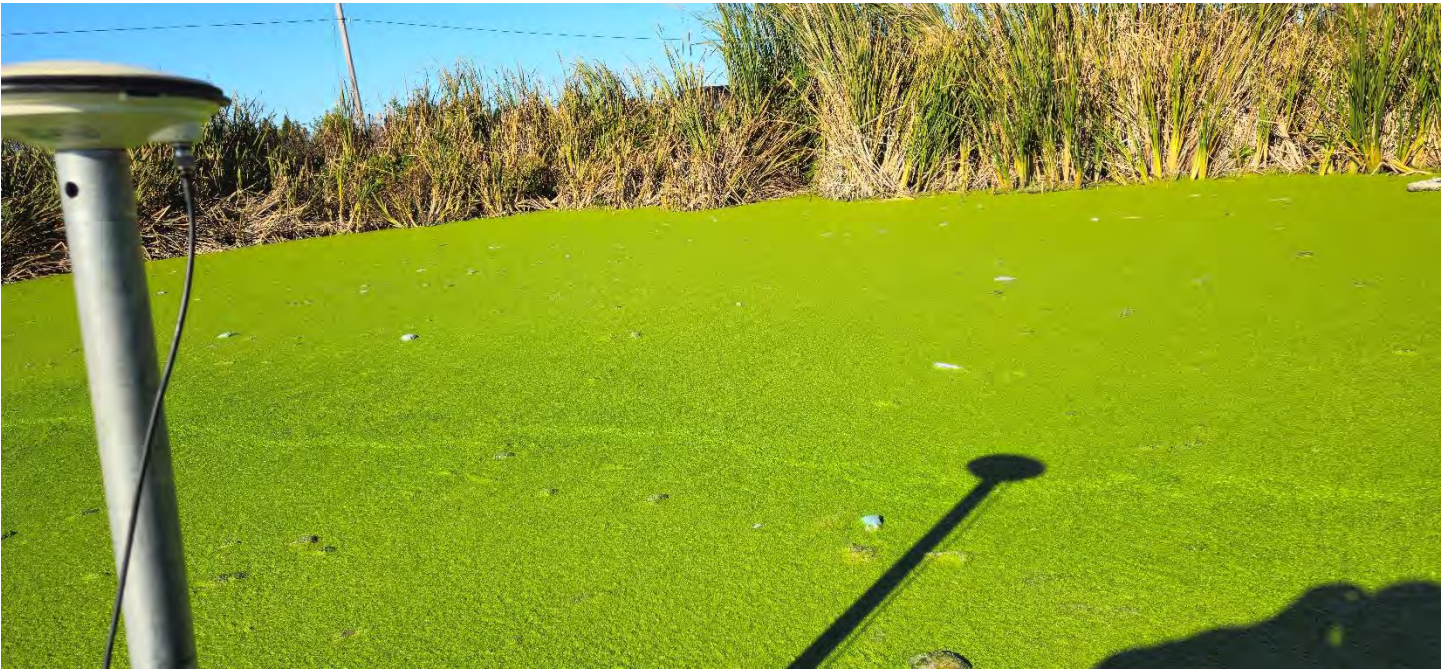
Digital Image 5. Tobermory East Secondary Cell 2. Conducting baseline sludge sub-bottom/liner and bathymetry, sludge blanket depths for post-processing validation.
