MUNICIPALITY OF NORTHERN BRUCE PENINSULA

2020 STRUCTURE INSPECTION REPORT

FINAL
PROJECT NO.: 201-01605-00
DATE: MARCH 10, 2021

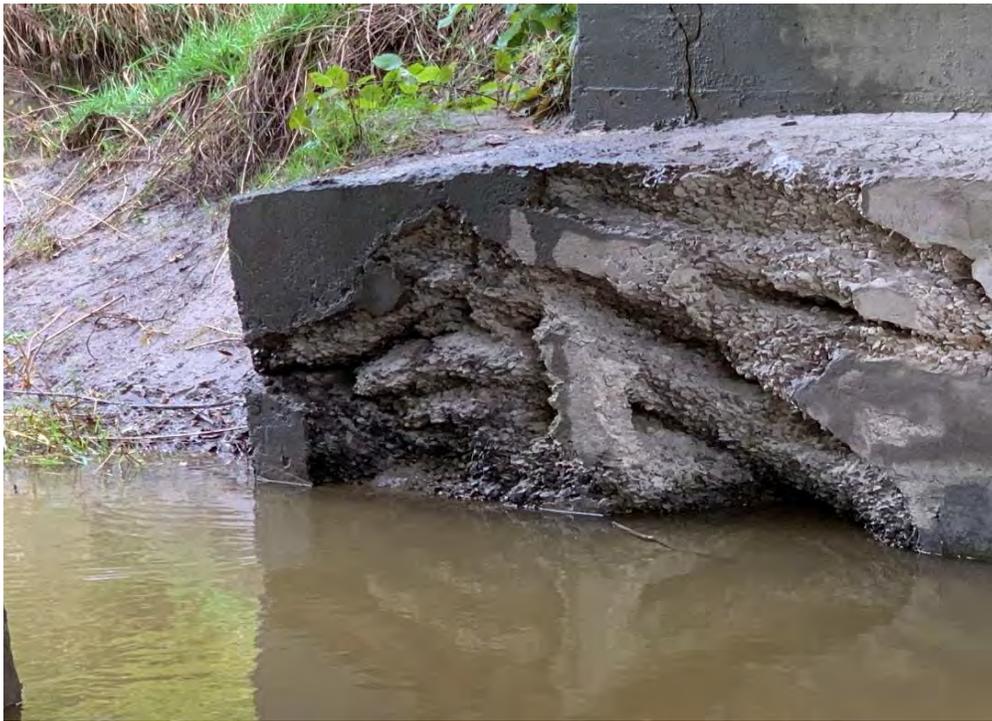
Photo 1-7 - Embankment erosion behind south footing and abutment

Element Group:	Embankments & Streams		Length:				
Element Name:	Embankments		Width:				
Location:			Height:				
Material:	Earth / Stone		Count:				
Element Type:			Total Quantity:	6			
Environment:	Moderate		Limited Insp'n:				
Protection System:							
Condition Data:	Units	Exc.	Good	Fair	Poor	Perform. Deficiencies	Maint. Needs
	Each			4	2	Yes	
Comments:	Stone and well vegetated Earth embankments with some erosion observed along the back of the wingwall.						
Recommended Work:	<input type="checkbox"/> None <input type="checkbox"/> 6-10 Years <input type="checkbox"/> 1-5 Years <input type="checkbox"/> < 1 Year <input type="checkbox"/> Urgent Stabilize the eroded slopes by adding rip rap and/or rock protection.

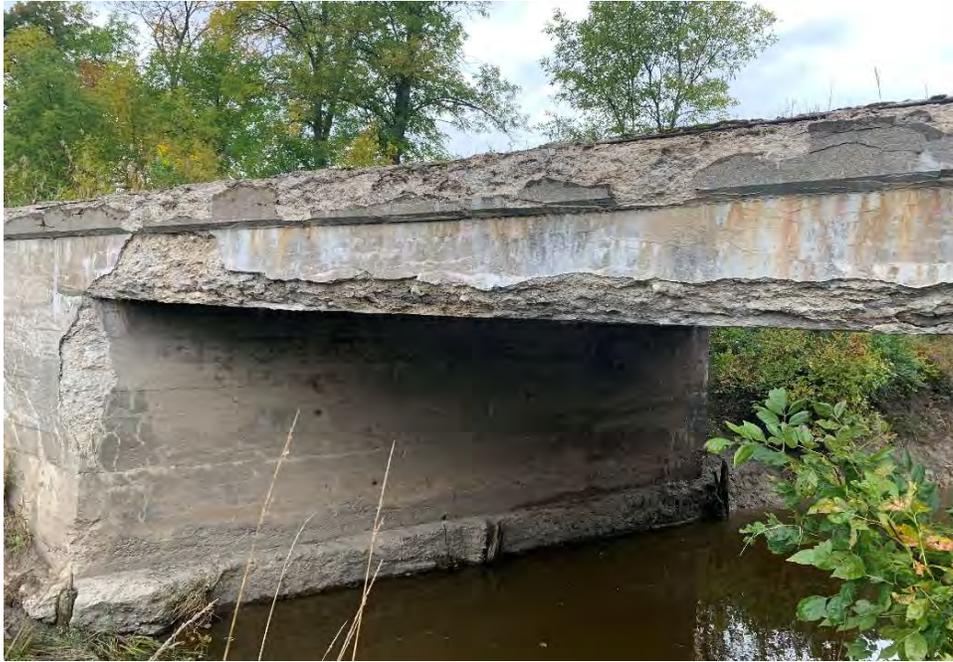
Photo 2-4: West abutment and south exterior soffit

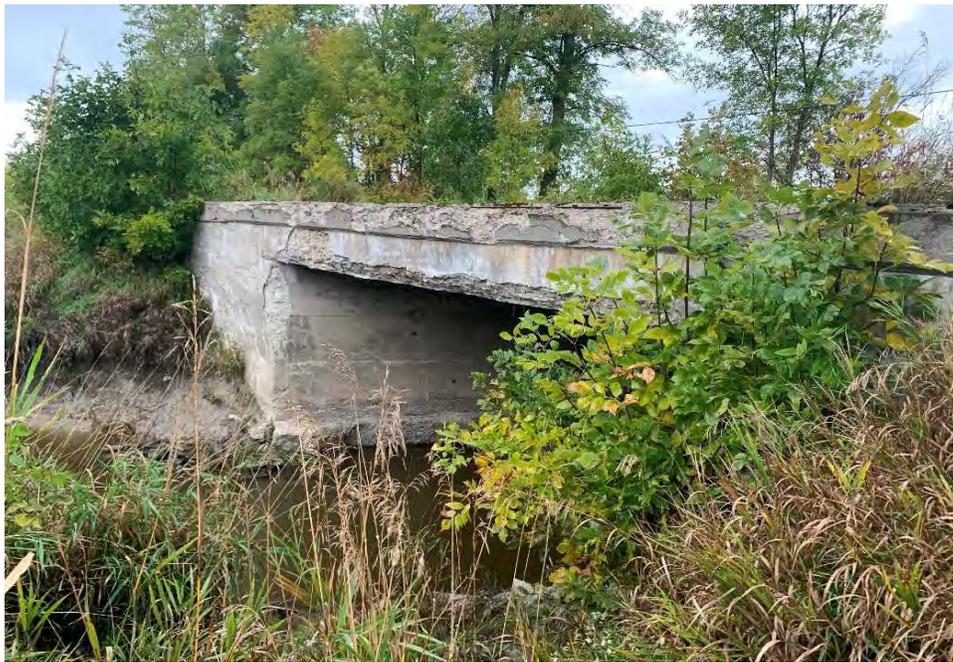
Photo 2-5: Structure elevation, wingwalls, exterior curb and soffit

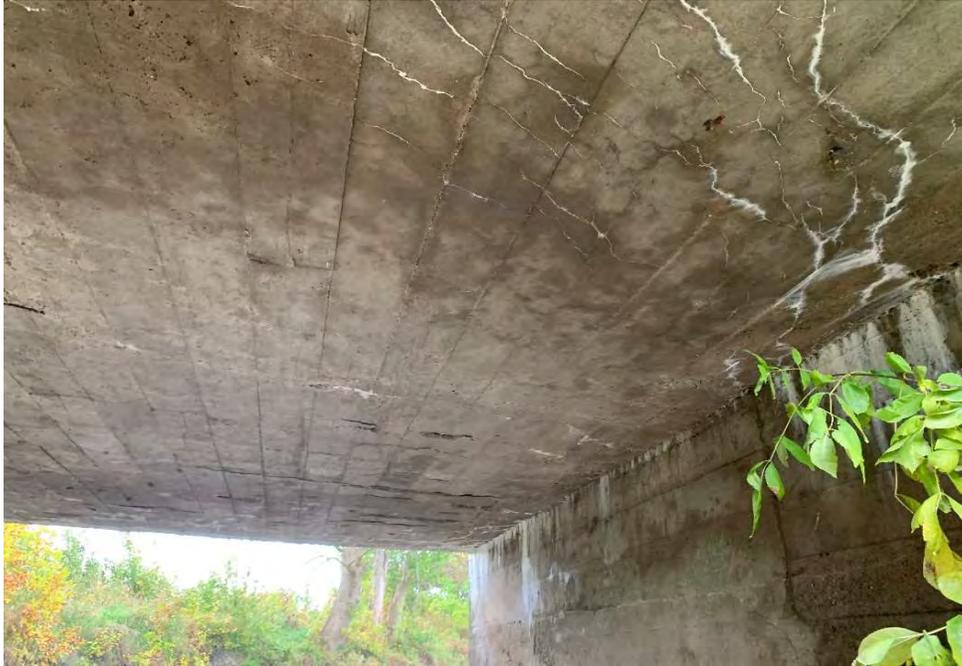
Photo 2-6: Extreme efflorescence at joint

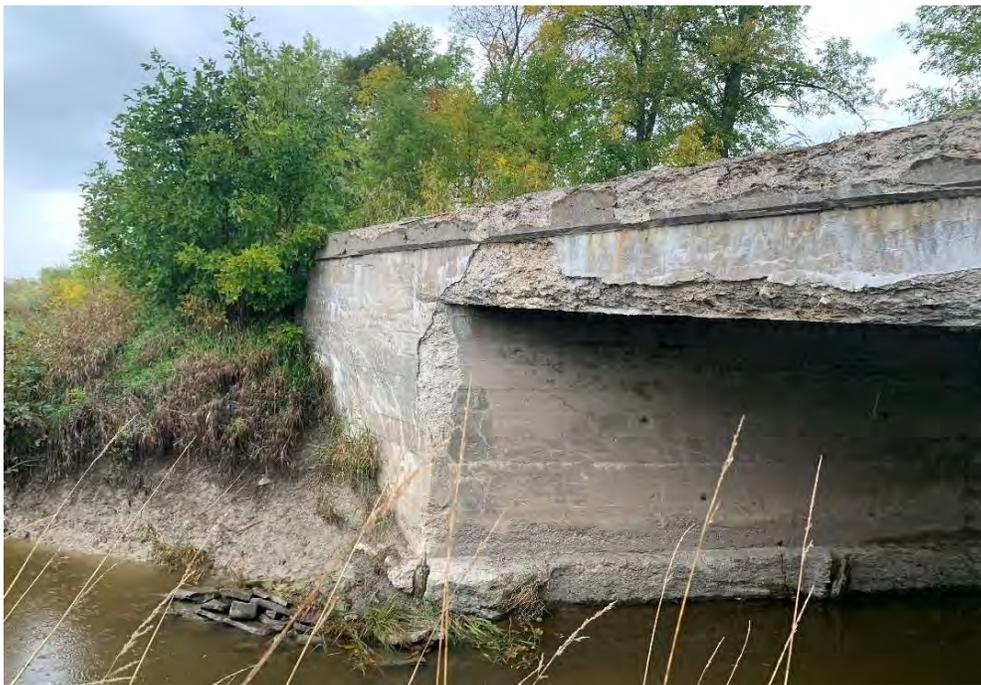
Photo 2-7: Erosion at structure footing, efflorescence of wingwall (typ)

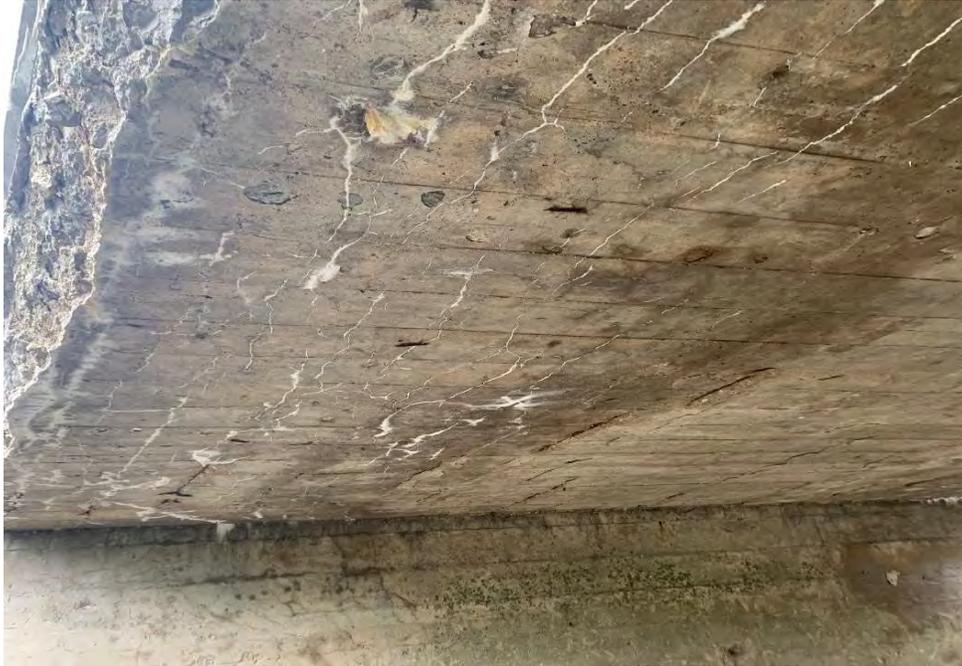
Photo 2-8: Delamination of soffit

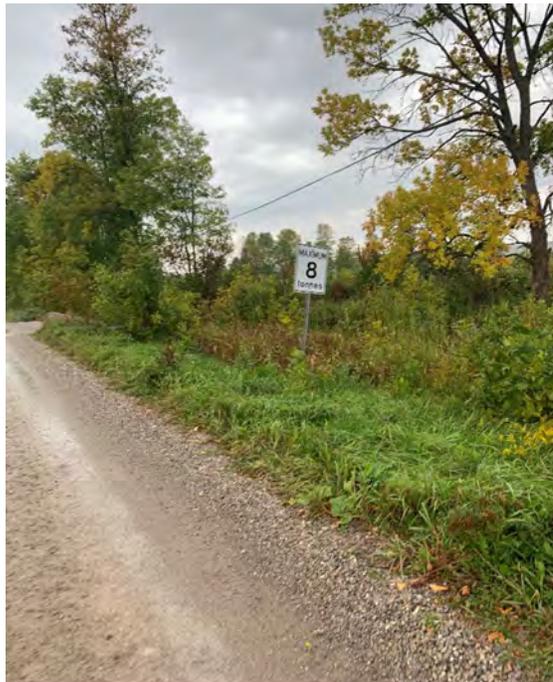
Photo 2-9: Load limit posting

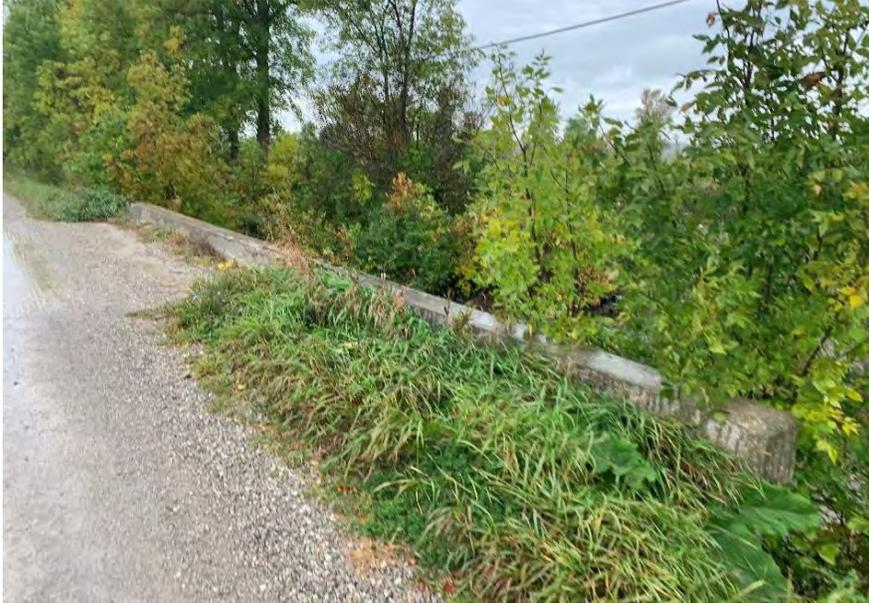
Photo 2-12: Vegetation and debris accumulation at curb and along approach shoulder

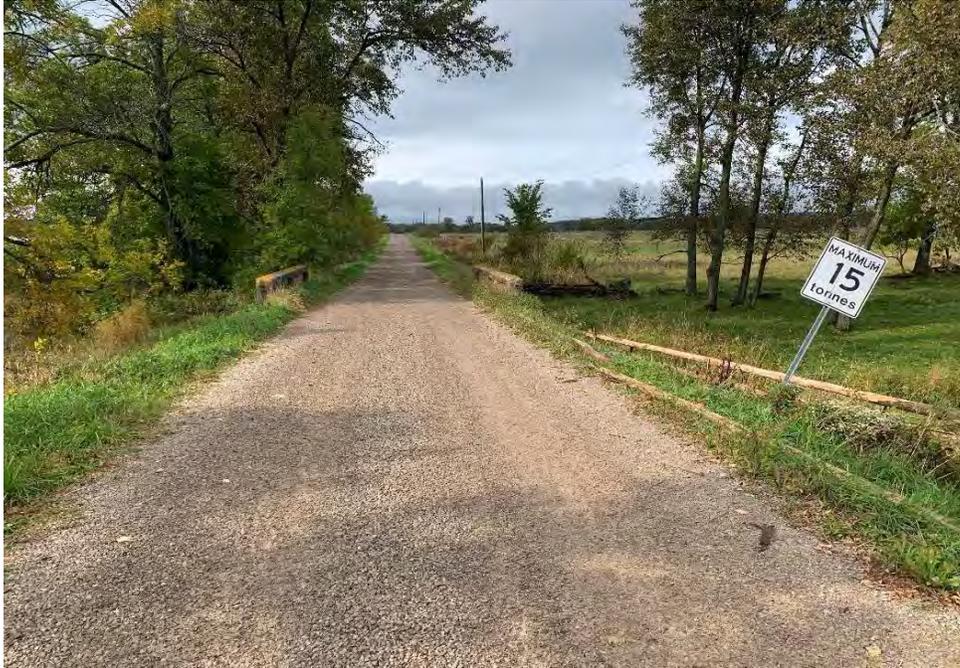
Photo 3-2: View of structure from the south approach

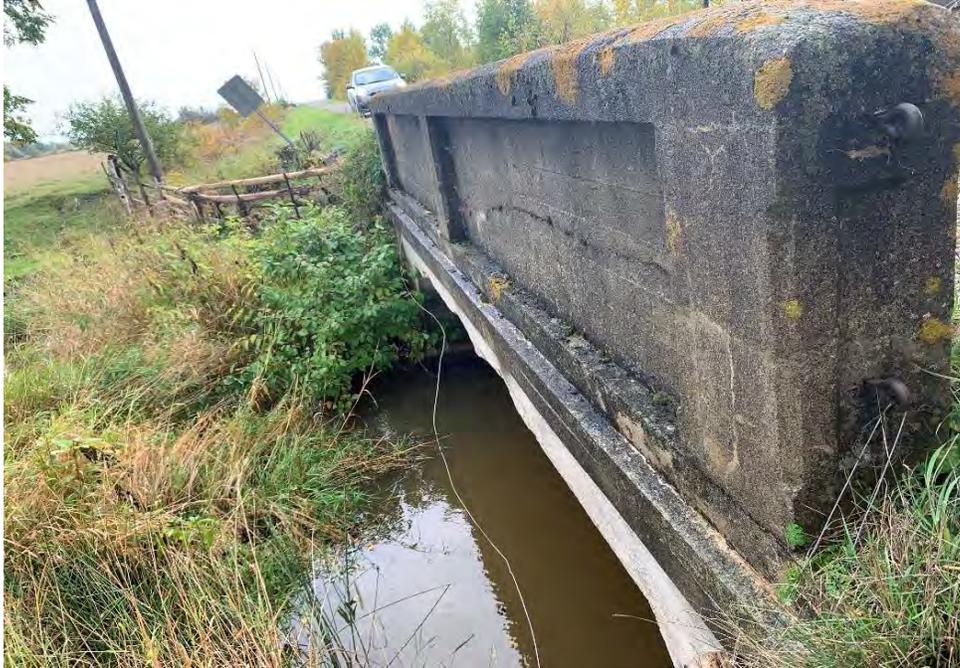
Photo 3-6: East structure elevation, exterior girder and barrier wall

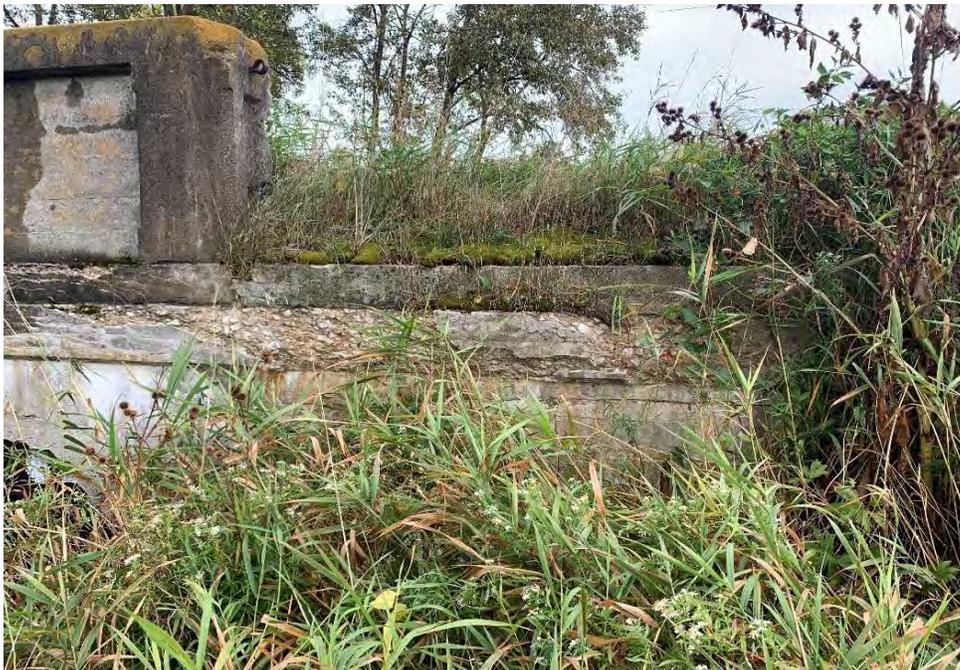
Photo 3-7: Wingwall and exterior curb (typical)

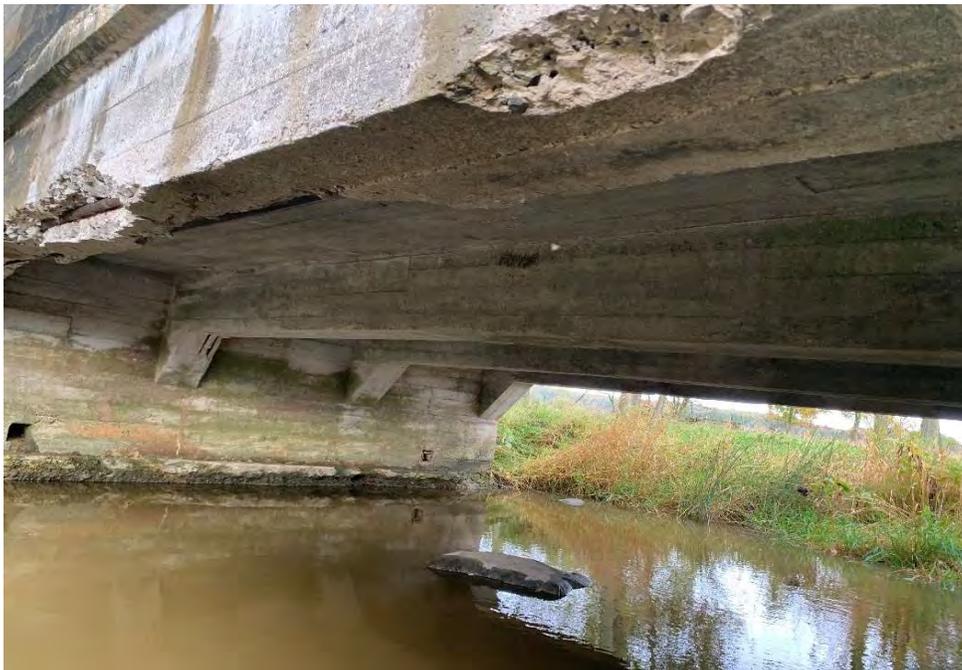
Photo 3-9: View of concrete girders and soffit

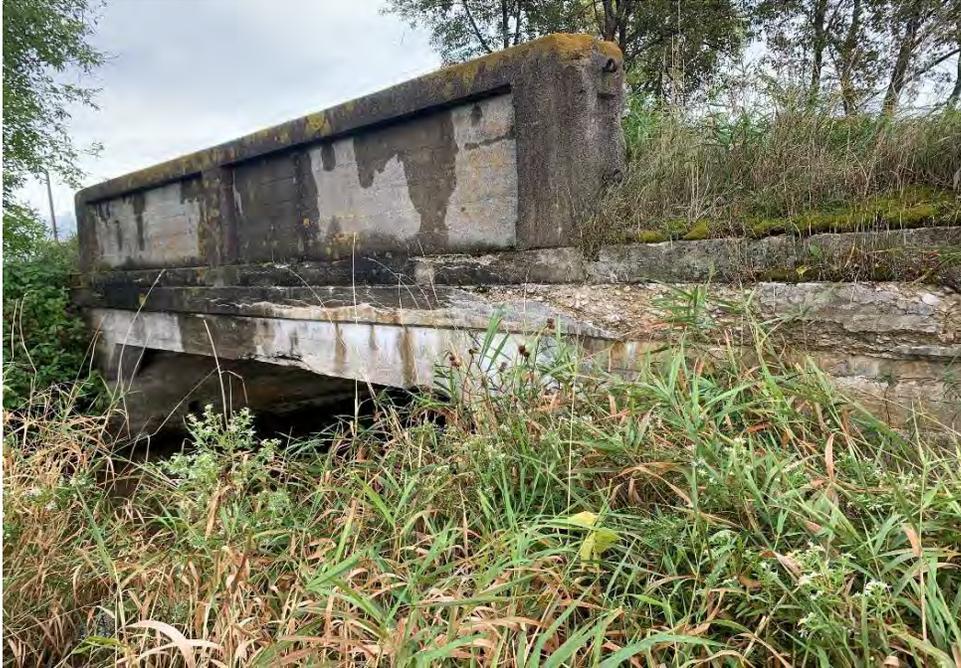
Photo 3-10: View of west structure elevation, exterior girder and barrier wall

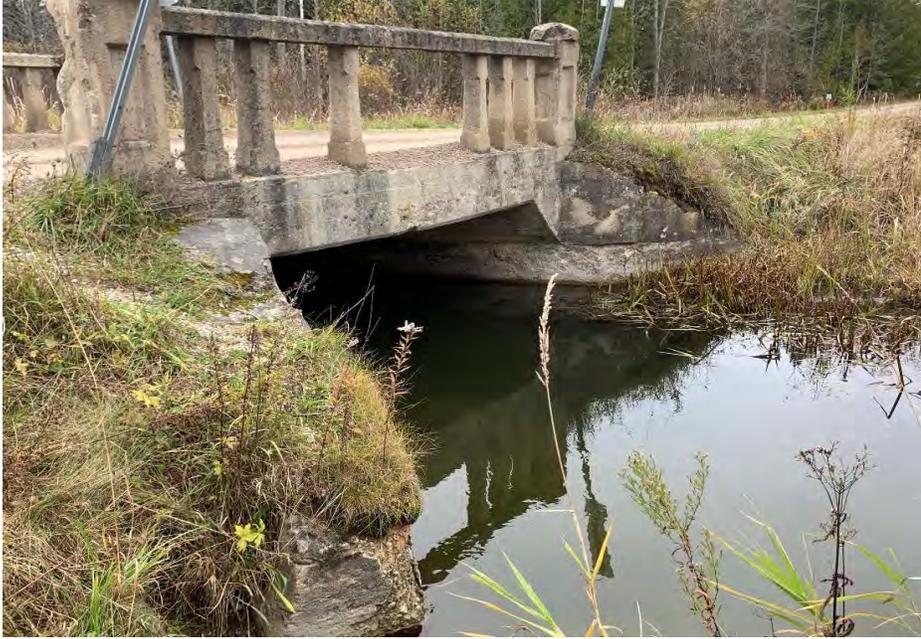
Photo 4-2: View of east structure elevation, wingwalls, exterior curb and barrier

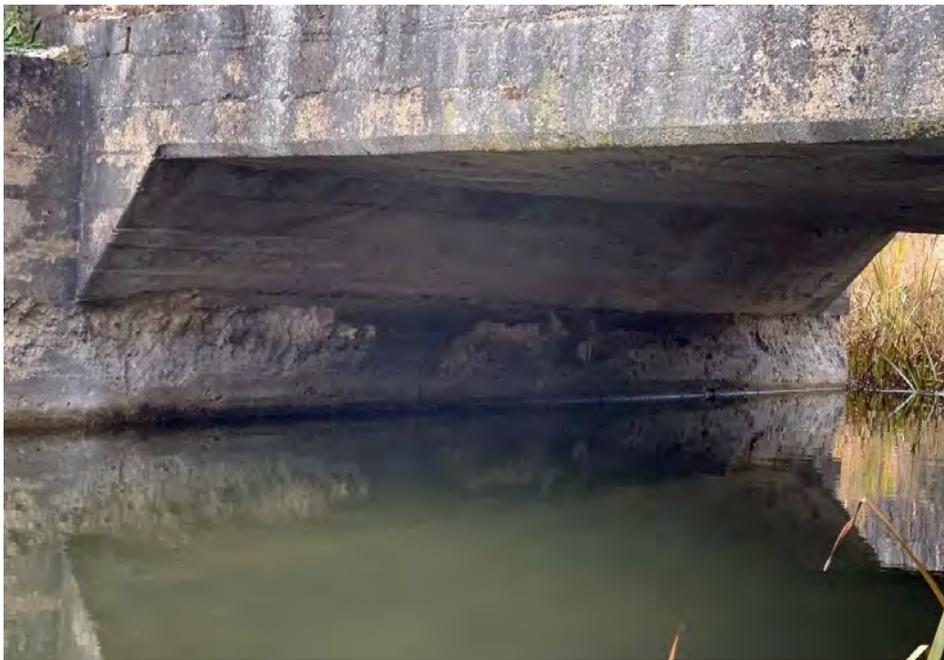
Photo 4-3: View of soffit and abutment wall

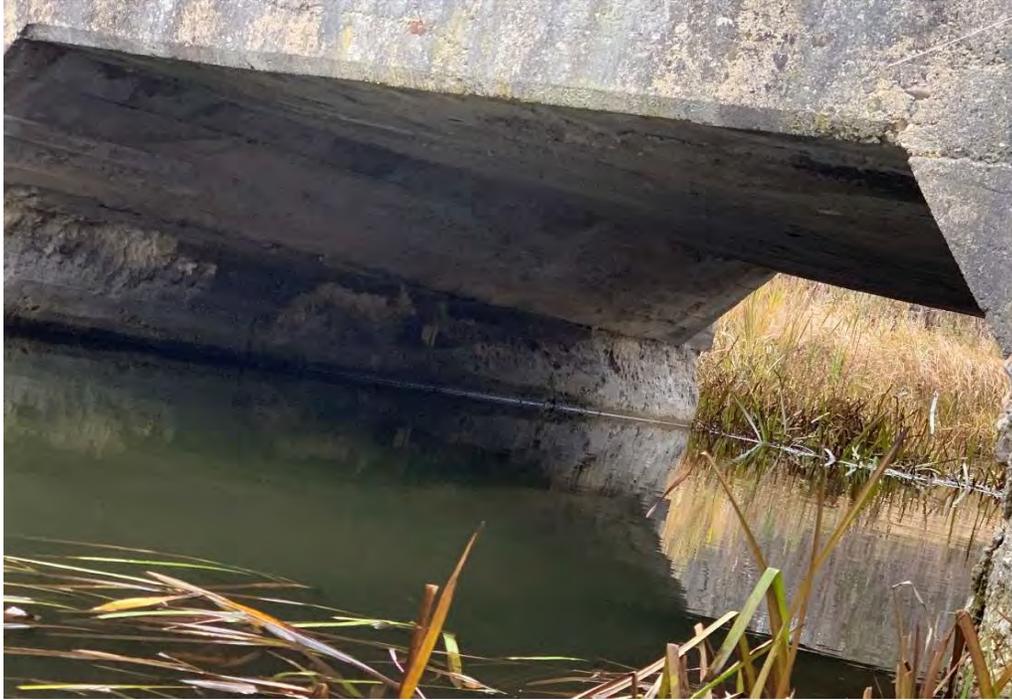
Photo 4-4: View of soffit, exterior curb and barrier

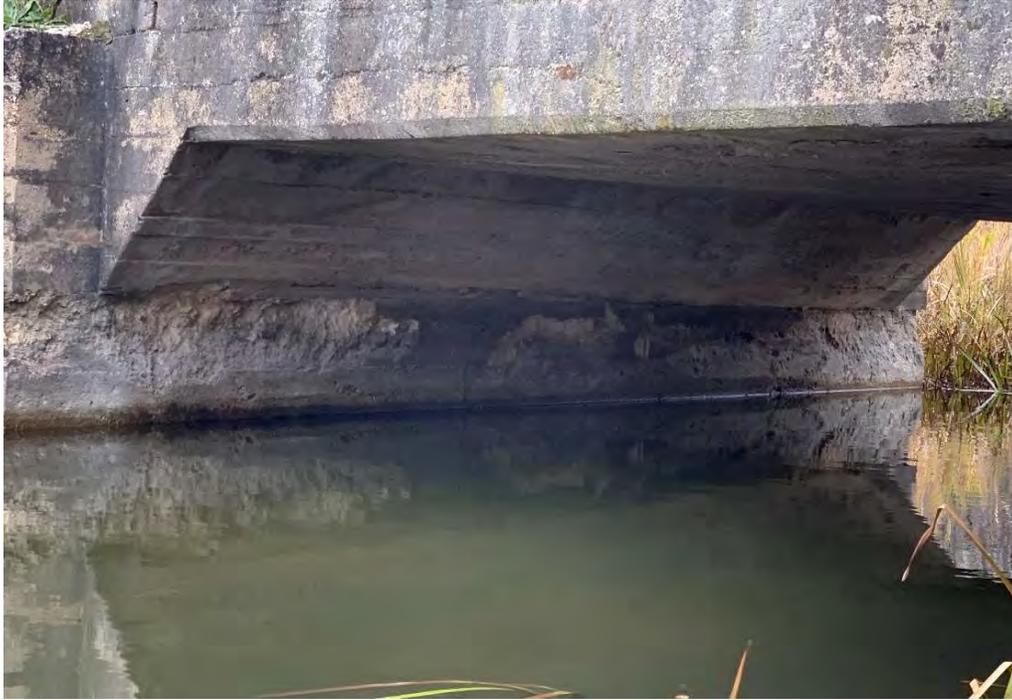
Photo 4-6: View of south abutment wall

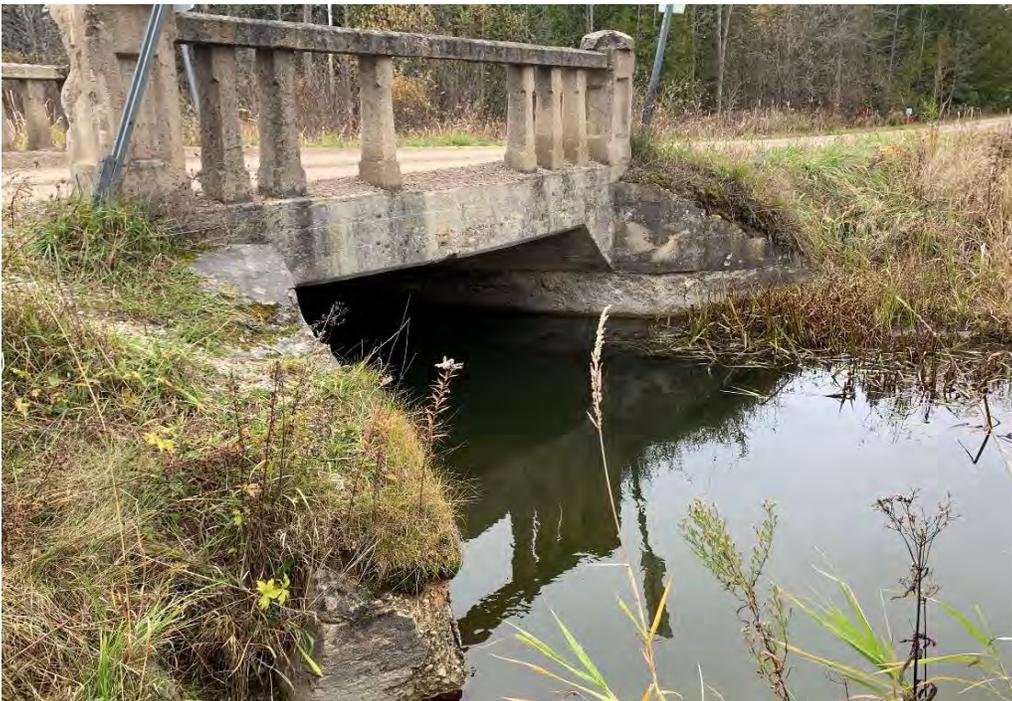
Photo 4-7: View of west structure elevation, exterior soffit, curb and barrier

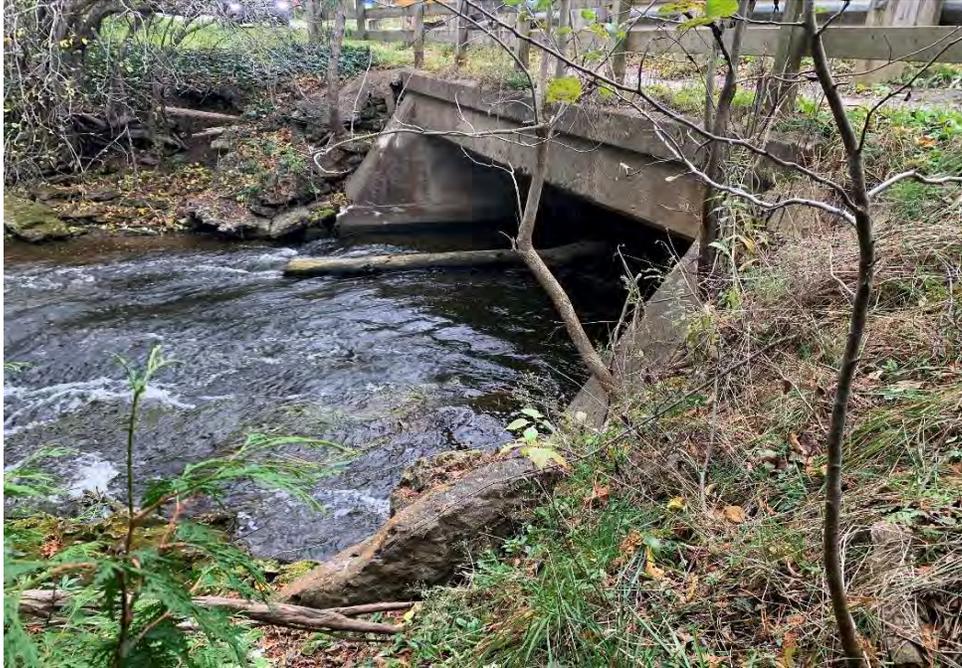
Photo 5-2: View of south structure elevation, exterior curb and soffit, wingwalls and slope protection

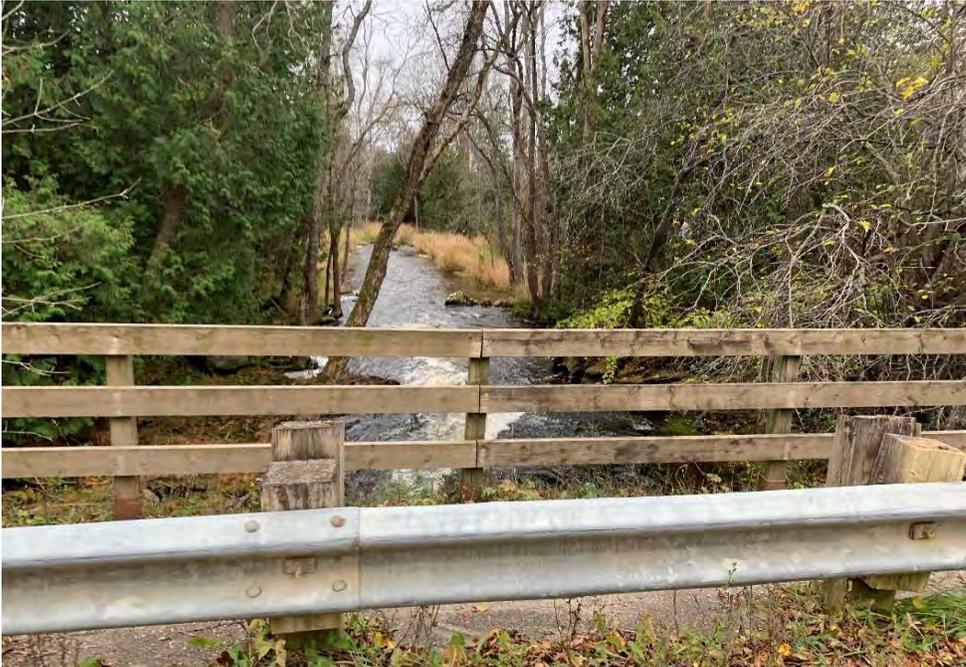
Photo 5-5: Pedestrian (south side only) and structure barrier (typ)

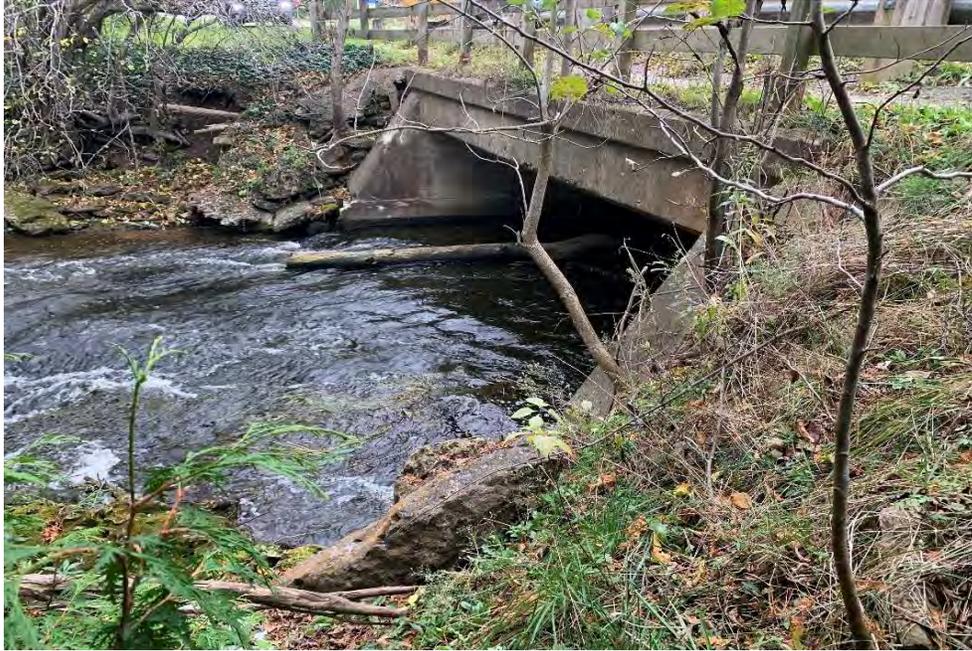
Photo 5-6: Southeast structure embankment erosion

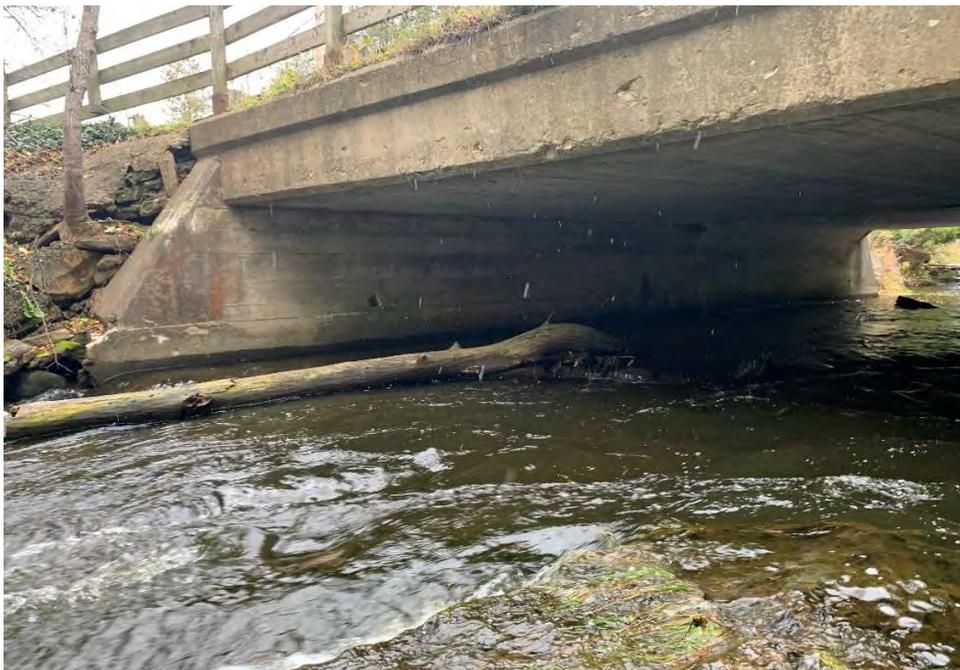
Photo 5-7: View of structure exterior soffit and curb

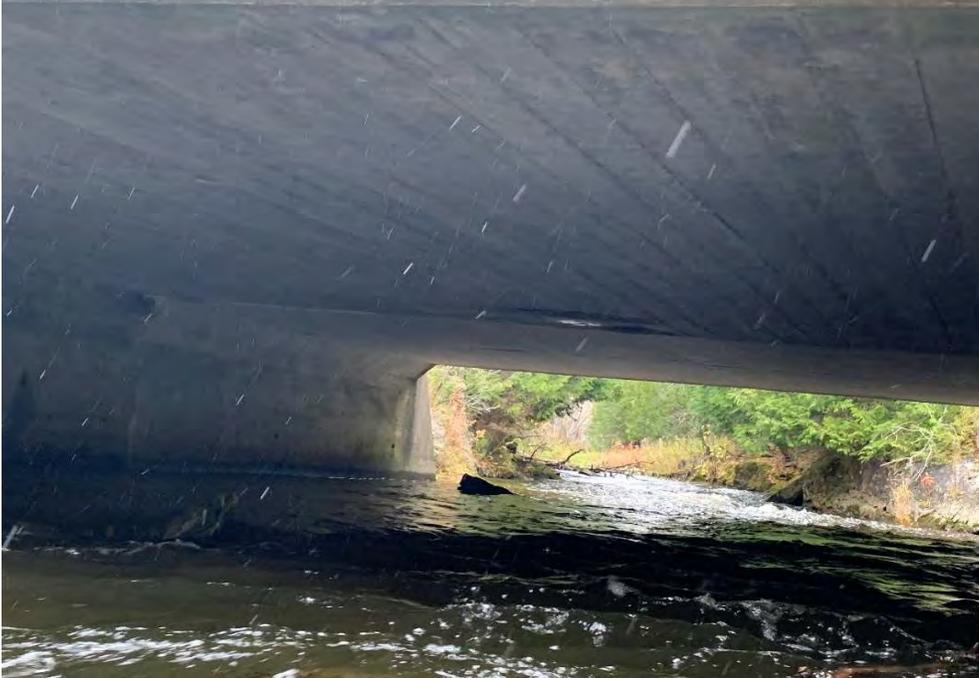
Photo 5-8: View of structure soffit

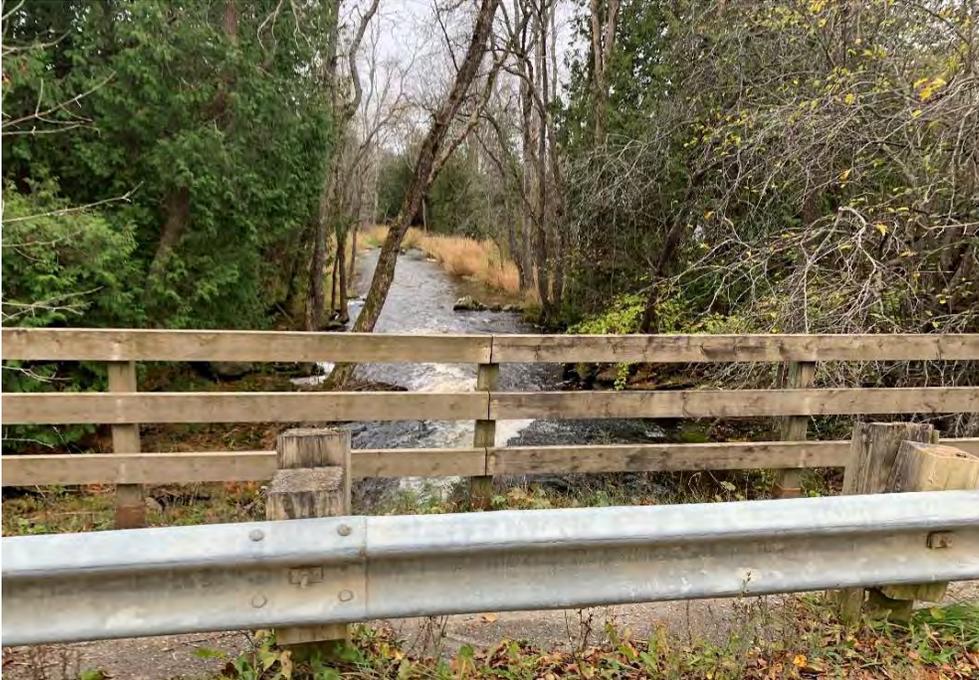
Photo 5-10: View of downstream watercourse

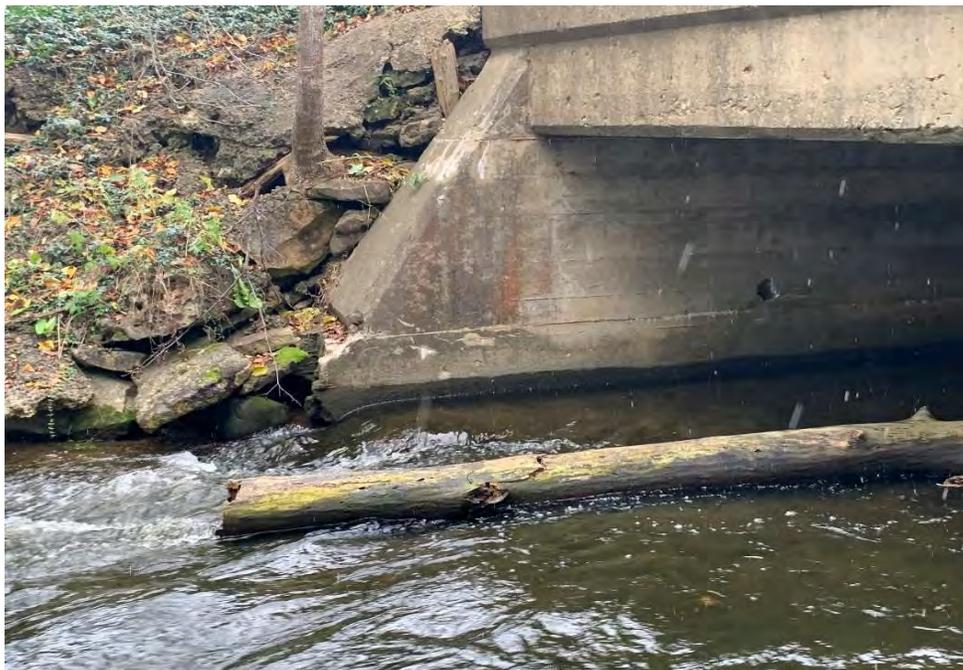
Photo 5-11: View of south structure elevation, exterior curb and soffit and northwest wingwall

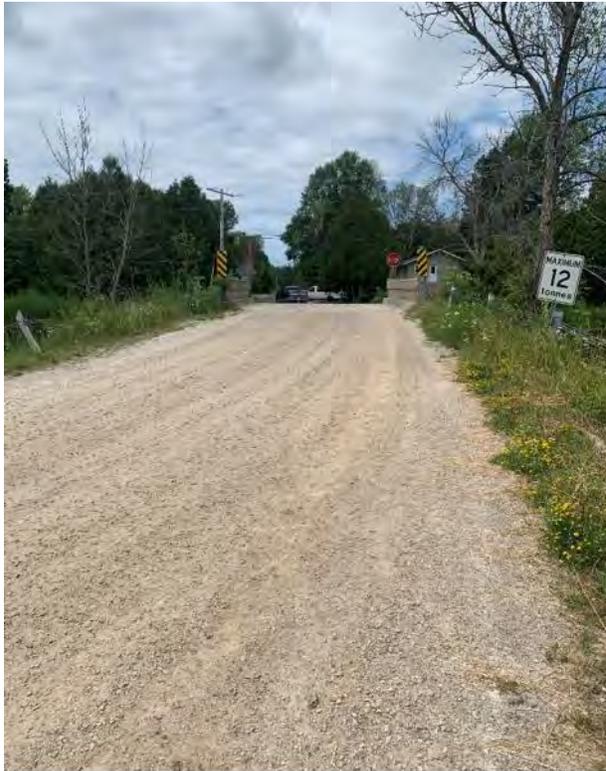
Photo 6-3: View of structure from south approach

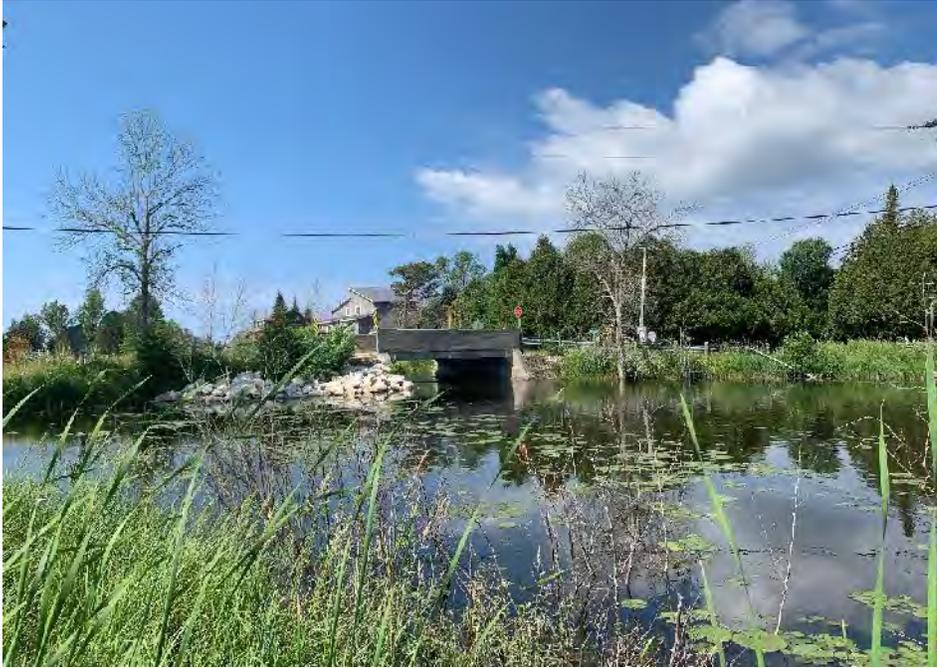
Photo 6-4: View of east structure elevation, slope protection and exterior of parapet wall

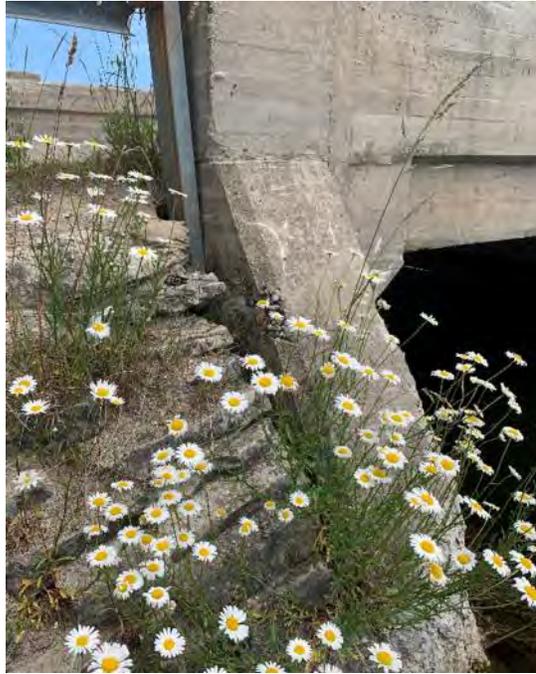
Photo 6-6: View of west structure elevation, wingwalls, exterior curb and parapet wall

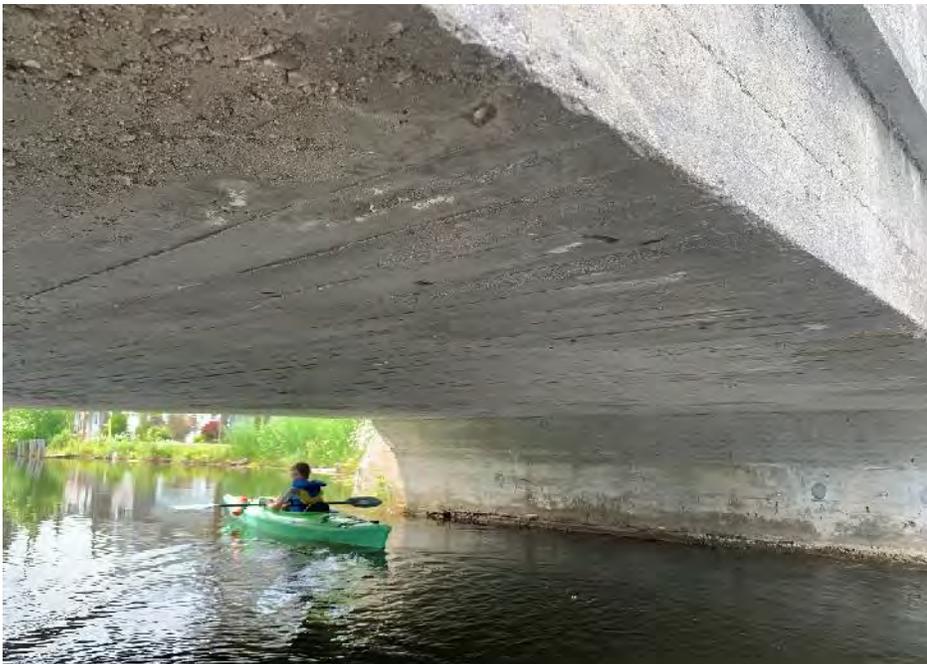
Photo 6-7: View of structure soffit

Element Group:	Decks		Length:	7.41 m			
Element Name:	Soffit - Thick Slab		Width:	6.8 m			
Location:			Height:				
Material:	Concrete		Count:				
Element Type:			Total Quantity:	50.39 m ²			
Environment:	Moderate		Limited Insp'n:				
Protection System:							
Condition Data:	Units	Exc.	Good	Fair	Poor	Perform. Deficiencies	Maint. Needs
	m ²			45.35	5.04		
Comments:	Observed spalling, cracking, and staining with effervescence of the soffit. The spalling is severe at all corners. The southeast haunch is in very poor condition.						
Recommended Work:	None 6-10 Years <input checked="" type="checkbox"/> 1-5 Years < 1 Year Urgent Remove all poor concrete, clean reinforcing steel and replace concrete.

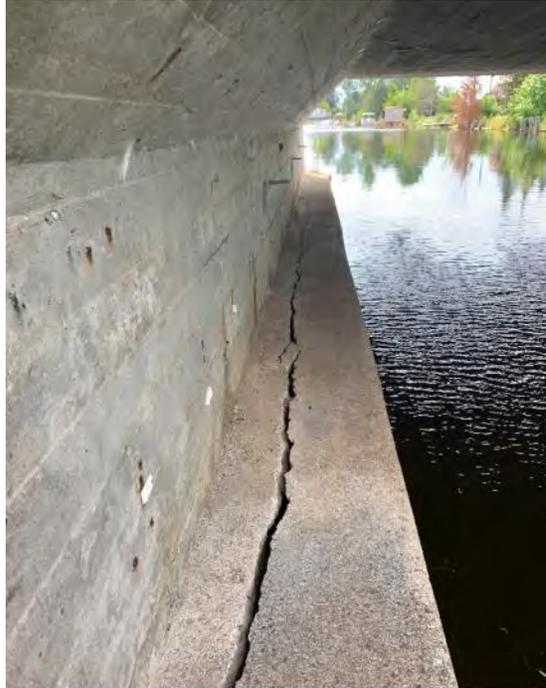
Photo 6-8: View of foundation crack and abutment wall

Element Group:	Foundations		Length:				
Element Name:	Foundation (below ground level)		Width:	9.5			
Location:			Height:	0.85			
Material:	Concrete		Count:	2			
Element Type:			Total Quantity:				
Environment:	Moderate		Limited Insp'n:				
Protection System:							
Condition Data:	Units	Exc.	Good	Fair	Poor	Perform. Deficiencies	Maint. Needs
						Yes	
Comments:	Founded on bedrock. Split through the centre severely spalled and delaminated. A detailed structural assessment should be completed and the load carrying capacity determined if the structure is to remain open.						
Recommended Work:	None 6-10 Years <input checked="" type="checkbox"/> 1-5 Years < 1 Year Urgent Remove and replace all poor concrete, clean reinforcing steel, and replace concrete.

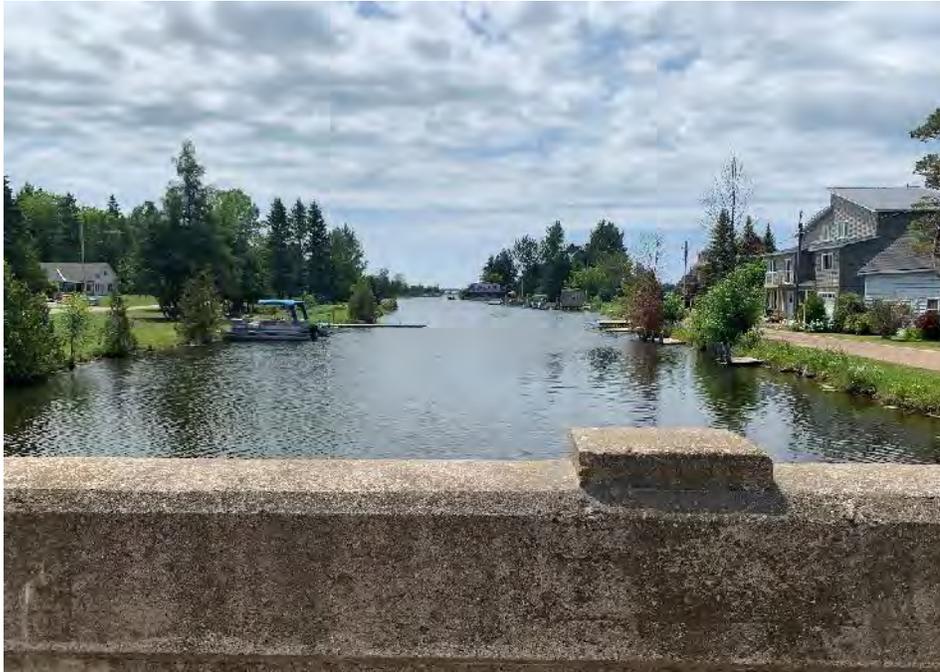
Photo 6-10: View of watercourse downstream

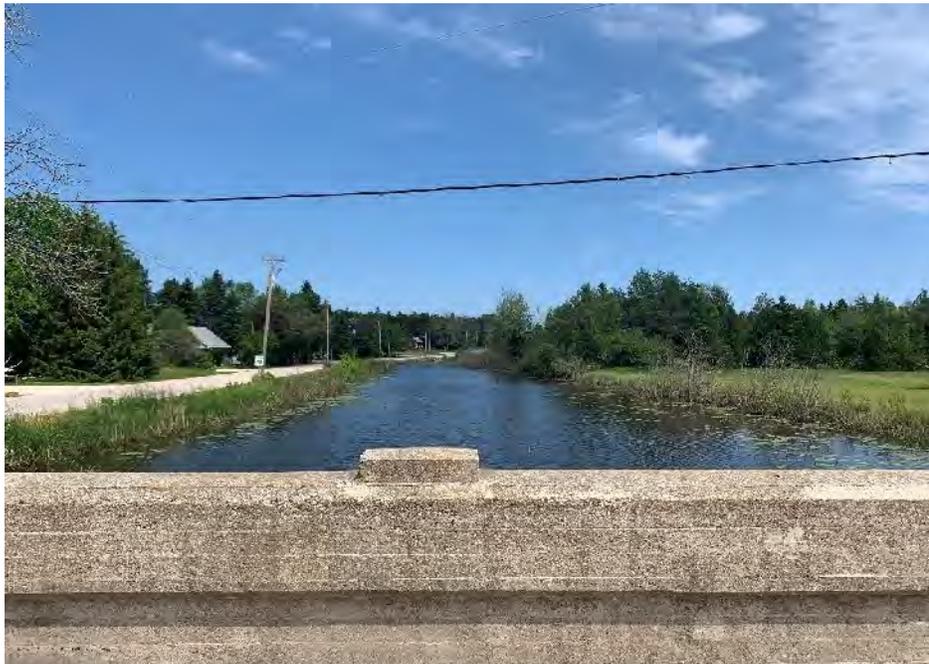
Photo 6-11: View of watercourse upstream

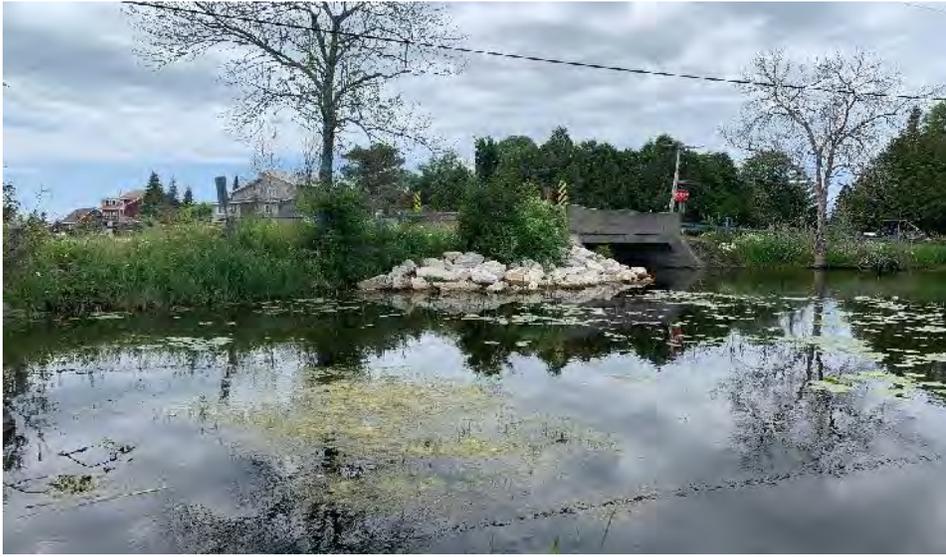
Photo 6-12: Southeast rock embankment protection

Element Group:	Embankments & Streams		Length:				
Element Name:	Slope Protection		Width:				
Location:			Height:				
Material:	Earth / Stone / Rock		Count:	6			
Element Type:			Total Quantity:	6			
Environment:	Moderate		Limited Insp'n:				
Protection System:							
Condition Data:	Units	Exc.	Good	Fair	Poor	Perform. Deficiencies	Maint. Needs
	Each			6			
Comments:	Both vegetated earth and rock protected slopes. Some corner erosion and settlement of the existing rock protection was observed. New rip rap placed in 2017 to protect the embankment exposed following the failure of the structure wingwall.						
Recommended Work:	None 6-10 Years		<input checked="" type="checkbox"/> 1-5 Years	< 1 Year	Urgent		
	Place erosion protection at the corners.

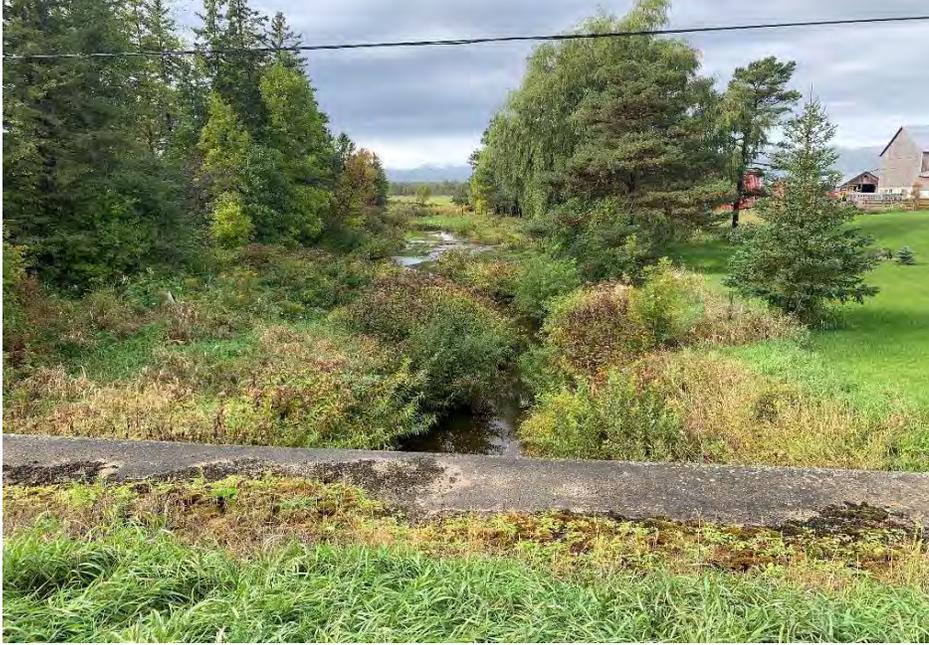
Photo 7-2: View of watercourse upstream and upstream culvert end

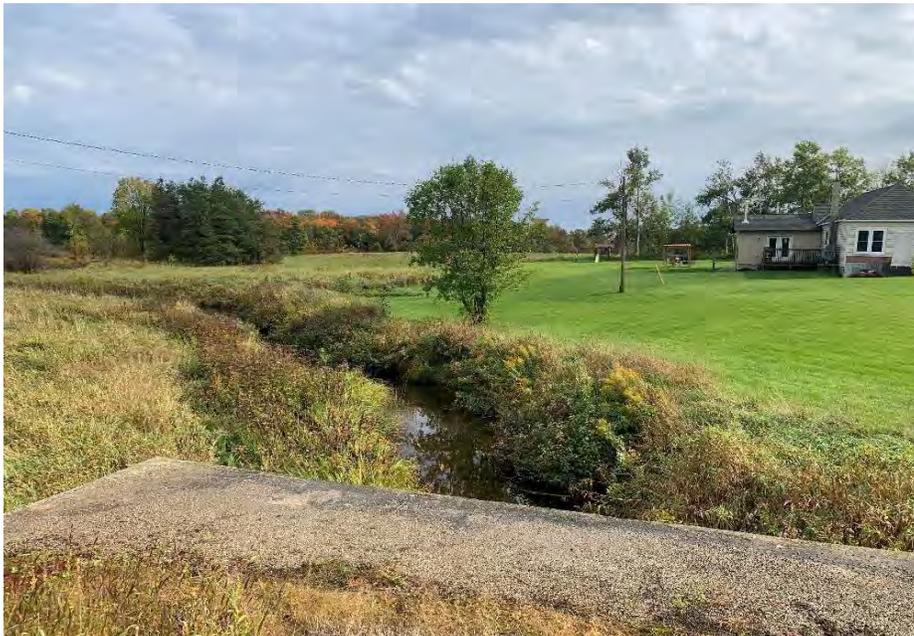
Photo 7-3: View of watercourse downstream and downstream culvert end
