MUNICIPALITY OF NORTHERN BRUCE PENINSULA

2020 STRUCTURE INSPECTION REPORT

FINAL
PROJECT NO.: 201-01605-00
DATE: MARCH 10, 2021

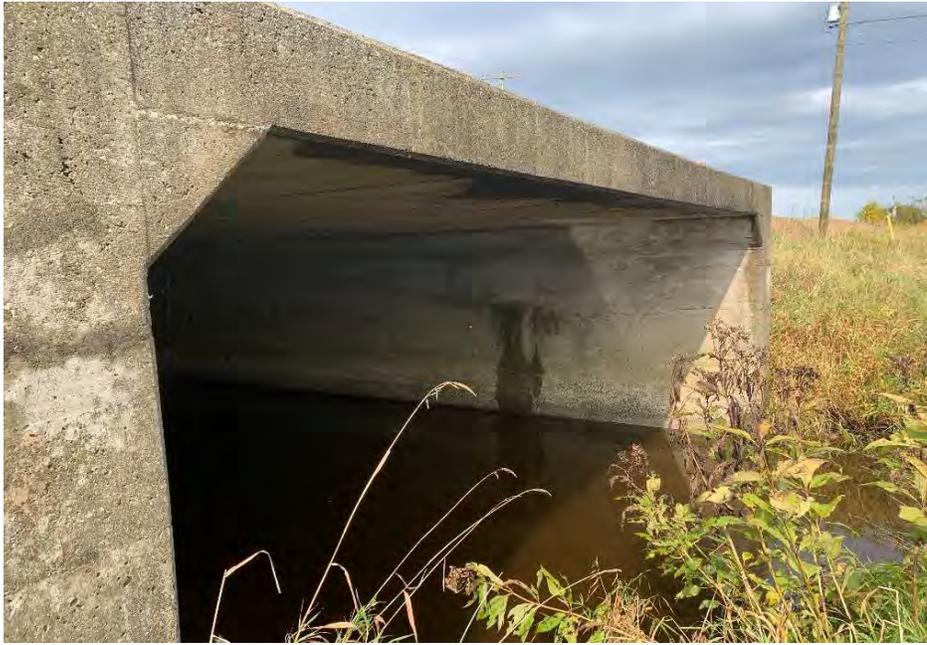
Photo 7-4: Structure Elevation

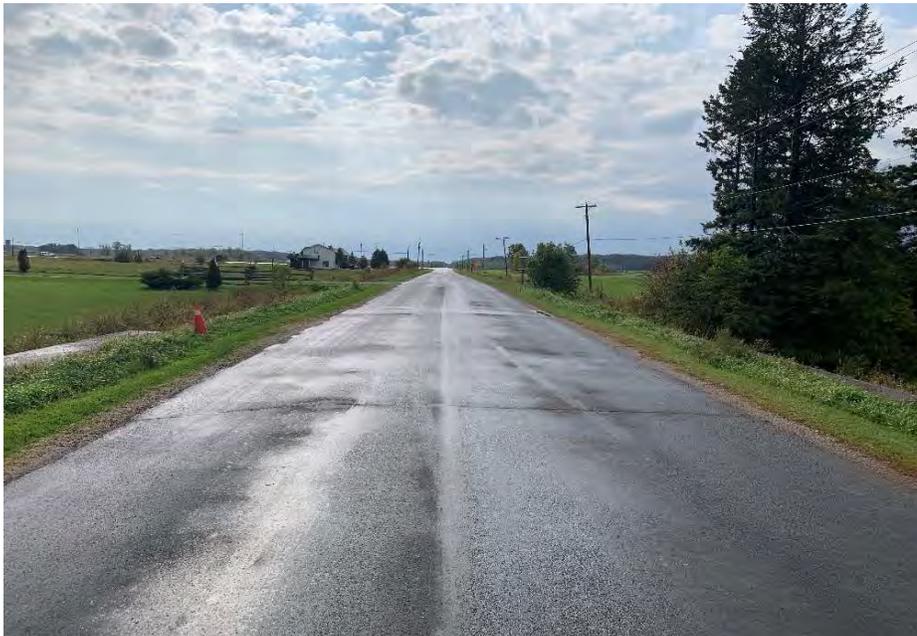
Photo 7-5: Wearing Surface

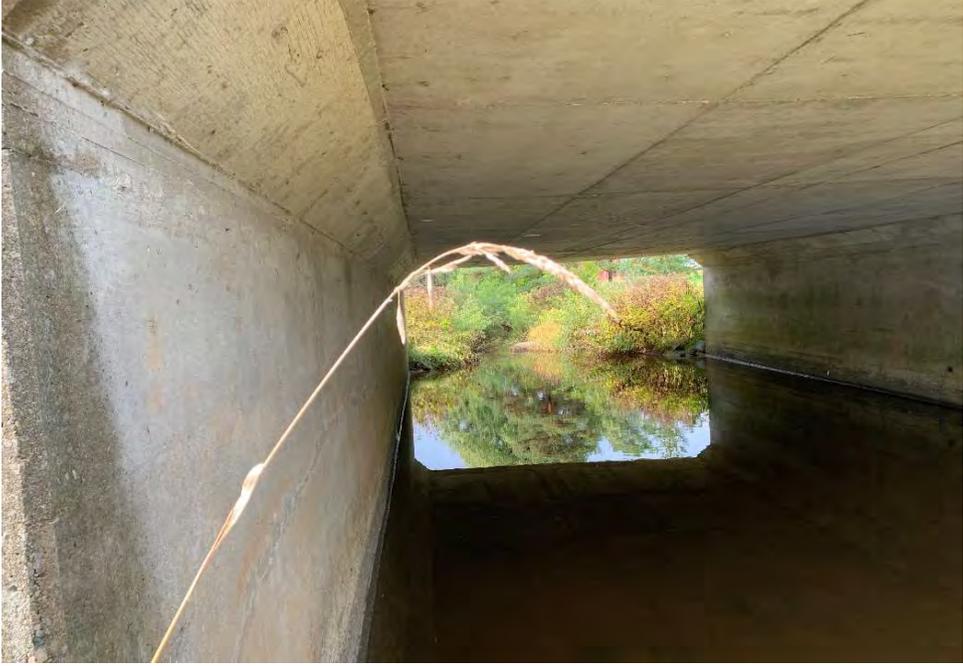
Photo 7-6: View of soffit and abutment walls

Element Group:	Abutments		Length:				
Element Name:	Abutment Walls		Width:				
Location:	Each Side		Height:				
Material:	Concrete		Count:				
Element Type:			Total Quantity:				
Environment:	Moderate		Limited Insp'n:				
Protection System:							
Condition Data:	Units	Exc.	Good	Fair	Poor	Perform. Deficiencies	Maint. Needs
	%		80	20			
Comments:	Hairline cracks at cold joint in haunches and some spalling (honeycomb) on walls. Transverse cracking at cold joint, 1/3 way up from footing on each side.						
Recommended Work:	None <input checked="" type="checkbox"/> 6-10 Years <input type="checkbox"/> 1-5 Years <input type="checkbox"/> < 1 Year <input type="checkbox"/> Urgent Concrete repair, seal cold joint.

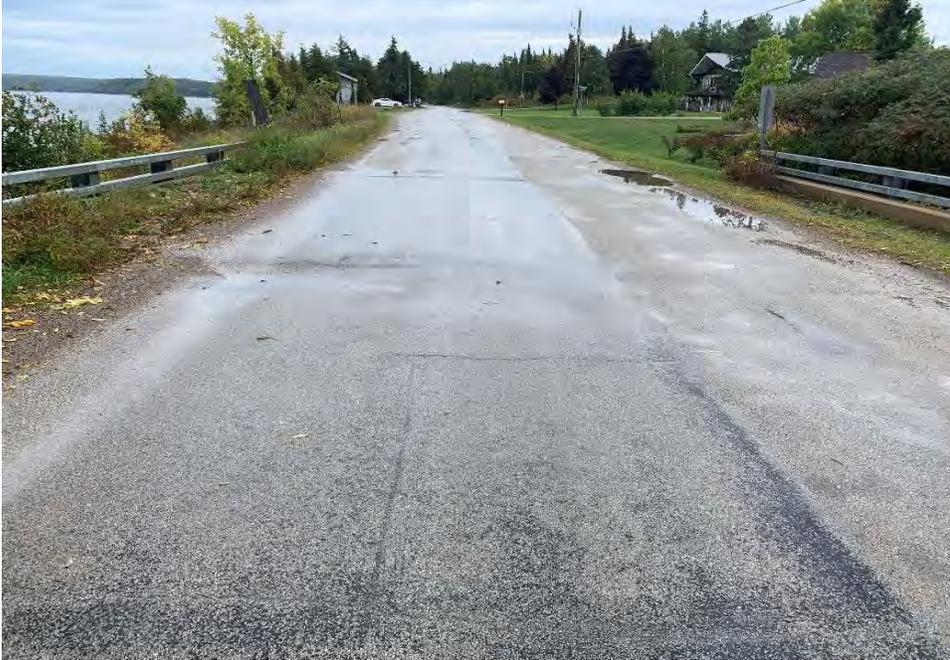
Photo 8-6: View of structure approach and deck wearing surface

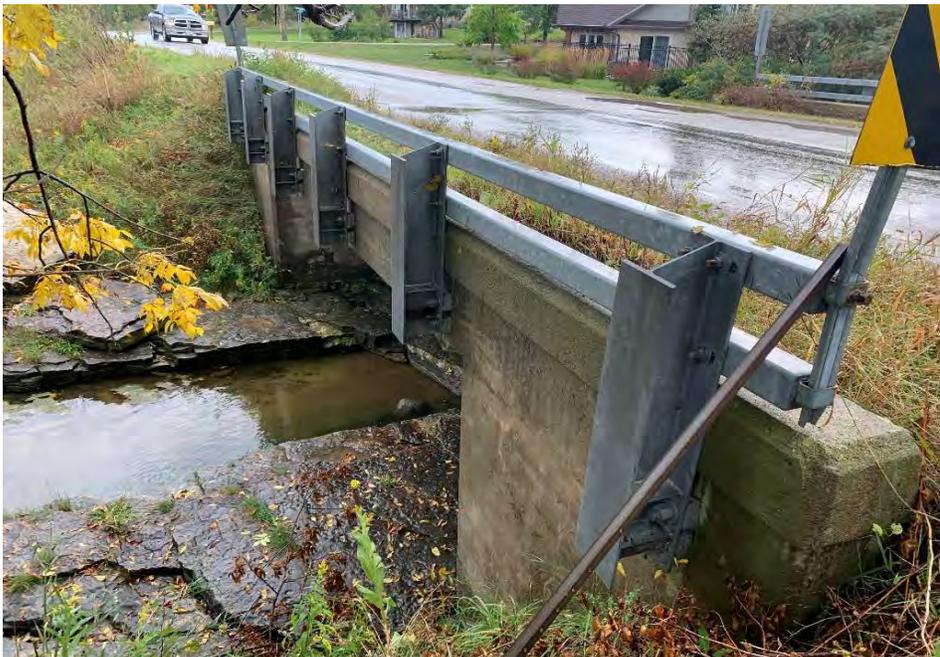
Photo 8-7: View of east structure elevation, wingwalls, exterior soffit and curb

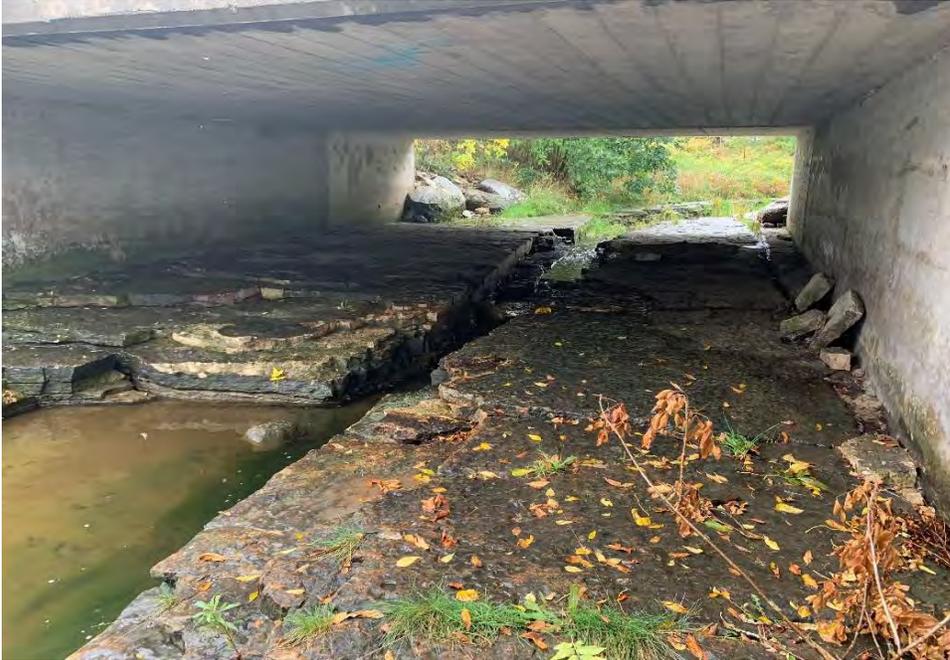
Photo 8-8: View of north abutment wall and bedrock streambed

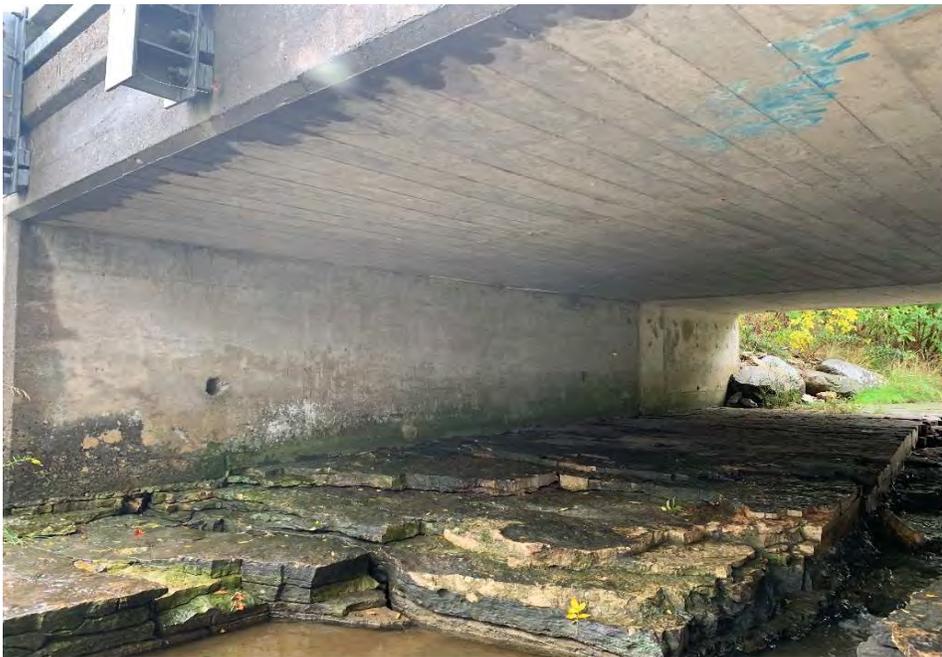
Photo 8-9: View of south abutment wall and soffit

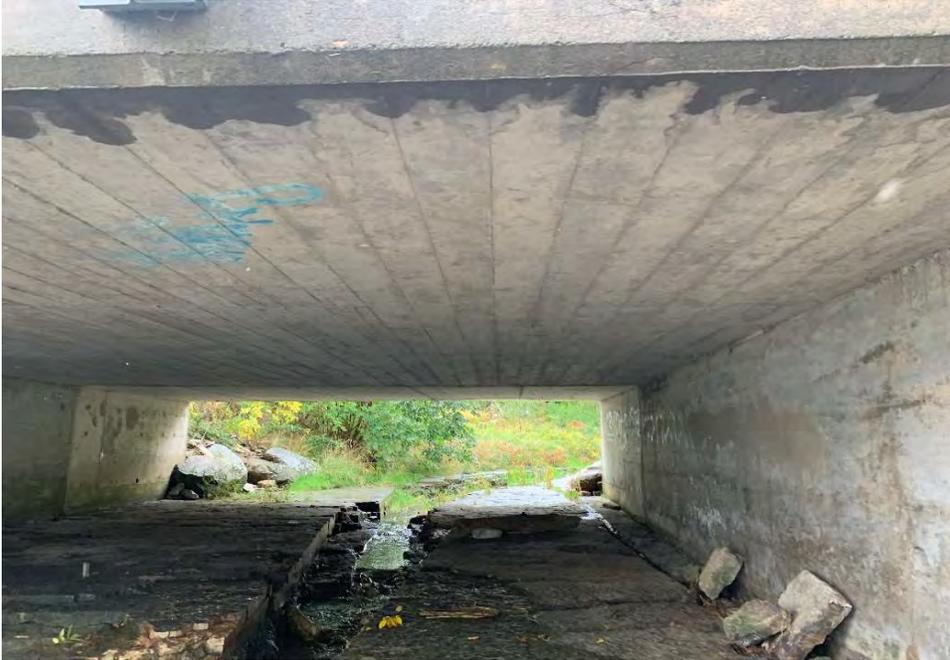
Photo 8-10: View of structure soffit

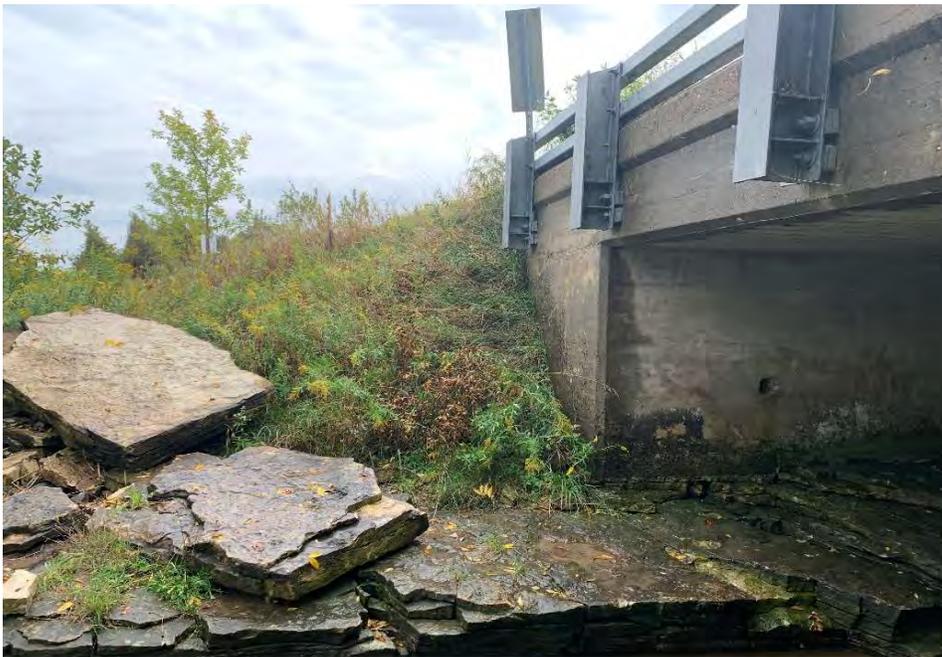
Photo 8-11: View of structure elevation, exterior barrier protection, curb and soffit

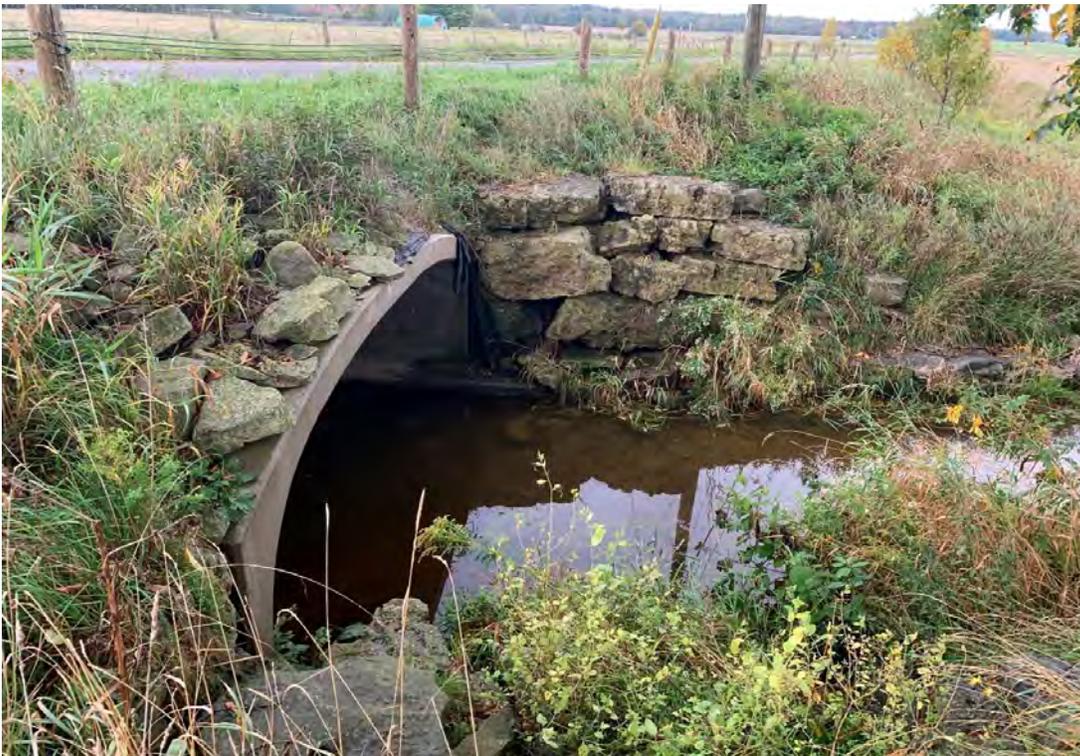
Photo 9-3 - View of structure outlet elevation and embankments

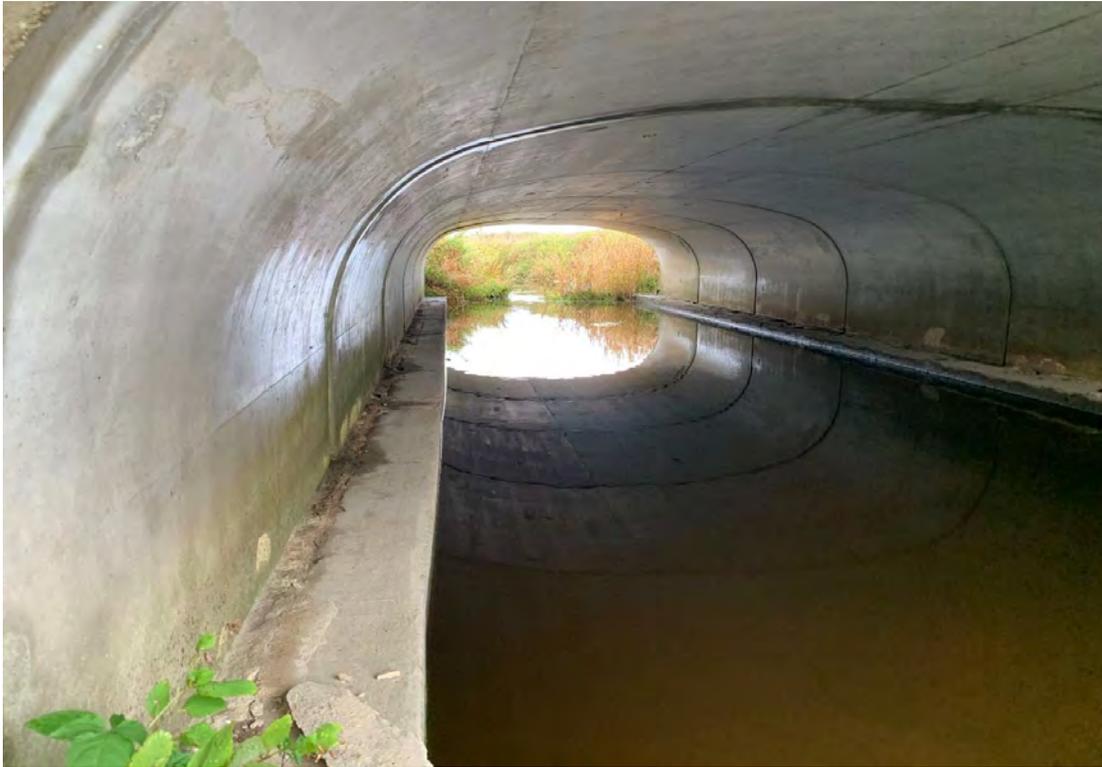
Photo 9-4 - View of pipe arch soffit and walls

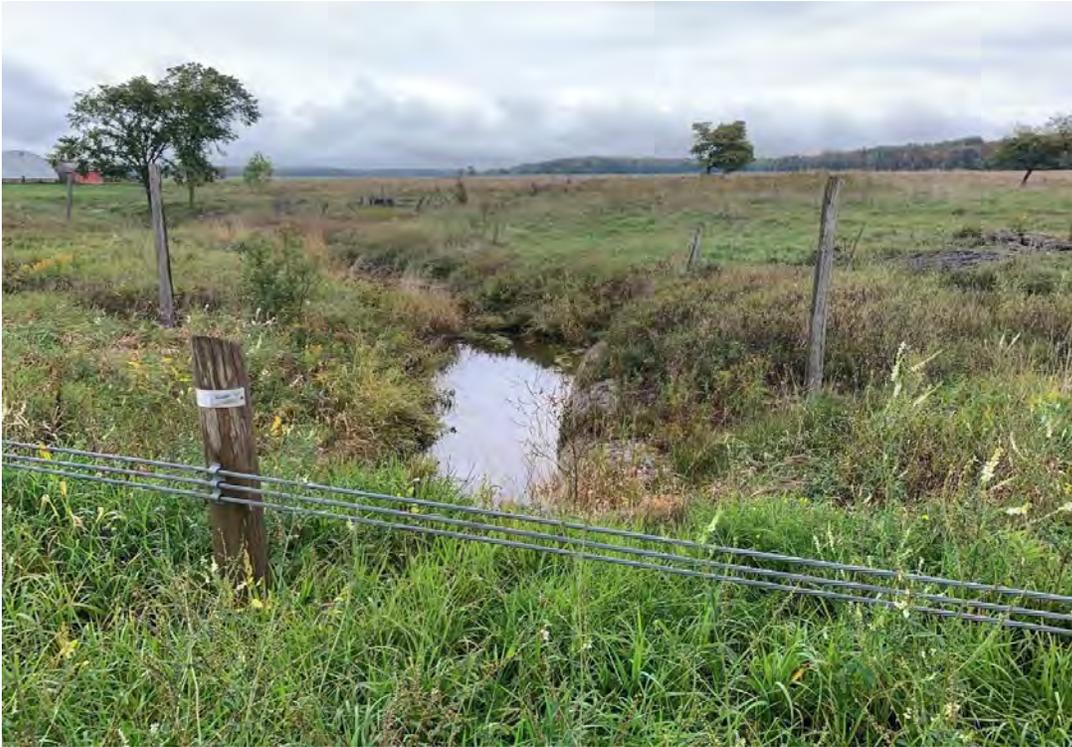
Photo 9-6 - View of watercourse upstream

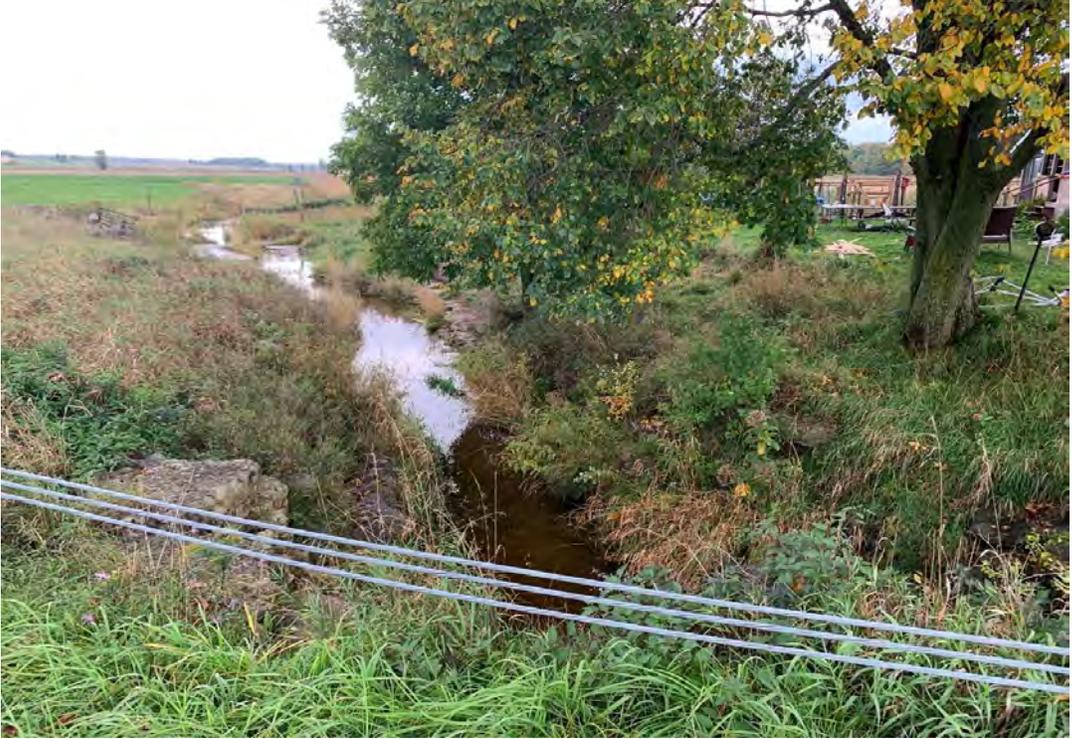
Photo 9-7 - View of watercourse downstream

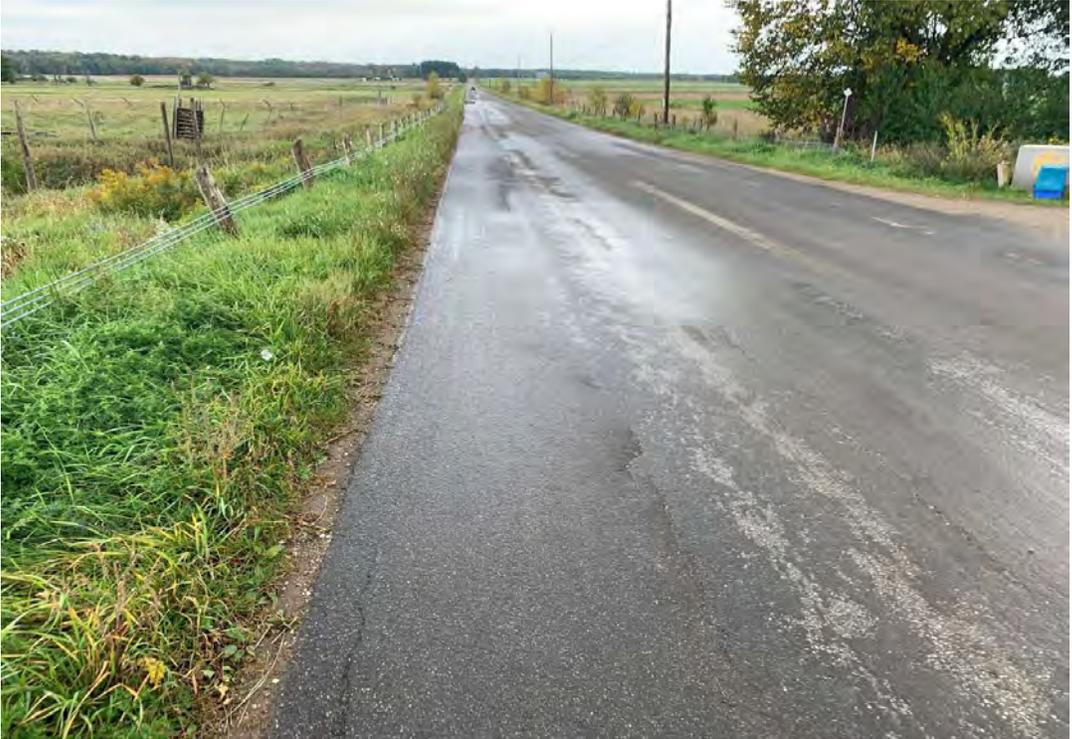
Photo 9-9 - View of structure wearing surface from approaching perspective

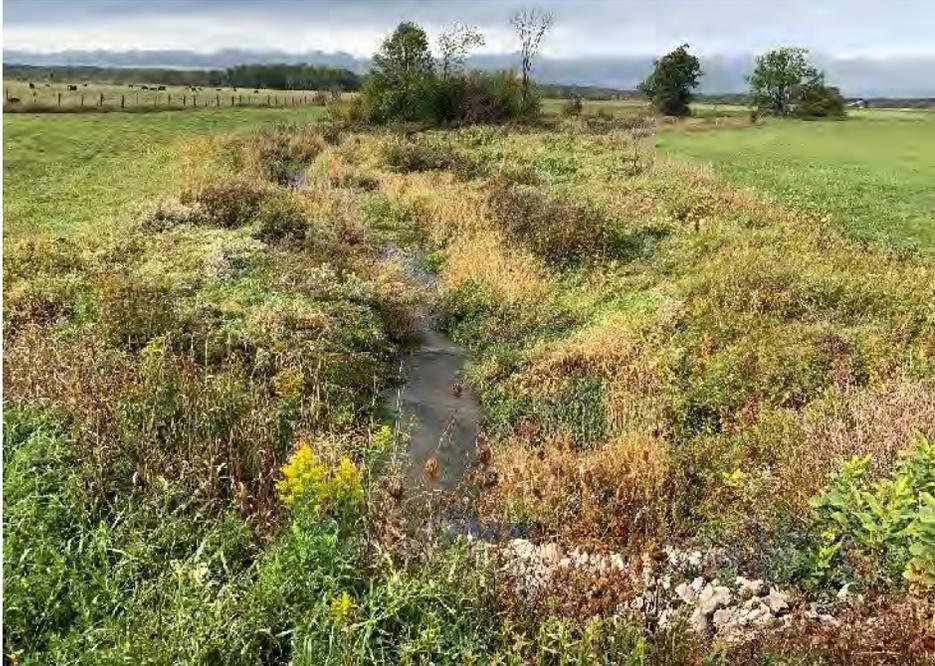
Photo 10-2: View of watercourse upstream and inlet component

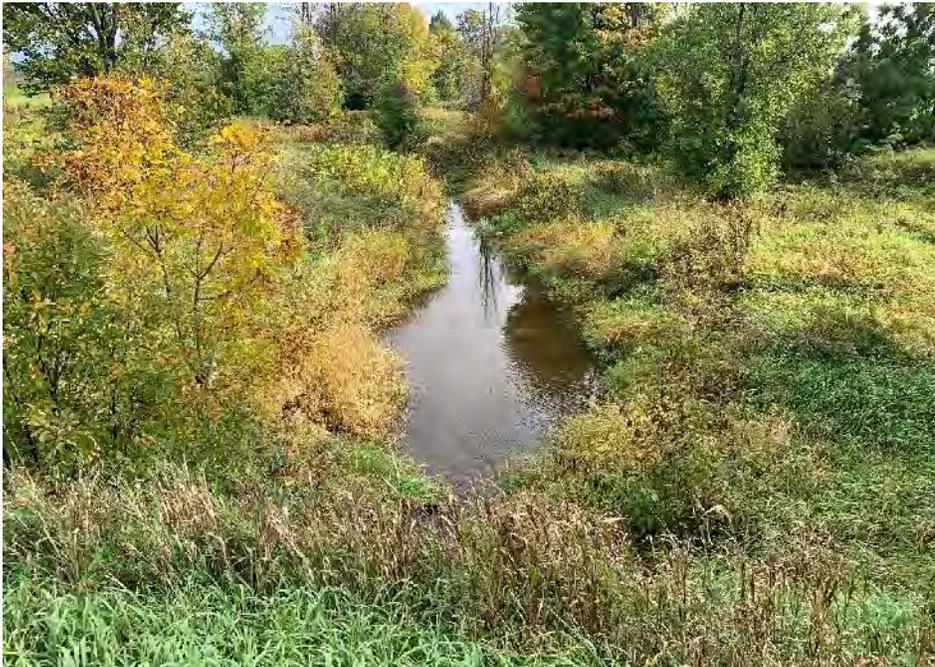
Photo 10-3: View of watercourse downstream and outlet component

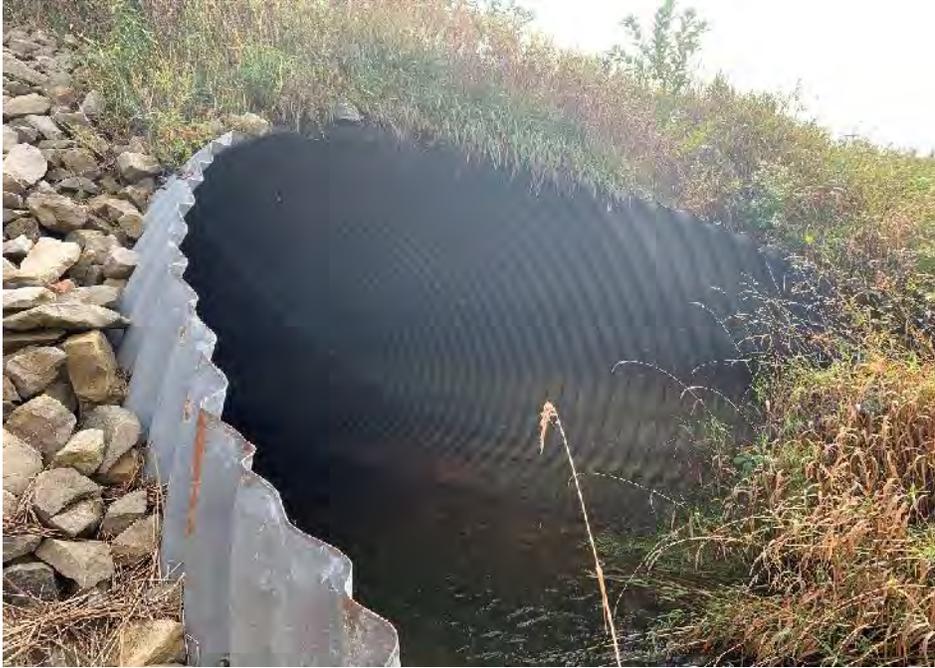
Photo 10-4: View of culvert barrel in elevation

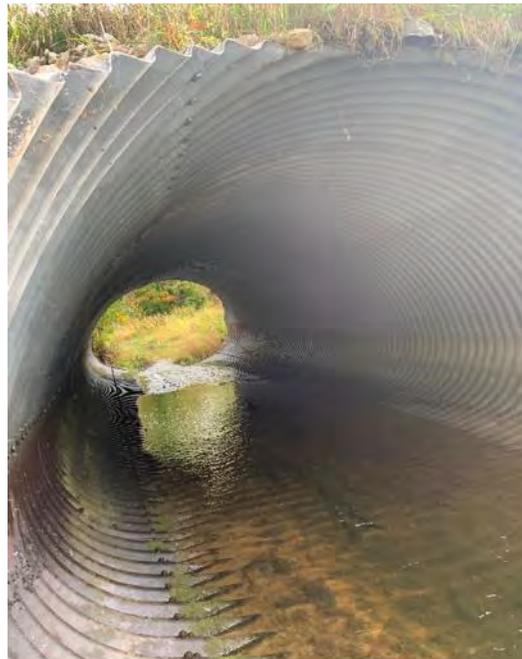
Photo 10-5: View of interior culvert barrel

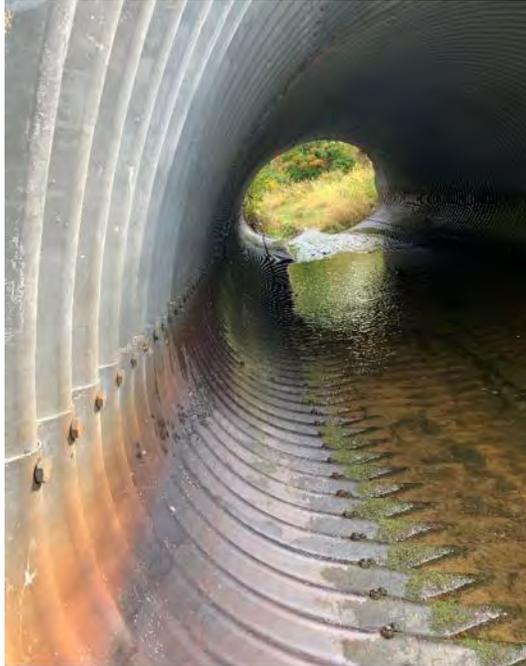
Photo 10-6: Localized corrosion with section loss

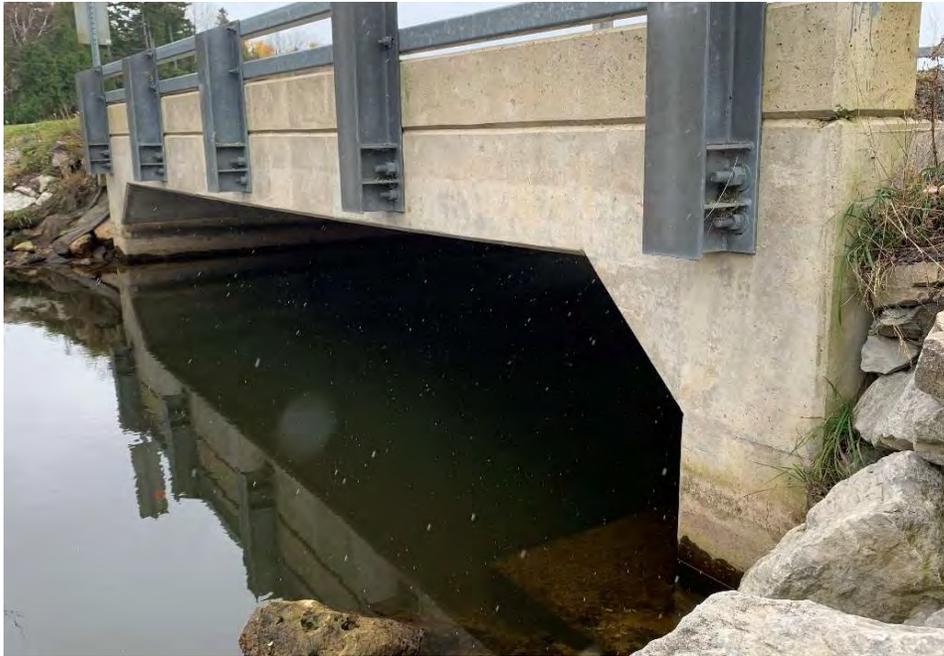
Photo 11-2: View of east structure elevation, exterior soffit, barrier and embankments

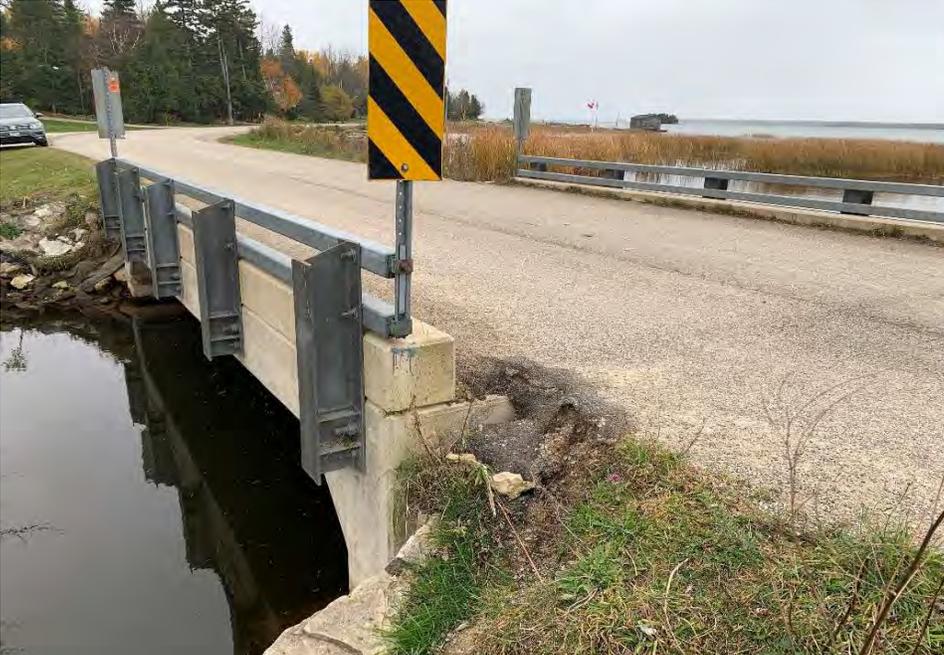
Photo 11-3: View of east exterior barrier protection, soffit and wingwalls

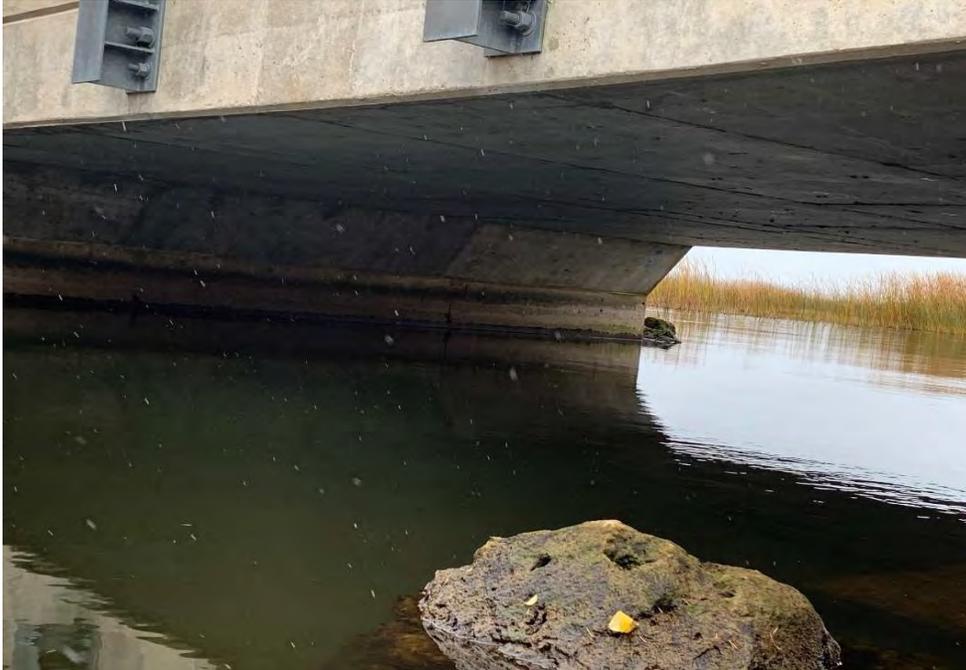
11-4: View of structure soffit

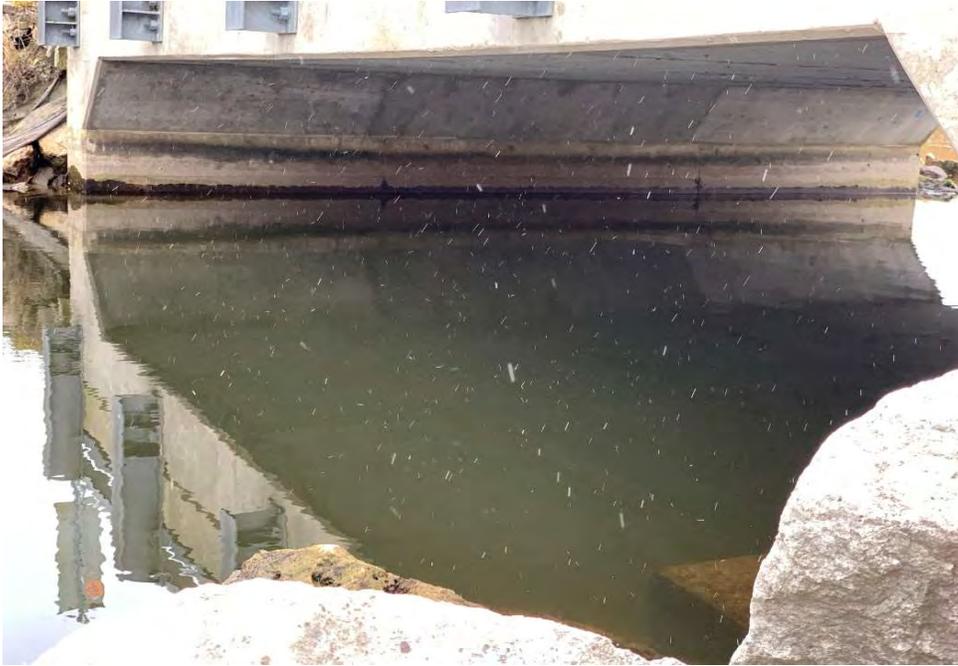
11-6: View of north abutment wall and soffit

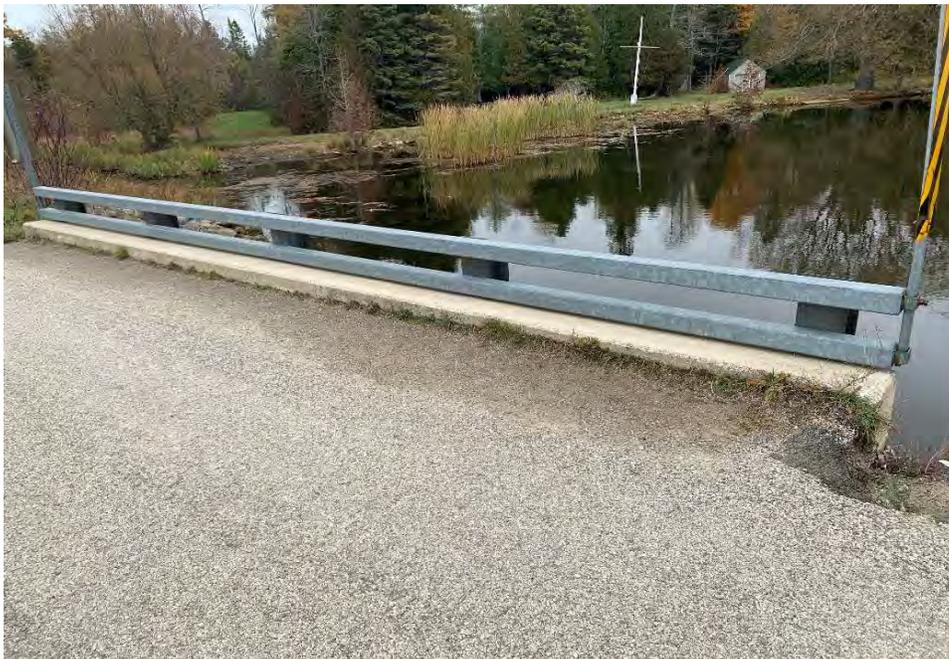
11-7: View of structure wearing surface, barrier protection and end hazard signage

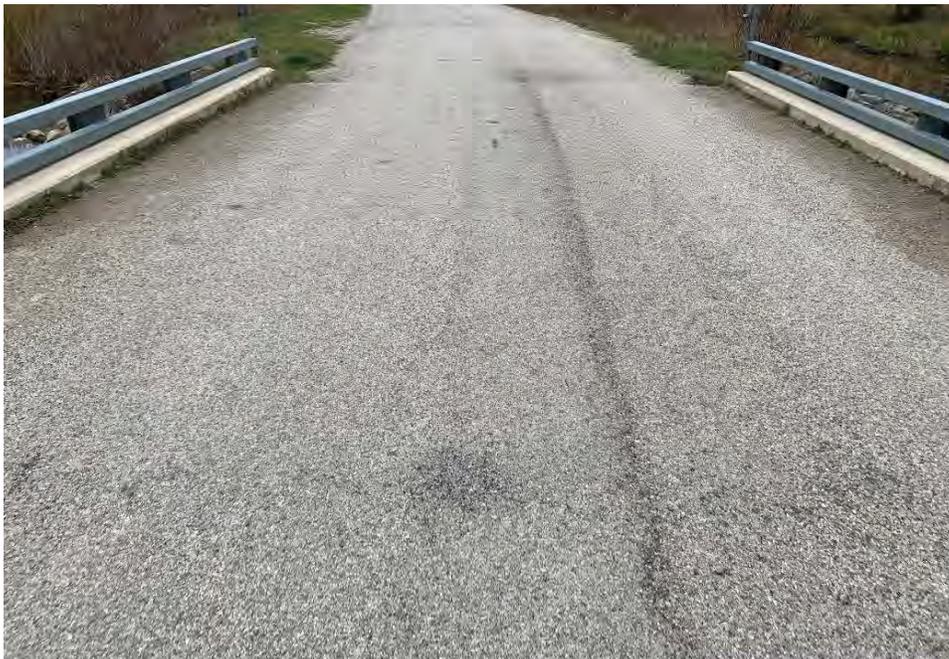
11-11: Structure wearing surface

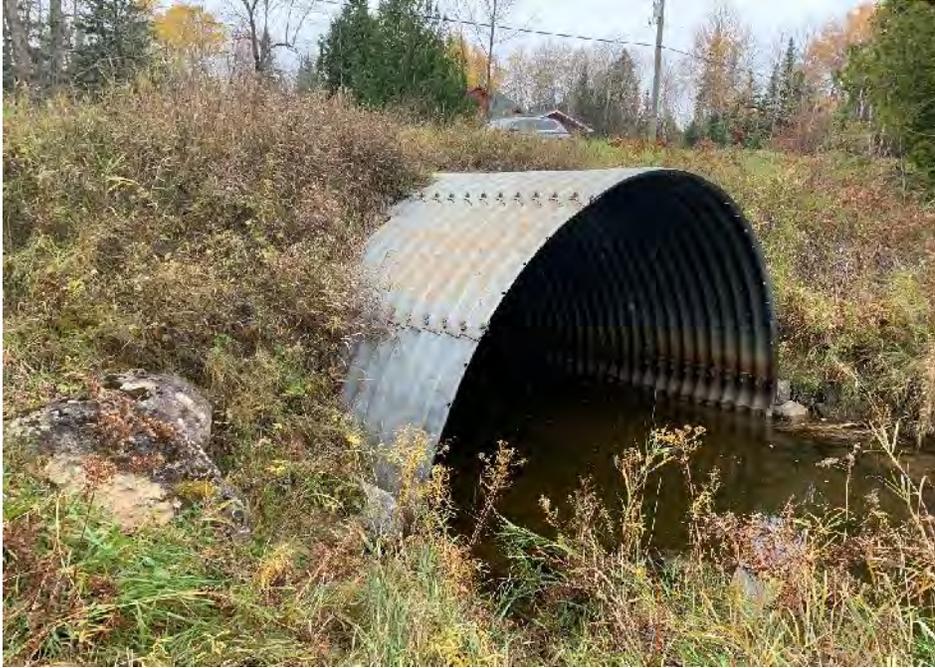
Photo 12-2: View of culvert inlet in elevation (north perspective)

Element Group:	Culverts		Length:				
Element Name:	Inlet Component		Width:				
Location:	East End		Height:				
Material:	Stone and Earth		Count:				
Element Type:			Total Quantity:				
Environment:	Moderate		Limited Insp'n:				
Protection System:	None						
Condition Data:	Units	Exc.	Good	Fair	Poor	Perform. Deficiencies	Maint. Needs
	%			60	40	Yes	
Comments:	A scour was observed at the base of the inlet and is restricting flow (southeast corner).						
Recommended Work:	None <input type="checkbox"/> 6-10 Years <input type="checkbox"/> 1-5 Years <input checked="" type="checkbox"/> < 1 Year <input type="checkbox"/> Urgent <input type="checkbox"/> Replace the missing stones and rip-rap.

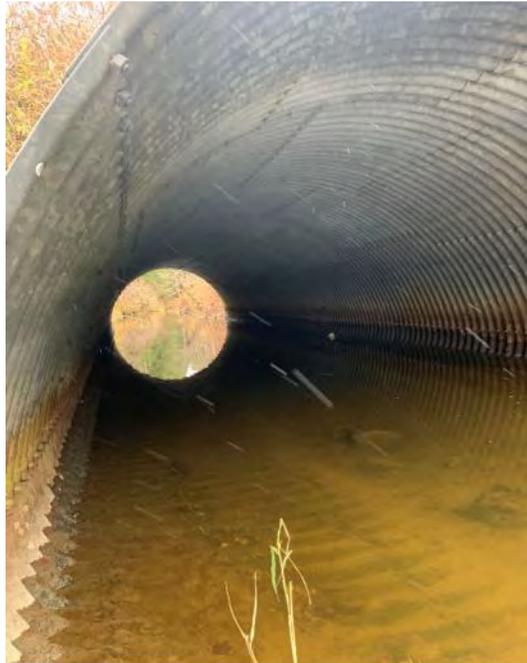
Photo 12-3: View of culvert barrel interior

Element Group:	Culvert		Length:				
Element Name:	Barrel		Width:				
Location:			Height:				
Material:	Steel		Count:				
Element Type:	Pipe Arch		Total Quantity:				
Environment:	Moderate		Limited Insp'n:				
Protection System:	Galvanized						
Condition Data:	Units	Exc.	Good	Fair	Poor	Perform. Deficiencies	Maint. Needs
	%		40	50	10		
Comments:	Deformations are visible at the obvert, with corrosion and swelling near the water level. Section loss is 10% at most.						
Recommended Work:	None 6-10 Years <input checked="" type="checkbox"/> 1-5 Years < 1 Year Urgent Monitor the deformation for movement.

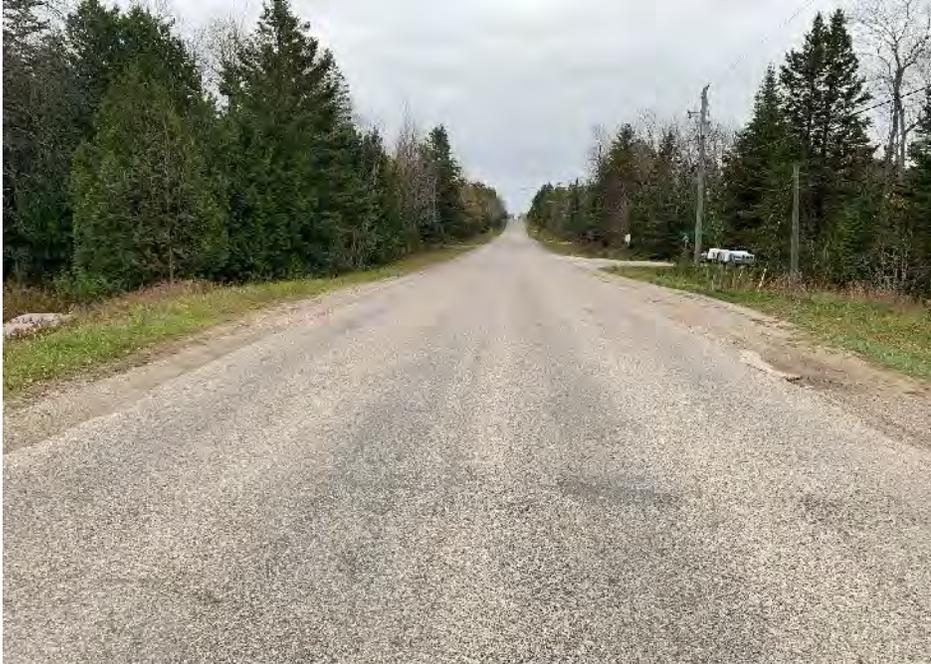
Photo 12-4: View of surface treatment wearing surface

Element Group:	Decks		Length:				
Element Name:	Wearing Surface		Width:				
Location:			Height:				
Material:	Surface Treatment		Count:				
Element Type:			Total Quantity:				
Environment:	Severe		Limited Insp'n:				
Protection System:	None						
Condition Data:	Units	Exc.	Good	Fair	Poor	Perform. Deficiencies	Maint. Needs
	%		75	25			
Comments:	The surface treatment wearing surface is in good to fair condition with minor settlement and wheel path rutting observed.						
Recommended Work:	None <input type="checkbox"/> 6-10 Years <input checked="" type="checkbox"/> 1-5 Years <input type="checkbox"/> < 1 Year <input type="checkbox"/> Urgent <input type="checkbox"/> Replace the surface treatment.

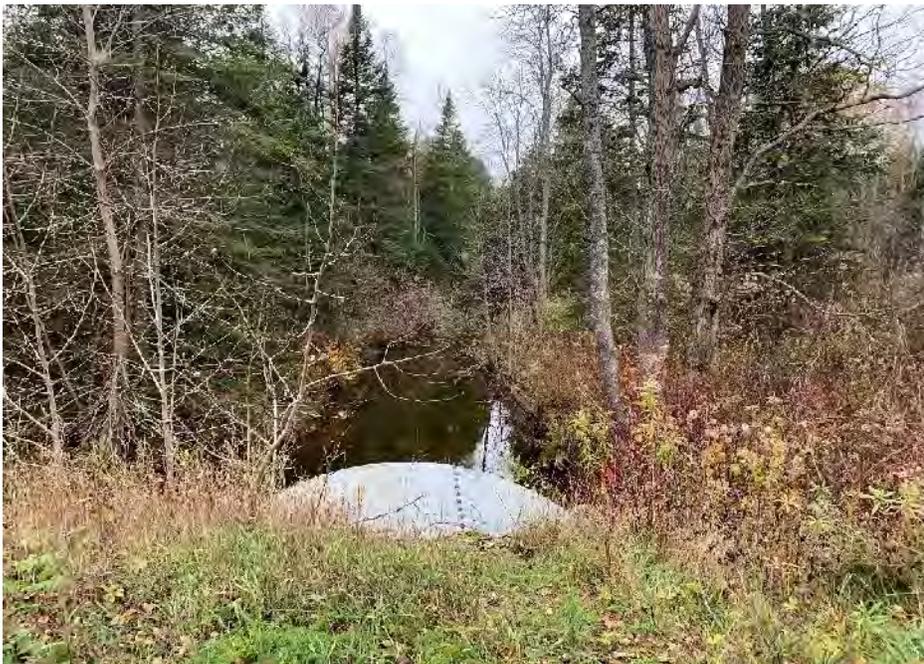
Photo 12-5: View of culvert outlet

Element Group:	Culverts		Length:				
Element Name:	Outlet Components		Width:				
Location:	West End		Height:				
Material:	Stone and Earth		Count:				
Element Type:			Total Quantity:				
Environment:	Moderate		Limited Insp'n:				
Protection System:	None						
Condition Data:	Units	Exc.	Good	Fair	Poor	Perform. Deficiencies	Maint. Needs
	%		30	60	10	Yes	
Comments:	Some of the rip rap and rock slope protection has failed.						
Recommended Work:	None 6-10 Years <input checked="" type="checkbox"/> 1-5 Years < 1 Year Urgent Replace the missing stones and rip-rap.

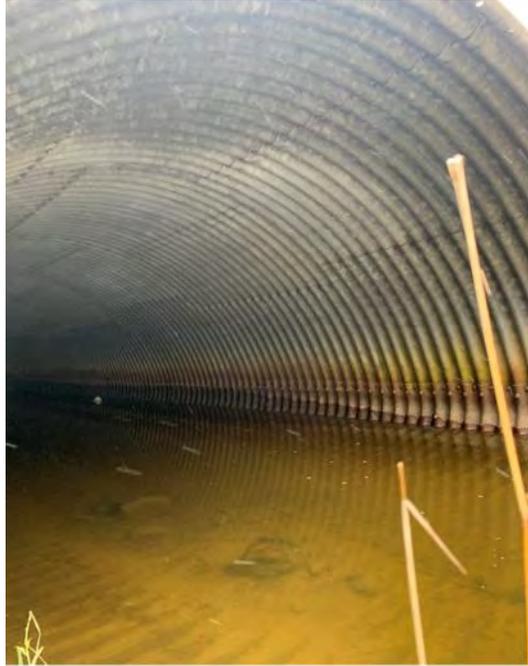
Photo 12-8: View of culvert barrel interior

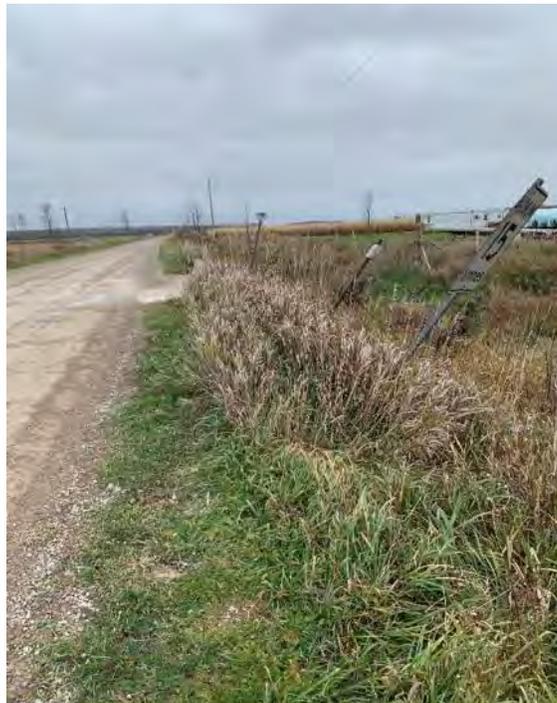
Photo 13-3: Posted weight limit signage requires realignment

Element Group:	Accessories		Length:				
Element Name:	Signs		Width:				
Location:			Height:				
Material:	Steel		Count:	2			
Element Type:			Total Quantity:	2			
Environment:	Severe		Limited Insp'n:				
Protection System:	None						
Condition Data:	Units	Exc.	Good	Fair	Poor	Perform. Deficiencies	Maint. Needs
	%			2		Yes	Yes
Comments:	There are currently two 15 tonne load limit signs. The signs are in good condition but are not plumb and require straightening. There are no end hazard signs currently in place.						
Recommended Work:	<input type="checkbox"/> None	<input type="checkbox"/> 6-10 Years	<input type="checkbox"/> 1-5 Years	<input checked="" type="checkbox"/> < 1 Year	<input type="checkbox"/> Urgent		
	Straighten the load limit signs and install end hazard signs.

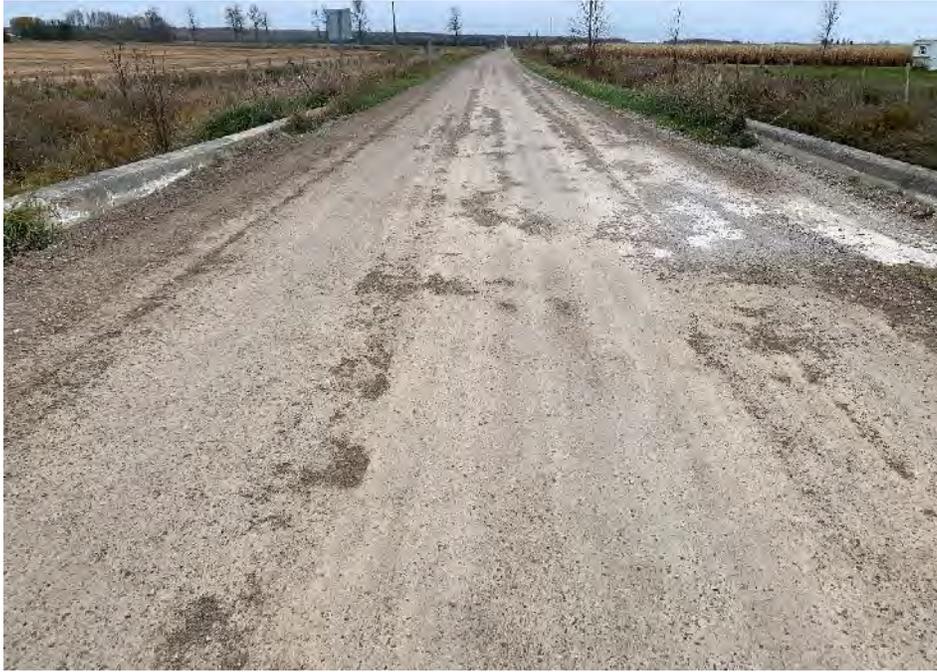
Photo 13-4: Approach and structure wearing surface

Element Group:	Decks		Length:				
Element Name:	Deck Top		Width:				
Location:			Height:				
Material:	Concrete		Count:				
Element Type:			Total Quantity:				
Environment:	Moderate		Limited Insp'n:	Yes			
Protection System:	Wearing Surface						
Condition Data:	Units	Exc.	Good	Fair	Poor	Perform. Deficiencies	Maint. Needs
	%			80	20		
Comments:	The visible ends are in fair condition, the majority of the deck top is debris/gravel covered and not visible for inspection. Remove the granular cover and inspect the condition of the top deck.						
Recommended Work:	None 6-10 Years <input checked="" type="checkbox"/> 1-5 Years < 1 Year Urgent Clear the debris and gravel along curb, perform a deck condition survey, and seal and waterproof deck top.

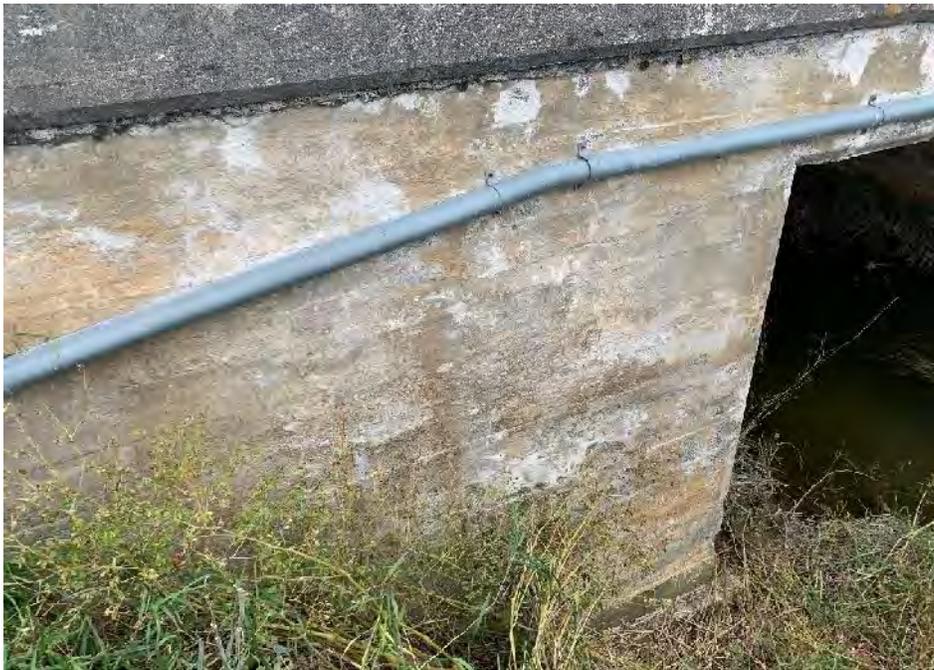
Photo 13-5: Southwest structure wingwall (typical)

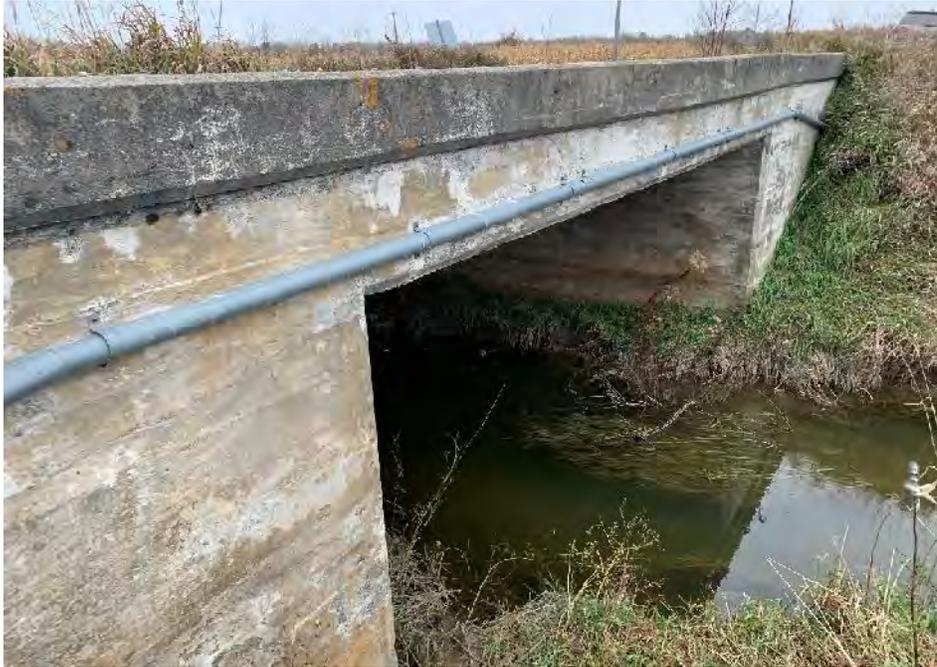
Photo 13-6: View of east structure elevation, exterior soffit and north abutment wall

Element Group:	Decks		Length:				
Element Name:	Soffit - Thick Slab		Width:				
Location:			Height:				
Material:	Concrete		Count:				
Element Type:			Total Quantity:				
Environment:	Moderate		Limited Insp'n:				
Protection System:	None						
Condition Data:	Units	Exc.	Good	Fair	Poor	Perform. Deficiencies	Maint. Needs
	%			30	70		
Comments:	Spalling and delaminated concrete with rebar exposed on both sides at abutment walls. An exterior soffit crack is developing (possibly a shear failure) at the northwest corner soffit exterior. Monitor annually for movement.						
Recommended Work:	None 6-10 Years <input checked="" type="checkbox"/> 1-5 Years < 1 Year Urgent Remove the delaminated concrete, sand blast rebar and complete concrete repair. Waterproof the deck top to prevent further deterioration. Monitor the crack annually.
