MUNICIPALITY OF NORTHERN BRUCE PENINSULA

2020 STRUCTURE INSPECTION REPORT

FINAL
PROJECT NO.: 201-01605-00
DATE: MARCH 10, 2021

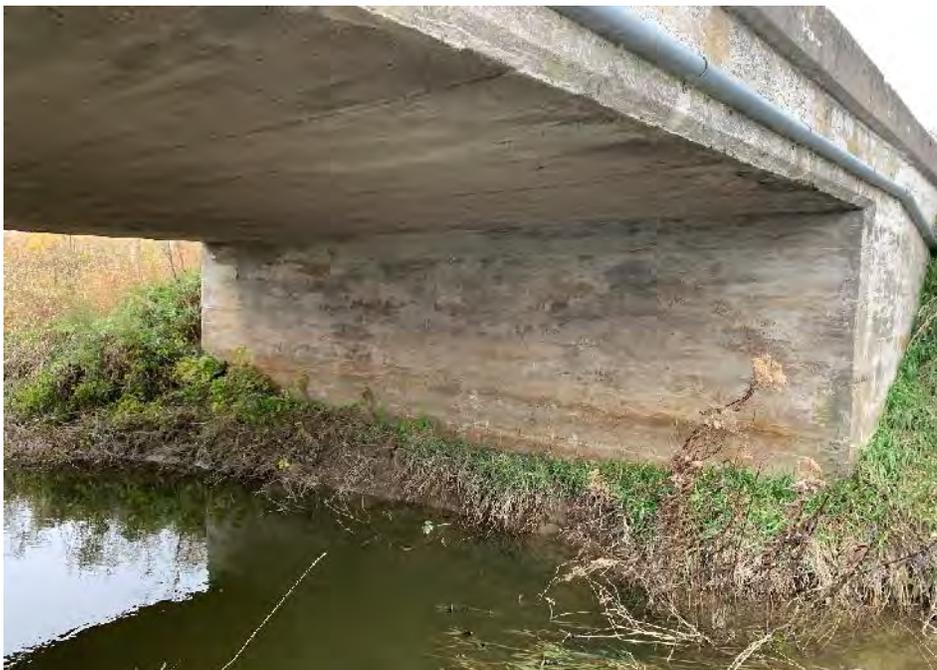
Photo 13-7: View of structure soffit and north abutment wall

Element Group:	Abutments		Length:				
Element Name:	Abutment Walls		Width:				
Location:	Each Side		Height:				
Material:	Concrete		Count:				
Element Type:			Total Quantity:				
Environment:	Moderate		Limited Insp'n:				
Protection System:							
Condition Data:	Units	Exc.	Good	Fair	Poor	Perform. Deficiencies	Maint. Needs
	%			80	20		
Comments:	Hairline cracks at cold joint where abutment/wingwall meets the soffit at the northwest corner. Surface spalling and calcite deposits were observed on each wingwall.						
Recommended Work:	None 6-10 Years <input checked="" type="checkbox"/> 1-5 Years < 1 Year Urgent Remove all poor concrete, clean the reinforcing steel, and replace concrete.

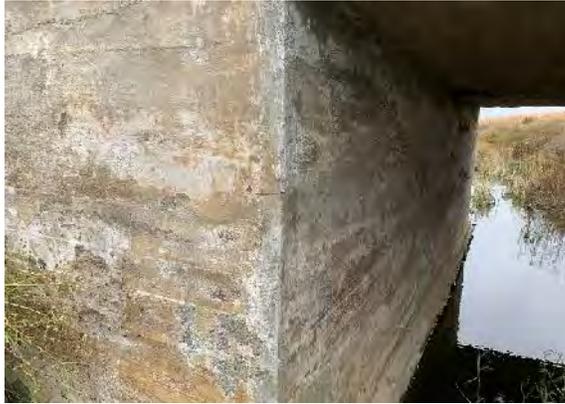
Photo 13-8: View of south abutment wall and exposed footing

Element Group:	Foundations		Length:				
	Foundation (below ground level)		Width:				
Location:	Each End		Height:				
Material:	Concrete		Count:				
Element Type:			Total Quantity:				
Environment:	Moderate		Limited Insp'n:	Yes			
Protection System:	None						
Condition Data:	Units	Exc.	Good	Fair	Poor	Perform. Deficiencies	Maint. Needs
	%						
Comments:	Some erosion surrounding the footing was observed at the downstream end and along north side and southwest corner.						
Recommended Work:	None 6-10 Years <input checked="" type="checkbox"/> 1-5 Years < 1 Year Urgent Place erosion protection along the base of the abutment walls/top of footings.

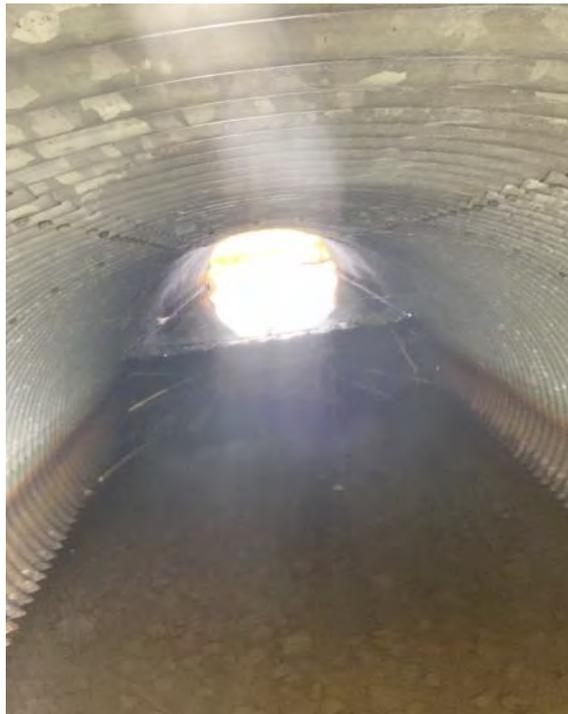
Photo 14-5: View of culvert barrel interior, obvert

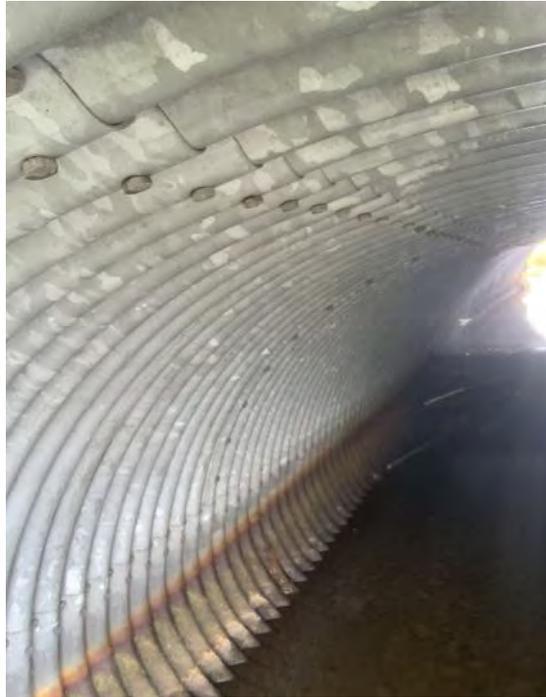
Photo 14-6: View of culvert barrel interior

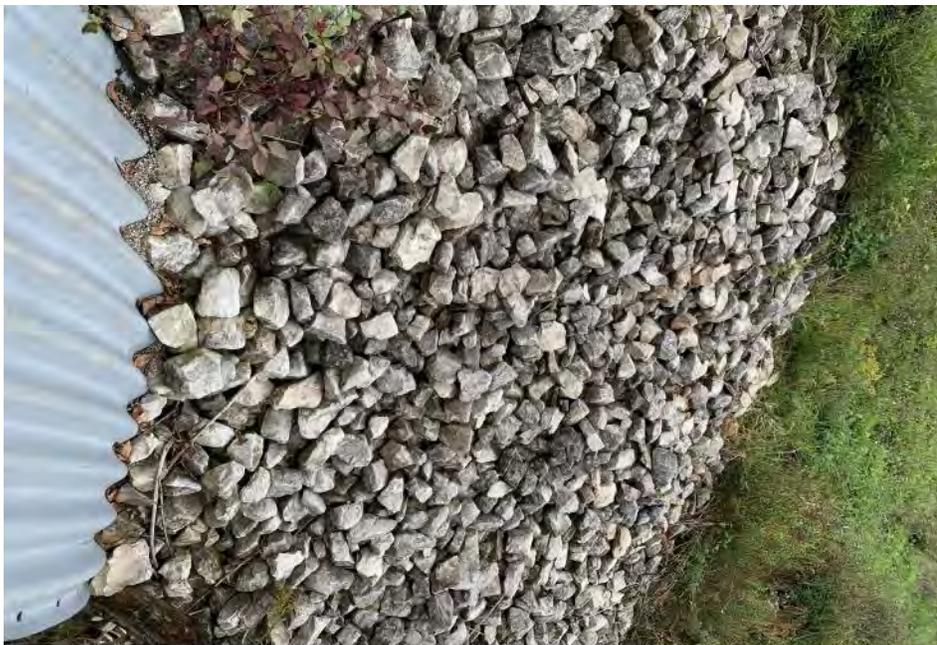
Photo 14-7: View of slope protection

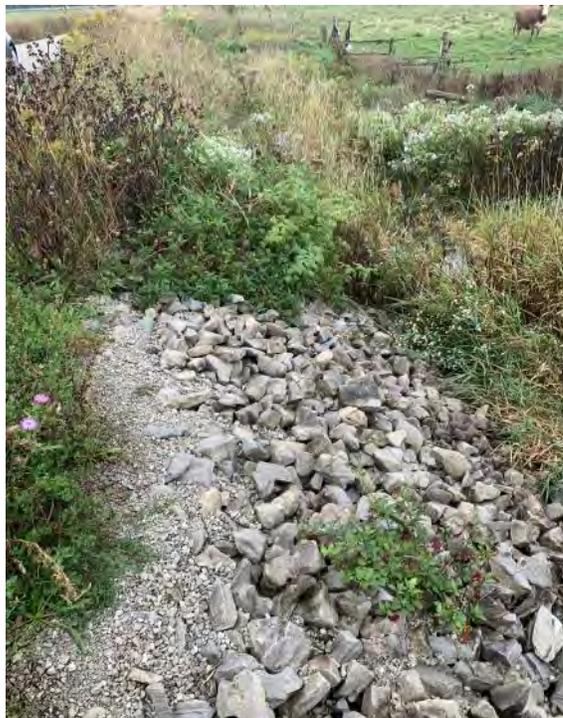
Photo 15-3: Rock protection at inlet end

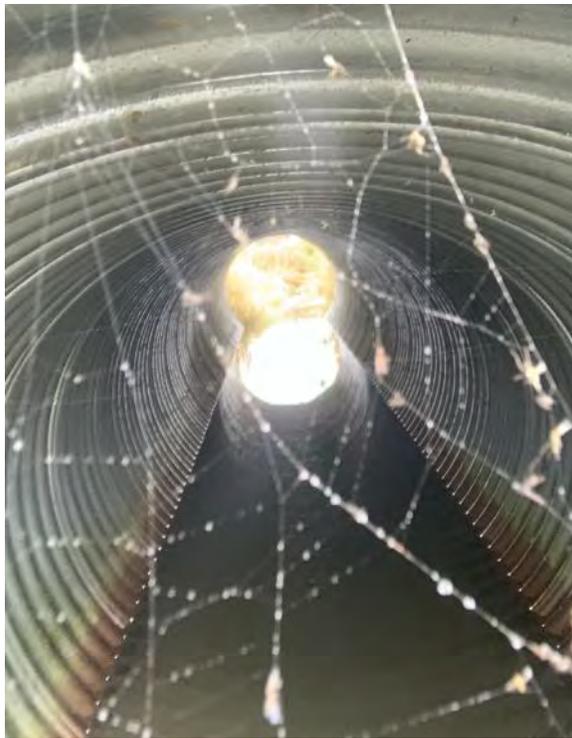
Photo 15-7: View of culvert barrel interior

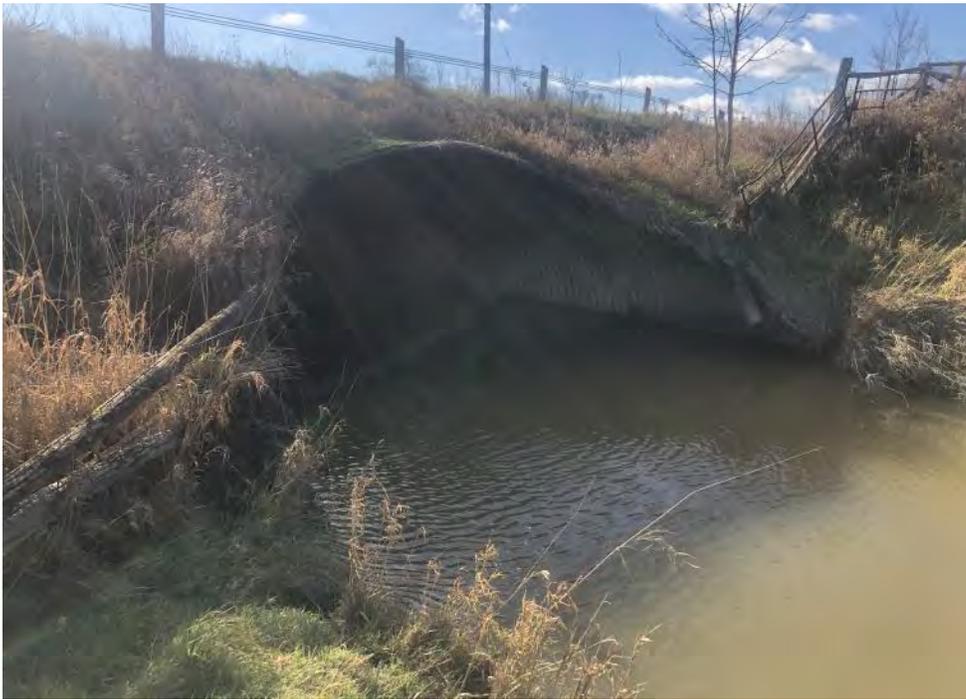
Photo 16-2: View of culvert barrel in elevation (outlet end)

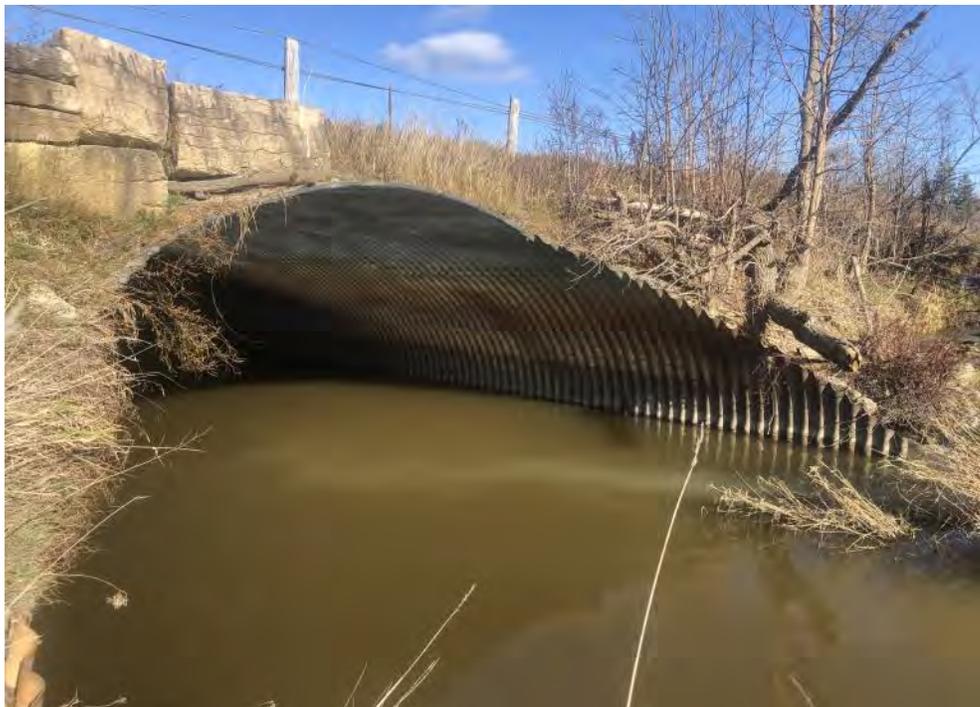
Photo 16-3: View of culvert barrel in elevation (inlet end)

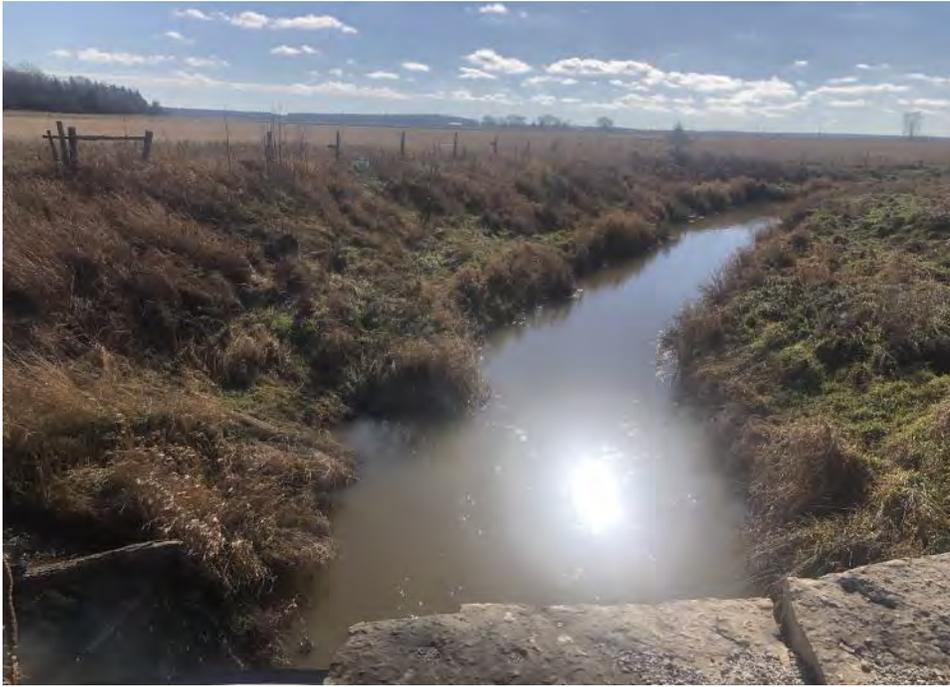
Photo 16-4: View of watercourse upstream

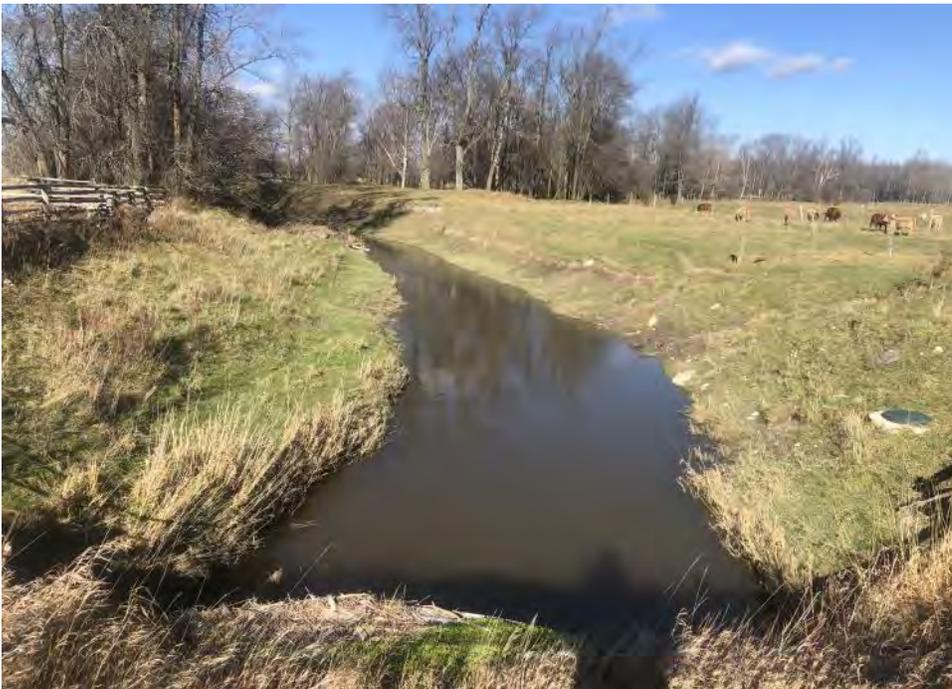
Photo 16-5: View of watercourse downstream

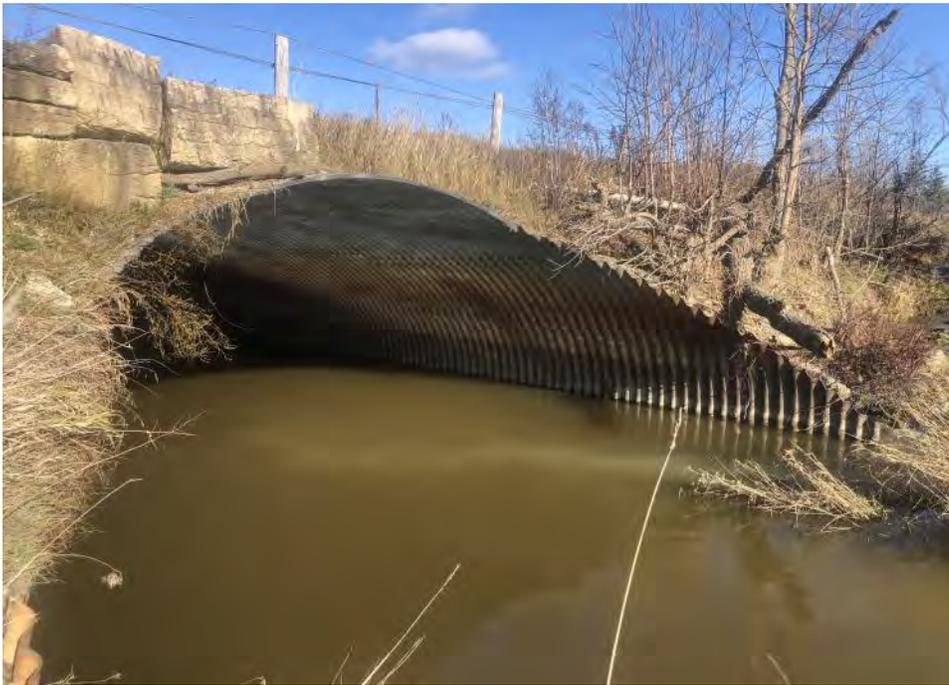
Photo 16-6: Culvert barrel interior

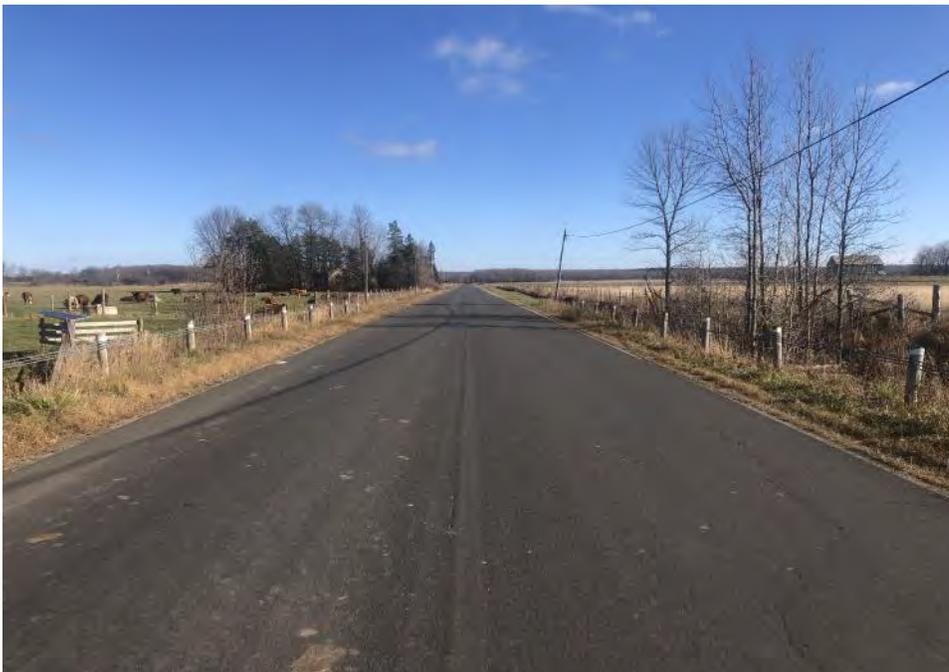
Photo 16-7: View of structure from approach

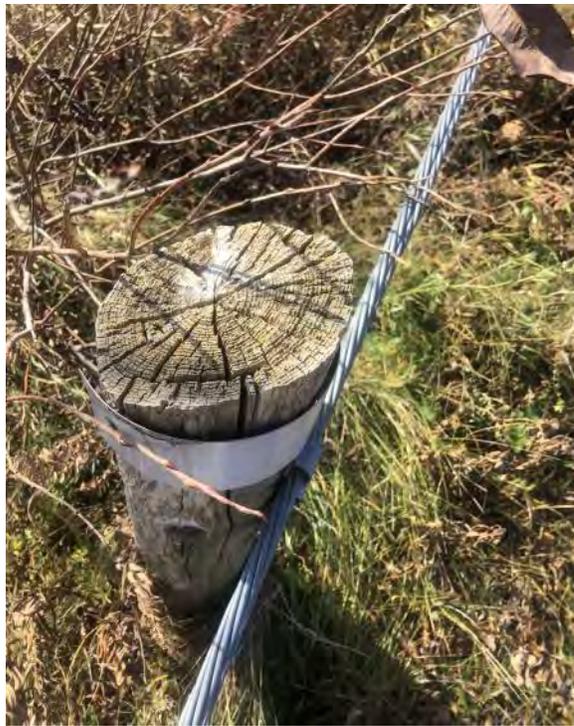
Photo 16-9: Wooden post (typical)

Element Group:	Barriers		Length:				
Element Name:	Barrier		Width:				
Location:	Each Side		Height:				
Material:	Steel/Wood		Count:	20 posts - 3 cable			
Element Type:	3-Cable Guiderail		Total Quantity:				
Environment:	Severe		Limited Insp'n:				
Protection System:	None						
Condition Data:	Units	Exc.	Good	Fair	Poor	Perform. Deficiencies	Maint. Needs
	Ea.		20				
Comments:	The three cable guide barrier is in fair overall condition. Some of the wooden posts are experiencing moderate rot and should be replaced for vehicle safety.						
Recommended Work:	<input type="checkbox"/> None		<input type="checkbox"/> 6-10 Years	<input checked="" type="checkbox"/> 1-5 Years	<input type="checkbox"/> < 1 Year	<input type="checkbox"/> Urgent	
	Replace the rotten barrier posts.

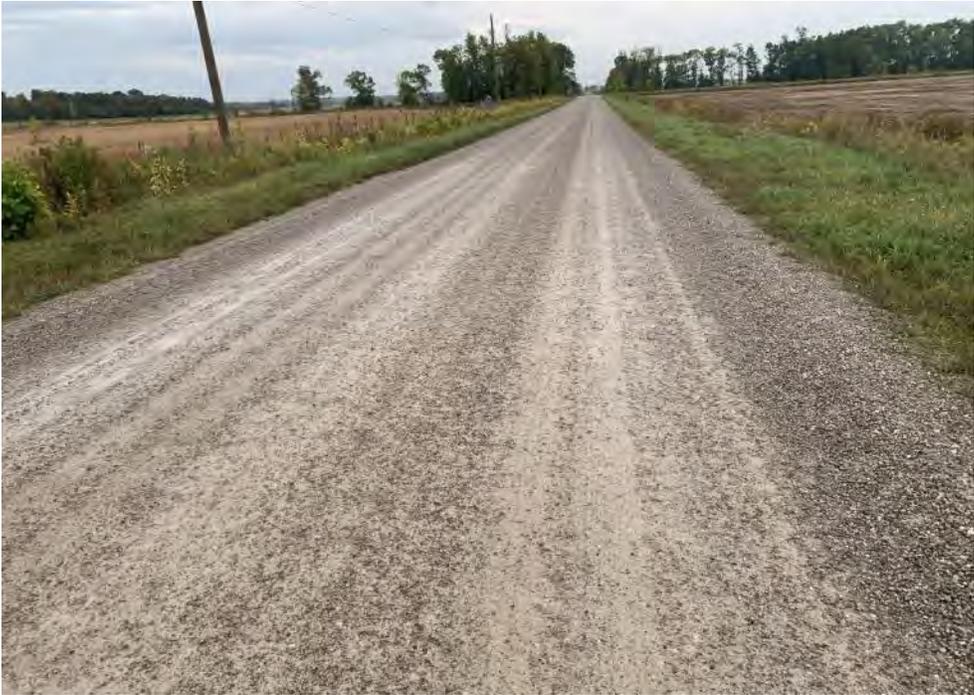
Photo 17-2: View of structure and approach wearing surface

Element Group:	Approaches	Length:					
Element Name:	Wearing Surface	Width:					
Location:	Each End	Height:					
Material:	Gravel	Count:					
Element Type:		Total Quantity:					
Environment:	Severe	Limited Insp'n:					
Protection System:	None						
Condition Data:	Units	Exc.	Good	Fair	Poor	Perform. Deficiencies	Maint. Needs
	%		100				Yes
Comments:	At the time of inspection, the wearing surface was in overall good condition. Continue annual grading.						
Recommended Work:	None	6-10 Years	1-5 Years	<input checked="" type="checkbox"/> < 1 Year	Urgent		
	Continue annual maintenance (annual grading).

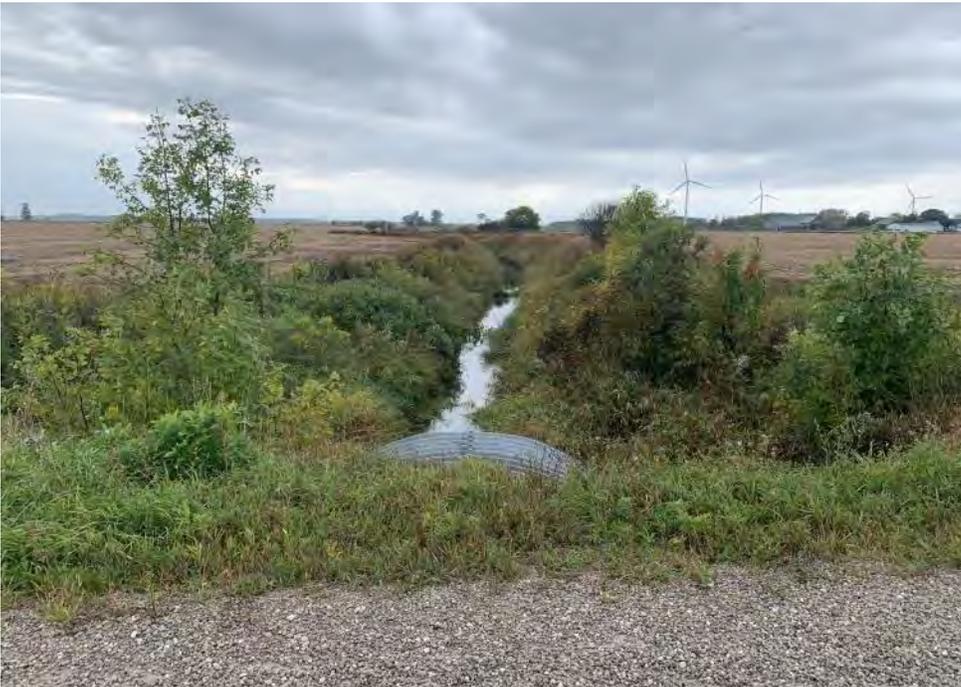
Photo 17-3: View of watercourse upstream and inlet culvert end

Element Group:	Culverts		Length:				
Element Name:	Inlet Component		Width:				
Location:	End		Height:				
Material:	Stone and Earth		Count:				
Element Type:	Stone Head Wall and Steel Culvert		Total Quantity:				
Environment:	Moderate		Limited Insp'n:				
Protection System:	None						
Condition Data:	Units	Exc.	Good	Fair	Poor	Perform. Deficiencies	Maint. Needs
	%			100			
Comments:	Minor erosion at corners.						
Recommended Work:	None 6-10 Years		1-5 Years	<input checked="" type="checkbox"/> < 1 Year	Urgent		
	Place rip-rap slope protection.

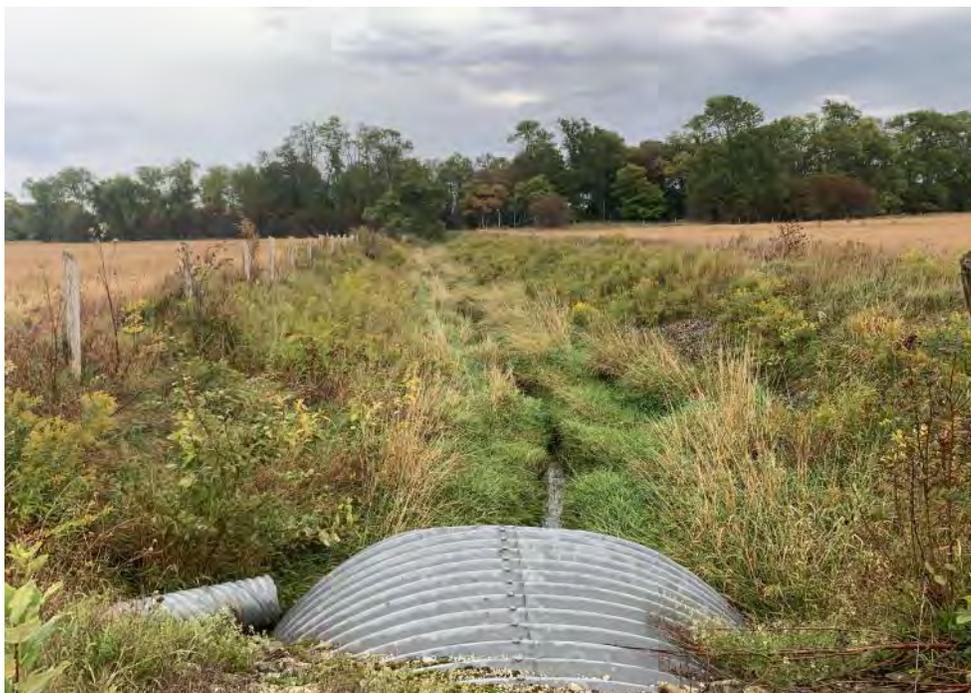
Photo 17-4: View of watercourse downstream and outlet culvert end

Element Group:	Culverts		Length:				
Element Name:	Outlet Components		Width:				
Location:	West End		Height:				
Material:	Stone and Earth		Count:				
Element Type:	Stone and Steel Culvert		Total Quantity:				
Environment:	Moderate		Limited Insp'n:				
Protection System:	None						
Condition Data:	Units	Exc.	Good	Fair	Poor	Perform. Deficiencies	Maint. Needs
	%			100			
Comments:	Minor erosion at corners.						
Recommended Work:	None		6-10 Years	<input checked="" type="checkbox"/> 1-5 Years	< 1 Year	Urgent	
	Place rip-rap slope protection.

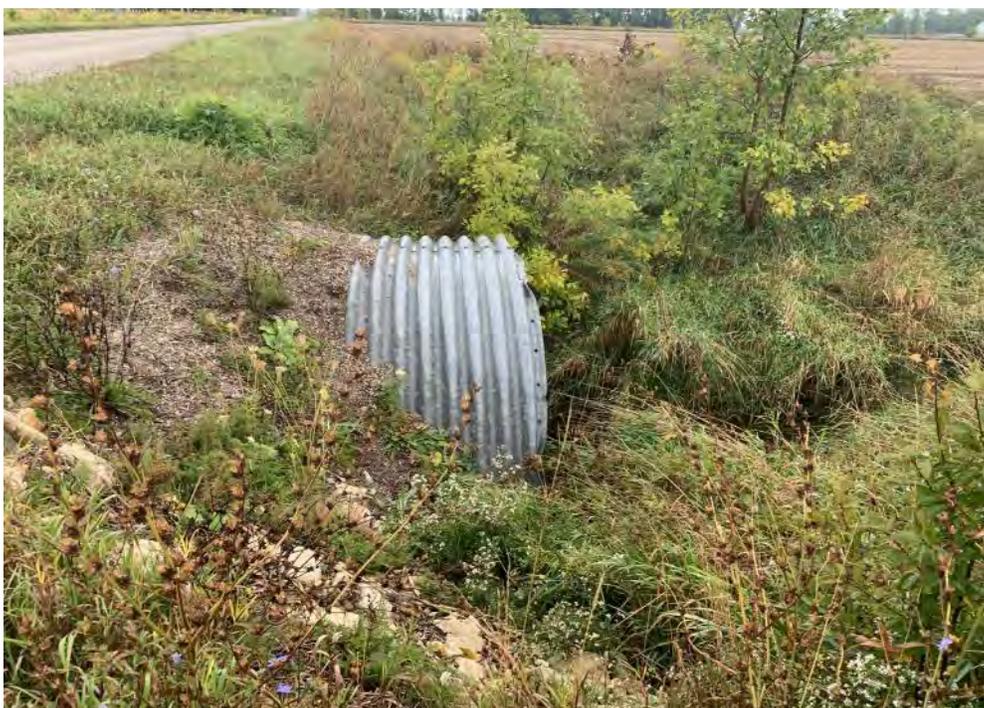
Photo 17-5: View of culvert in elevation and inlet components

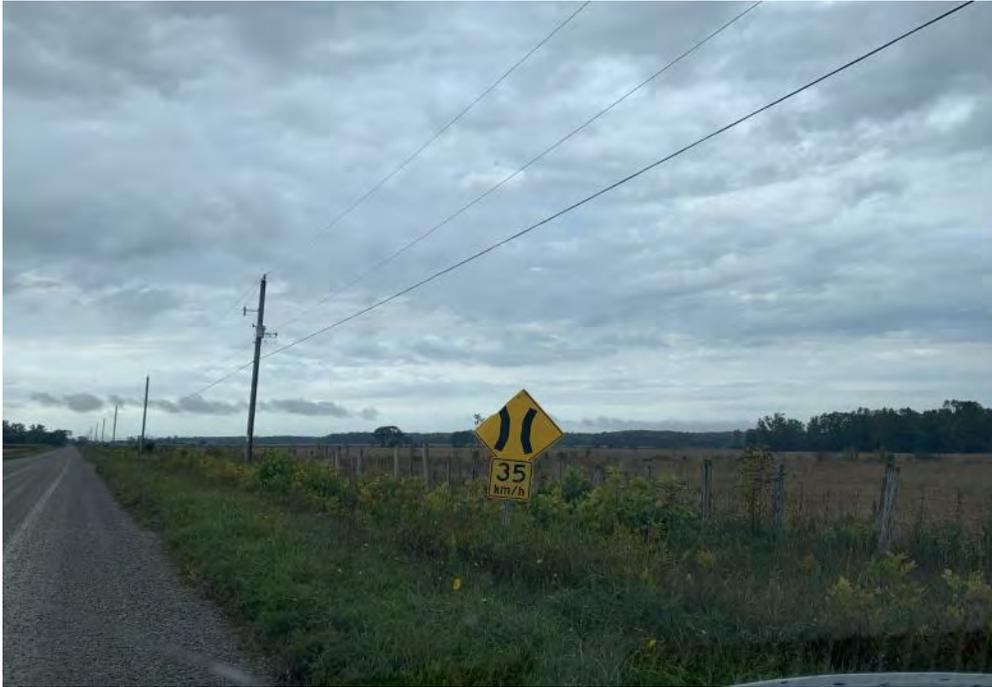
Photo 17-6: View of posted speed limit signage

Element Group:	Signs		Length:				
Element Name:	Signs		Width:				
Location:	Each Corner		Height:				
Material:			Count:	2			
Element Type:			Total Quantity:	2			
Environment:	Severe		Limited Insp'n:				
Protection System:	None						
Condition Data:	Units	Exc.	Good	Fair	Poor	Perform. Deficiencies	Maint. Needs
	%		1		1	Yes	Yes
Comments:	Two speed limit/narrow structure signs. The south sign is damaged and requires replacement (narrow structure portion only).						
Recommended Work:	<input type="checkbox"/> None	<input type="checkbox"/> 6-10 Years	<input checked="" type="checkbox"/> 1-5 Years	<input type="checkbox"/> < 1 Year	<input type="checkbox"/> Urgent		
	Install end hazard signs and maintain reduced speed limit signs prior to guiderail protection placement.

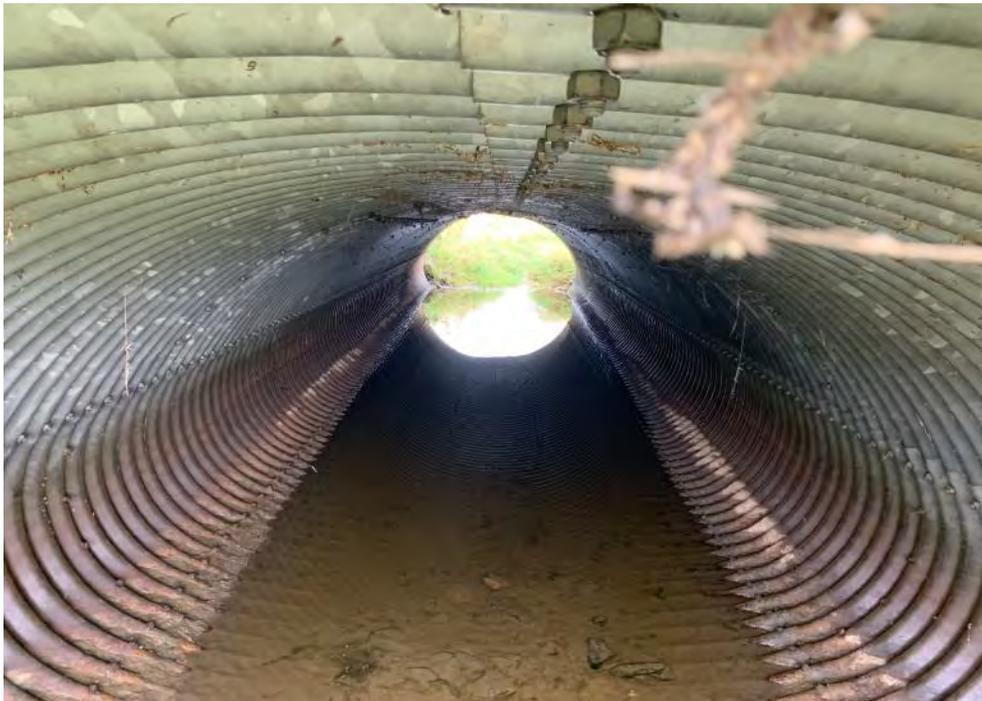
Photo 17-7: View of culvert barrel interior

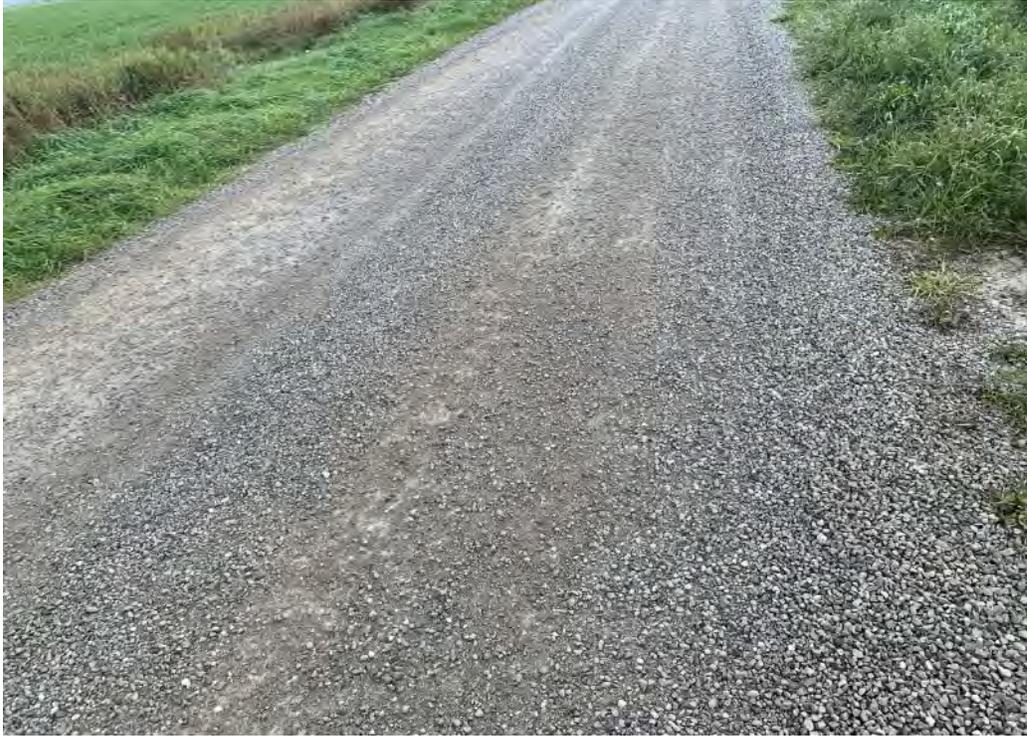
Photo 18-2: View of structure wearing surface

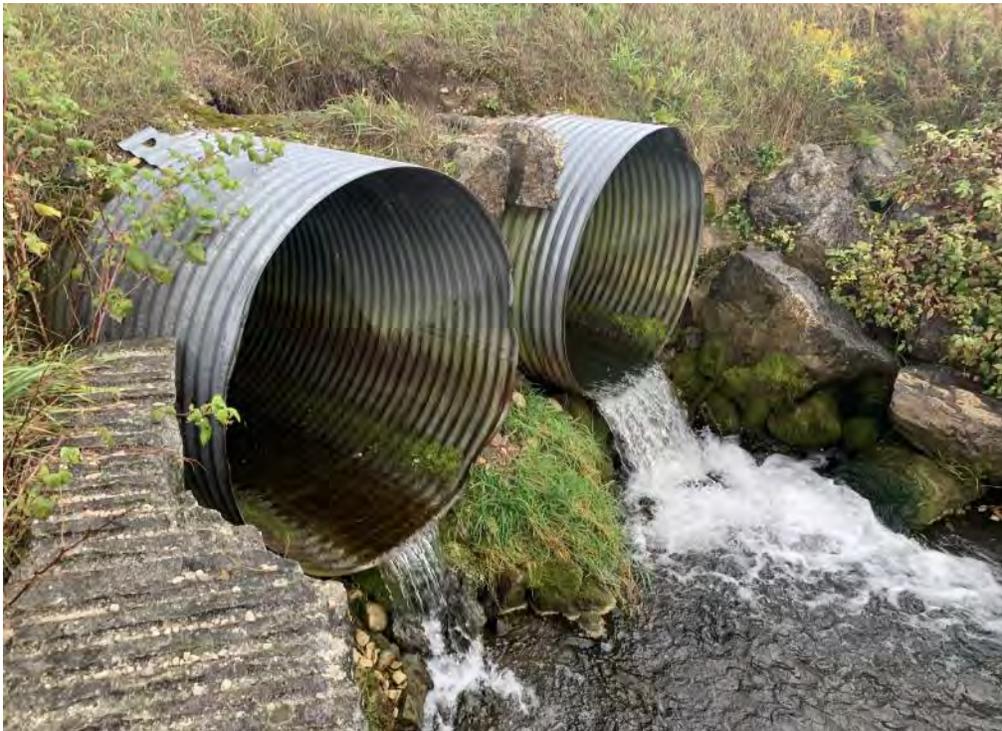
Photo 18-3: View of culvert in elevation and outlet end components

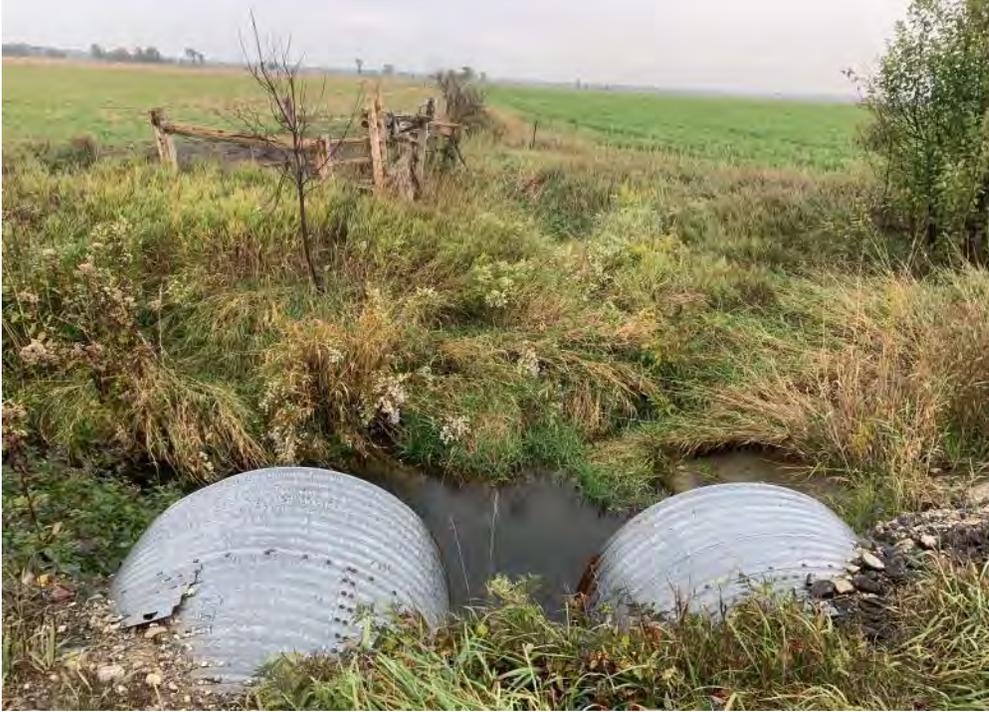
Photo 18-4: View of watercourse upstream and inlet ends

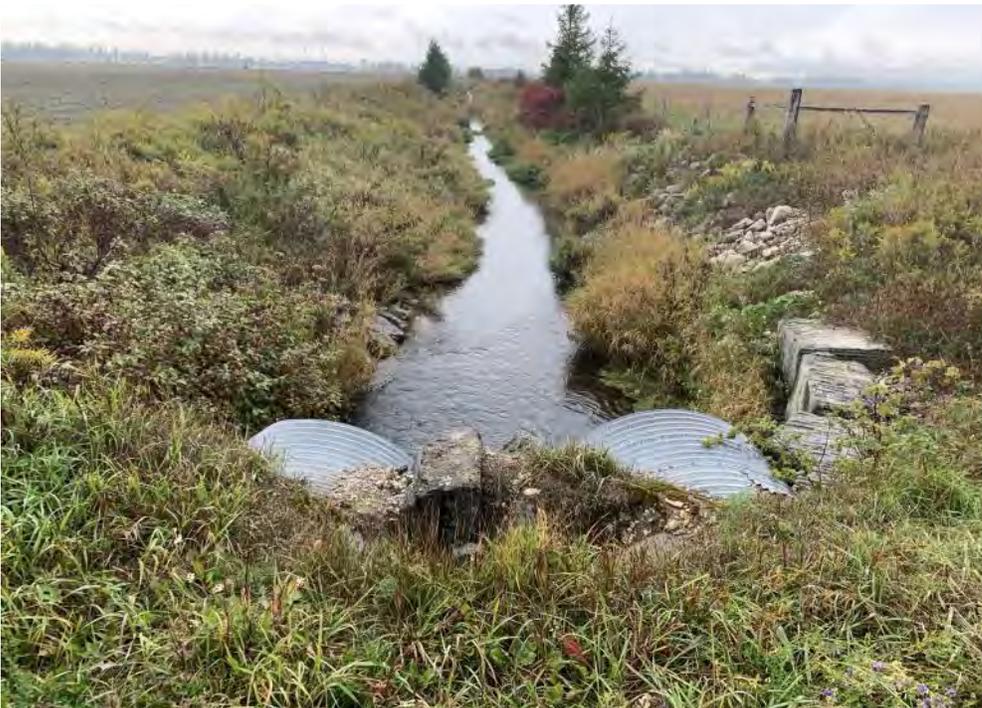
Photo 18-5: View of watercourse downstream and outlet culvert ends

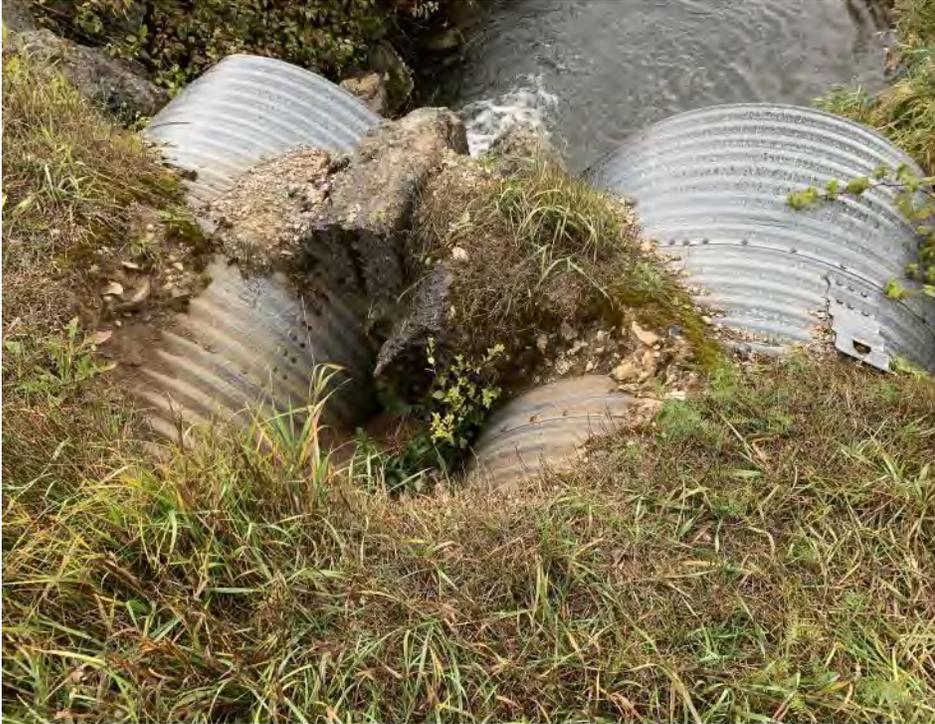
Photo 18-6: View of erosion of embankment and between pipes

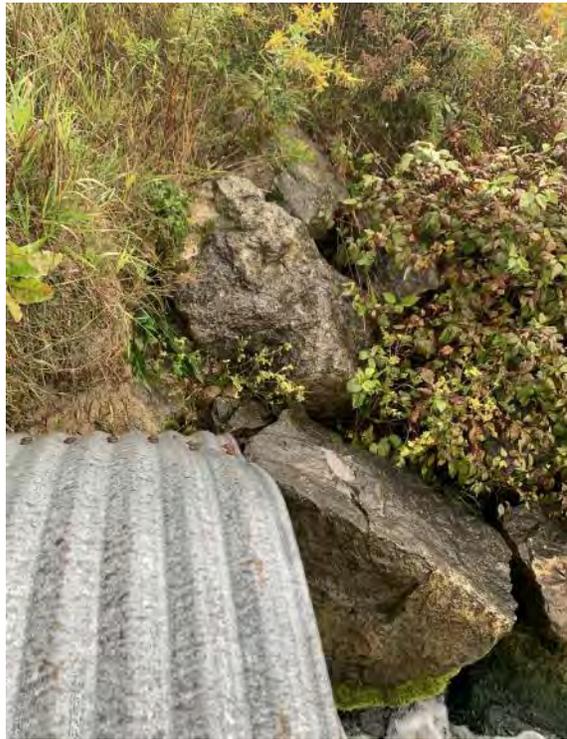
Photo 18-7: Erosion at the haunch of the outlet pipe

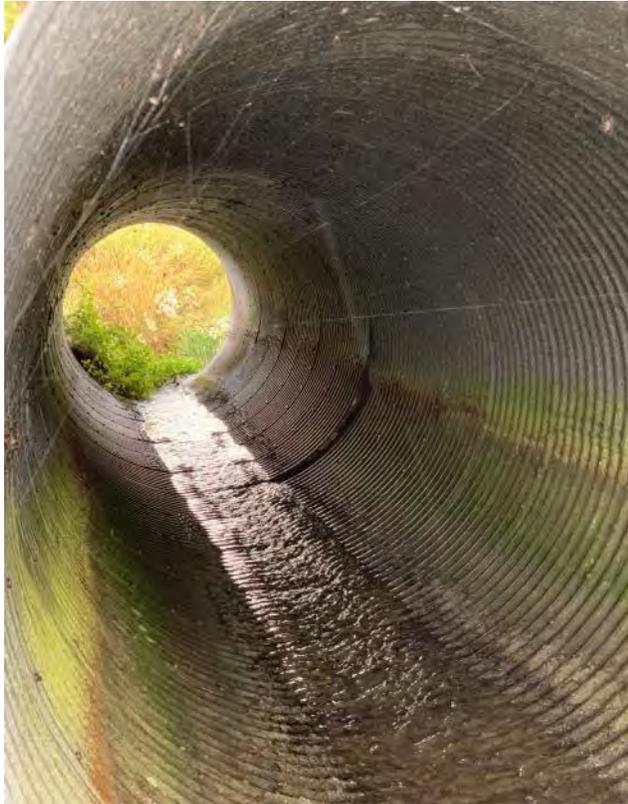
Photo 18-8: View of east culvert barrel interior

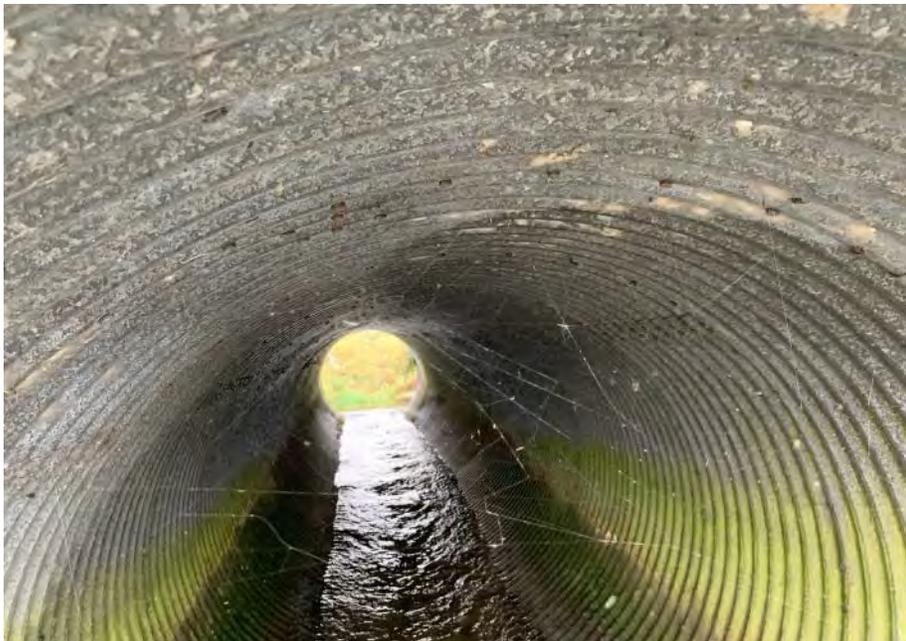
Photo 18-9: View of west culvert barrel interior

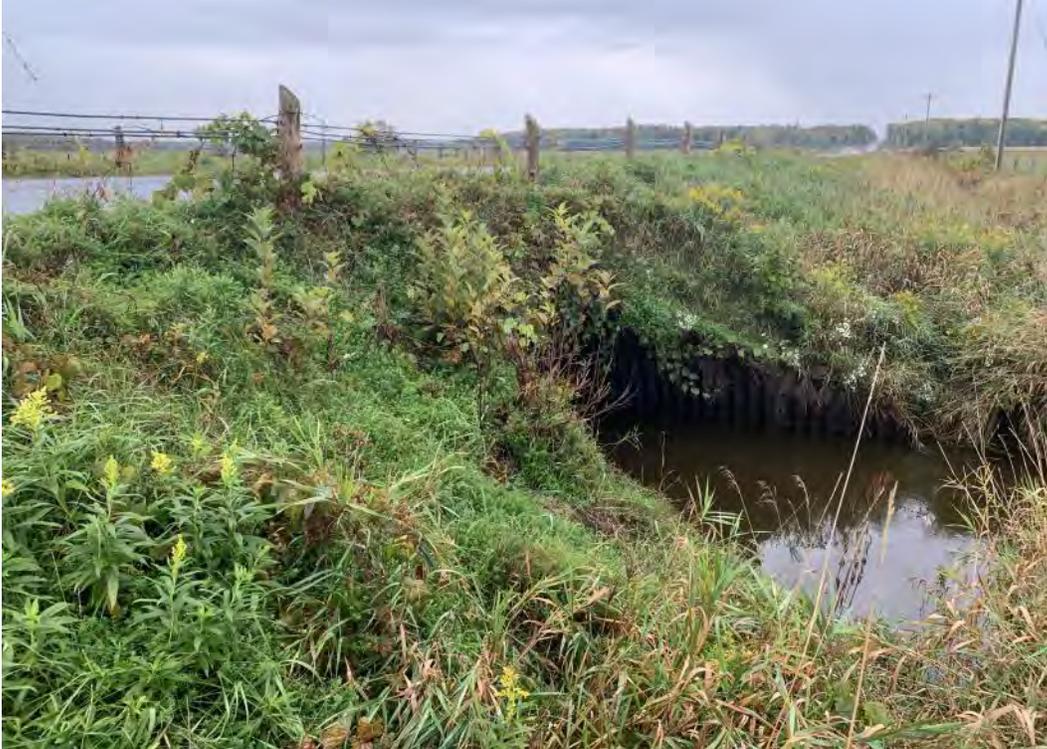
Photo 19-2: View of culvert in elevation and inlet components

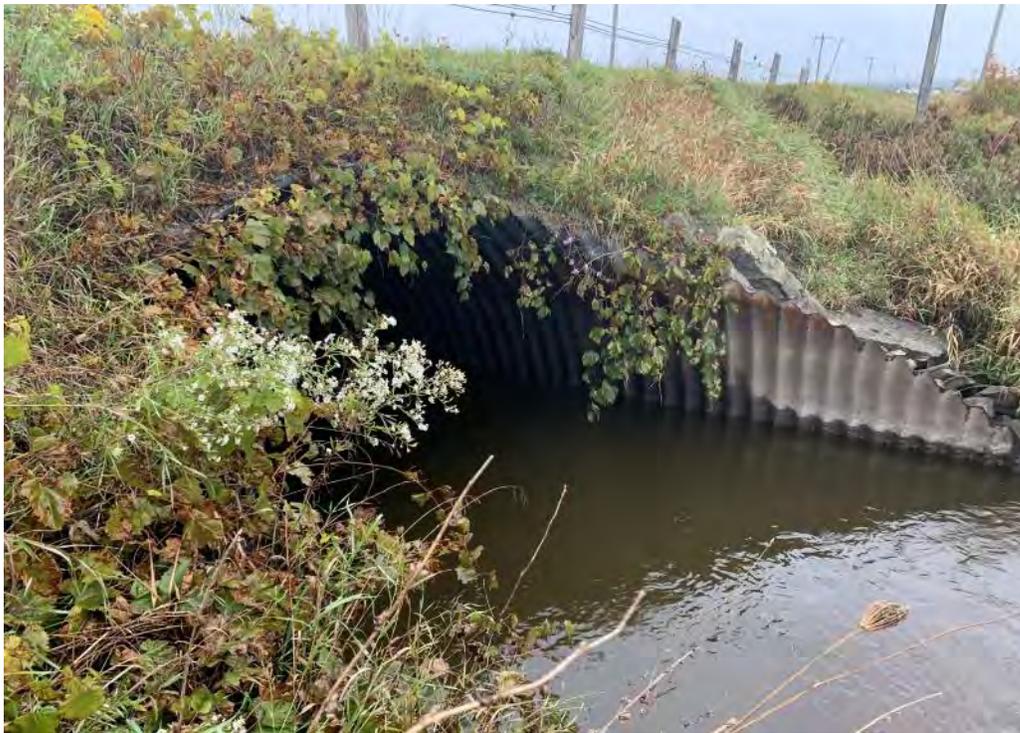
Photo 19-3: View of culvert in elevation and outlet components

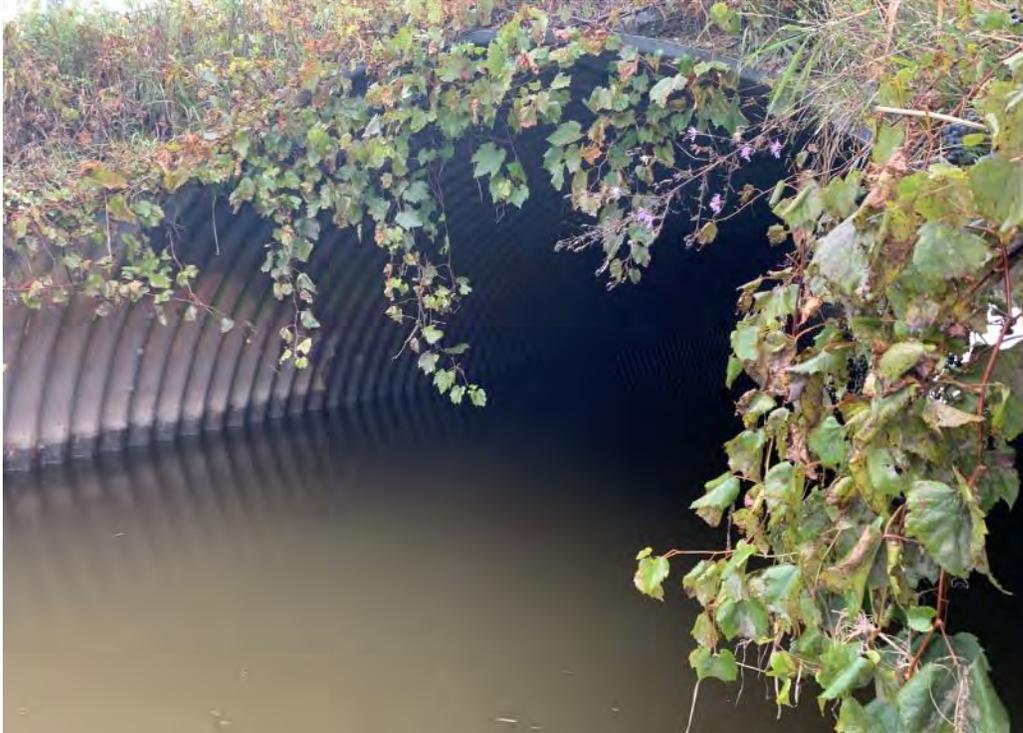
Photo 19-4: View of culvert barrel interior

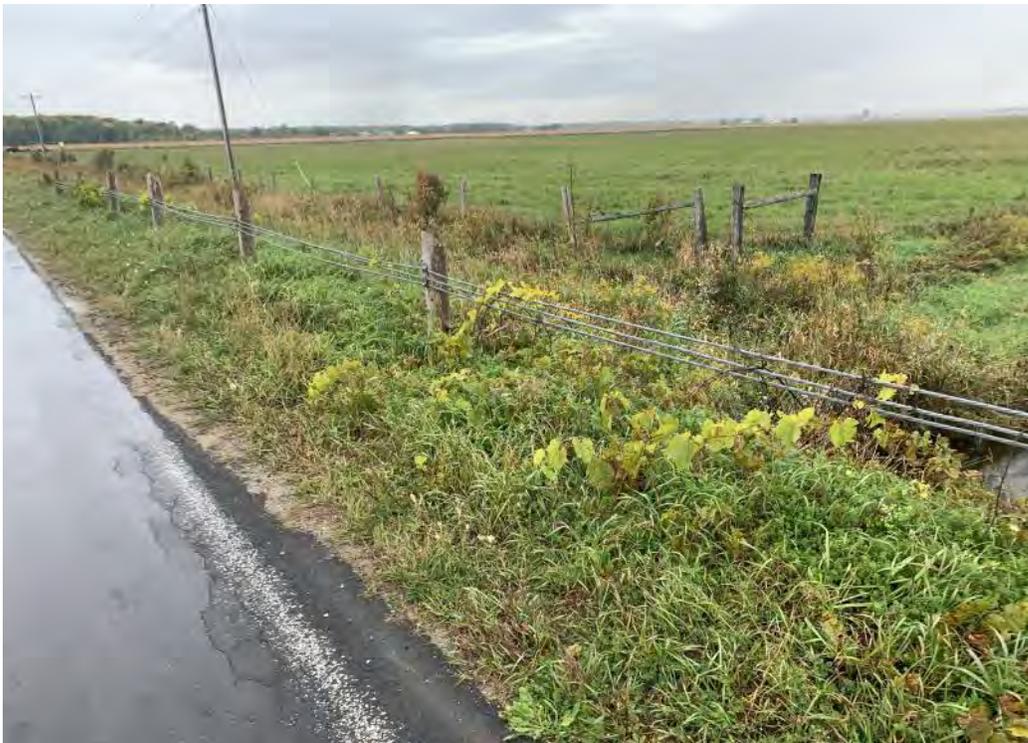
Photo 19-7: View of structure barrier protection (typical)

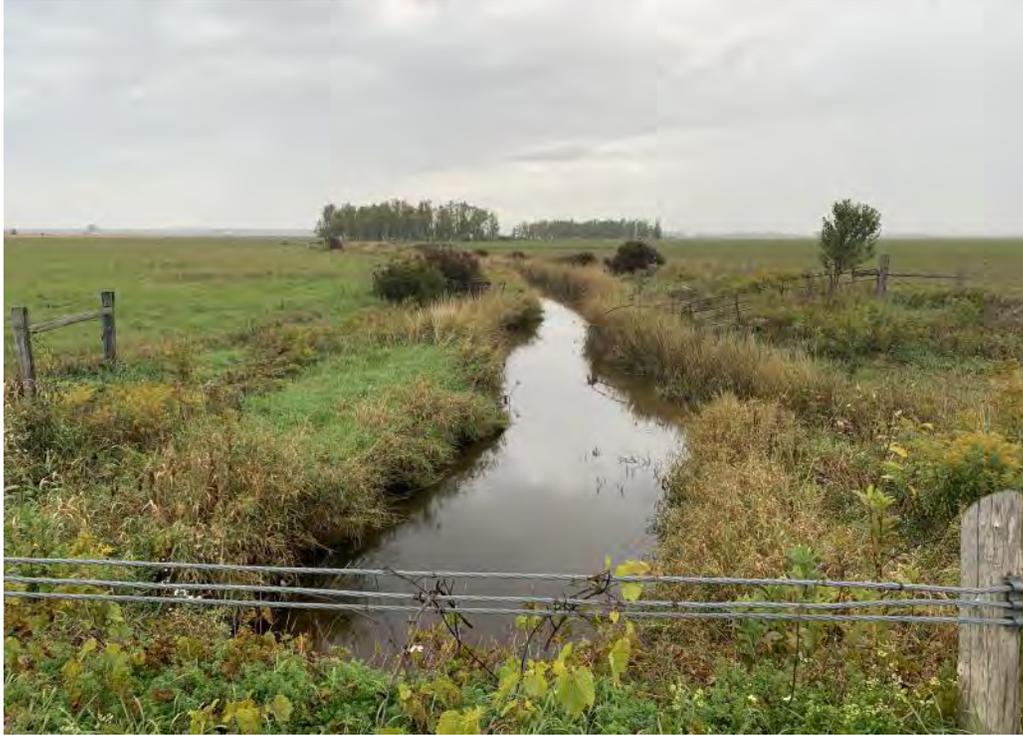
Photo 19-8: View of watercourse upstream

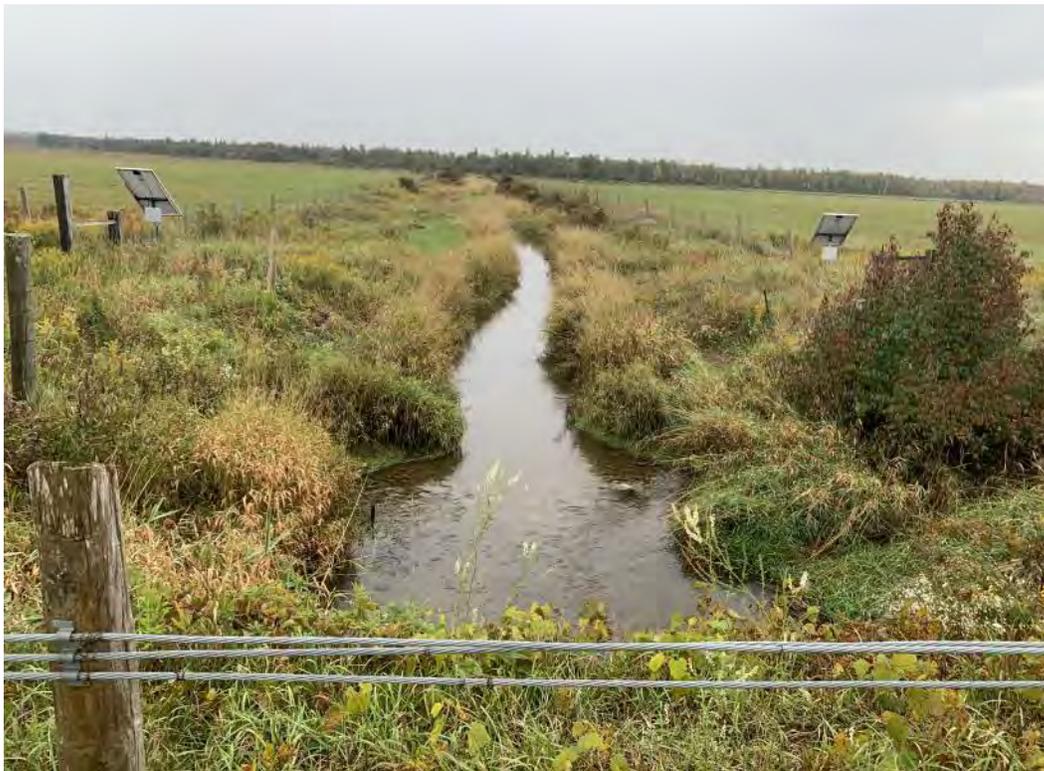
Photo 19-9: View of structure downstream
