MUNICIPALITY OF NORTHERN BRUCE PENINSULA

2020 STRUCTURE INSPECTION REPORT

FINAL
PROJECT NO.: 201-01605-00
DATE: MARCH 10, 2021

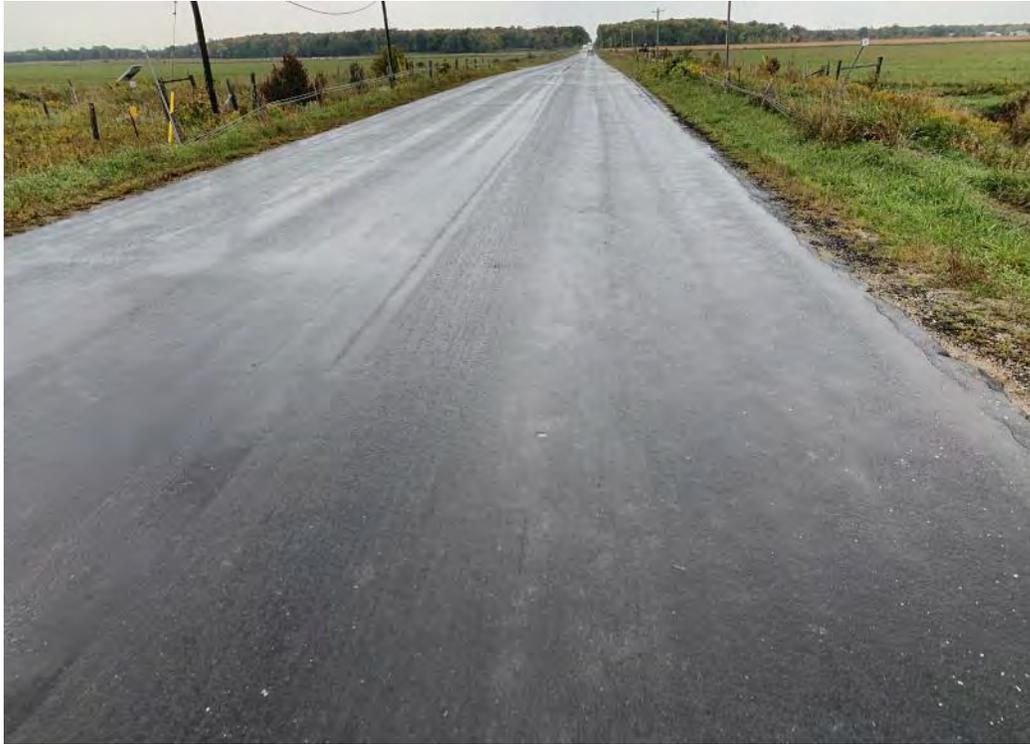
Photo 19-10: View of structure and approach wearing surface
