#### MUNICIPALITY OF NORTHERN BRUCE PENINSULA

## 2024 STRUCTURE INSPECTION REPORT

FINAL PROJECT NO.: CA0043256.3165 DATE: MARCH 06, 2025

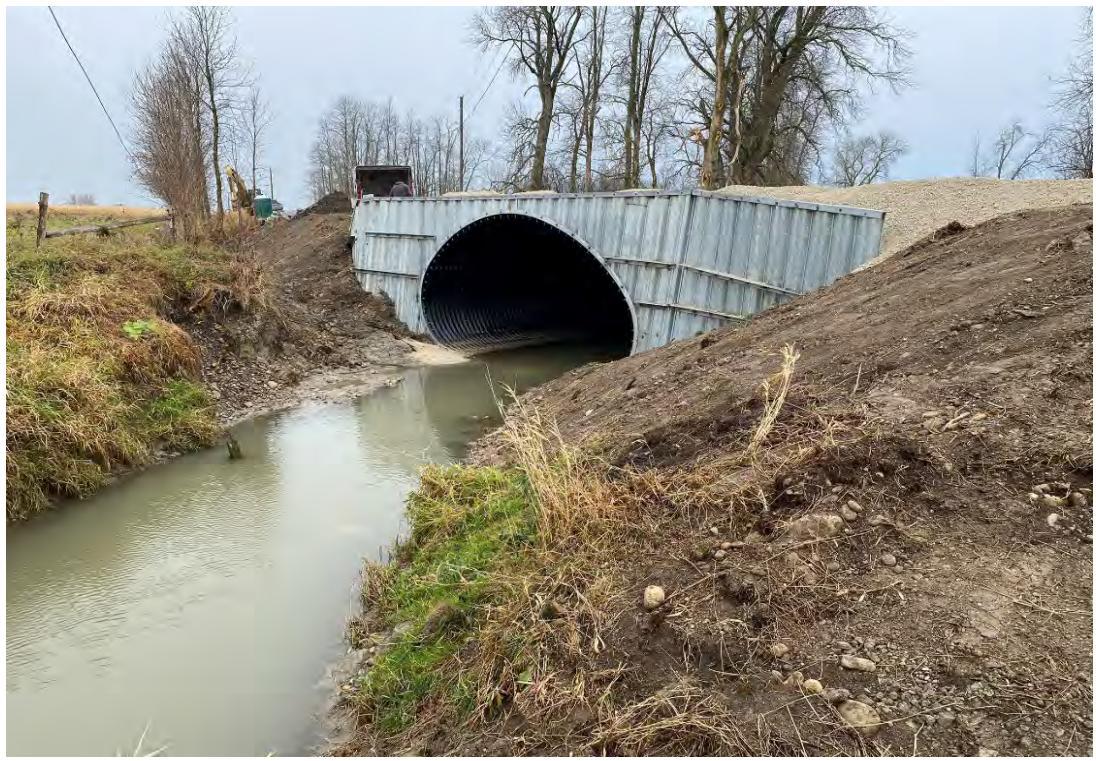
Photo 1-2: View of culvert in elevation and inlet components

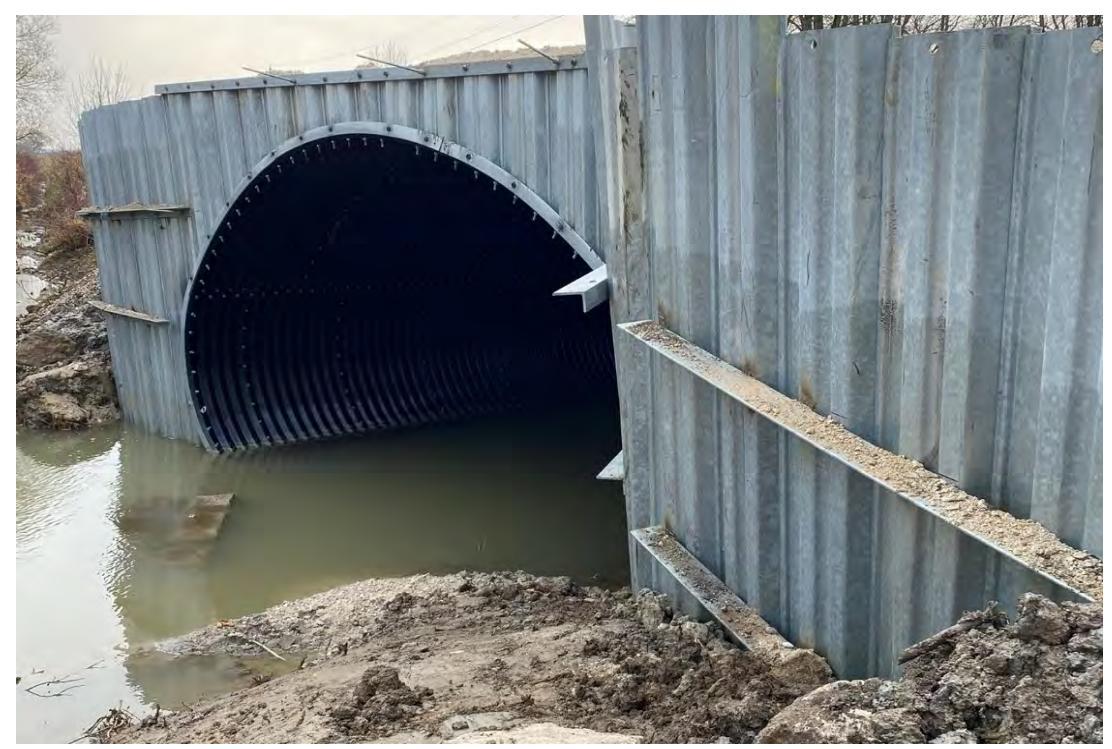
Photo 1-3: View of culvert in elevation and outlet components

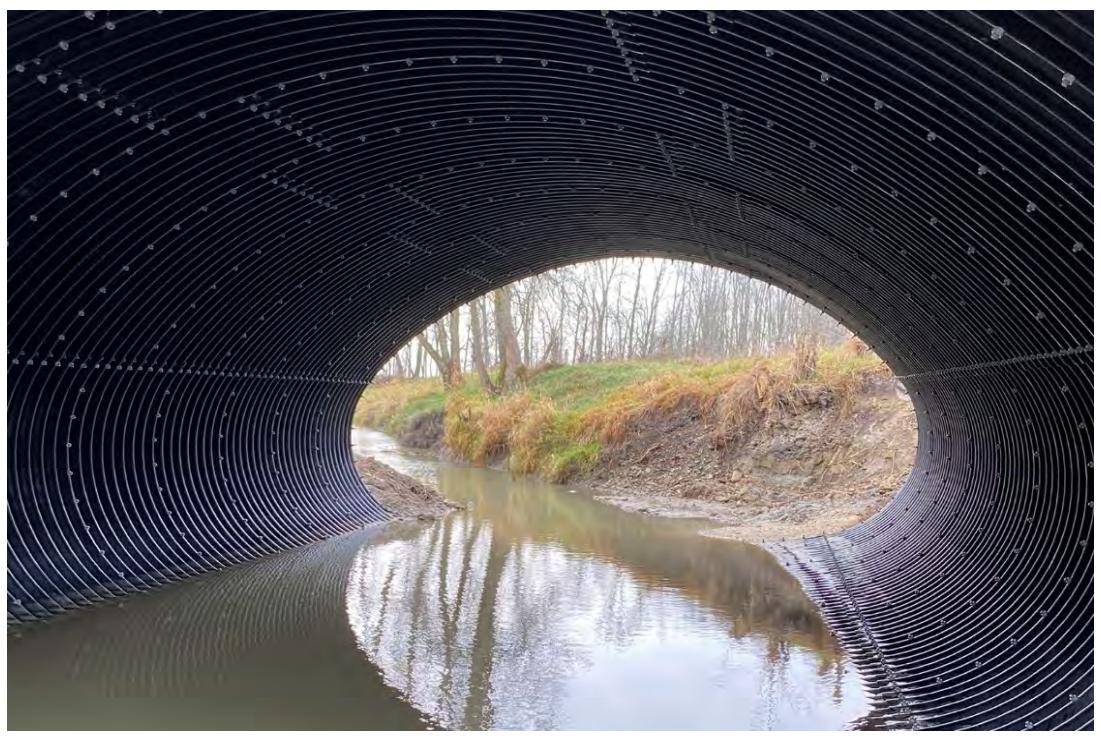
Photo 1-4: View of culvert barrel interior

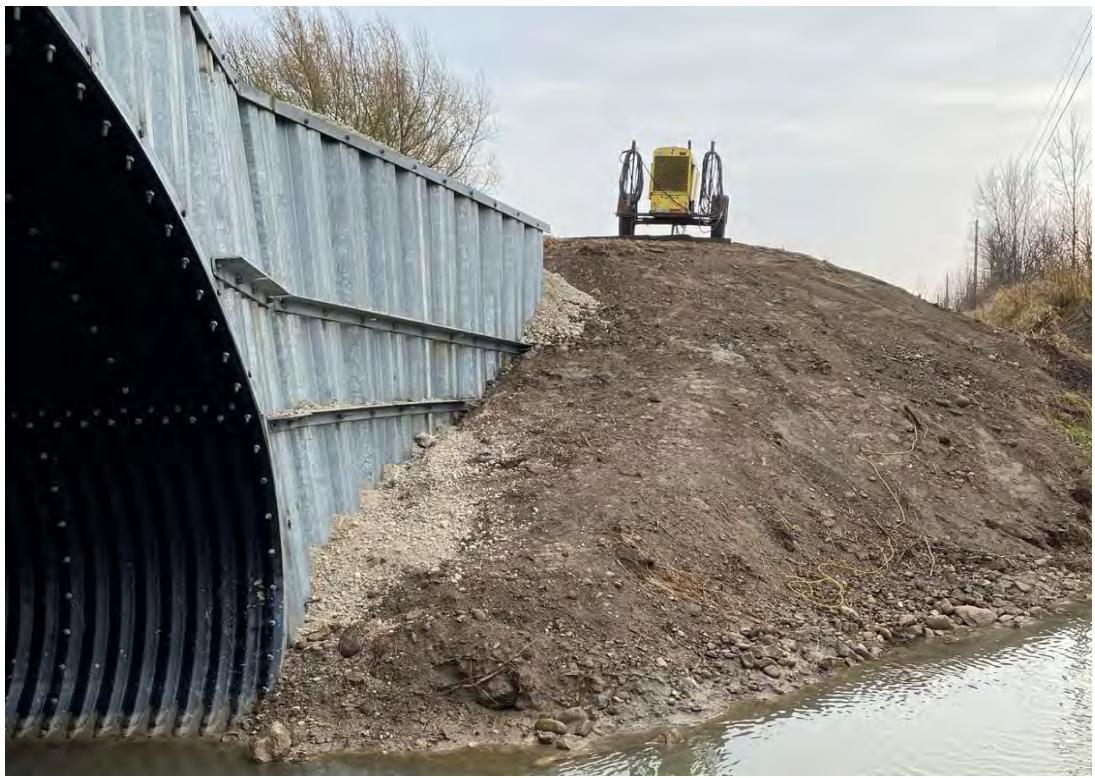
Photo 1-5: View of emankment and wingwall (typ.)

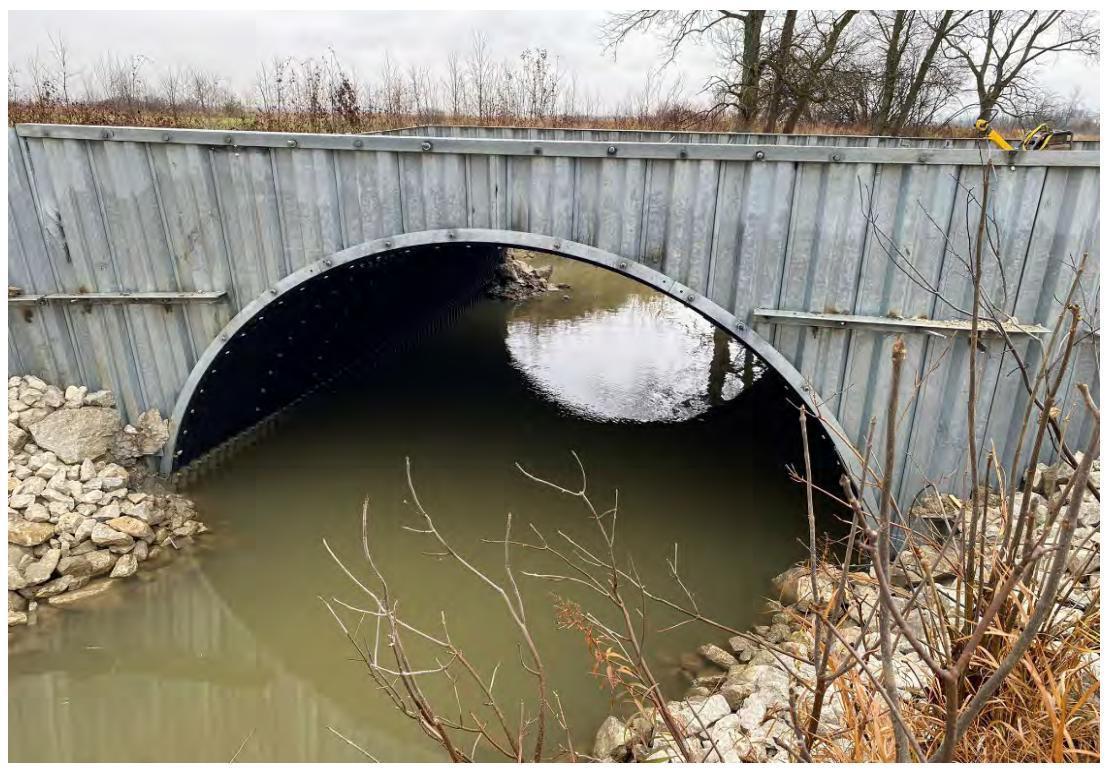
Photo 2-2: View of culvert in elevation and inlet components

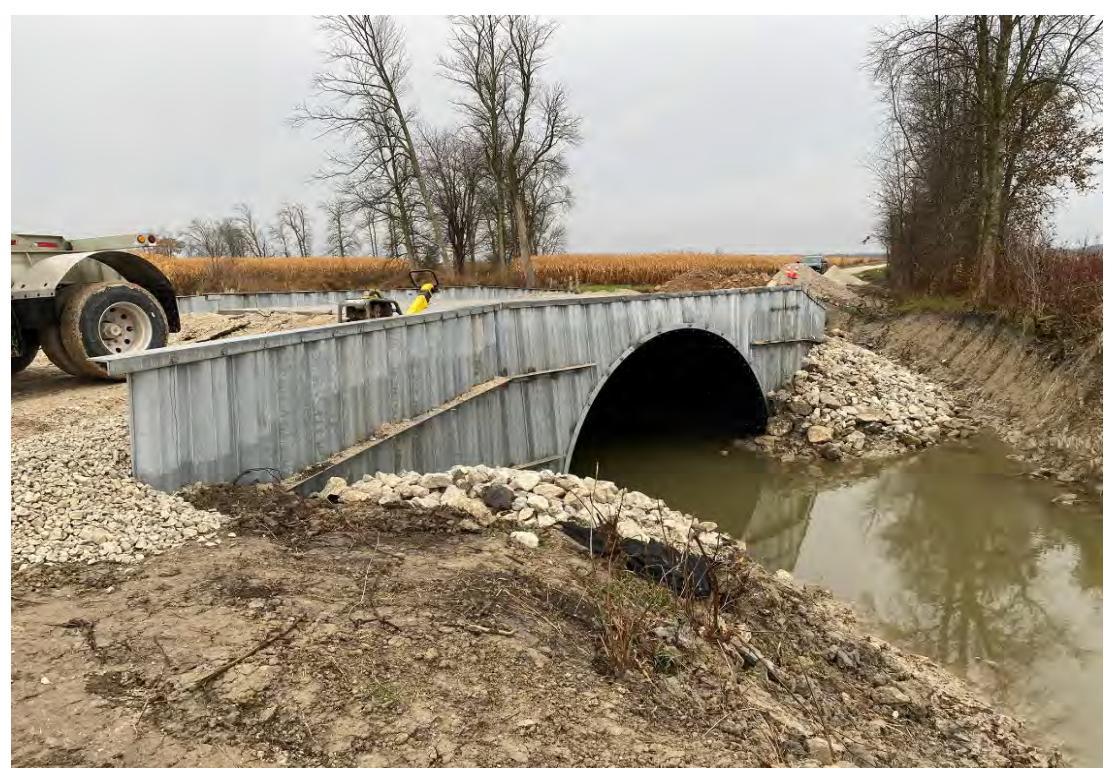
Photo 2-3: View of culvert in elevation and outlet components

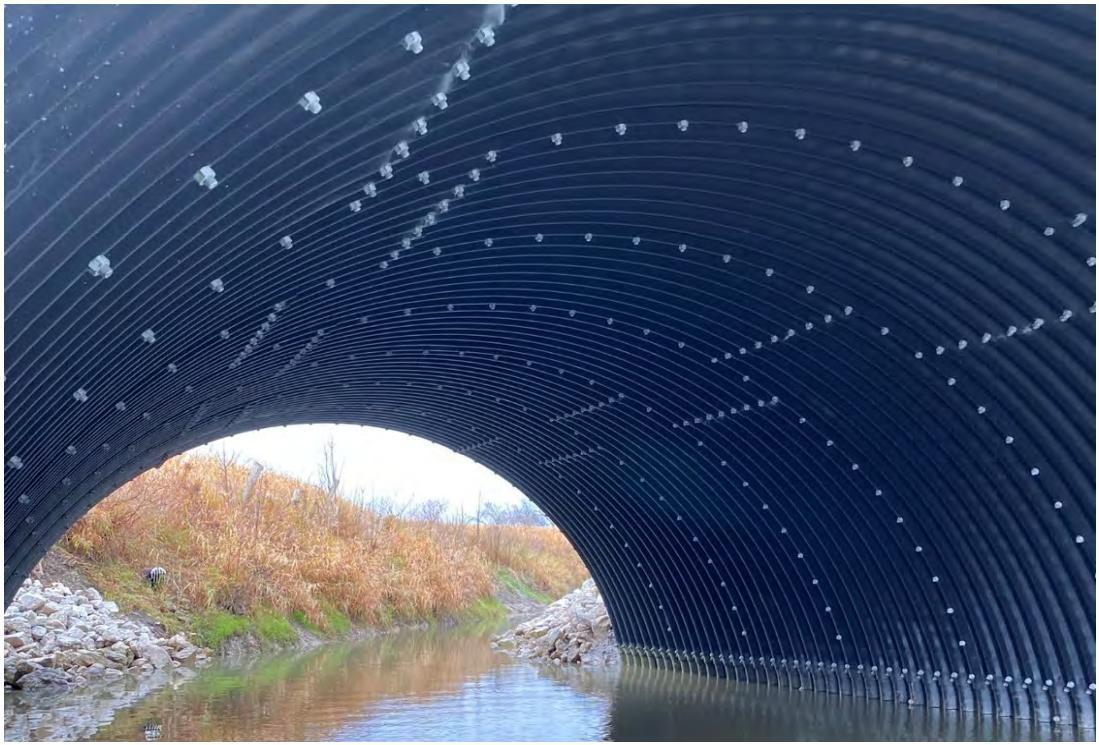
Photo 2-4: View of culvert barrel interior

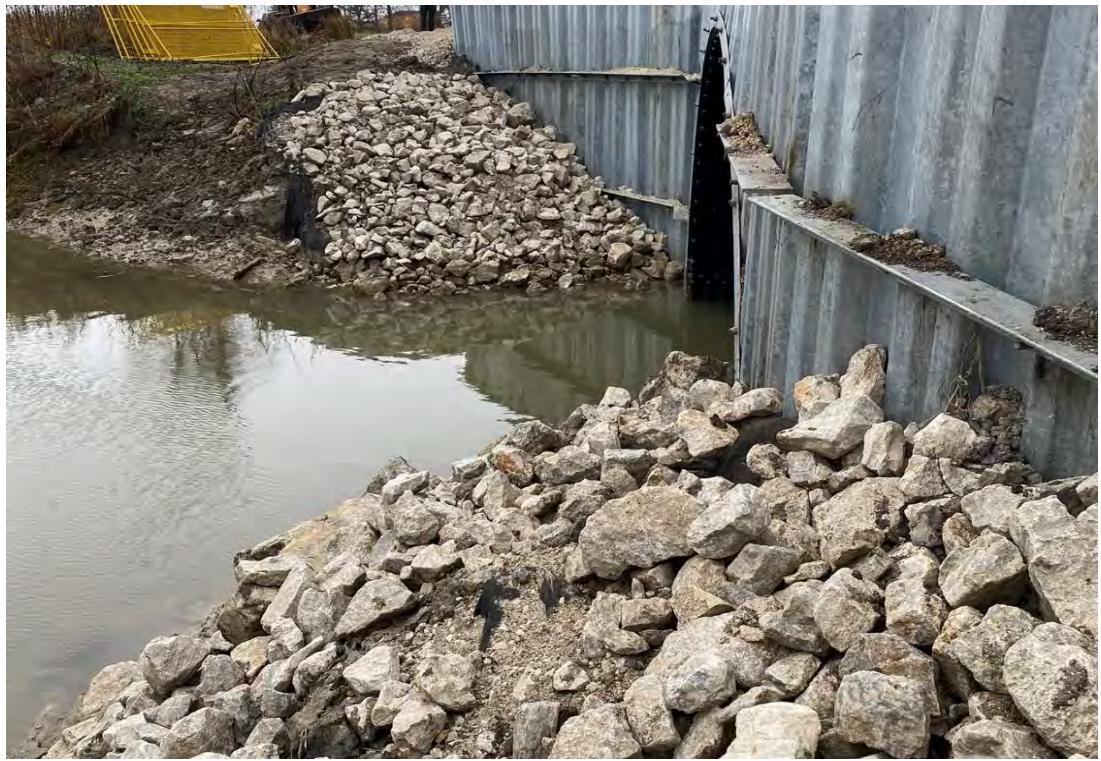
Photo 2-5: View of embankments and wingwalls (typ.)

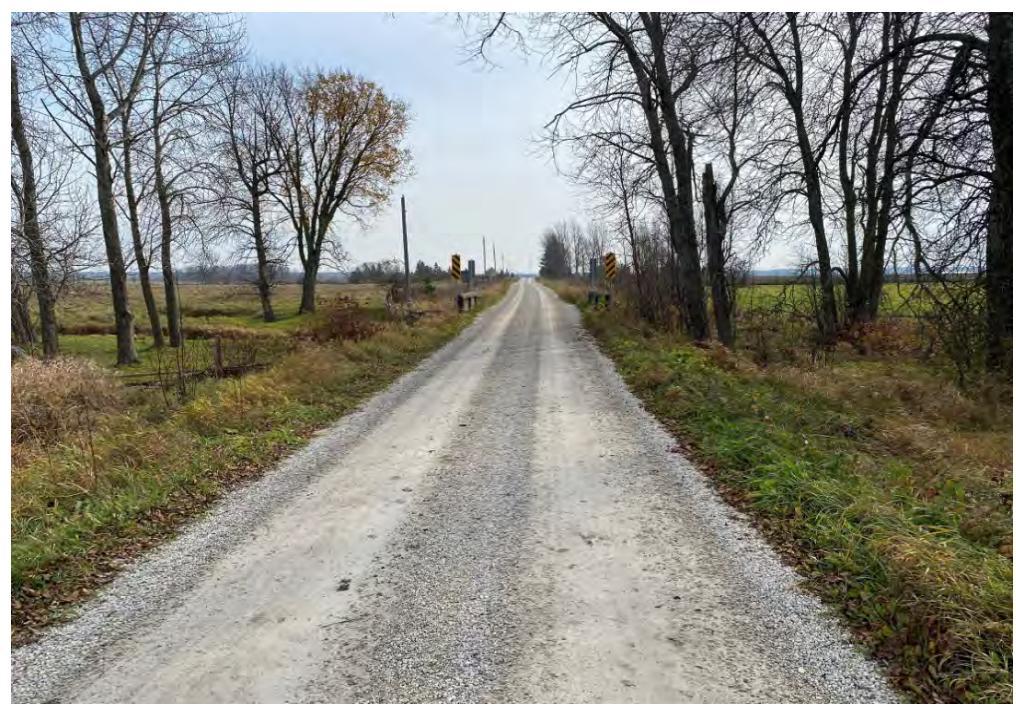
Photo 3-2: View of approach from the north

Element Group:	Approaches L		Length:	5				
Element Name:	Wearing Surface Wic		Width:	5				
Location:			Height:					
Material:	Gravel		Count:	2				
Element Type:			Total Quantity:	50				
Environment:	Severe		Limited Insp'n:					
Protection System:								
Condition Data:	Units	Exc.	Good	Fair	Poor	Perform.	Maint.	
	2			50		Denciencies	Needs	
Comments:       Narrow granular surface approach is in fair condition with minor wheel path rutting observed. Heavily vegetated edge of shoulders are likely impeding drainage.								
Recommended Work:         None         6-10 Years         1-5 Years         < 1 Year         Urgent           Grade the approaches and shoulders annually to maintain adequate positive drainage.

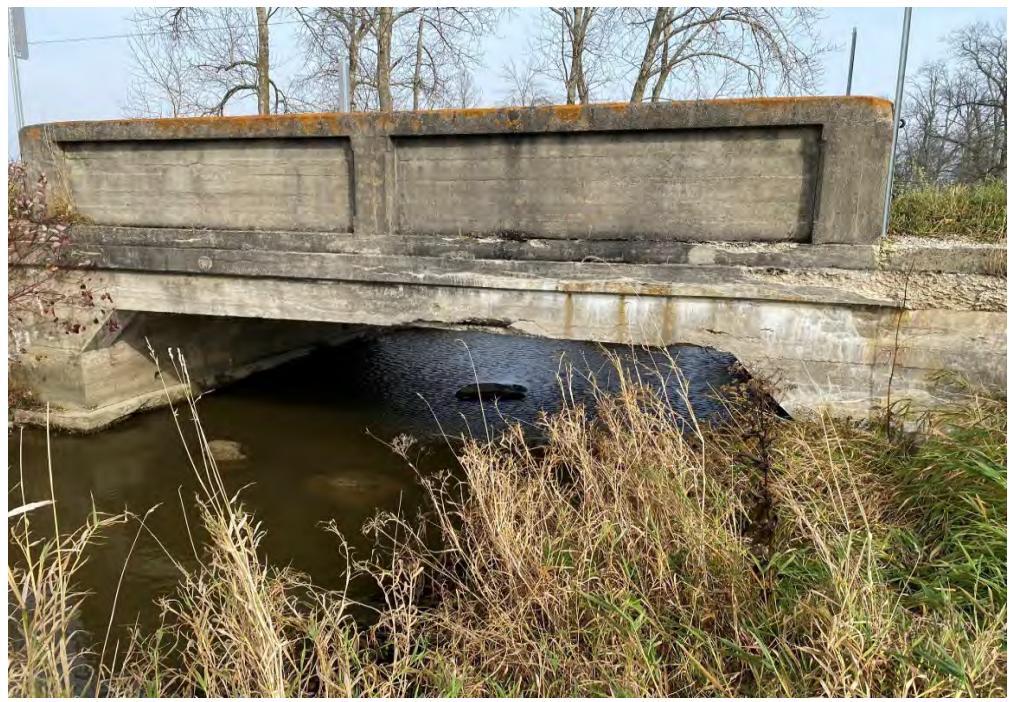
Photo 3-6: East structure elevation, exterior girder and barrier wall

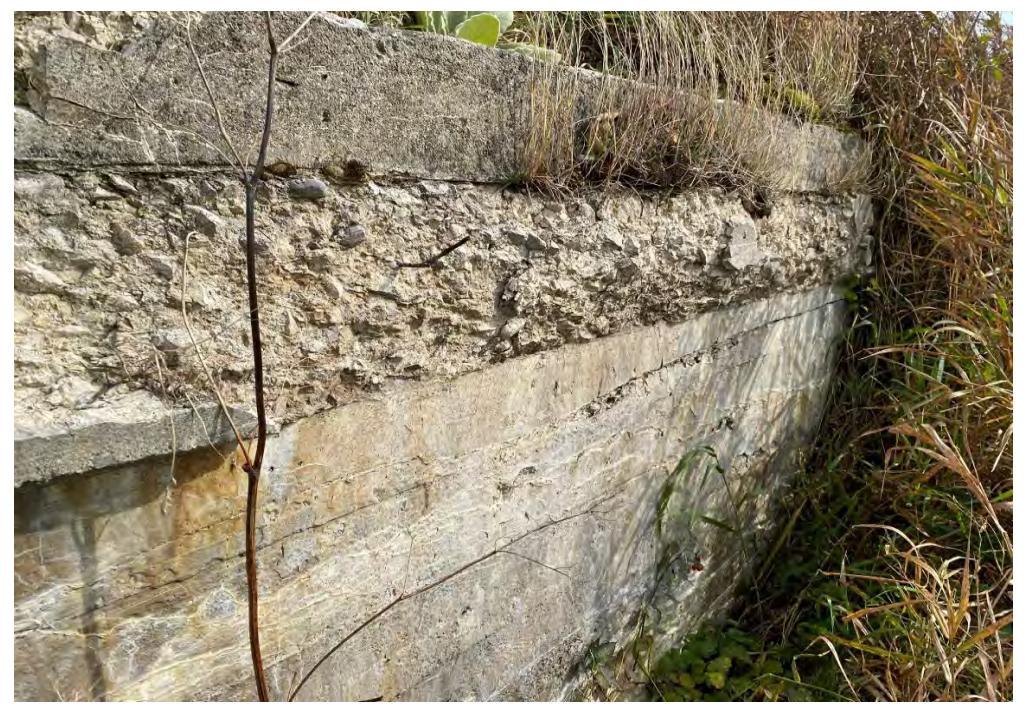
Photo 3-7: Wingwall and exterior curb (typical)

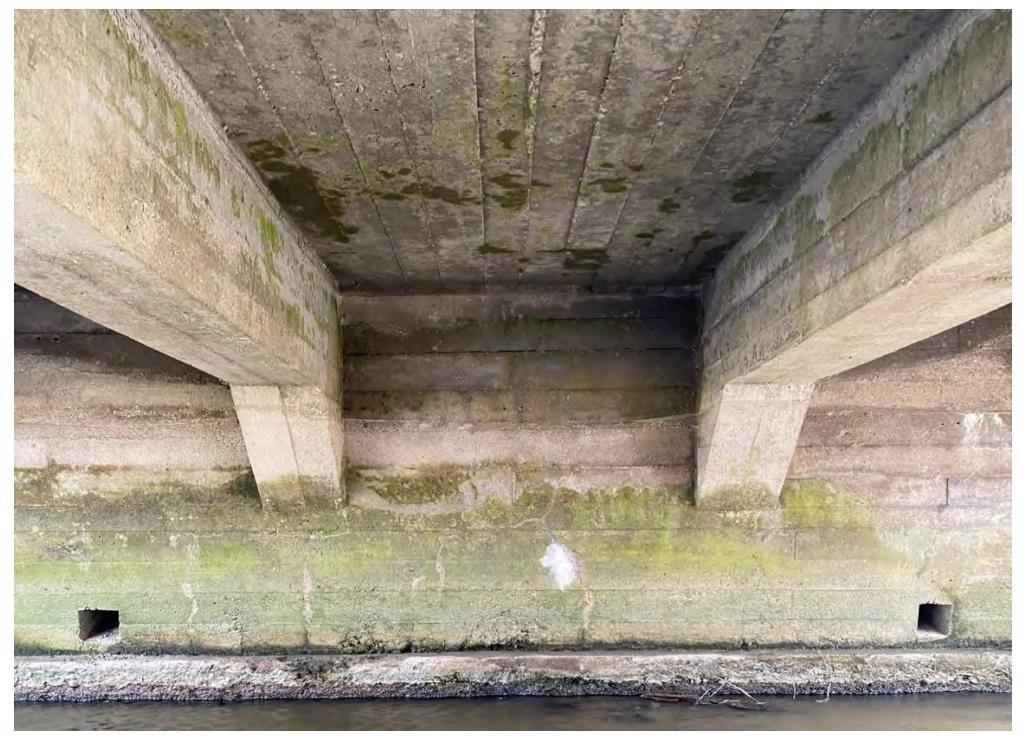
Element Group:	Decks		Length:	7					
Element Name:	Soffit - Thick	Slab	Width:	5.5					
Location:			Height:						
Material:	Concrete		Count:						
Element Type:			Total Quantity:		28.47				
Environment:	Moderate	Limited Insp'n:							
Protection System:									
Condition Data:	Units	Exc.	Good	Fair	Poor	Perform. Deficiencies	Maint. Needs		
	m <sup>2</sup>			24.20	4.27	Yes	Yes		
<b>Comments:</b> Some cracking and spalled surfaces were observed with more severe spalling of the exterior soffit.									
Recommended Work:None6-10 Years1-5 Years< 1 YearUrgentRemove all poor concrete areas, clean the reinforcing steel, and replace concrete.

Photo 3-9: Interior concrete girders and soffit

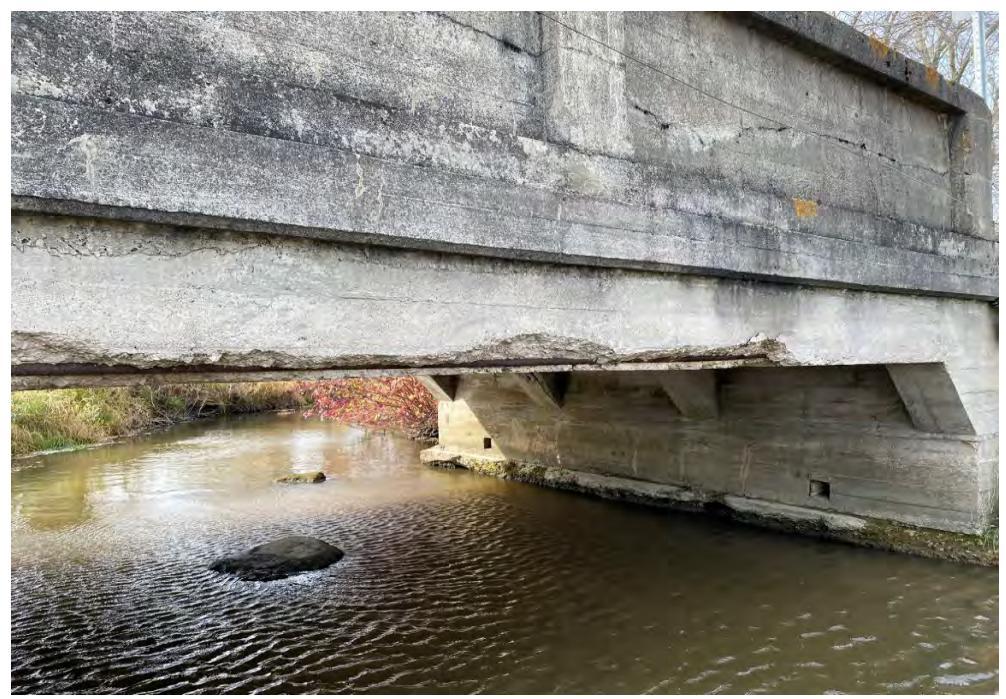
Photo 3-10: View of west structure elevation, exterior girder and barrier wall

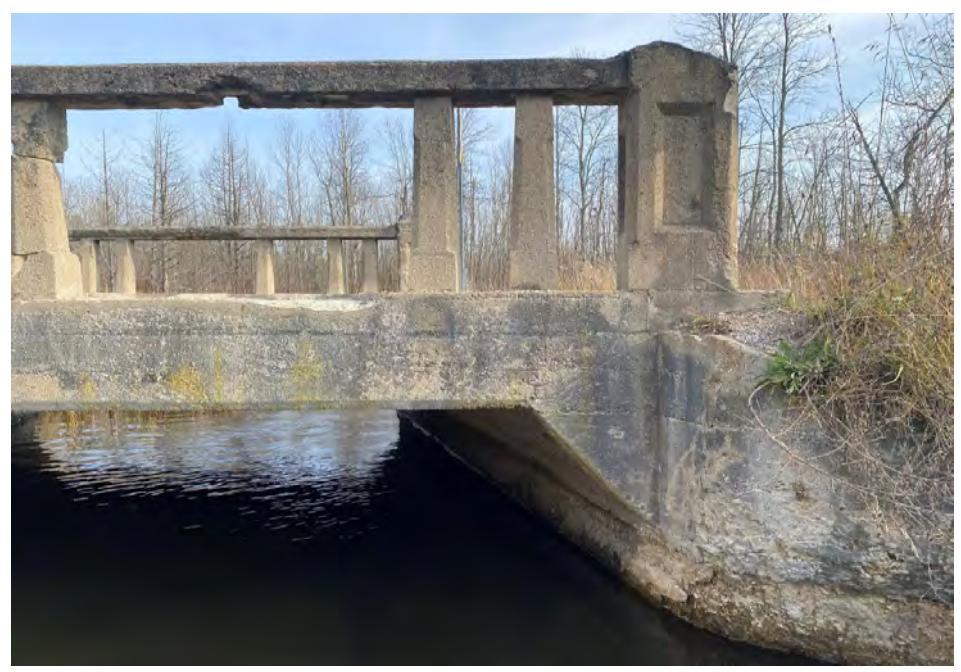
Photo 4-2: View of east structure elevation, wingwalls, exterior curb and barrier

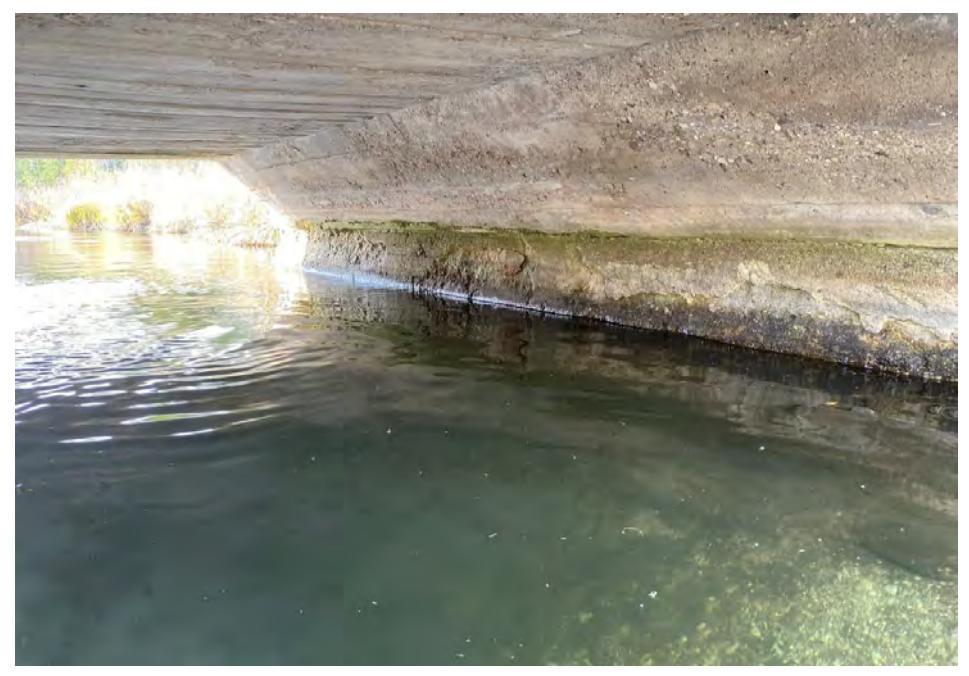
Photo 4-3: View of soffit and abutment wall

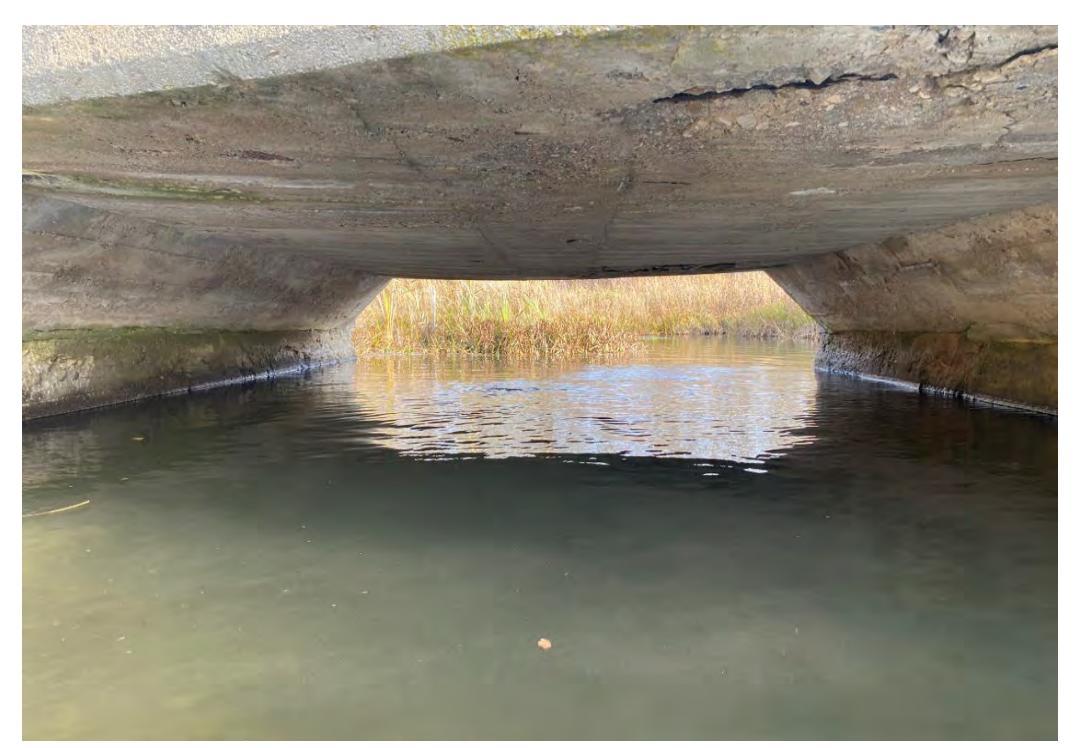
Photo 4-4: View of soffit

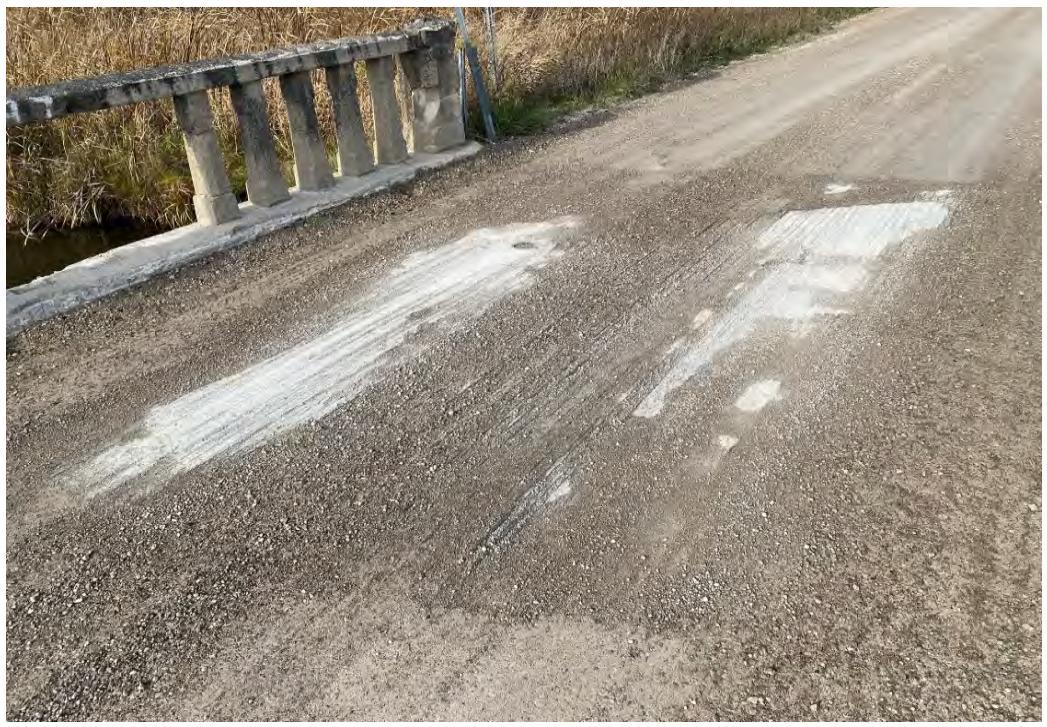
Photo 4-5: View of wearing surface

Element Group:	Approac	hes	Length:			5 m		
Element Name:	Wearing S	Wearing Surface		3.96 m				
Location:			Height:					
Material:	Grave	el	Count:		2			
Element Type:			Total Quantity:		39	9.6 m <sup>2</sup>		
Environment:	Modera	ate	Limited Insp'n:					
Protection System:								
Condition Data:	Units	Exc.	Good	Fair	Poor	Perform. Deficiencies	Maint. Needs	
	m <sup>2</sup>			39.6			Yes	
Comments:								
Recommended Work: None 6-10 Years Grade approach and structure wearing		1-5 Years surfaces annually.	< 1 Year	Urgent

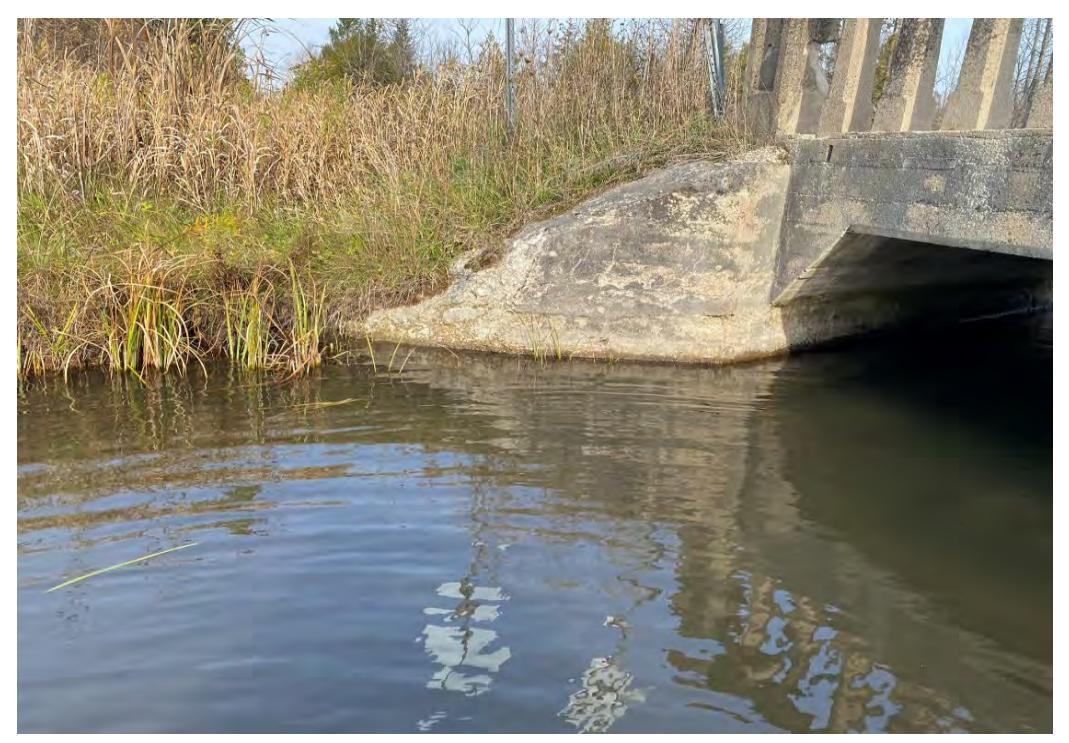
Photo 4-6: View of southeast wingwall

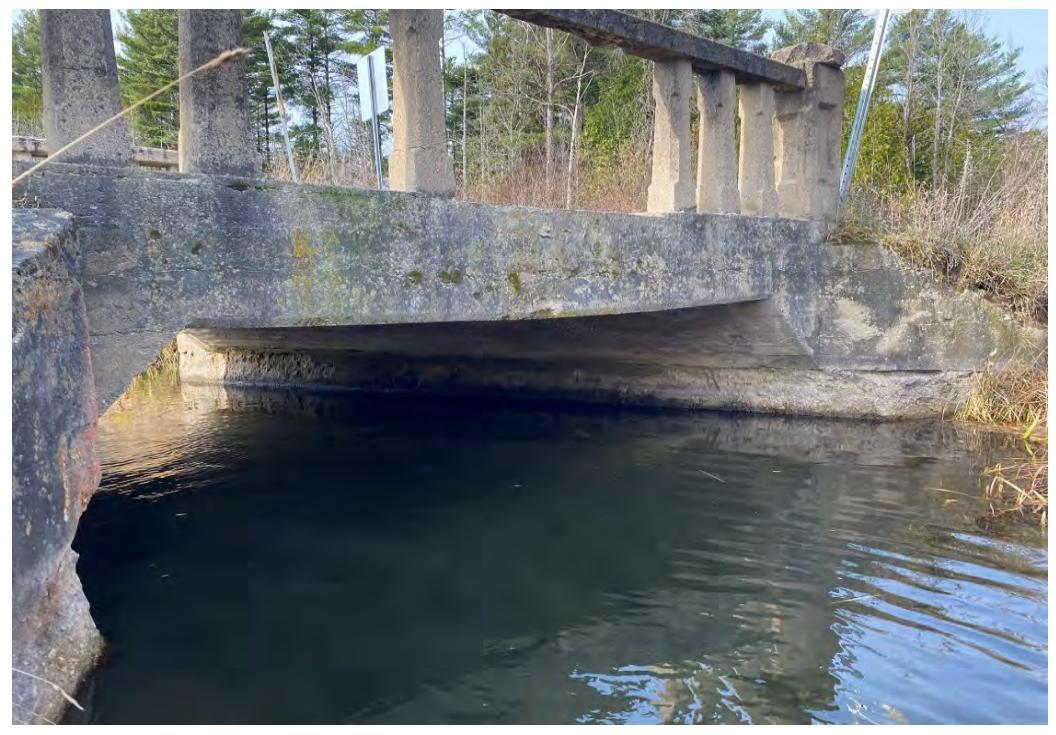
Photo 4-7: View of west structure elevation, exterior soffit, curb and barrier

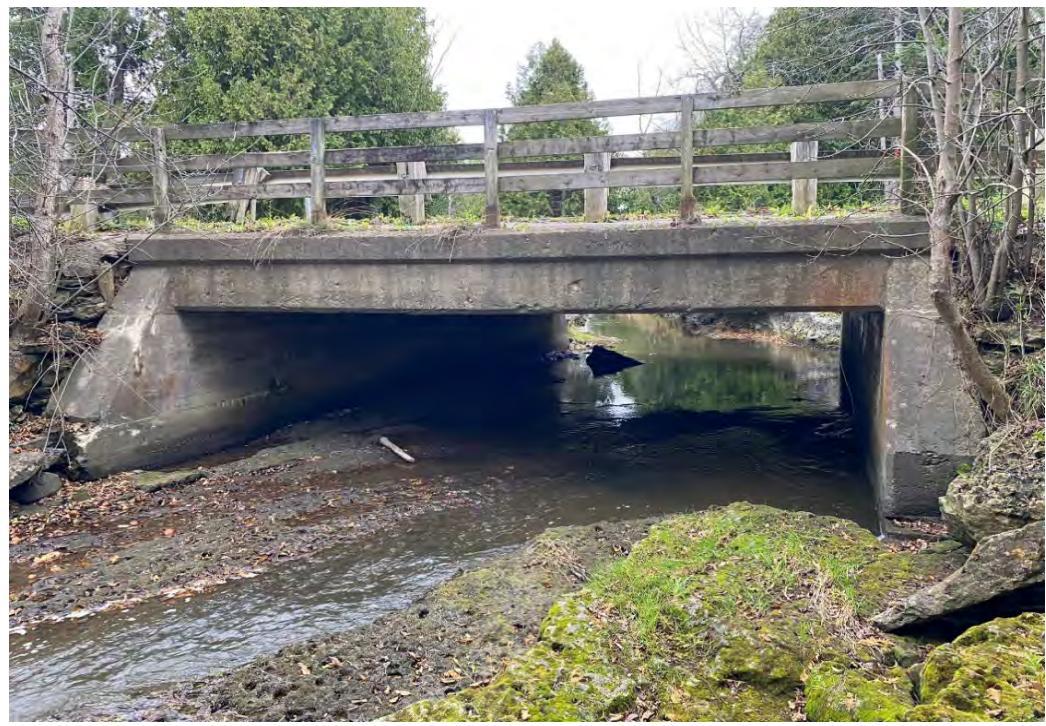
Photo 5-2: View of south structure elevation and streambed

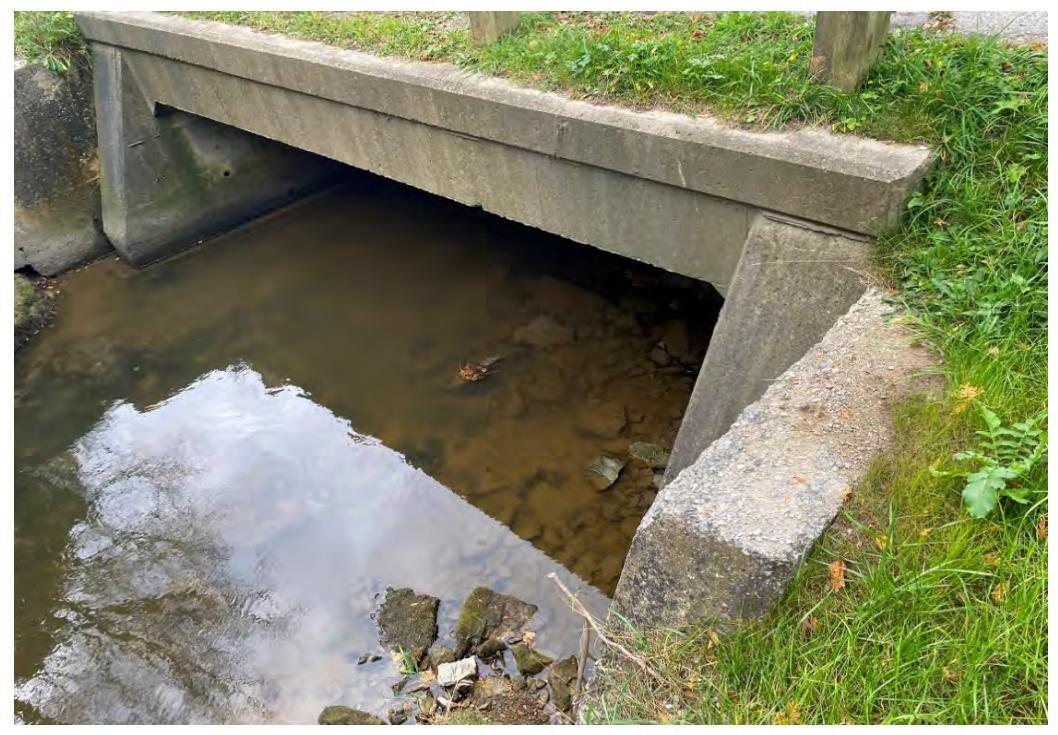
Photo 5-3: View of north structure elevation and streambed

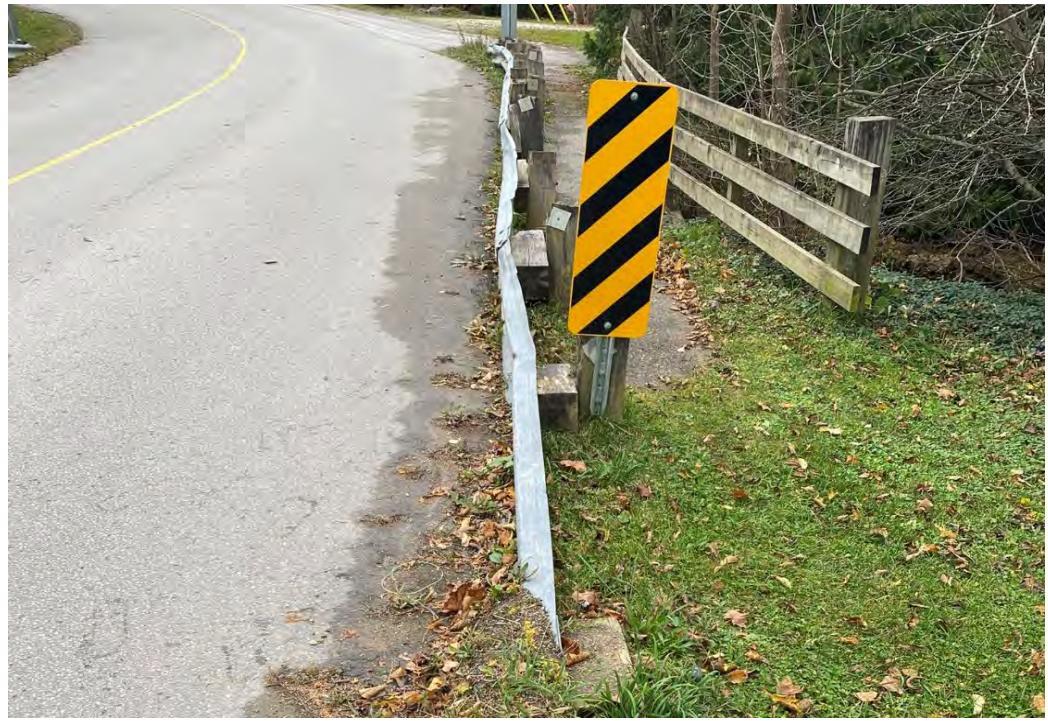
Photo 5-4: View of south barriers

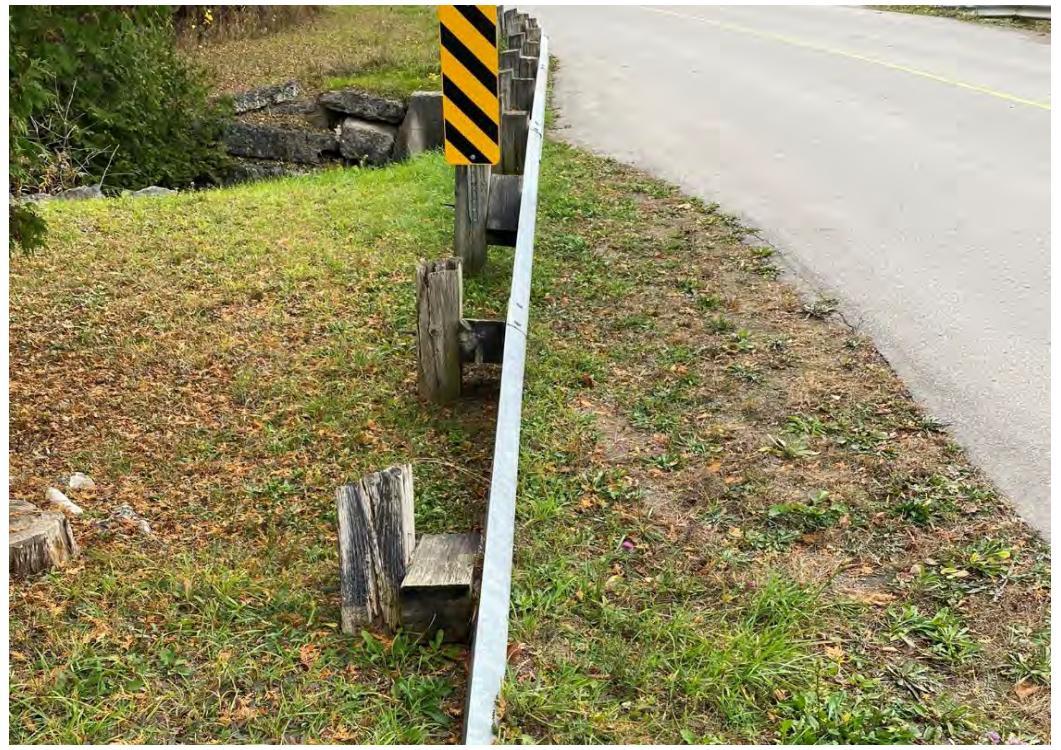
Photo 5-5: View of north barrier

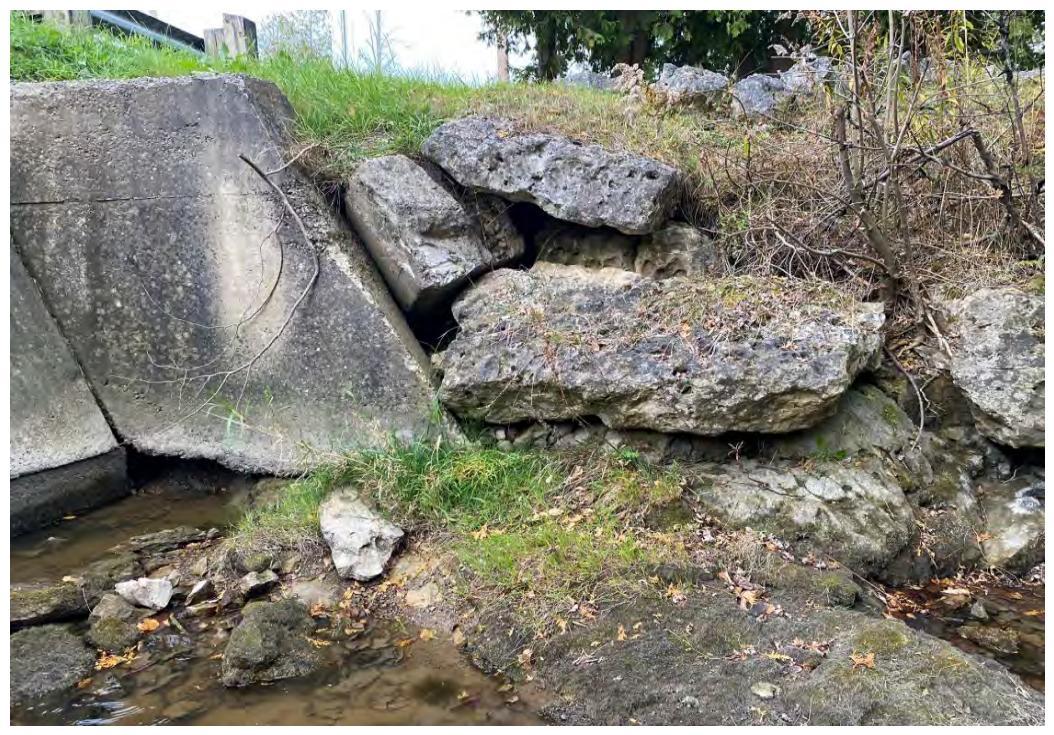
Photo 5-9: View of northwest wingwall and embankment

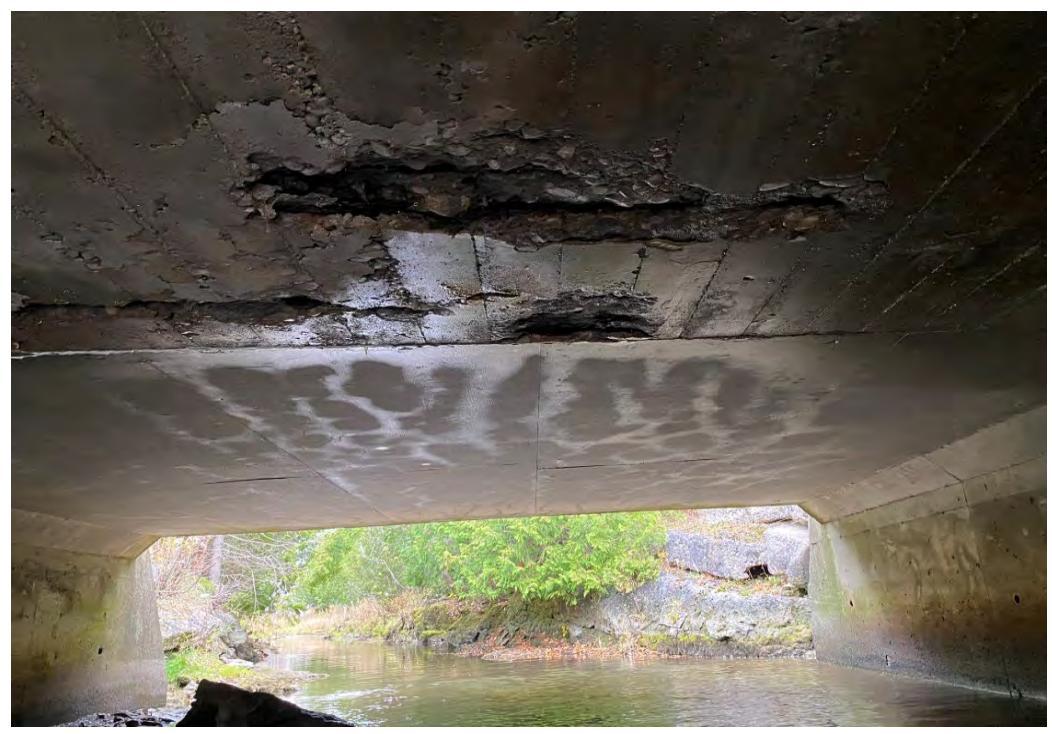
Photo 5-10: View of structure soffit

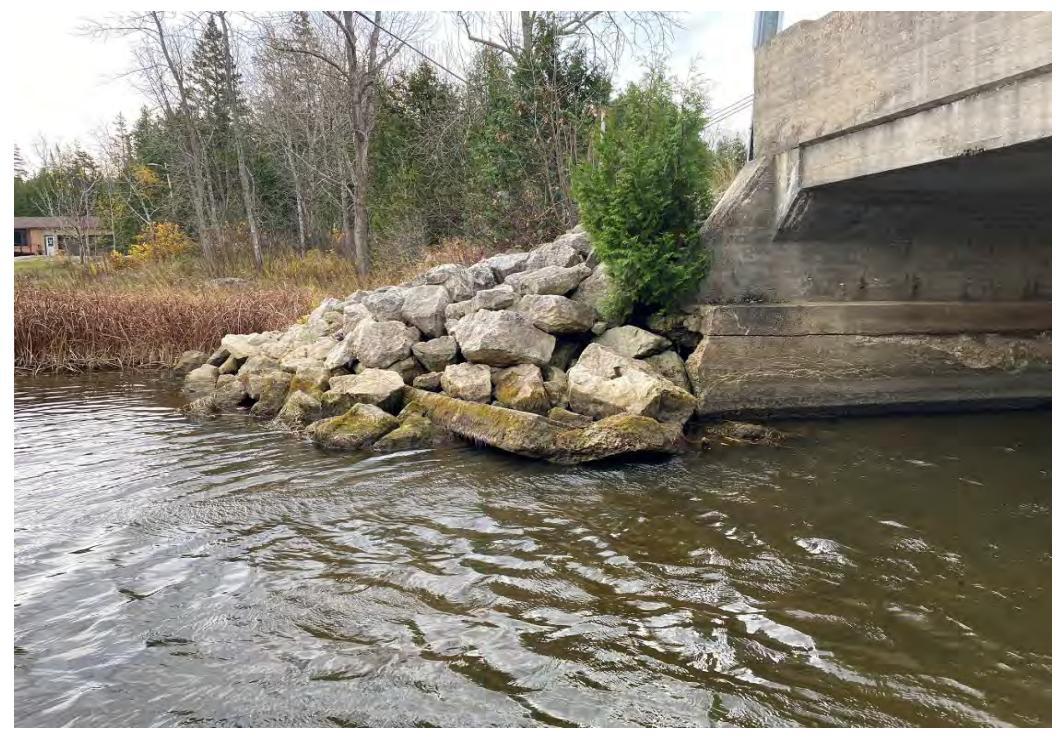
Photo 6-5: View of east structure elevation, south abutment wall and rock protection

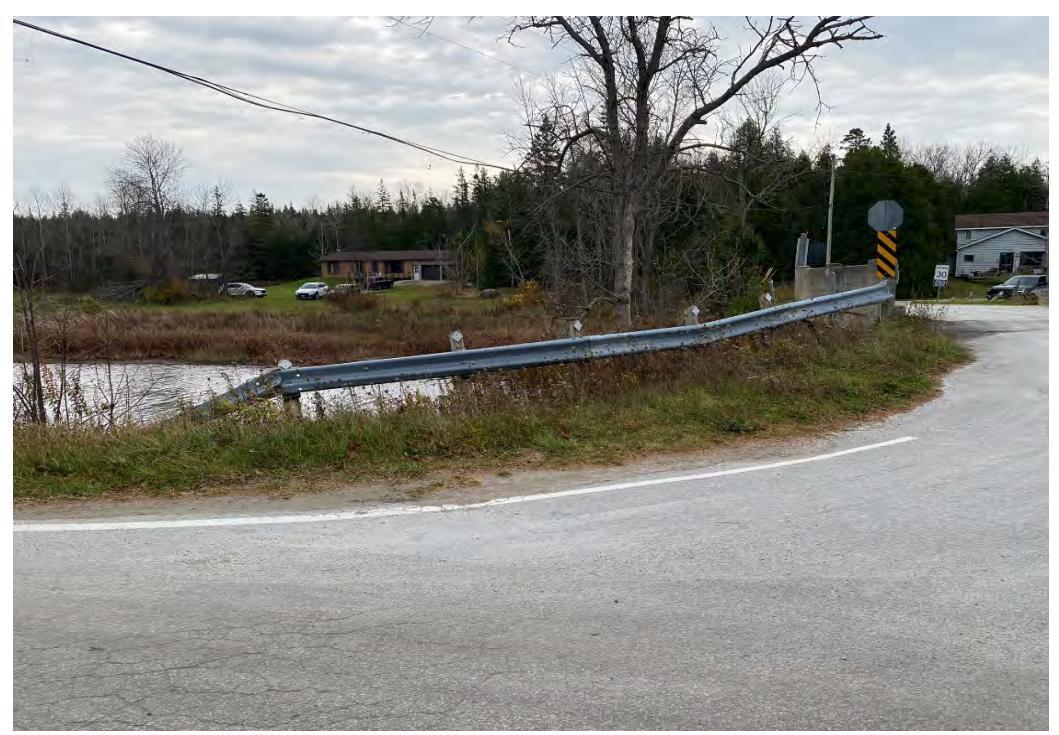
Photo 6-6: View of north approach flex beem and wooden post barrier (typ.)

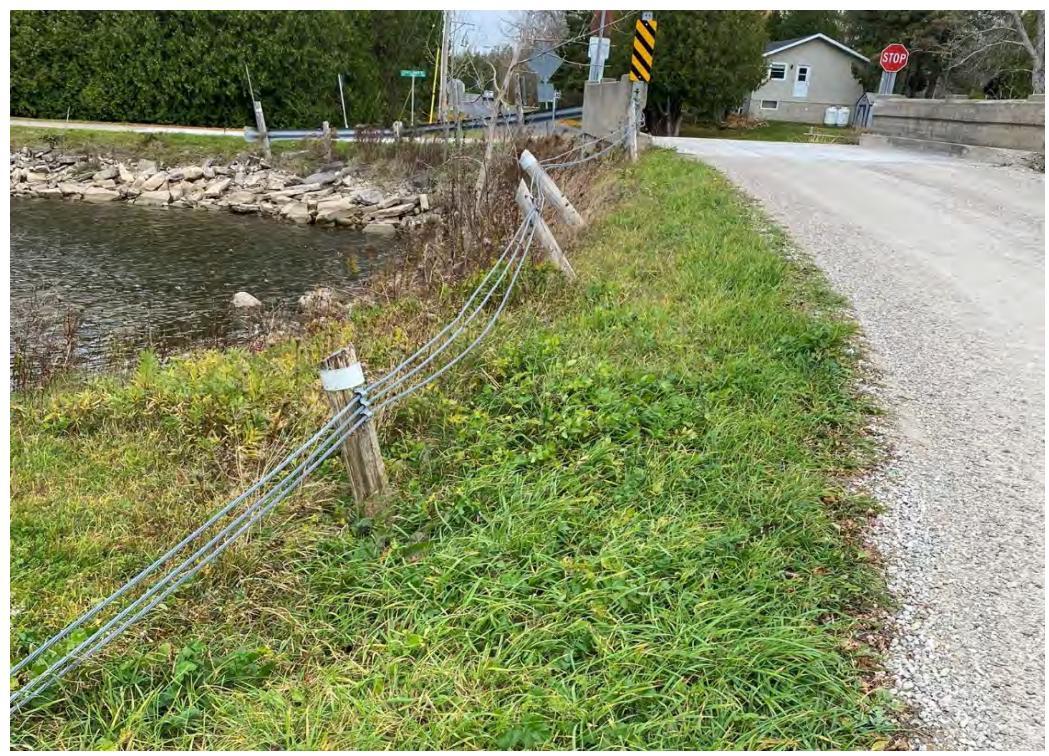
Photo 6-7: View of south approach cable and wooden post barrier (typ.)
