#### MUNICIPALITY OF NORTHERN BRUCE PENINSULA

## 2024 STRUCTURE INSPECTION REPORT

FINAL PROJECT NO.: CA0043256.3165 DATE: MARCH 06, 2025

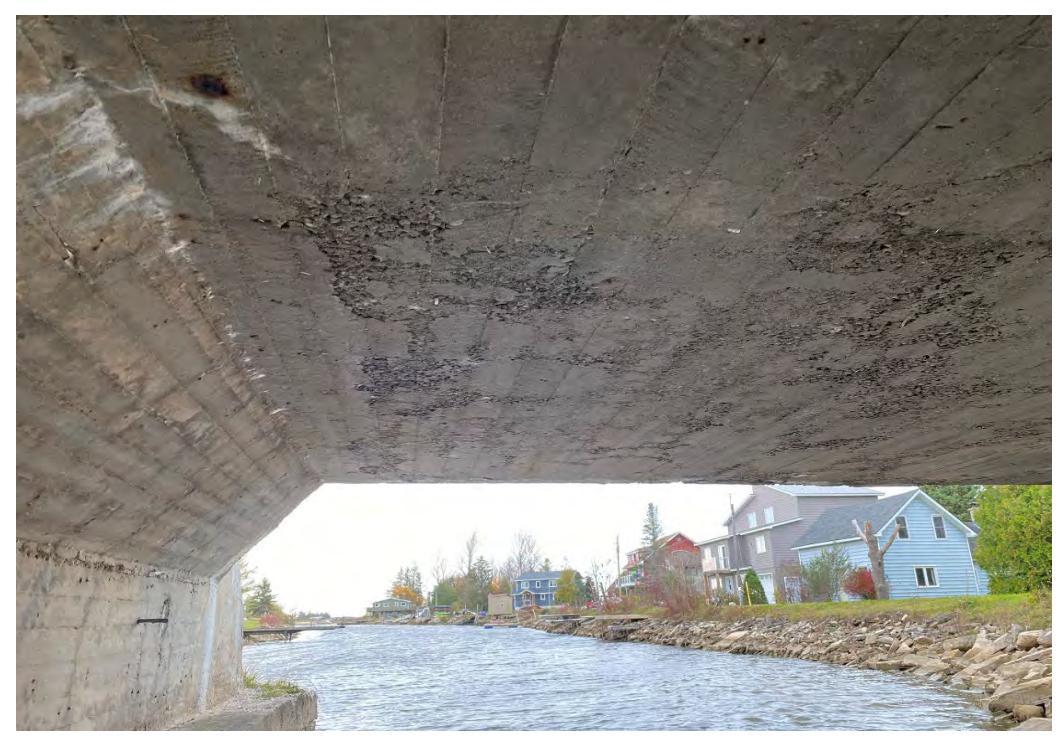
Photo 6-8: View of interior soffit, haunch and upper abutment wall

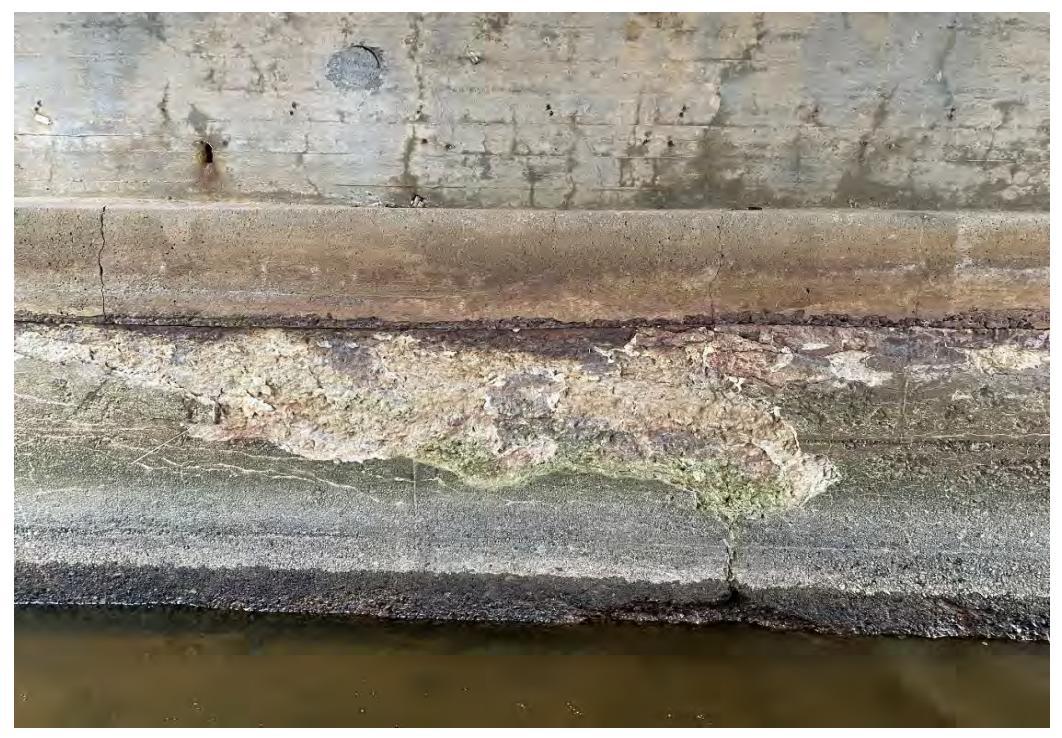
Photo 6-9: View of upper and lower abutment walls

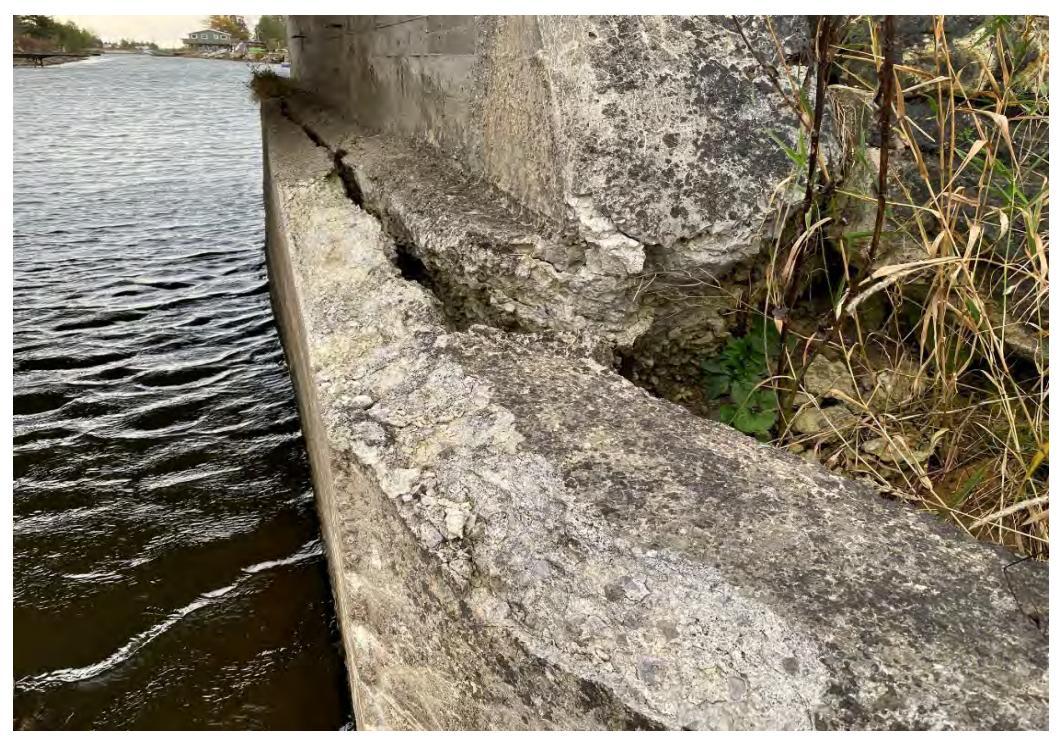
Photo 6-10: View of lower abutment wall separation from upper wall

Element Group:	Abutment	S	Length:					
Element Name:	Abutment W	alls	Width:		7.8			
Location:			Height:		0.64			
Material:	Concrete		Count:			2		
Element Type:	-		Total Quantity:		9.98 m <sup>2</sup>			
Environment:	Moderate	;	Limited Insp'n:					
Protection System:								
Condition Data:	Units	Exc.	Good	Fair	Poor	Perform. Deficiencies	Maint. Needs	
	m²			8.98	1			
Comments:	Surface cracking & mir	nor spalling c	bserved throughout t	he abutment	walls.			
	Remove all poor concr	ete, clean re	inforcing steel, and re	eplace concre	ete.

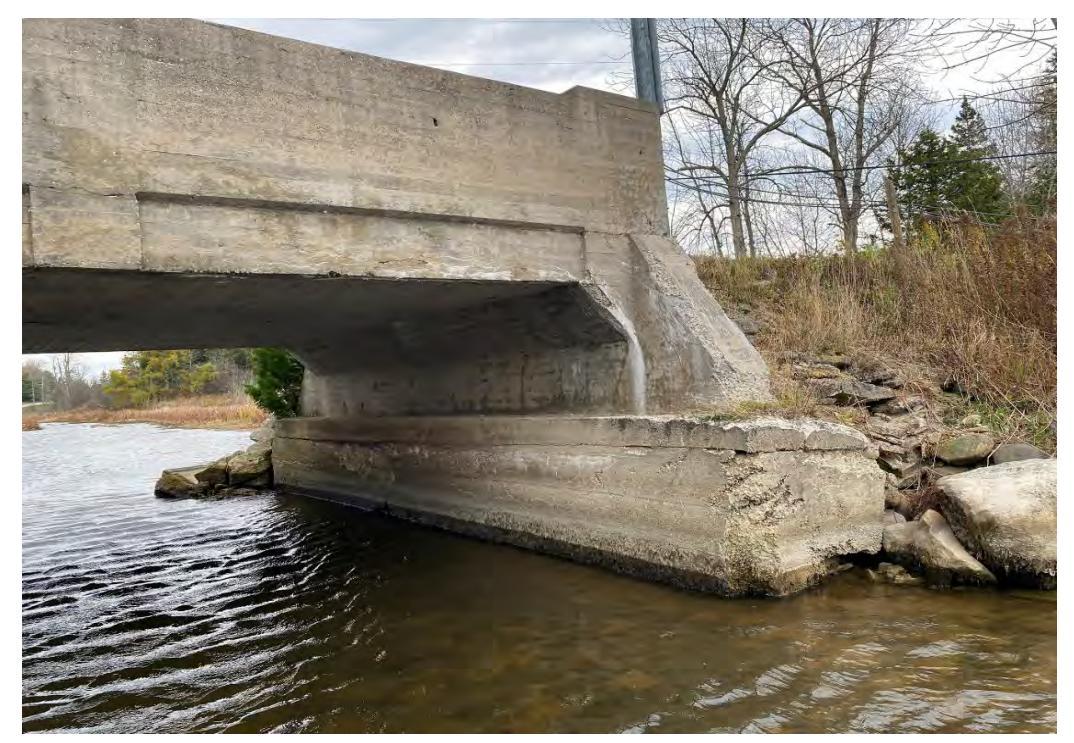
Photo 6-13: View of southwest wing wingwall / abutment wall scour

Element Group:	Abutmen	ts	Length:					
Element Name:	Wingwall	S	Width:	3.05				
Location:			Height:	0.6				
Material:	Concrete	Э	Count:	2				
Element Type:			Total Quantity:	Quantity: 1.83 m <sup>2</sup>				
Environment:	Moderate	Э	Limited Insp'n:	n:				
Protection System:								
Condition Data:	Units	Exc.	Good	Fair	Poor	Perform. Deficiencies	Maint. Needs	
	m <sup>2</sup>				1.83	Yes		
Comments:	The northeast wingwa scour was observed b severely cracked and	he northeast wingwall previously failed and was replaced with rock protection; however, severe scour was observed behind the rock protection and abutment wall/footing. The northwest wingwall i severely cracked and separating from the abutment wall connection.						
Recommended Wo	<b>fork:</b> None 6-10 Years 1-5 Years < 1 Year Urgent Monitor inlet conditions frequently. Replace wingwalls or place rock protection to prevent further scour/undercutting of abutment wall/footings.						ırther

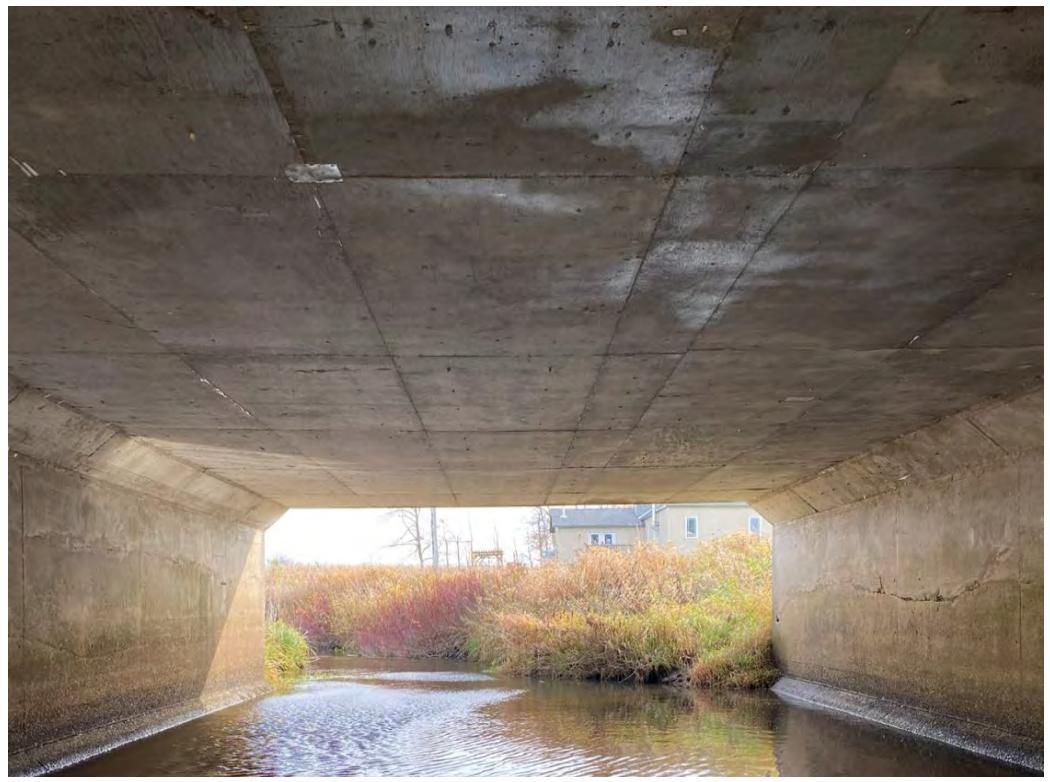
Photo 7-7: View of soffit and abutment wall

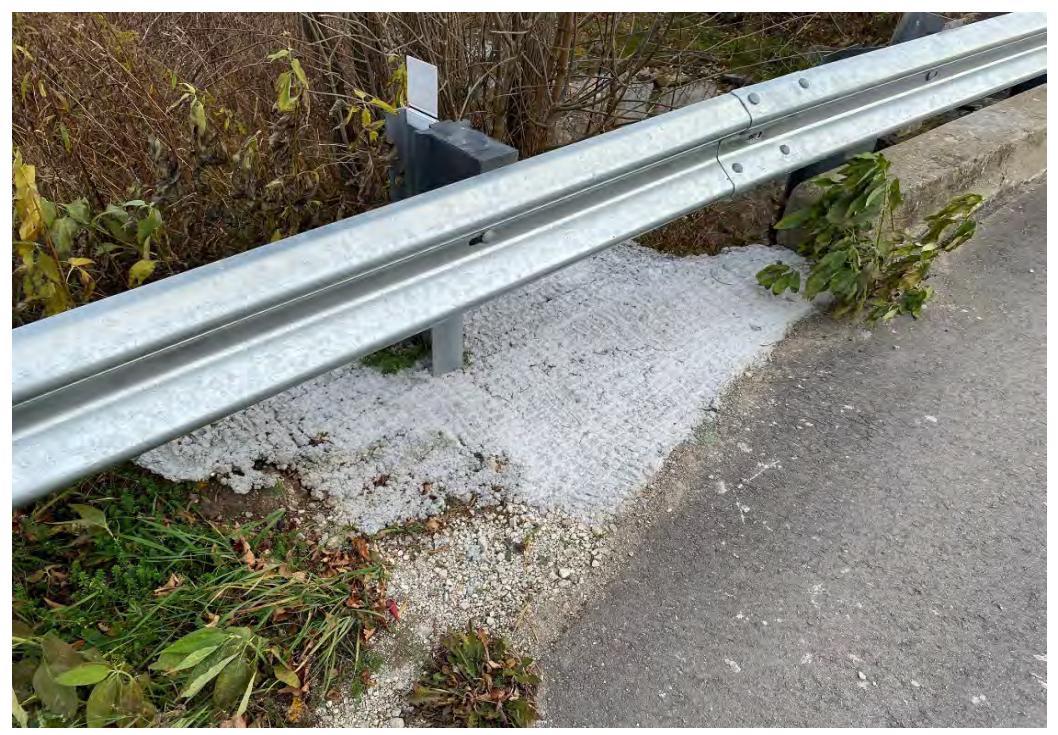
Photo 8-4: View of concrete spillway/slope protection

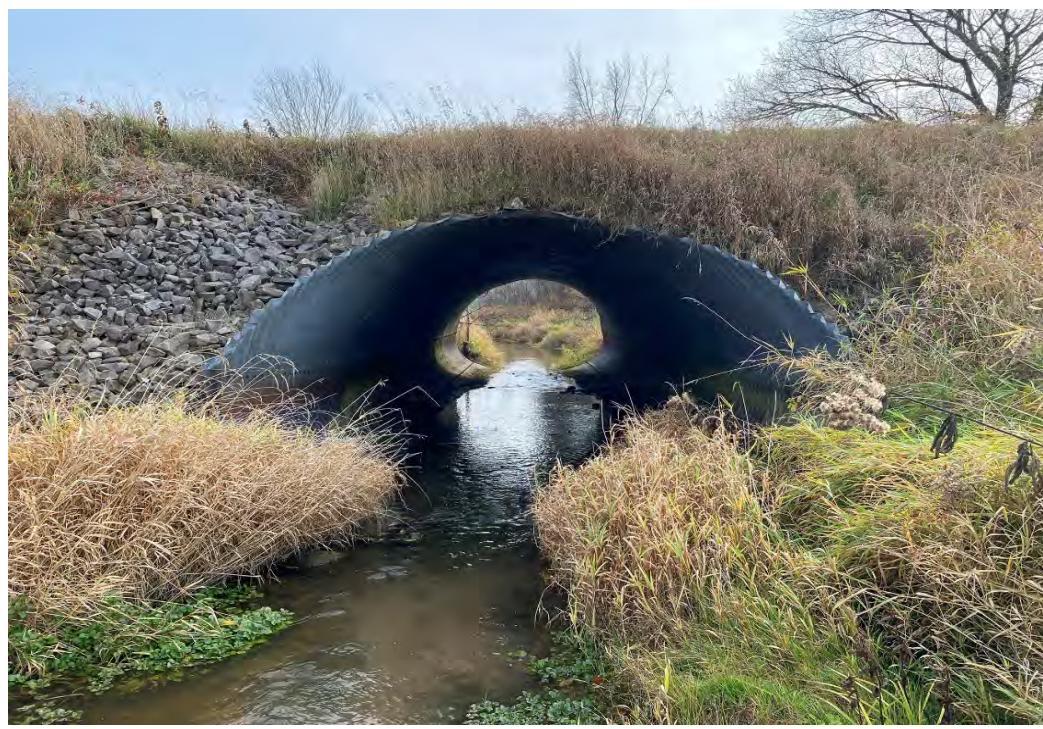
Photo 10-4: View of upstream elevation and slope protection

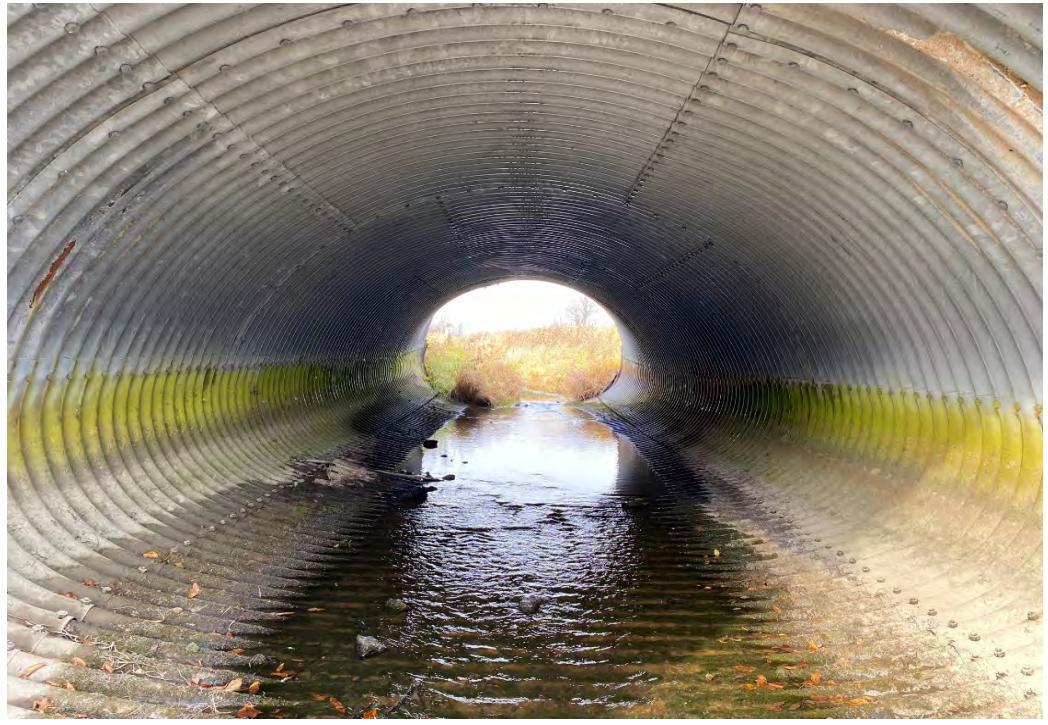
Photo 10-5: View of culvert barrel

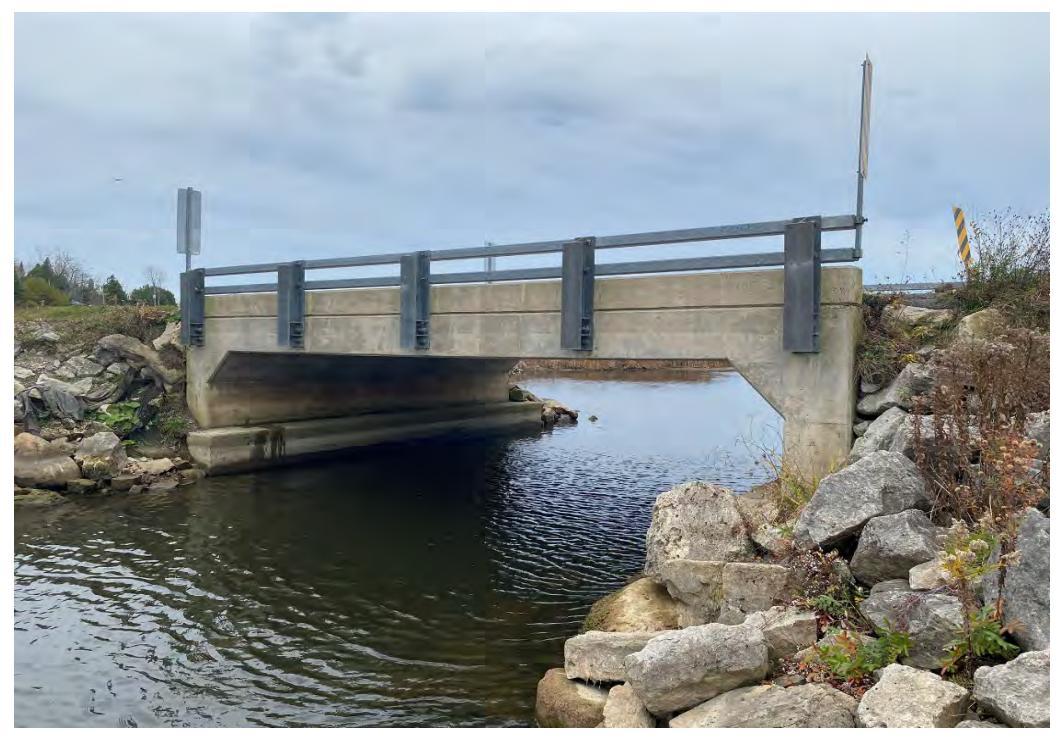
Photo 11-2: View of east structure elevation

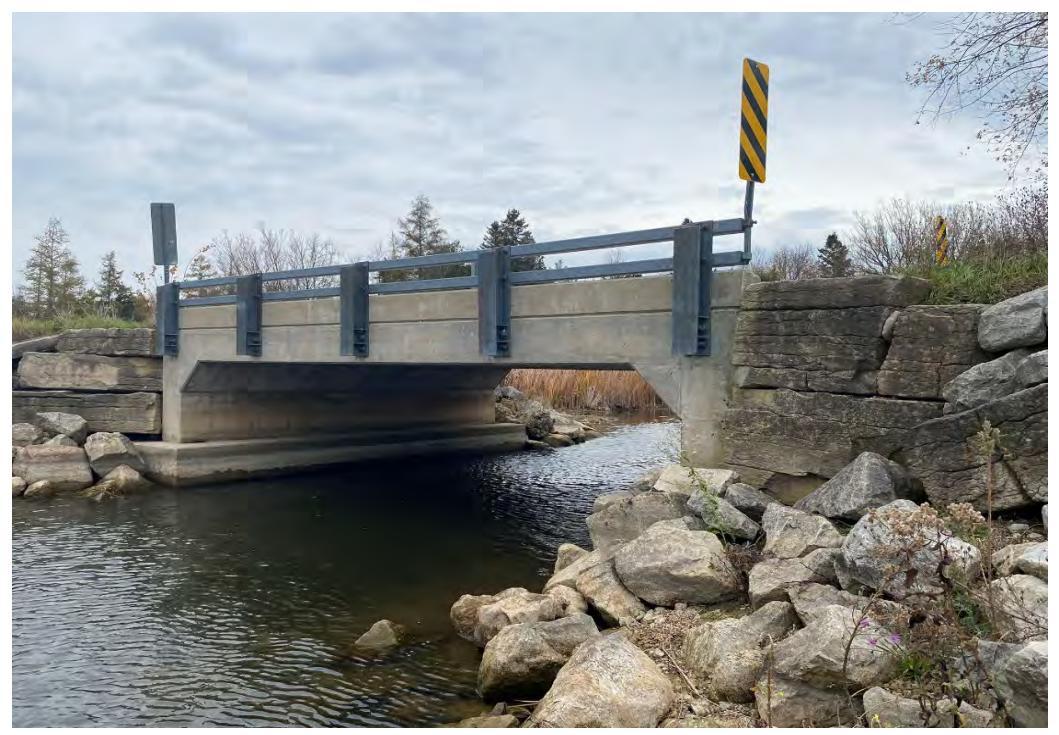
Photo 11-3: View of west structure elevation

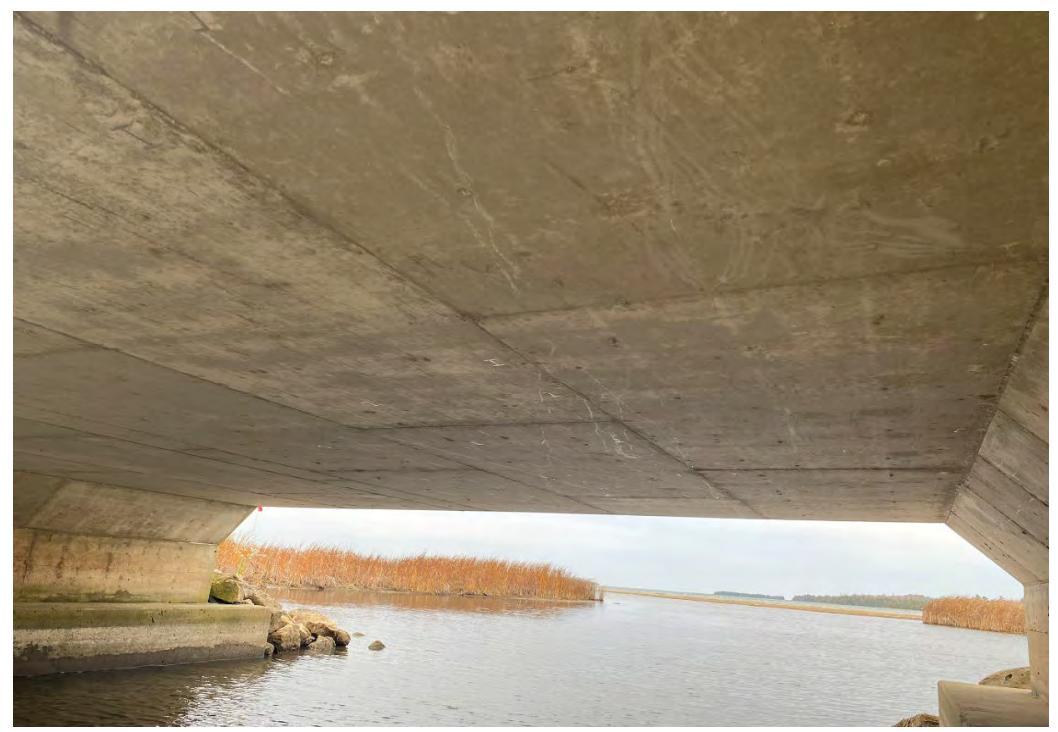
11-4: View of structure soffit

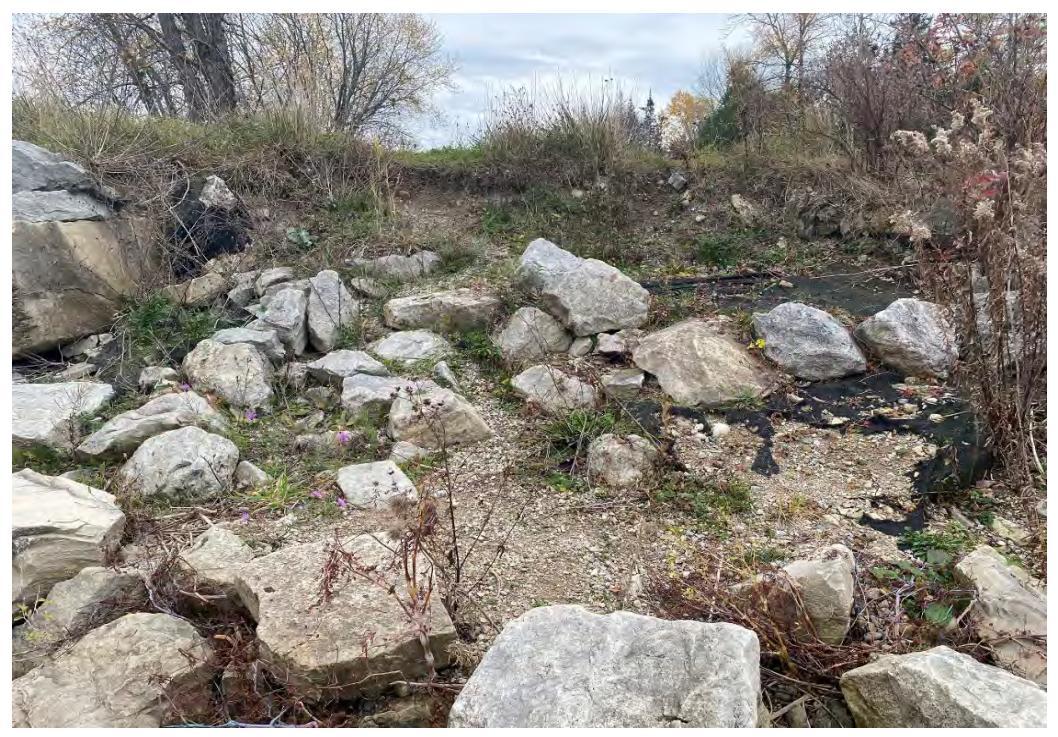
11-5: View of embankment erosion

Element Group:	Embankments	& Streams	Length:				
Element Name:	Embankn	nents	Width:				
Location:			Height:				
Material:	Earth / Stone		Count:			4	
Element Type:			Total Quantity:			4	
Environment:	Moderate		Limited Insp'n:				
Protection System:							
Condition Data:	Units	Exc.	Good	Fair	Poor	Perform. Deficiencies	Maint. Needs
	Each			2	2	Yes	Yes
Comments: Recommended Wo	The slopes are made u quadrants. <b>rk:</b> None Repair crossion and pla	6-10 Years	getated earth. Mile	d to severe	erosion obs Urgent	served at all fou	
	Repair erosion and pla	ice additional slop	e protection where	e required.

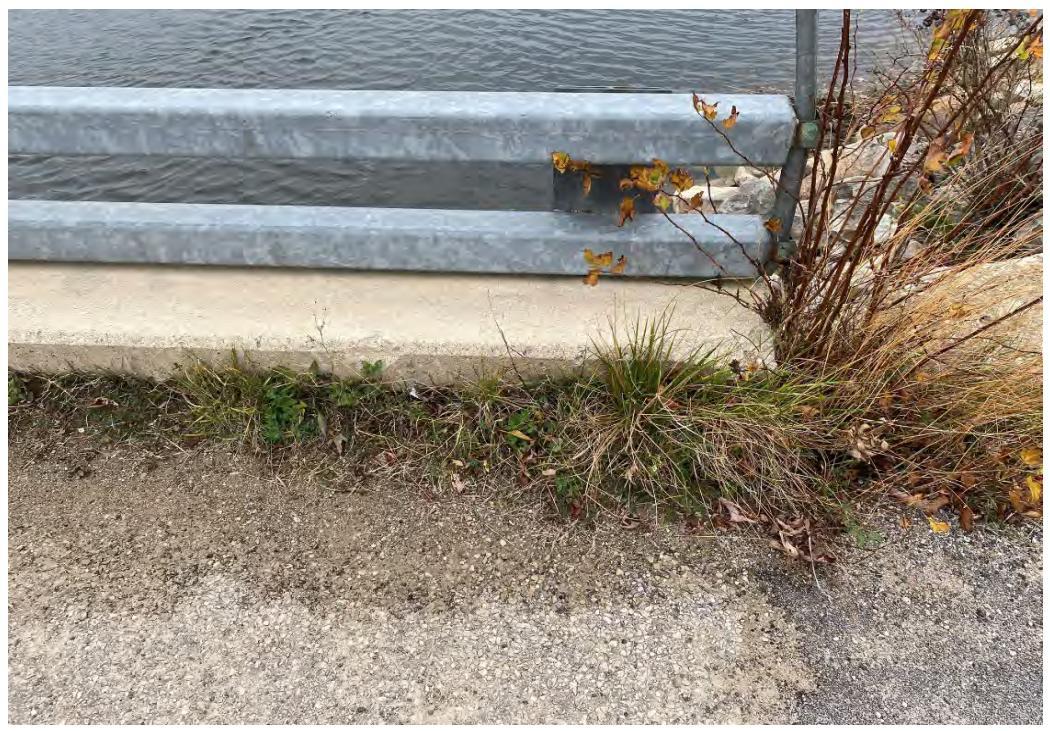
11-6: View of sand and vegetation build-up along curb (typ.)

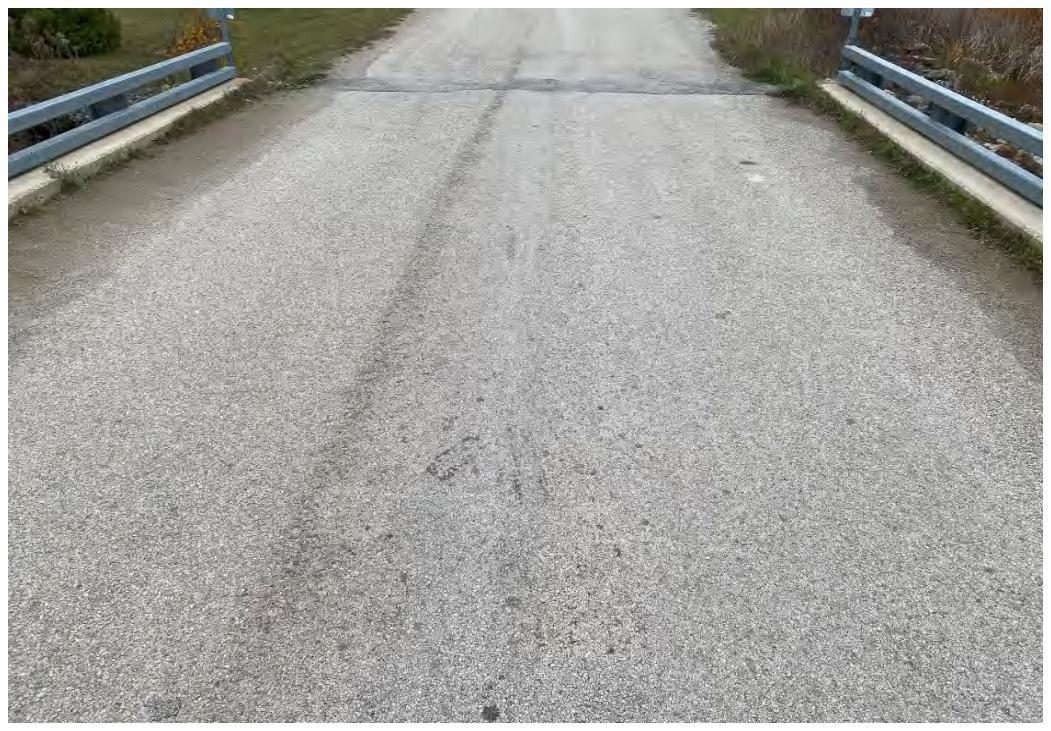
11-7: View of structure wearing surface and approach patching

Element Group:	Approach	es	Length:				
Element Name:	Wearing Sur	face	Width:				
Location:			Height:				
Material:	Surface Treatment 0		Count:				
Element Type:	Тс		Total Quantity:				
Environment:	Moderate	Moderate L					
Protection System:							
Condition Data:	Units	Exc.	Good	Fair	Poor	Perform. Deficiencies	Maint. Needs
	%			100		Yes	Yes
Comments:	The approach wearing surface is surface treatment in fair condition. Differential settlement observed at each approach with multiple layers of cold patch visible.						
Recommended Work: None 6-10 Years Monitor settlement and continue to pa and approaches.		1-5 Years atch as required.	< 1 Year Consider re	Urgent placing roa	ad base and pa	iving deck

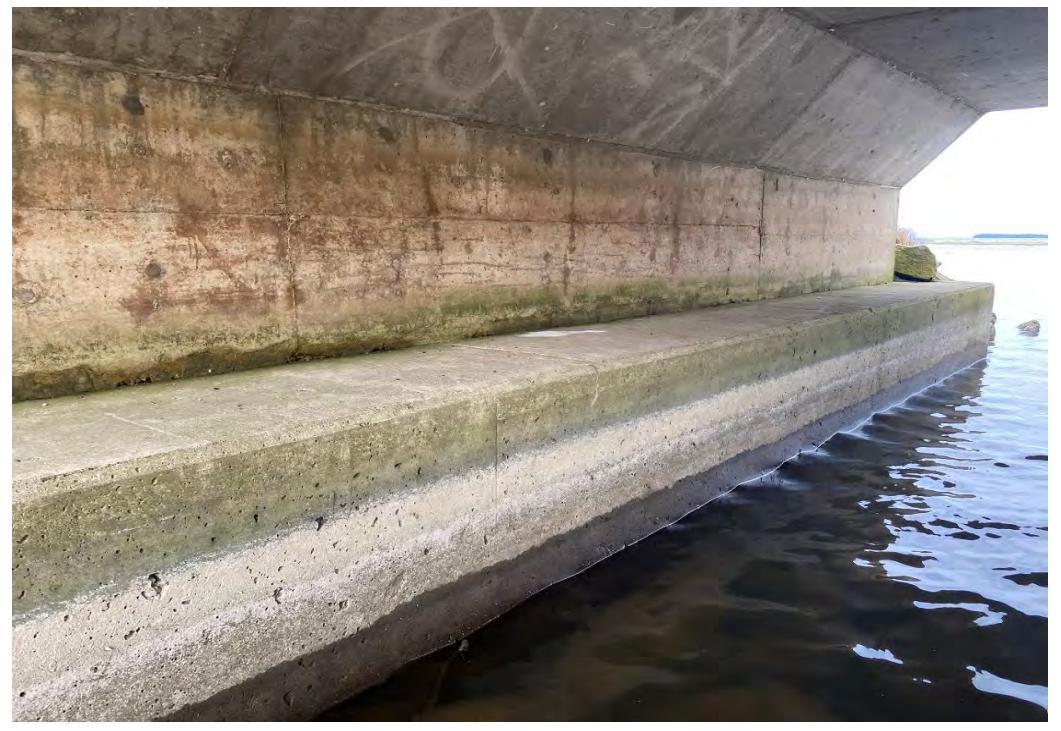
11-9: View of abutment wall and footing

Element Group:	Foundat	ions	Length:				
Element Name:	Foundation (below	r ground level)	Width:				
Location:			Height:				
Material:	Concre	ete	Count:				
Element Type:			Total Quantity:				
Environment:	Moderate		Limited Insp'n:			Yes	
Protection System:							
Condition Data:	Linits	Evo	Good	Fair	Poor	Perform.	Maint.
	Offits	EXC.	Guu		FUUI	Deficiencies	Needs
	%		100			Yes	Yes
Comments:	Limited inspection due	to water level. Ex	posed portions of	the footings	are in goo	d condition.	
	Previous inspection co	mments: I he south	h footings appear	stable and a	are well pro	tected. The nor	theast
	footing appears stable	, but is poorly prote	ected. The northw	est footing is	s heavily ui	ndermined and	poorly
	protected.						
Recommended Wo	rk: None	6-10 Years	1-5 Years	< 1 Year	Urgent		
	None based on curren	t inspection.		-			
	Previous inspection re	commendation: Ur	nderpin and stabili	ize northwes	t footing ar	nd provide more	rip-rap

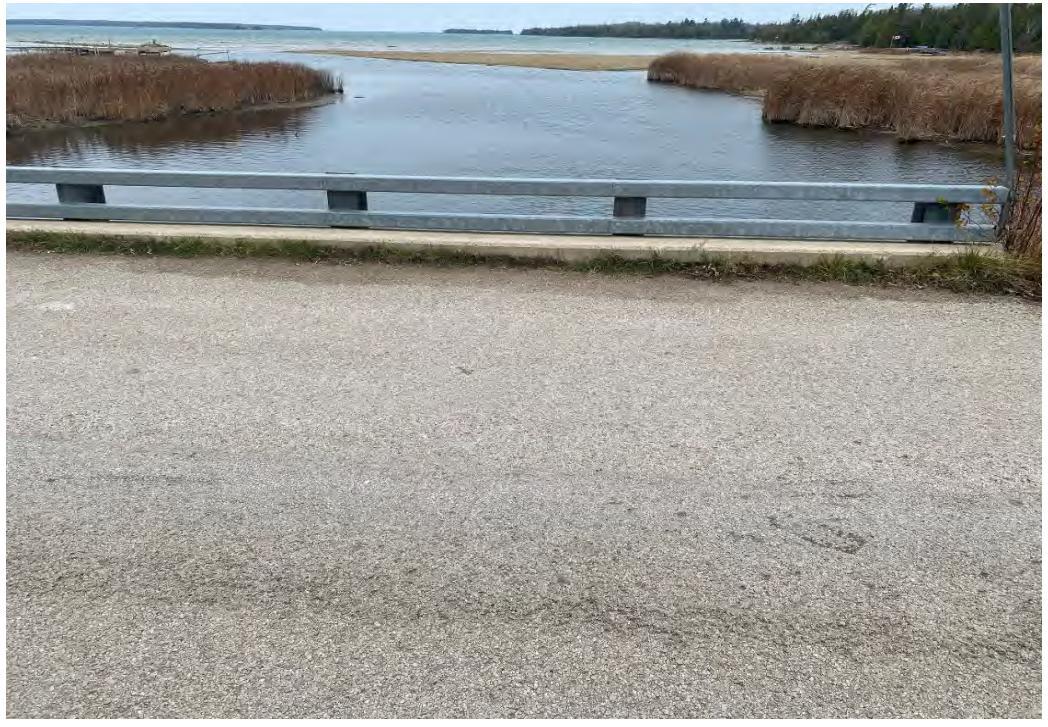
11-10: View of watercourse downstream, barrier and curb

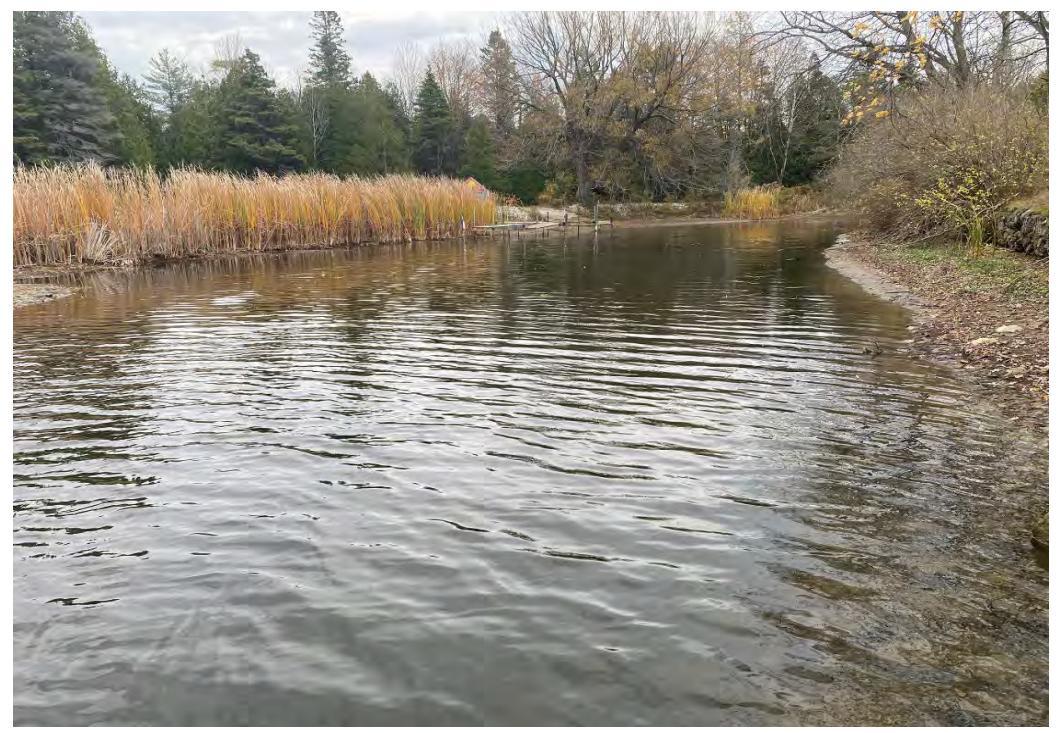
11-11: View of watercourse upstream

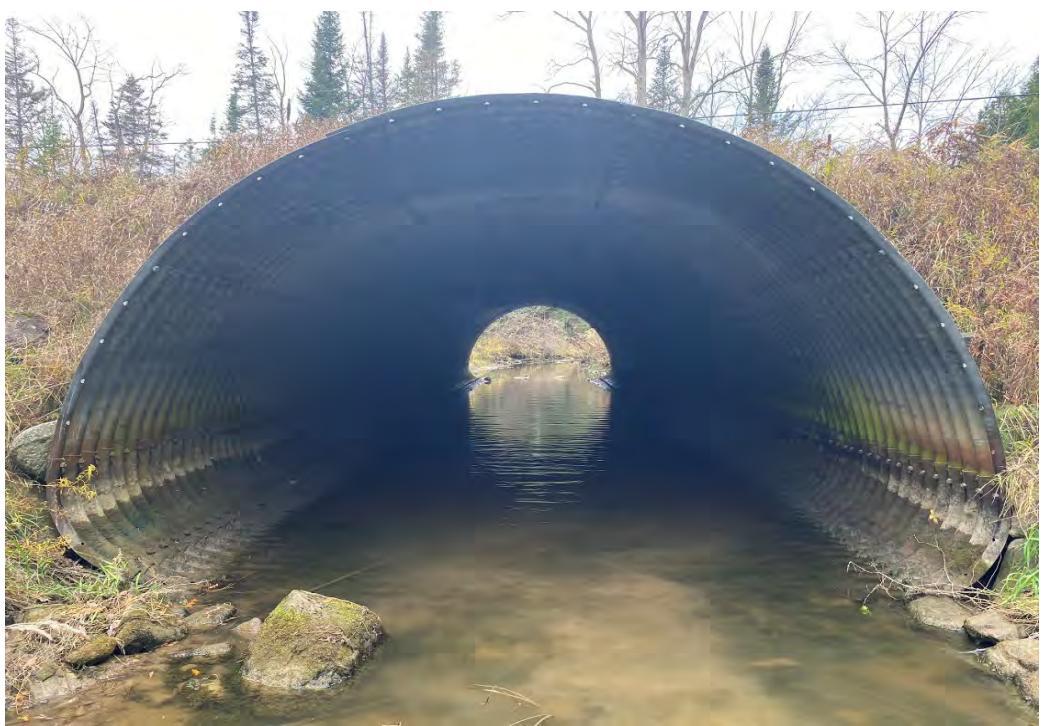
Photo 12-2: View of culvert inlet

Element Group:	Culverts		Length:					
Element Name:	Inlet Compor	nent	Width:					
Location:	East End		Height:					
Material:	Stone and E	arth	Count:					
Element Type:			Total Quantity:					
Environment:	Moderate	•	Limited Insp'n:					
Protection System:			None	9				
Condition Data:	Units	Exc.	Good	Fair	Poor	Perform. Deficiencies	Maint. Needs	
	%		75	25		Yes	Yes	
Comments: Heavily vegetated embankments with rock protection appear stable; however, some of the rock protection appears to have failed and fallen into the streambed. Moderate scour of the upstream embankments occurring.								
Recommended Work:   None   6-10 Years   1-5 Years   < 1 Year   Urgent     Repair scour by replacing and/or placing additional rock protection to prevent additional scour.						cour.

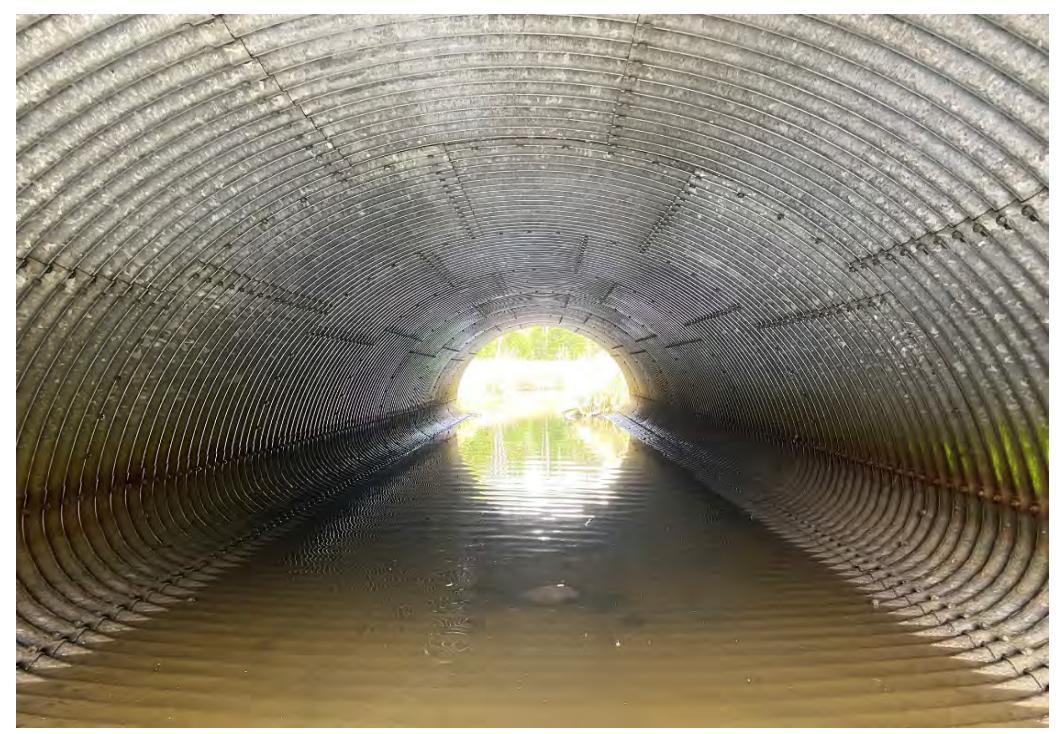
Photo 12-3: View of culvert barrel

Element Group:	Culvert		Length:					
Element Name:	Barrel		Width:					
Location:			Height:					
Material:	Steel		Count:					
Element Type:	Pipe Arch		Total Quantity:					
Environment:	Moderate	Limited Insp'n:						
Protection System:	Galvanized							
Condition Data:	Units	Exc.	Good	Fair	Poor	Perform. Deficiencies	Maint. Needs	
	%		40	40	20	Yes		
Comments: Deformations visible at the obvert. Corrosion and swelling observed in the haunches near the high water level. Minor to moderate section loss observed.   Recommended Work: None 6-10 Years 1-5 Years < 1 Year								
Monitor the deformations and section loss.

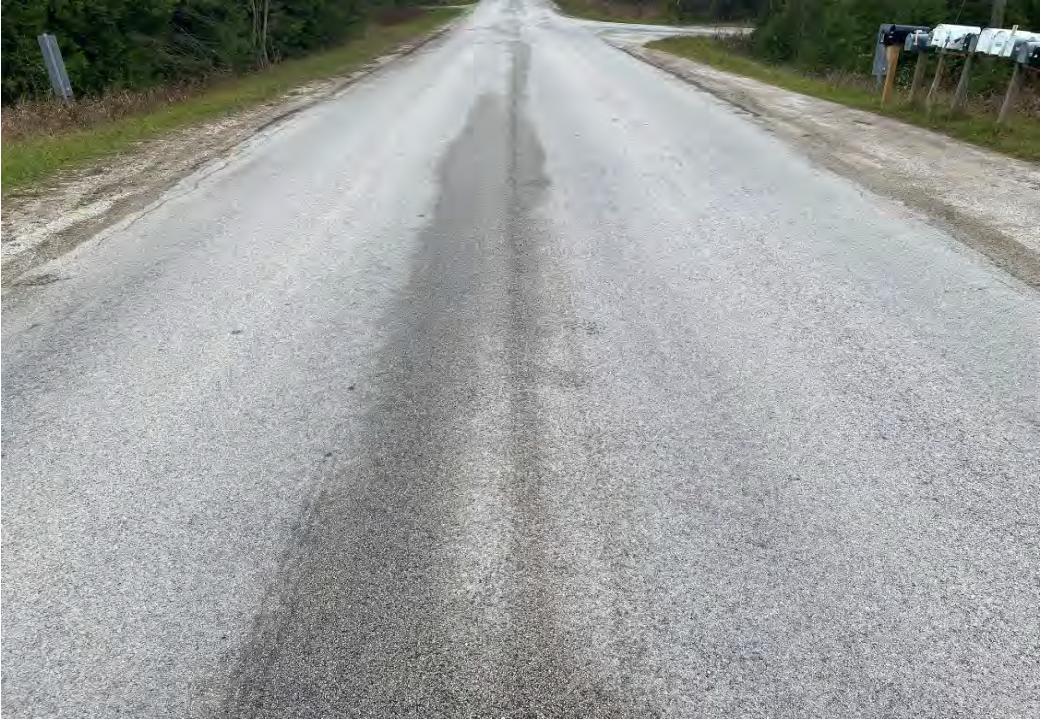
Photo 12-4: View of surface treatment wearing surface

Element Group:	Decks		Length:				
Element Name:	Wearing Surf	face	Width:				
Location:			Height:				
Material:	Surface Treatment C		Count:				
Element Type:	Т		Total Quantity:				
Environment:	Severe		Limited Insp'n:				
Protection System:			None	9			
Condition Data:	Units	Exc.	Good	Fair	Poor	Perform. Deficiencies	Maint. Needs
	%			75	25		
Comments: The surface treatment wearing surface is relatively fair condition with minor settlement, wheel path rutting observed, and cracking along the shoulders.   Recommended Work: None							
Replace the surface treatment with r			oad resurfacing.

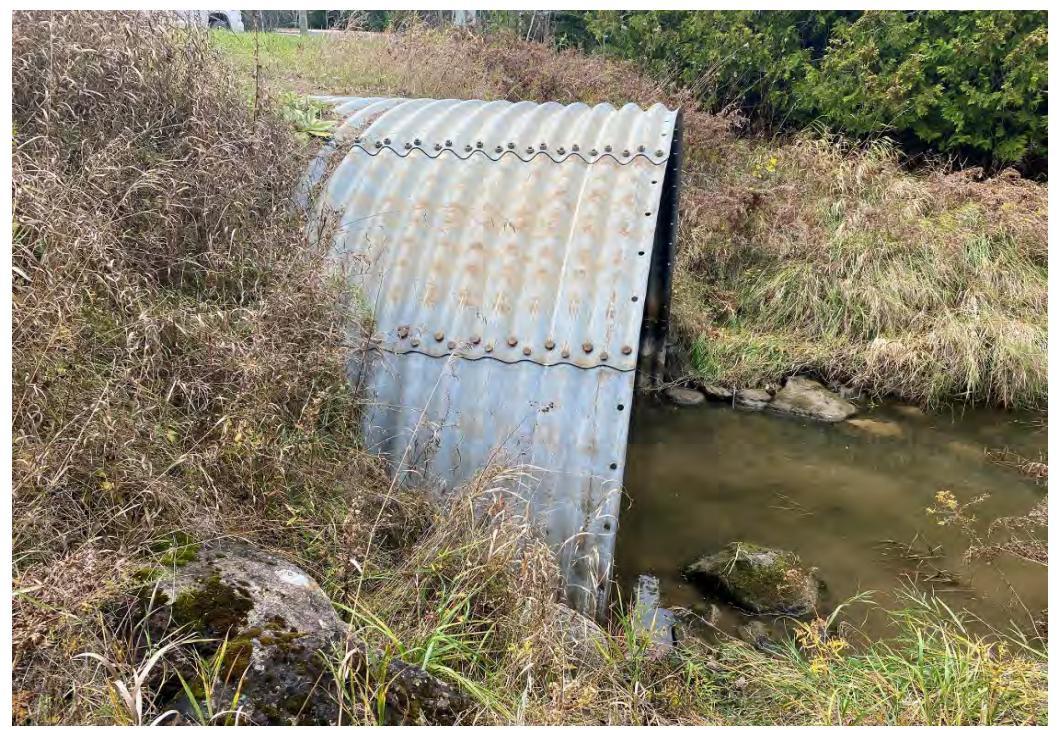
Photo 12-7: View of culvert inlet end

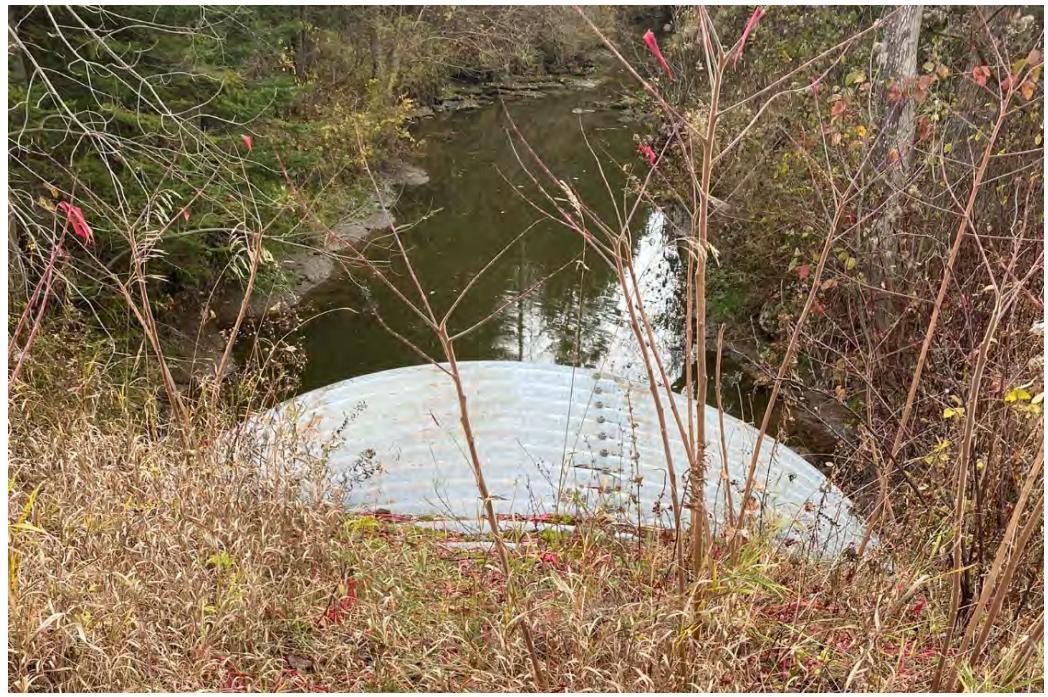
Photo 12-8: View of downstream culvert end and watercourse

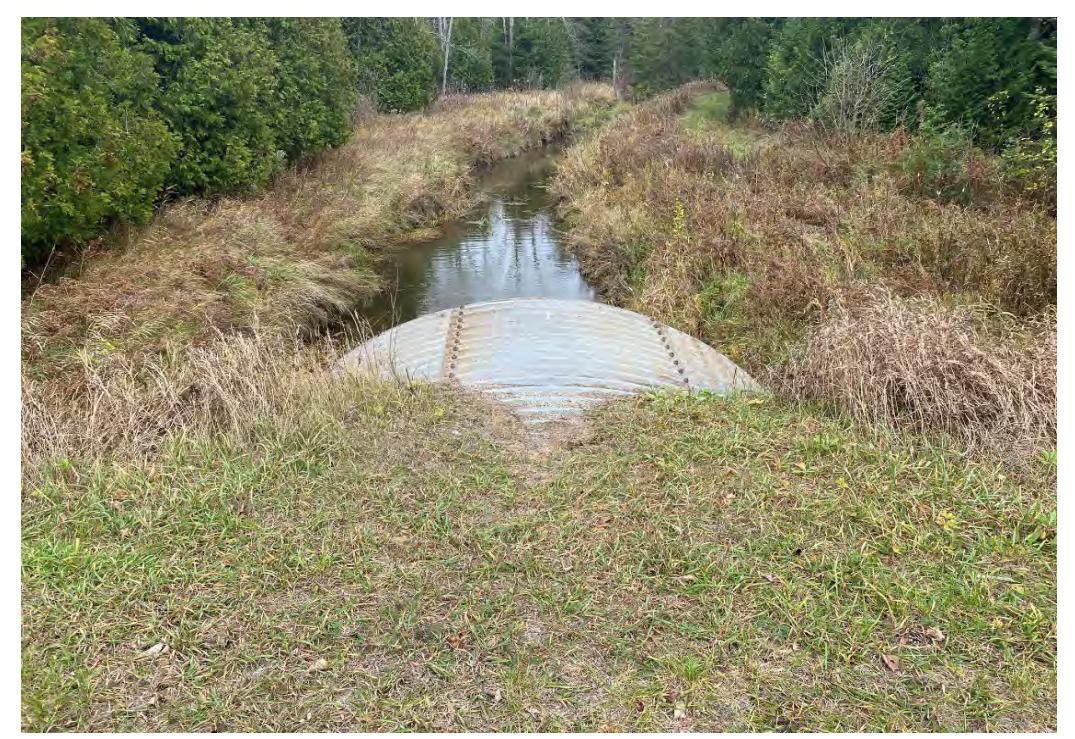
Photo 12-9: View of upstream culvert end and watercourse

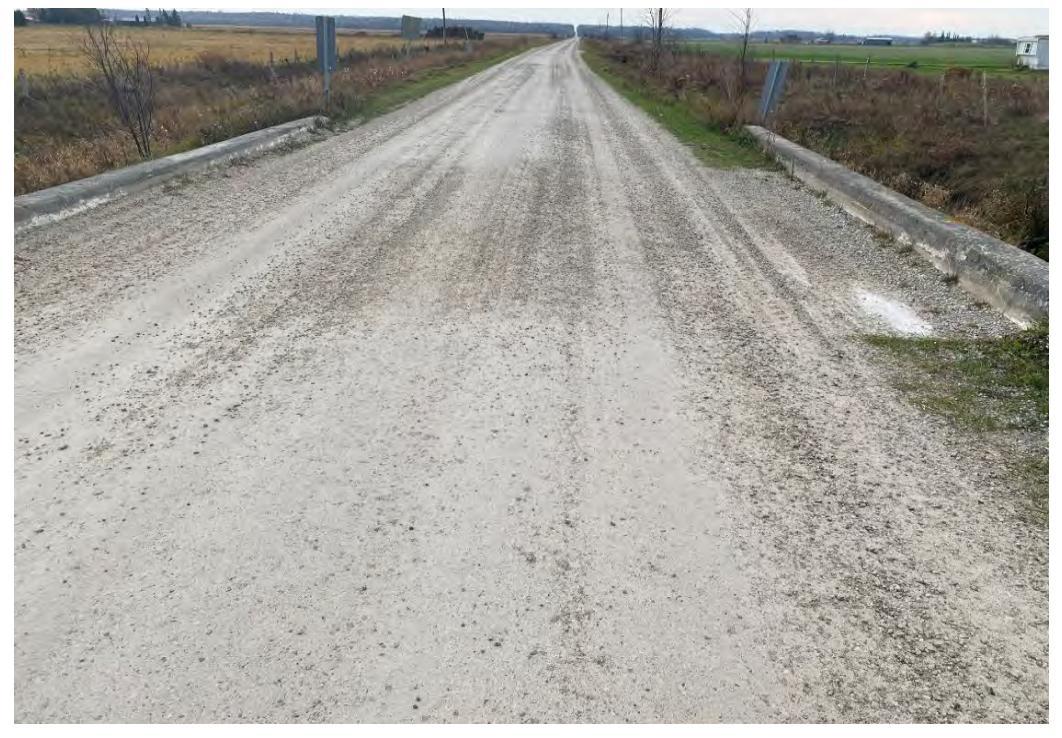
Photo 13-2: View of wearing surface

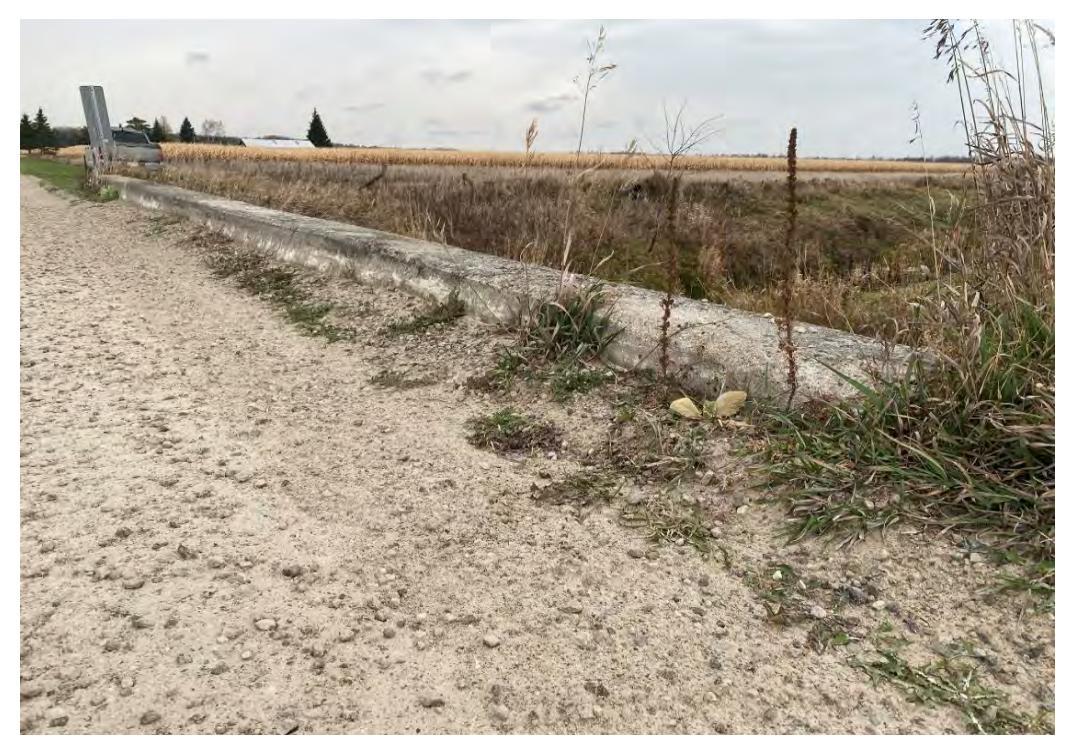
Photo 13-3: View of curb

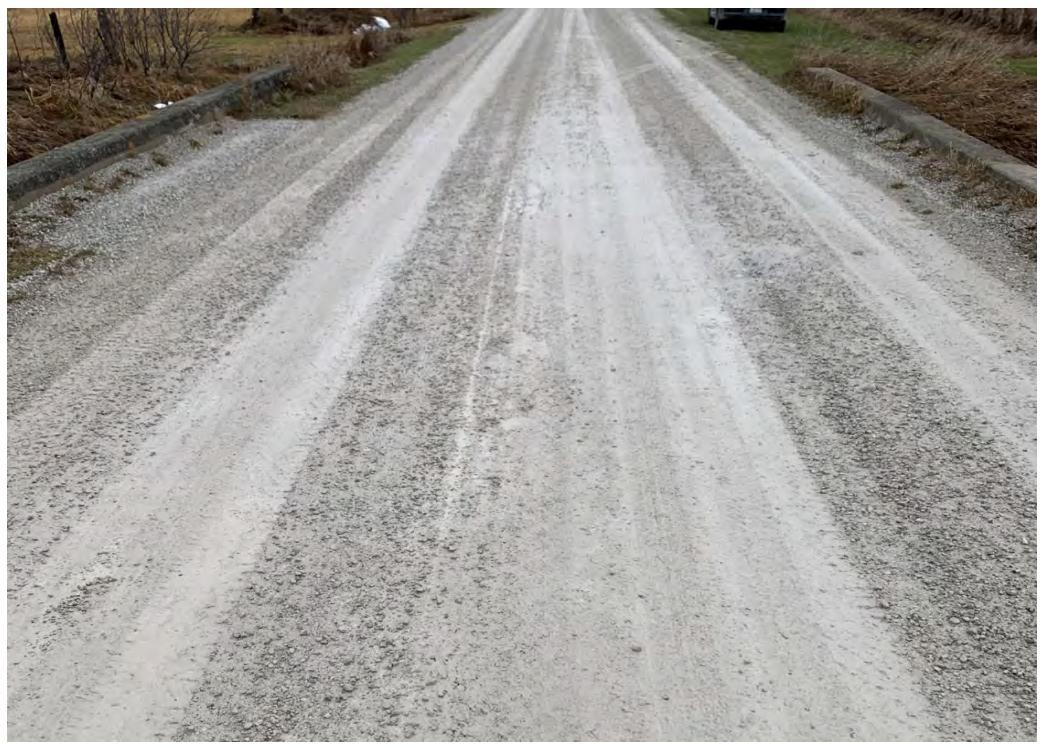
Photo 13-4: View of approach and structure wearing surface

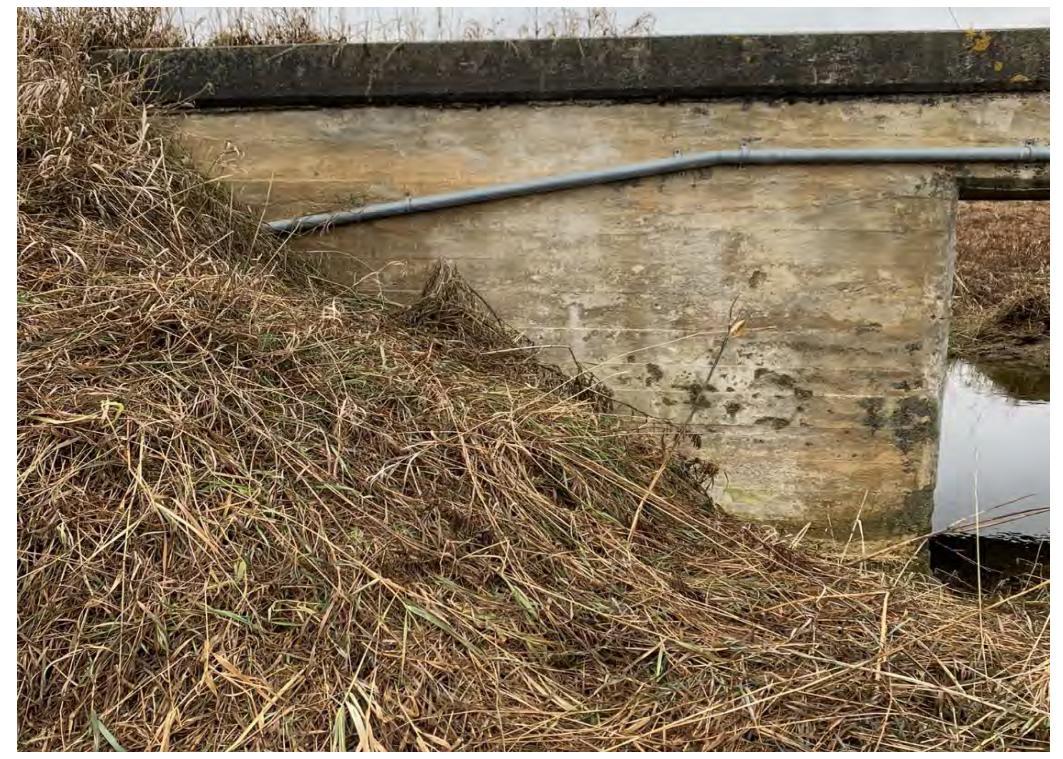
Photo 13-5: View of southwest structure wingwall
