#### MUNICIPALITY OF NORTHERN BRUCE PENINSULA

## 2024 STRUCTURE INSPECTION REPORT

FINAL PROJECT NO.: CA0043256.3165 DATE: MARCH 06, 2025

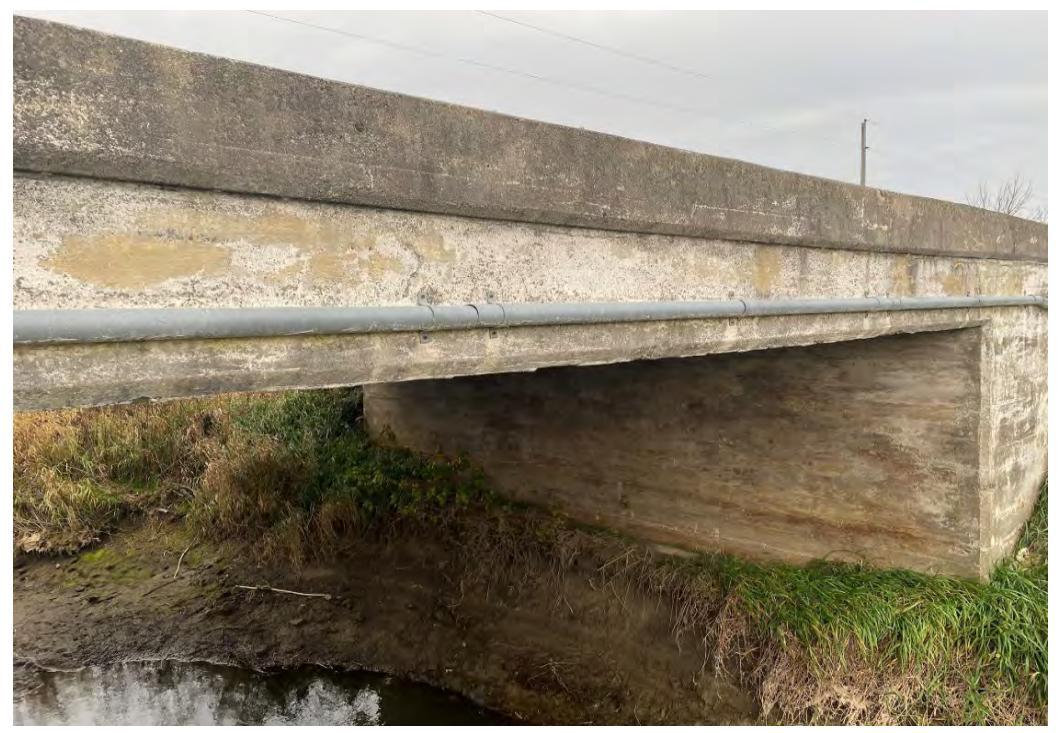
Photo 13-6: View of east structure elevation, exterior soffit and abutment wall

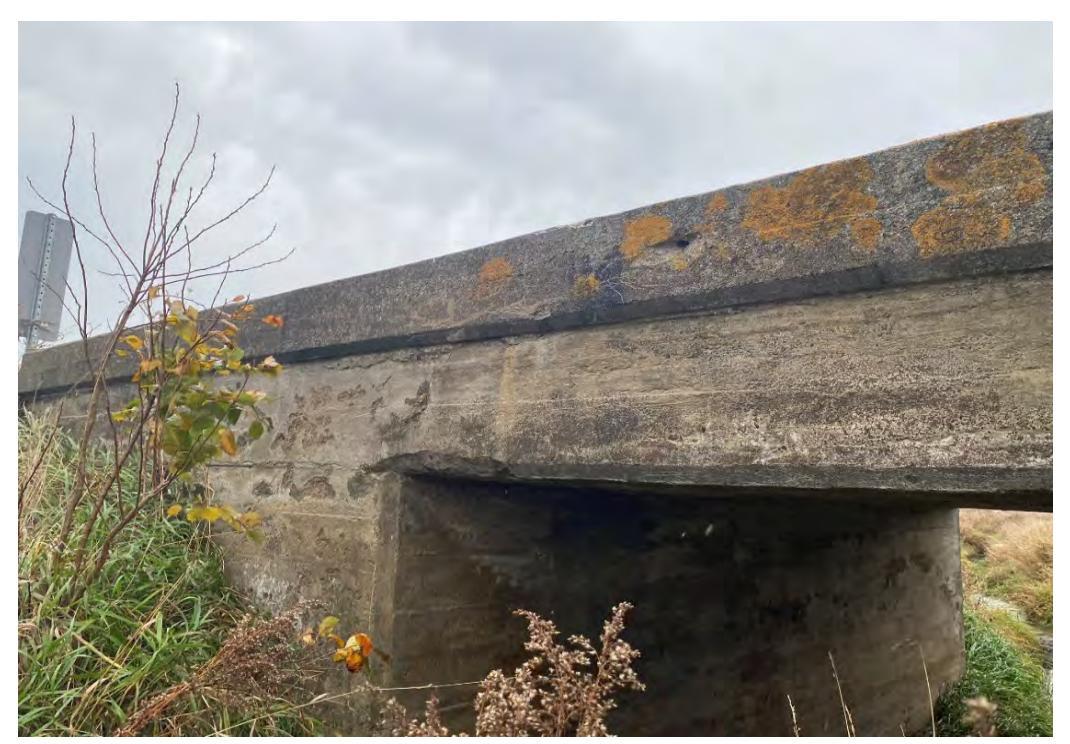
Photo 13-7: View of west structure elevation, exterior soffit and curb

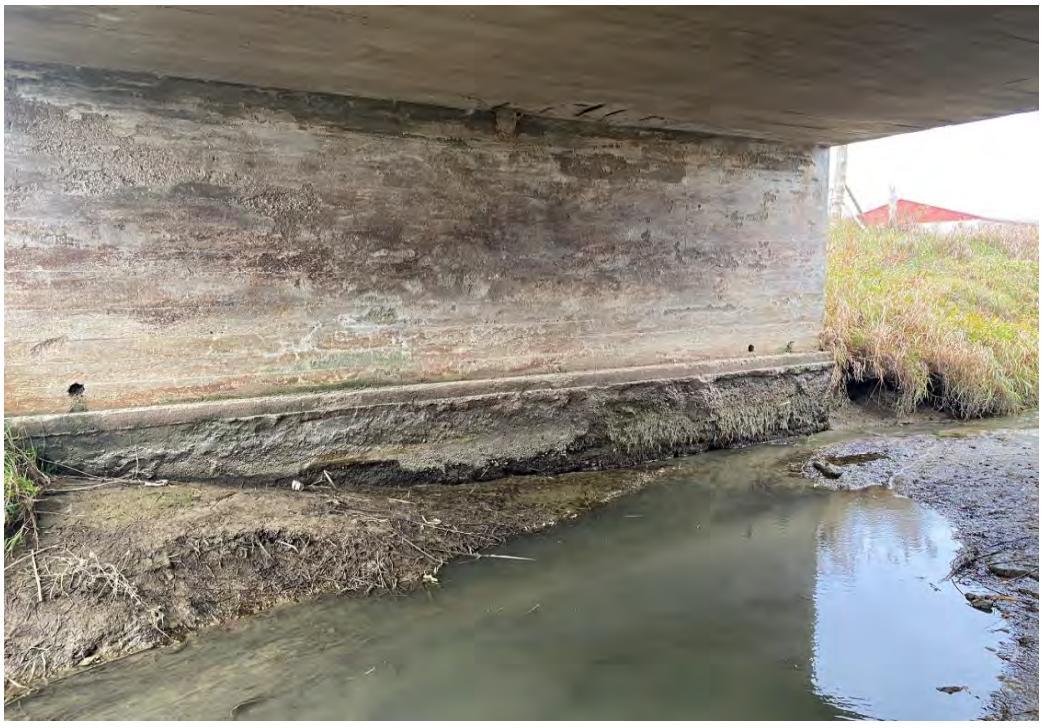
Photo 13-8: View of abutment wall, exposed footing and soffit

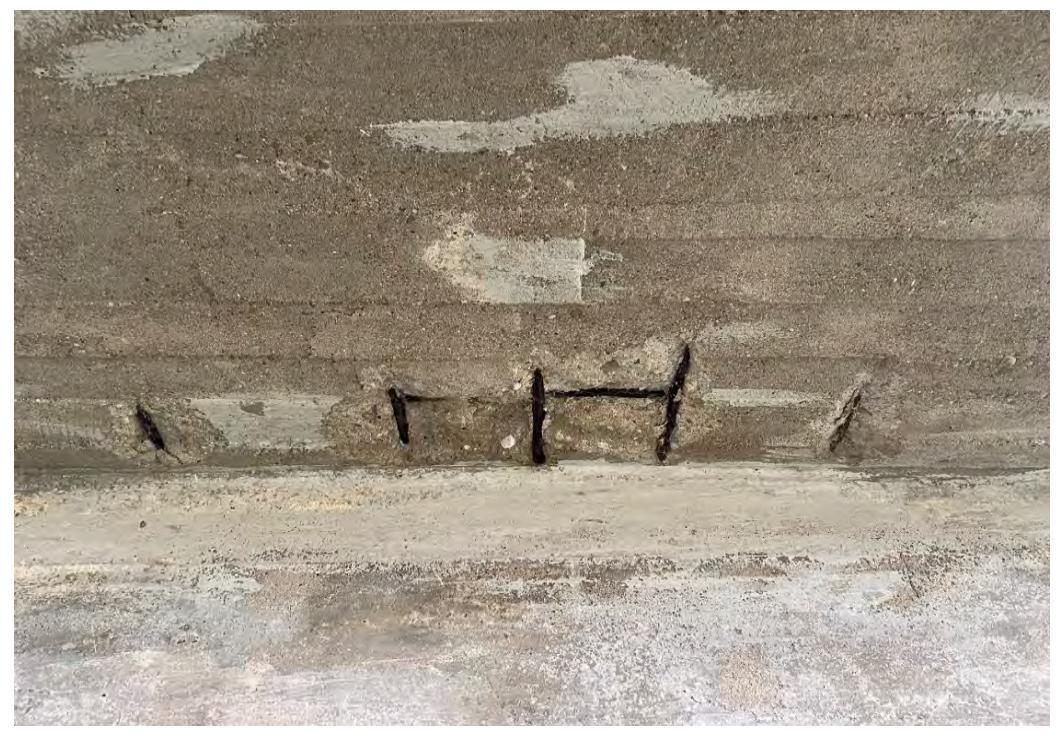
Photo 13-9: View of exposed rebar in the soffit

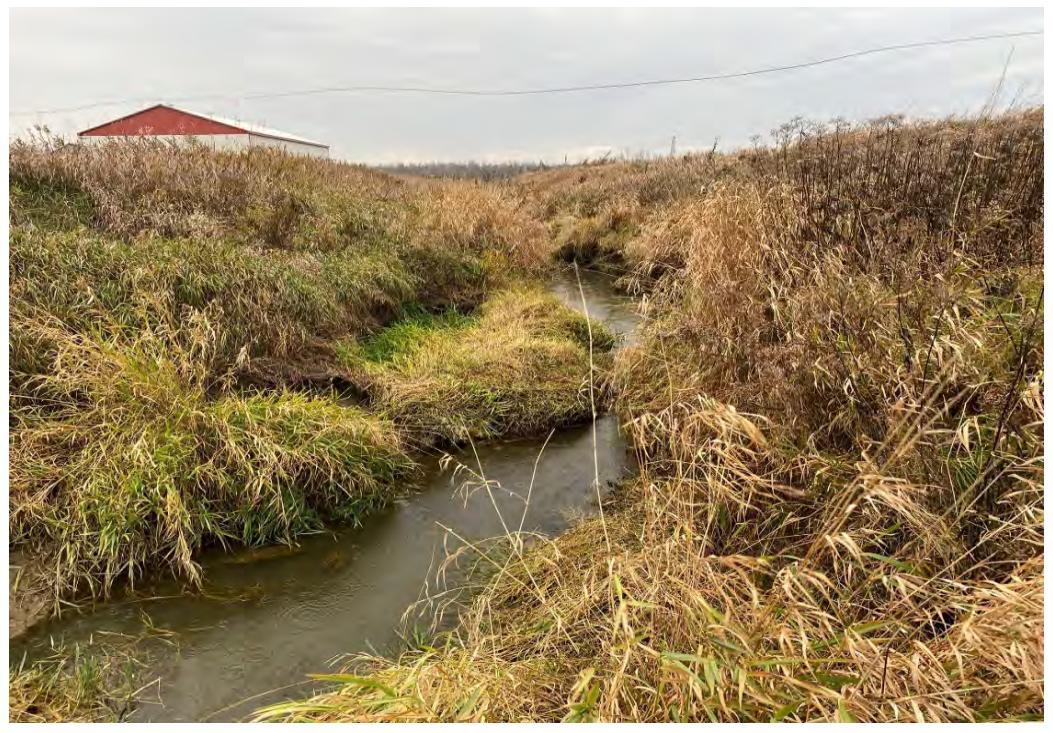
Photo 13-10: View of watercourse downstream

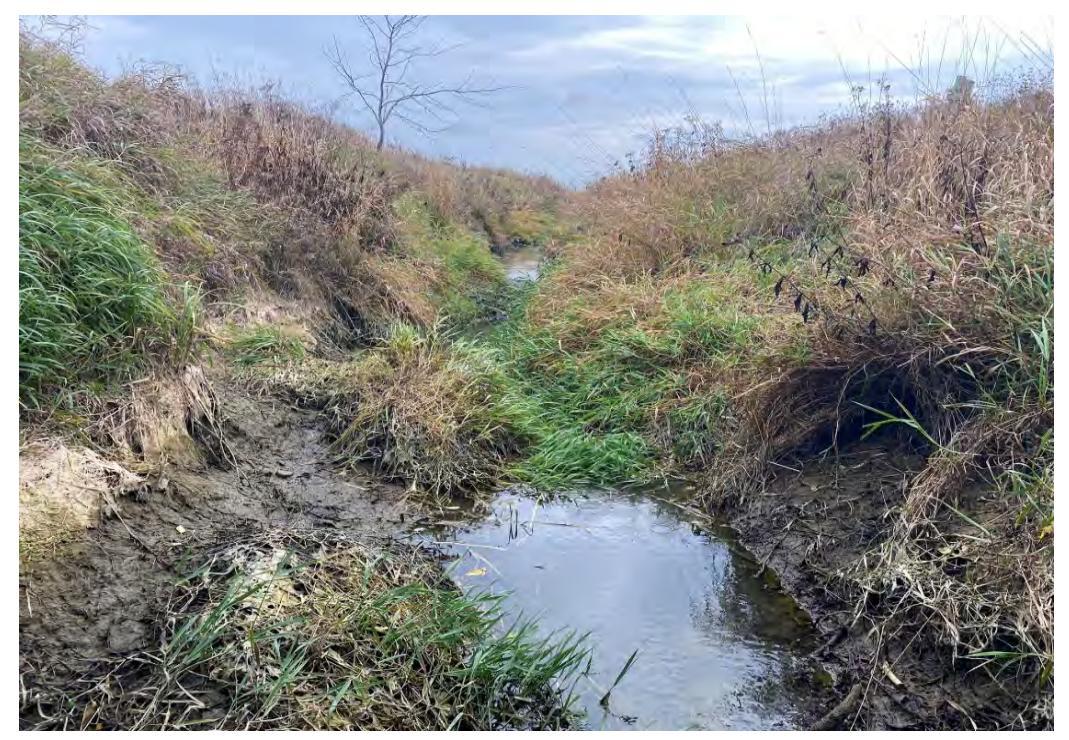
Photo 13-11: View of watercourse upstream
## **Bridge/Culvert Inspection Report**

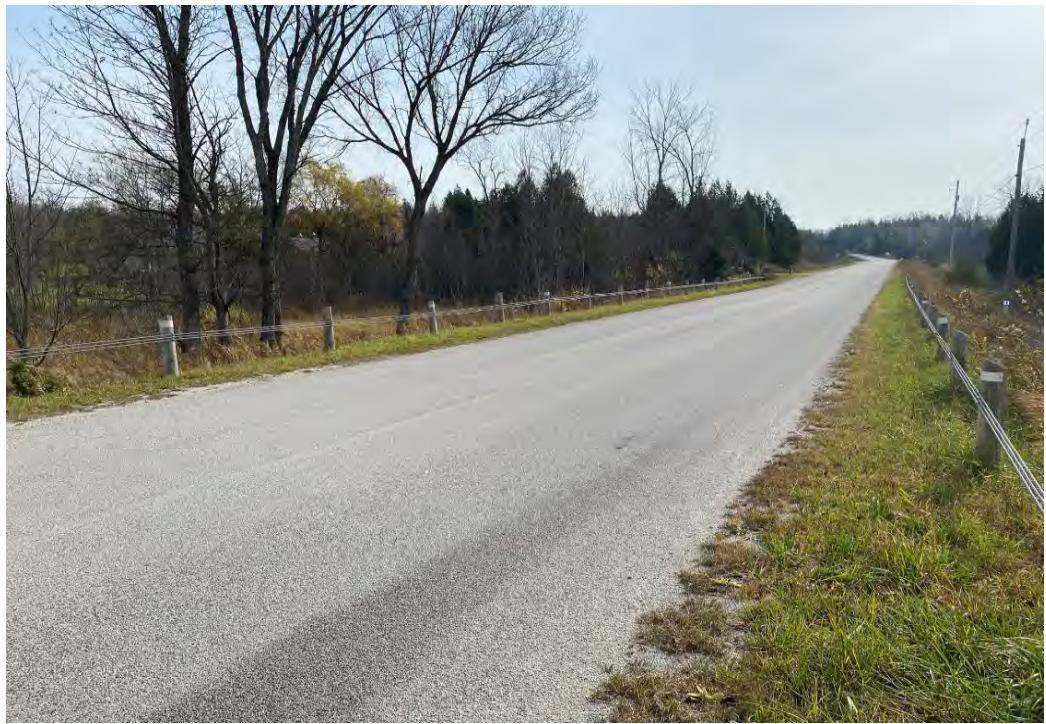
Photo 14-2: View of wearing surface and guiderail

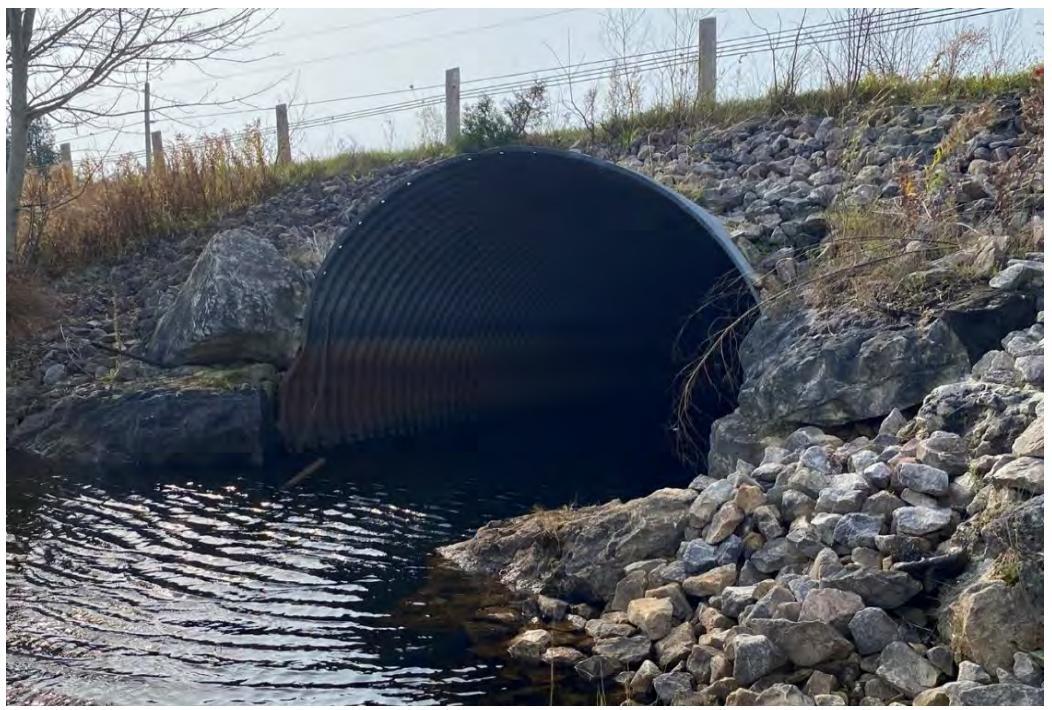
Photo 14-4: Upstream culvert end elevation

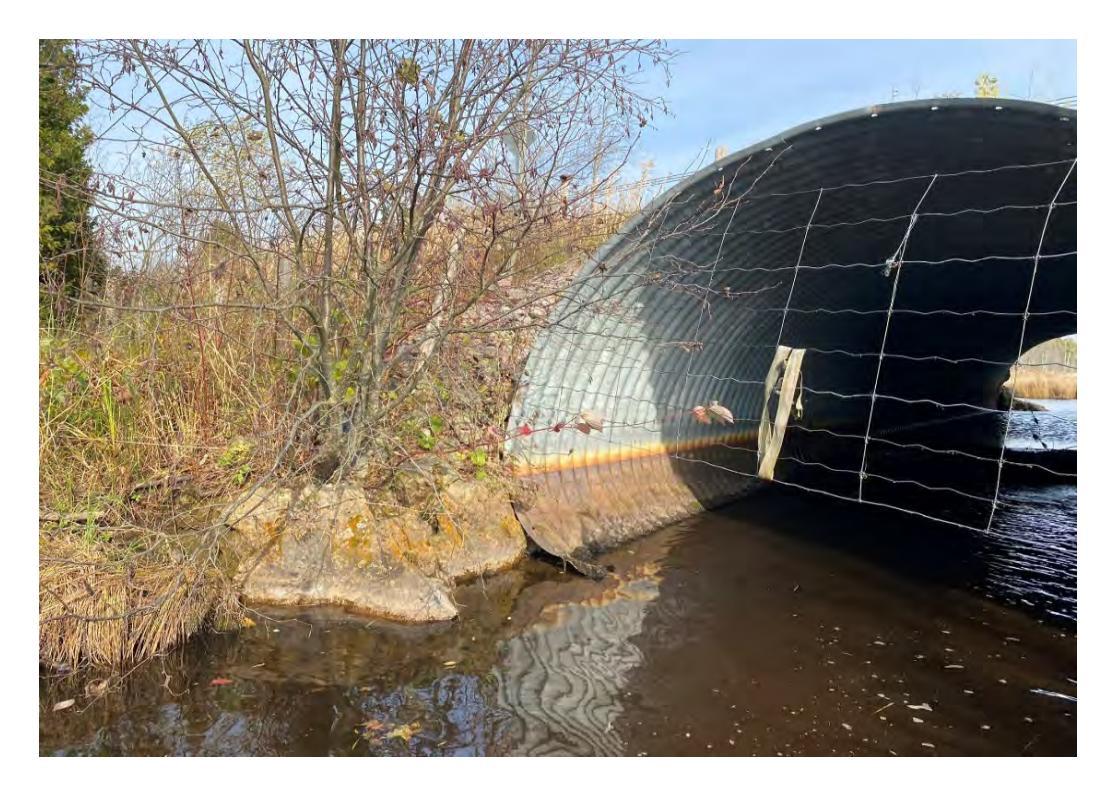
Photo 14-5: Downstream culvert end elevation

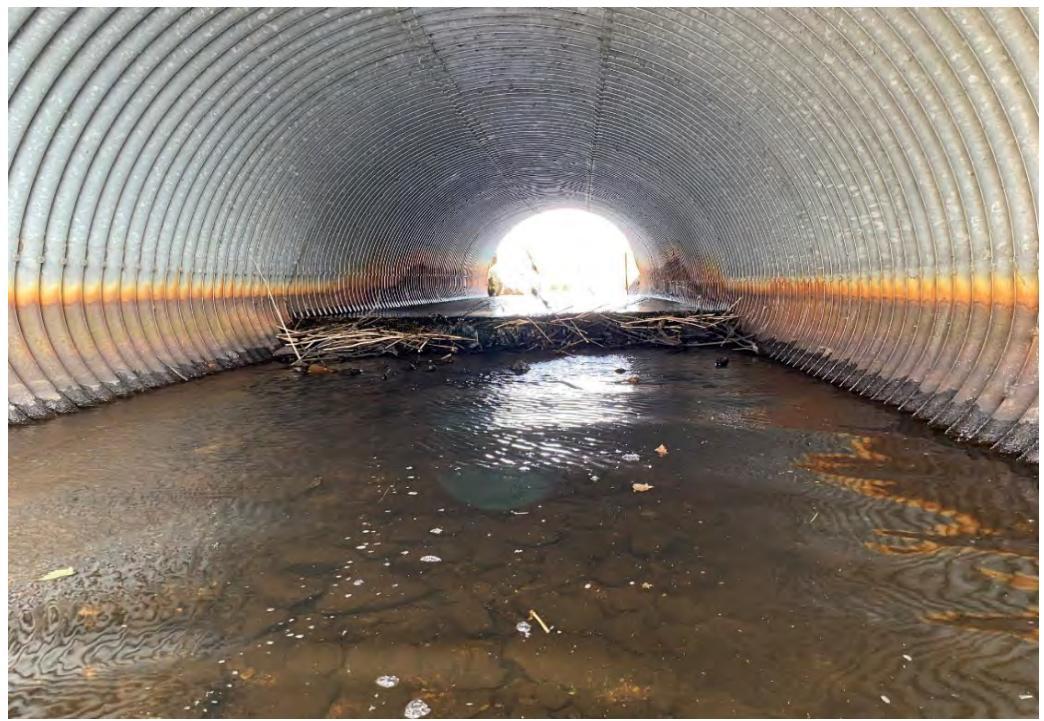
Photo 14-6: View of culvert barrel and obstruction

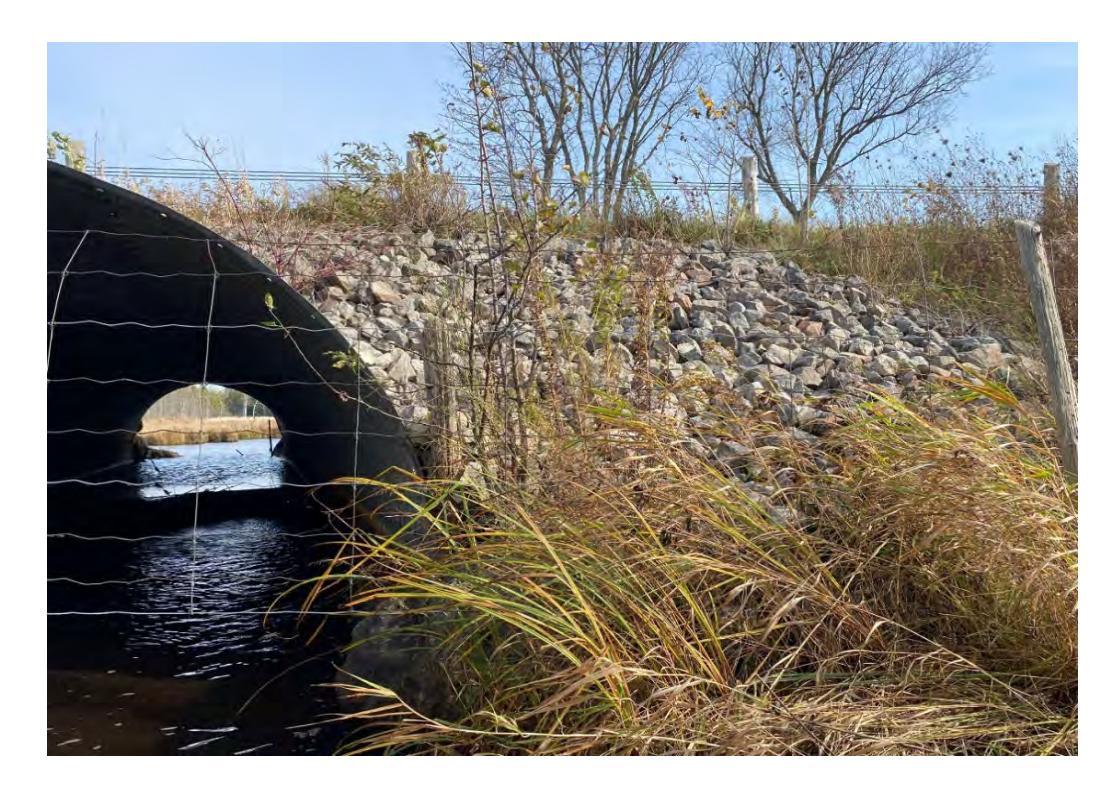
Photo 14-7: View of slope protection

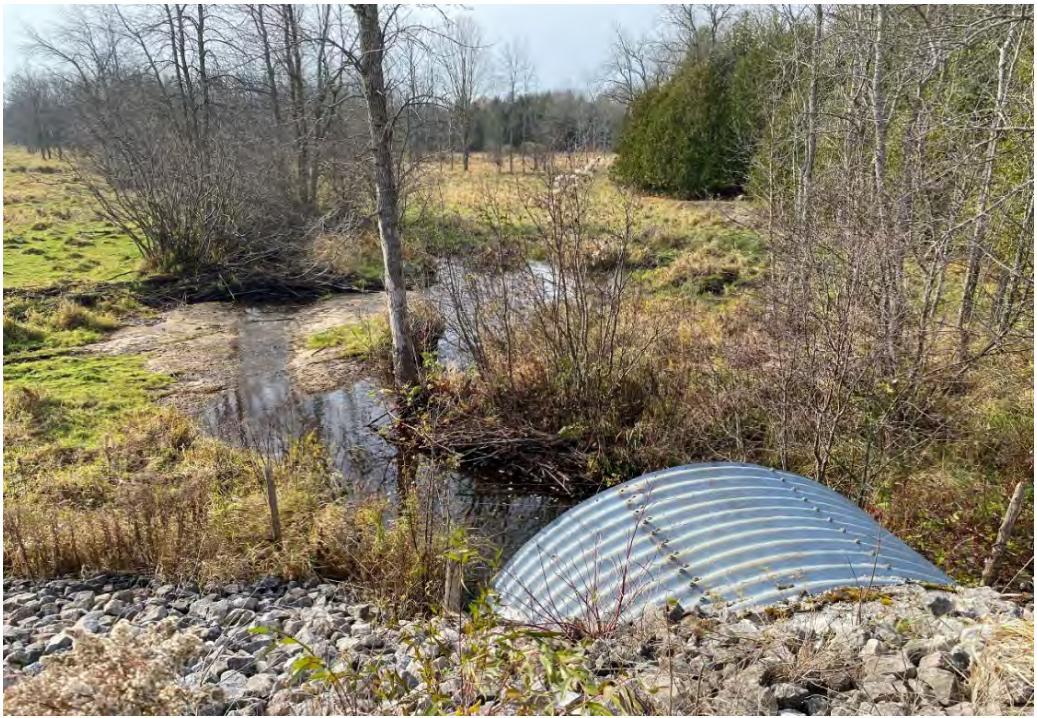
Photo 14-8: View of watercourse downstream

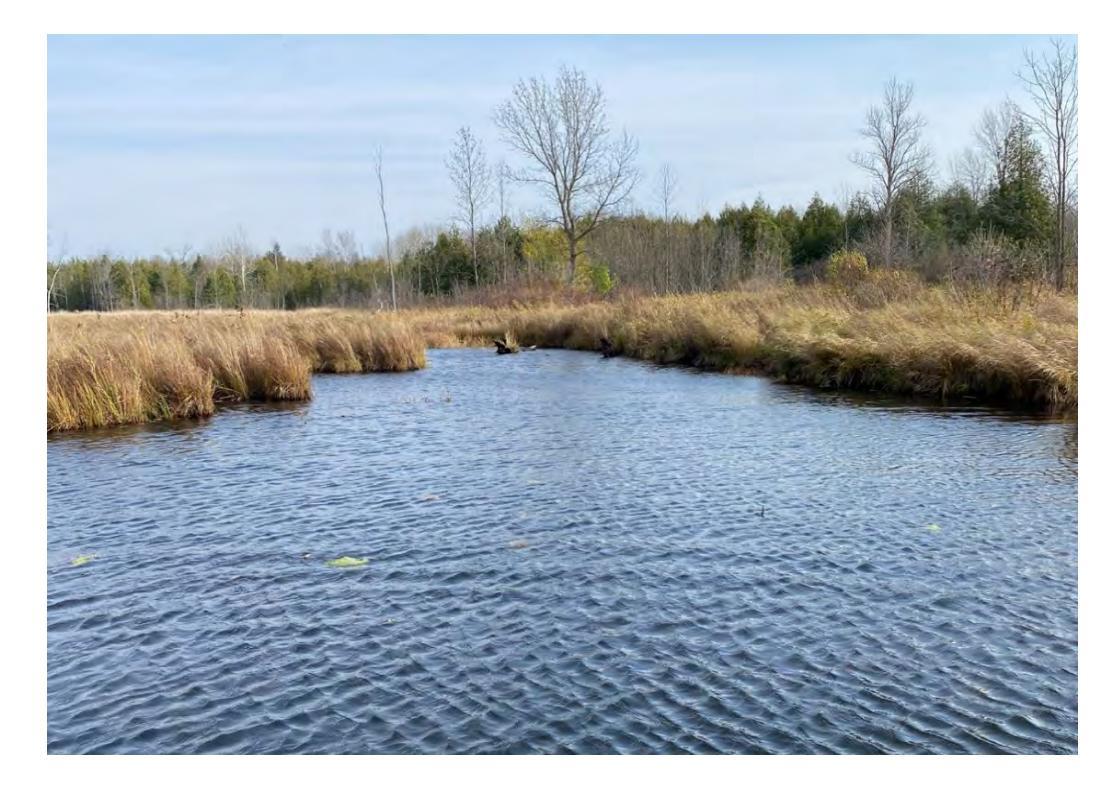
Photo 14-9: View of watercourse upstream

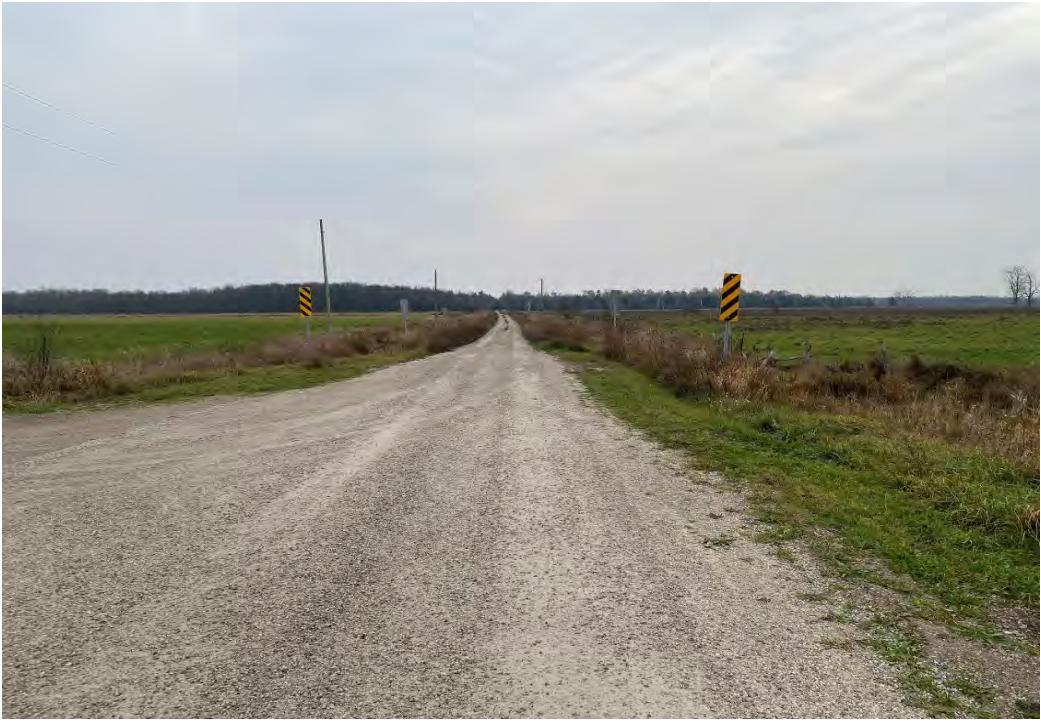
Element Group:	Signs		Length:						
Element Name:	Signs		Width:						
Location:			Height:						
Material:	Steel		Count:		7				
Element Type:	Т		Total Quantity:			7			
Environment:	Severe		Limited Insp'n:						
Protection System:			Paint						
Condition Data:	Units	Exc.	Good	Fair	Poor	Perform. Deficiencies	Maint. Needs		
	Each		6		1	Yes	Yes		
Comments: Four (4) end hazd signs, one (1) narrow road and one speed warning sign are in good condition. Speed warning sign at the north approach is damaged.									
Recommended Wor	k: None Replace damaged spe	6-10 Years ed warning si	1-5 Years gn.	< 1 Year	Urgent

Photo 15-2: View of wearing surface and hazard signs

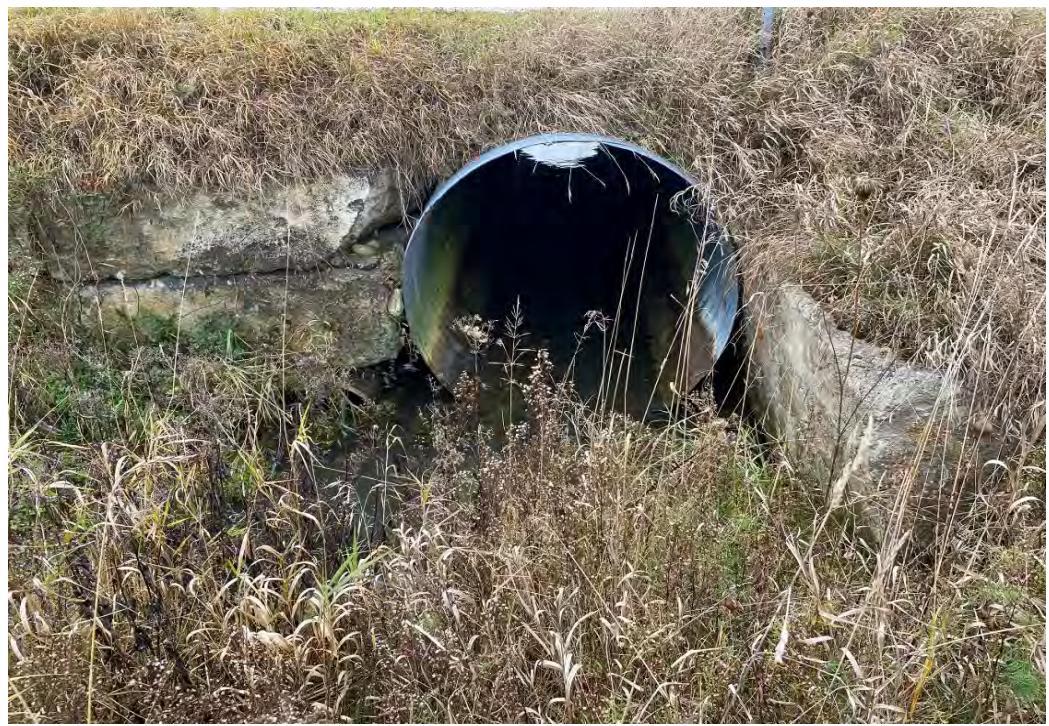
Photo 15-4: View of east culvert end

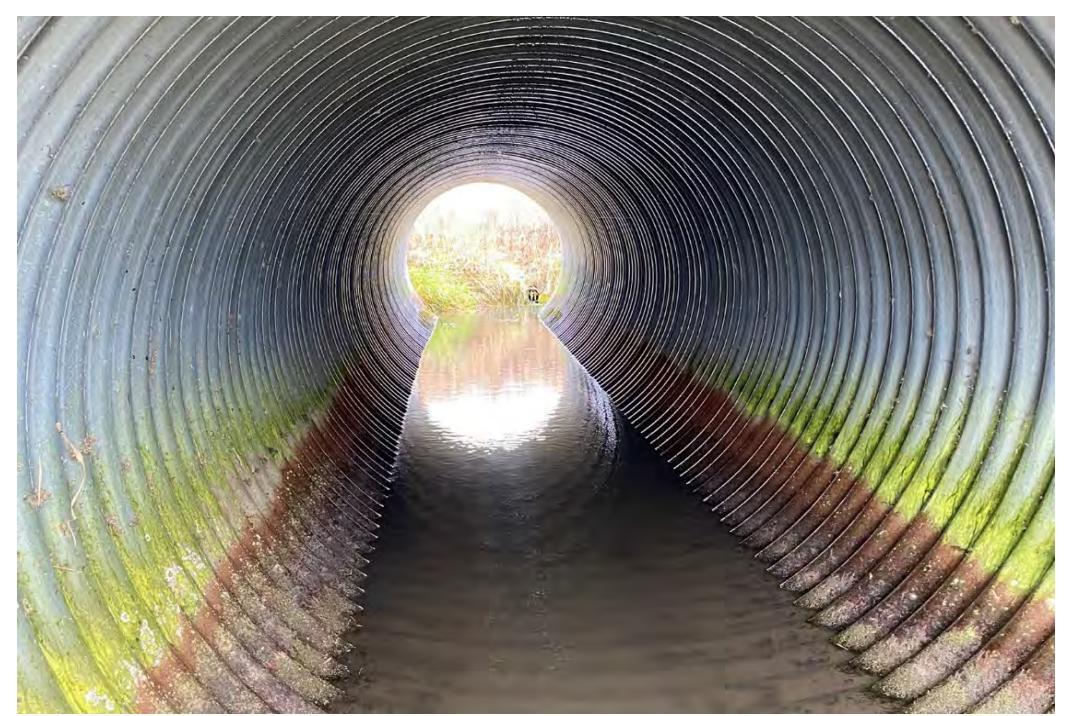
Photo 15-5: View of upper culvert barrel

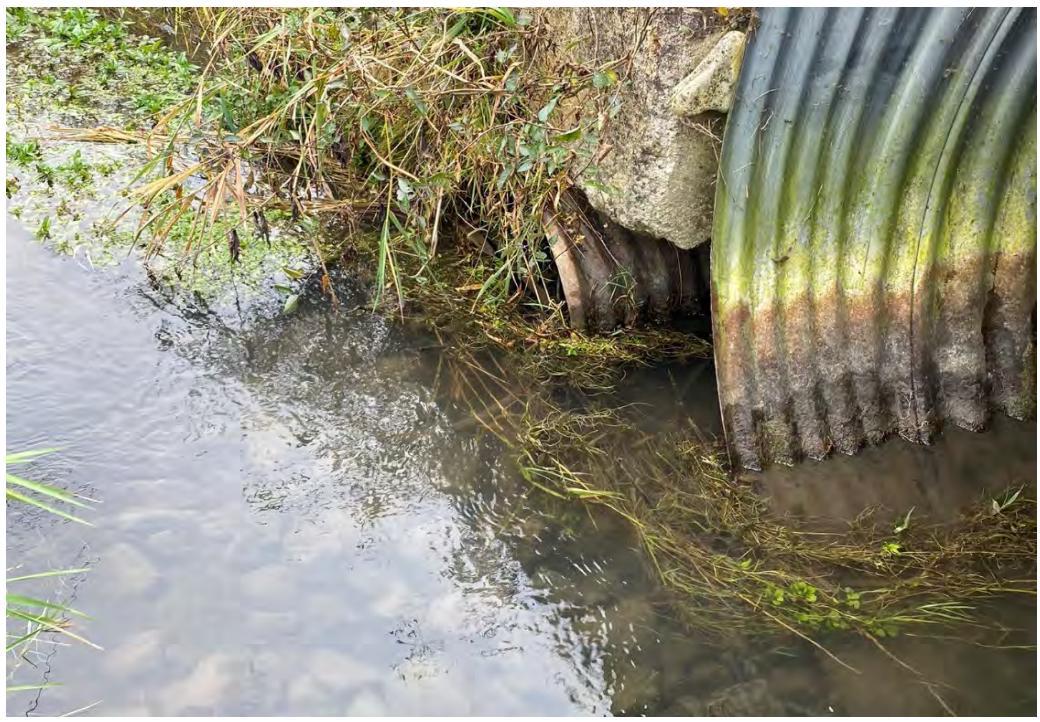
Photo 15-6: View lower culvert inlet obstruction

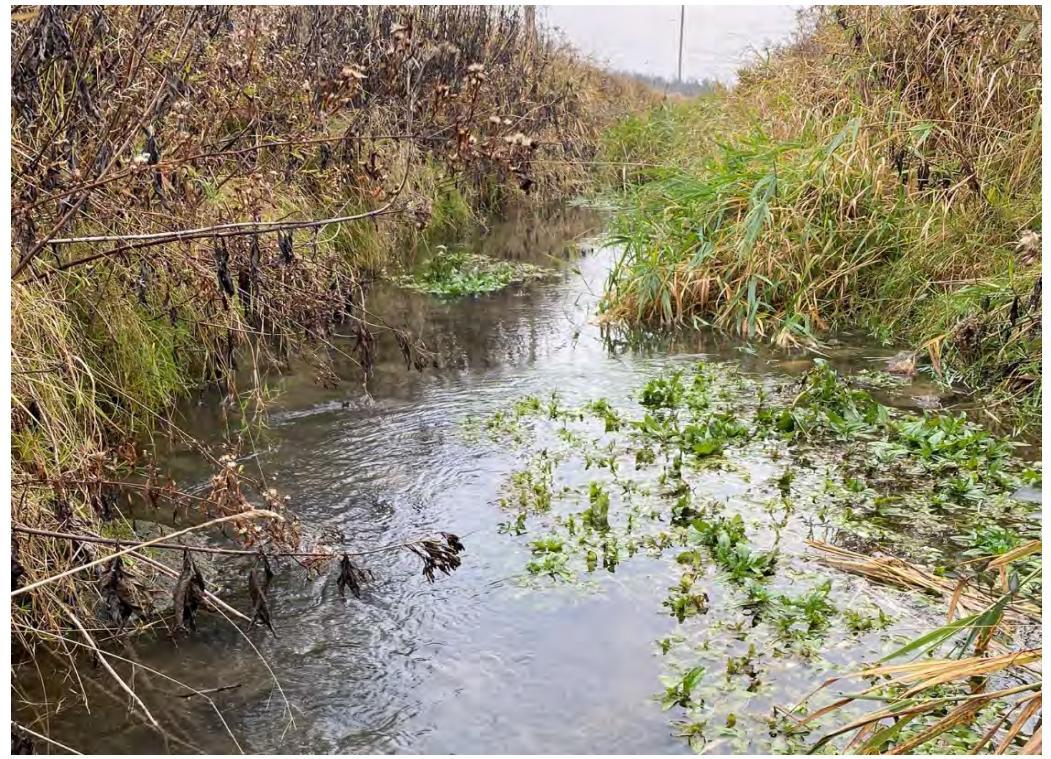
Photo 15-7: View of watercourse upstream

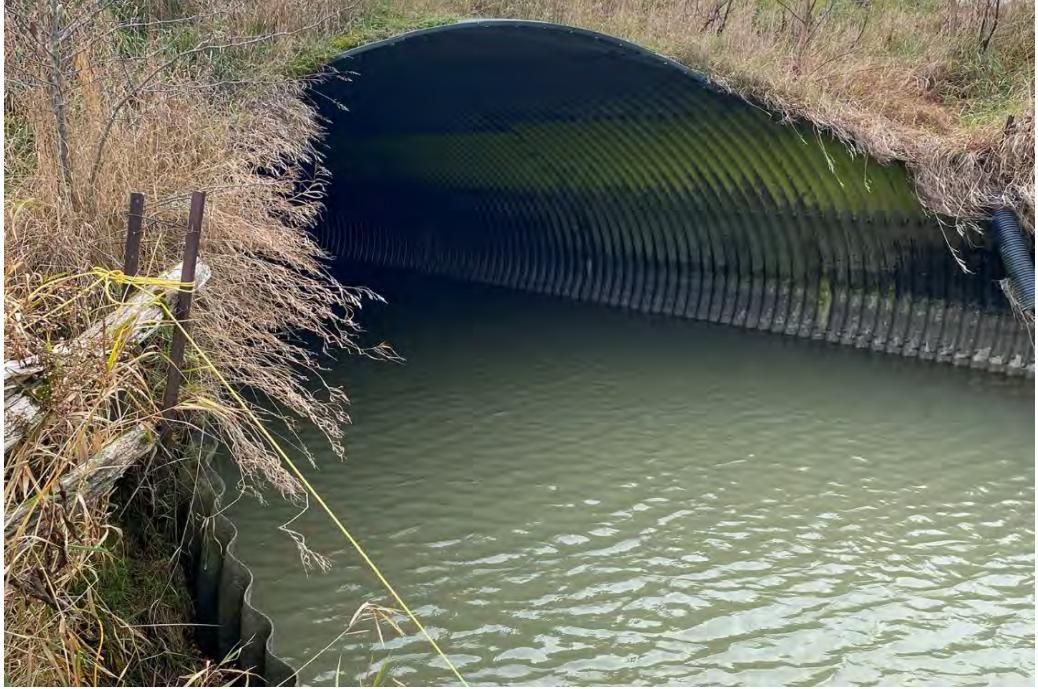
Photo 16-2: View of culvert barrel in elevation (outlet end)

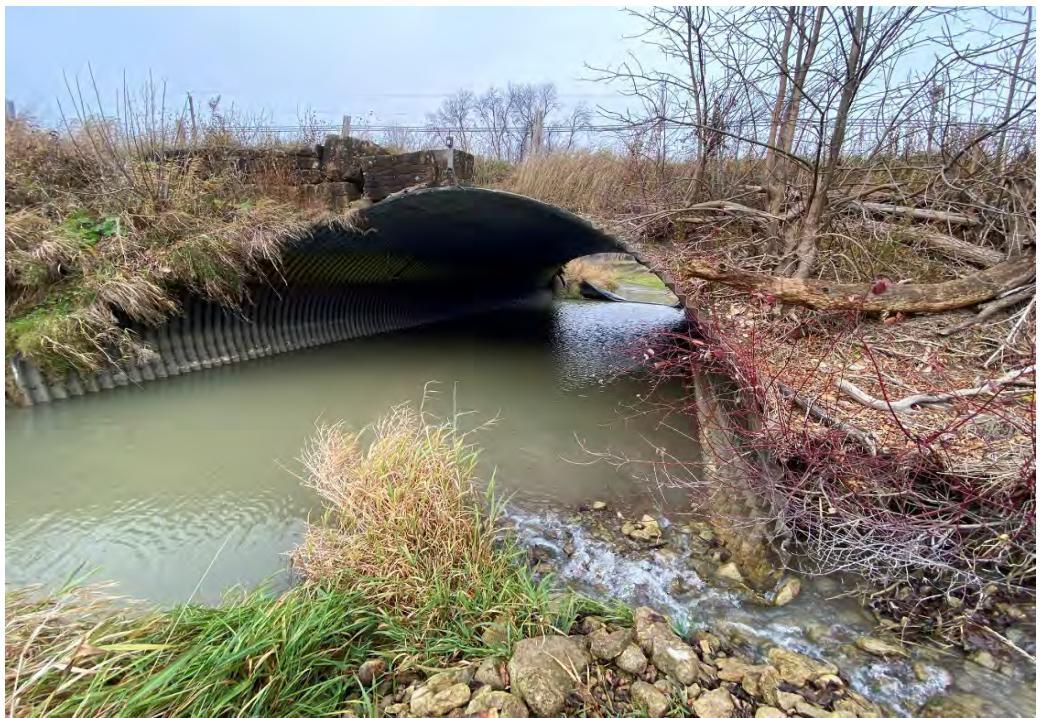
Photo 16-3: View of culvert barrel in elevation (inlet end)

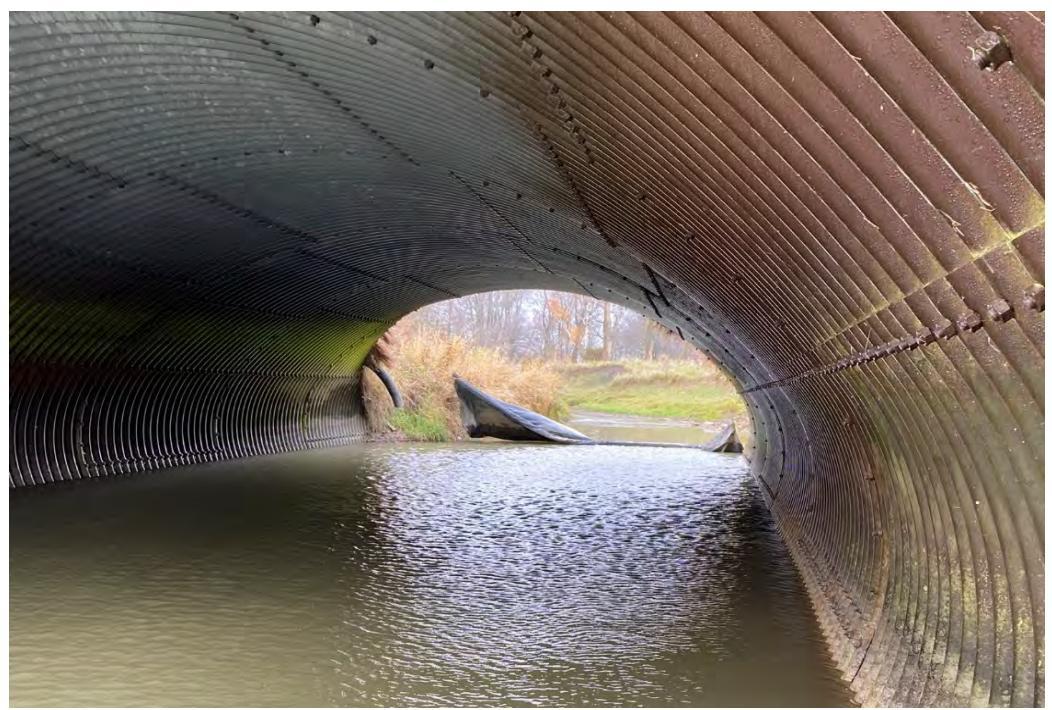
Element Group:	Culvert		Length:						
Element Name:	Barrel		Width:						
Location:			Height:						
Material:	Steel		Count:						
Element Type:	Pipe Arch		Total Quantity:						
Environment:	Moderate	Limited Insp'n:							
Protection System:		Galvanized							
Condition Data:	Units	Exc.	Good	Fair	Poor	Perform. Deficiencies	Maint. Needs		
	%			100					
Comments: Minor to moderate corrosion and swelling were observed at water level. No section loss observed.									
Recommended Worl	k: None	6-10 Years	1-5 Years	< 1 Year	Urgent

Photo 16-6: View of culvert barrel interior

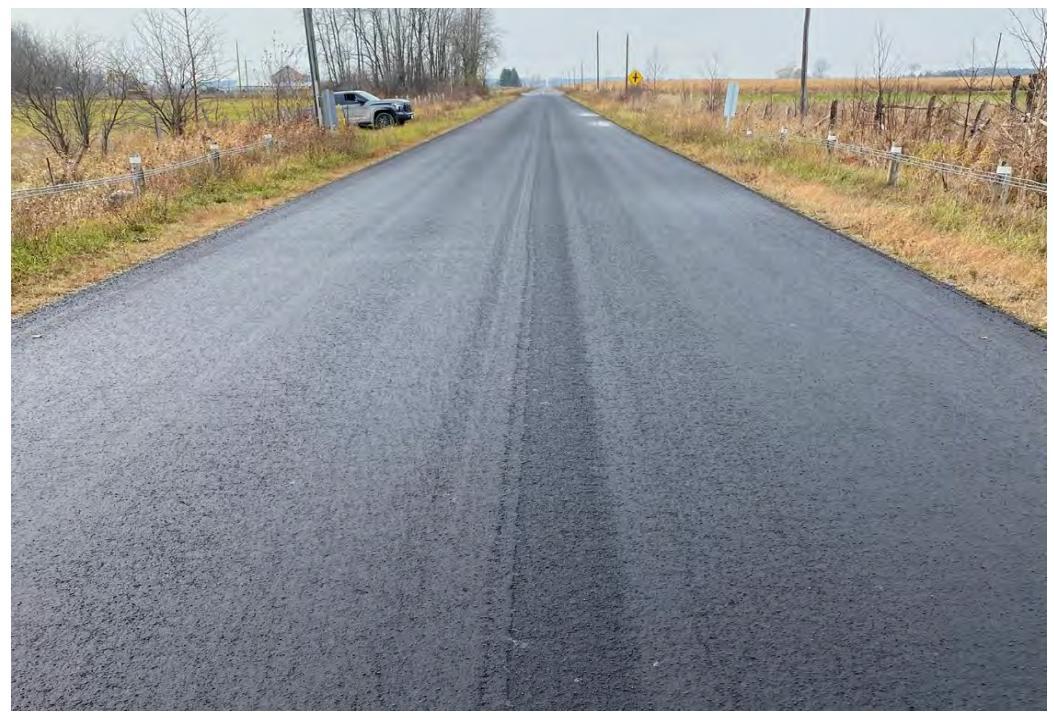
Element Group:	Decks		Length:				
Element Name:	Wearing Sur	face	Width:				
Location:	H		Height:				
Material:	Surface Treat	tment	Count:				
Element Type:	Т. Тт.		Total Quantity:				
Environment:	Severe	Limited Insp'n:					
Protection System:	None						
Condition Data:	Units	Exc.	Good	Fair	Poor	Perform. Deficiencies	Maint. Needs
	%	100	85				
Comments:	Recently placed surface	ce treatment is	in excellent cond	ition.			
Recommended Work: None 6-10 Years 1-5 Years < 1 Year Urgent

Photo 16-7: View of wearing surface

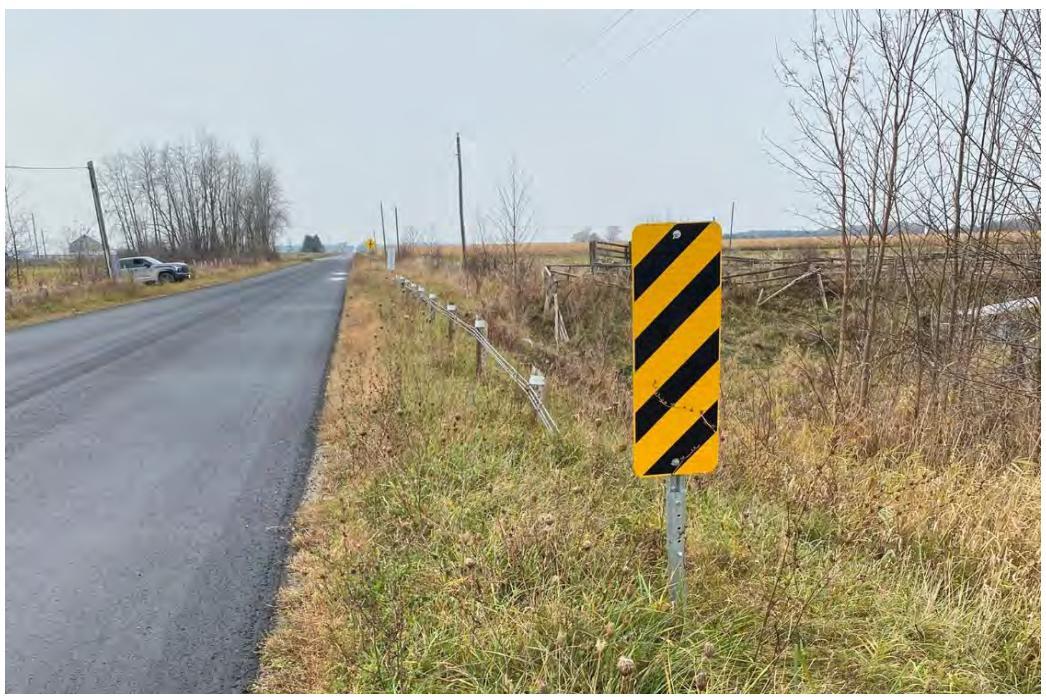
Element Group:	Barriers		Length:					
Element Name:	Barrier		Width:					
Location:	Each Side		Height:					
Material:	Steel/Woo	bd	Count:		20 posts - 3 cable			
Element Type:	3-Cable Guiderail T		Total Quantity:					
Environment:	Severe	Limited Insp'n:						
Protection System:	None							
Condition Data:	Units	Exc.	Good	Fair	Poor	Perform. Deficiencies	Maint. Needs	
	%			90	10	Yes	Yes	
<b>Comments:</b> The three cable guide barrier is in fair overall condition. Some of the wooden posts are experiencing moderate to severe rot near their bases.								
Recommended Worl	<b>::</b> None Replace the rotten bar	6-10 Years rier posts.	1-5 Years	< 1 Year	Urgent

Photo 16-8: View of hazard sign and guiderail (typ.)

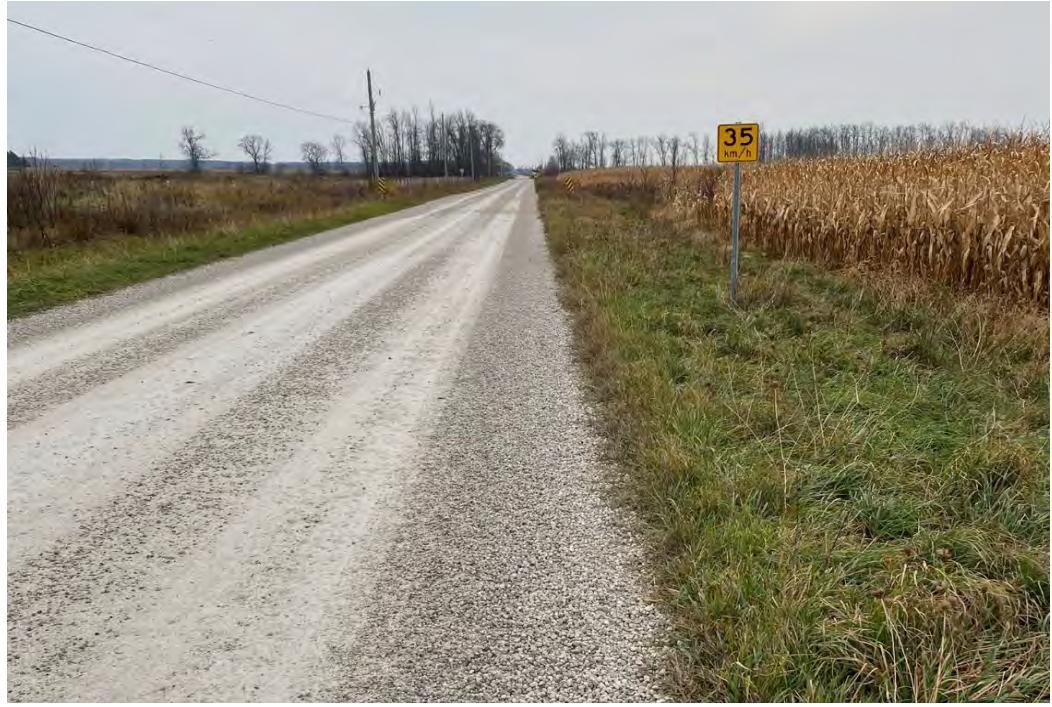
Photo 17-2: View of north approach and speed warning sign

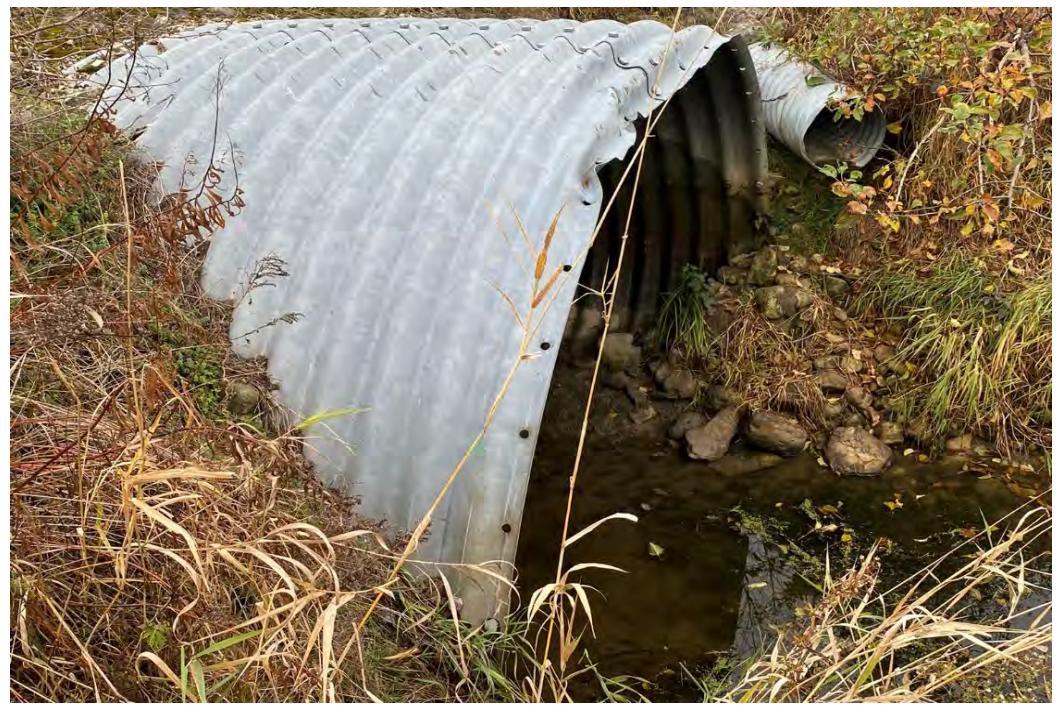
Element Group:	Culver	ts	Length:					
Element Name:	Outlet Comp	onents	Width:					
Location:	West E	nd	Height:					
Material:	Stone and Earth		Count:					
Element Type:								
Environment:	Moderate		Limited Insp'n:					
Protection System:		None						
Condition Data:	Units	Exc.	Good	Fair	Poor	Perform. Deficiencies	Maint. Needs	
	%			80	20		Yes	
Comments:	Minor erosion observed CSP.	d near the culver	t haunches with m	aterial build	up at the b	ase of the uppe	er drainage	
Recommended Wo	ork: None Repair erosion and pla	6-10 Years ce slope pretection	1-5 Years on as required.	< 1 Year	Urgent

Photo 17-4: View of culvert outlet and drainage pipe

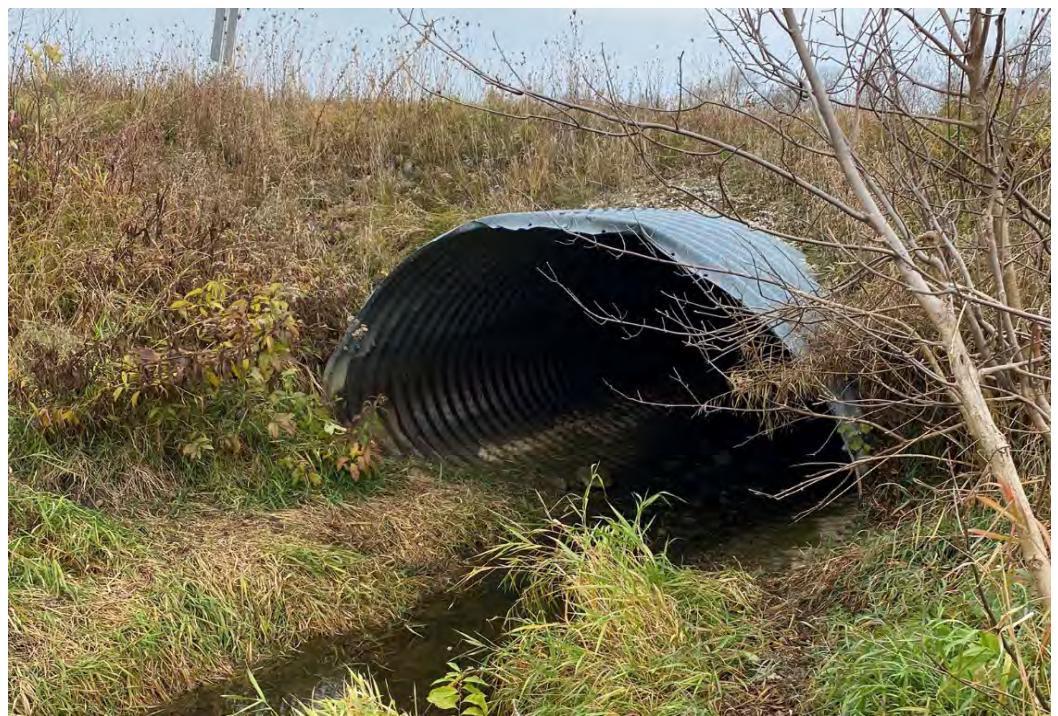
Element Group:	Culverts		Length:							
Element Name:	Inlet Compo	nent	Width:							
Location:	End		Height:							
Material:	Stone and Earth		Count:							
Element Type:			Total Quantity:							
Environment:	Moderate		Limited Insp'n:							
Protection System:		None								
Condition Data:	Units	Exc.	Good	Fair	Poor	Perform. Deficiencies	Maint. Needs			
	%			100			Yes			
Comments:	Comments: Minor erosion observed near the culvert haunches.									
Recommended Wo	ork: None Repair erosion and pla	6-10 Years ace slope pret	1-5 Years ection as required.	< 1 Year	Urgent

Photo 17-5: View of culvert inlet end

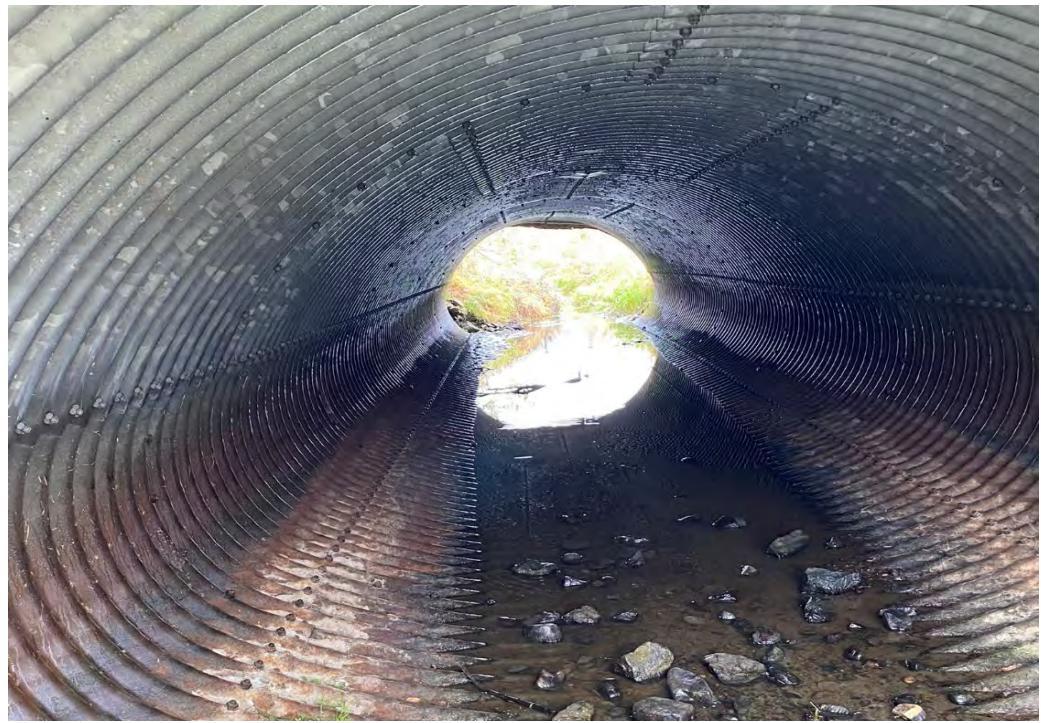
Element Group:	Culve	rt	Length:				
Element Name:	Barre	) I	Width:				
Location:			Height:				
Material:	Steel		Count:				
Element Type:	Pipe Ar	ch	Total Quantity:				
Environment:	Modera	Limited Insp'n:					
Protection System:			Galvanize	ed			
Condition Data:	Units	Exc	Good	Fair	Poor	Perform.	Maint.
	01113	EX0.	0000	i ali	1 001	Deficiencies	Needs
	%		70	30			
Comments:	Minor corrosion observ	ed near in the bas	se up to the haun	iches.			
Recommended Wo	rk: None	6-10 Years	1-5 Years	< 1 Year	Urgent

Photo 17-7: View of culvert barrel interior

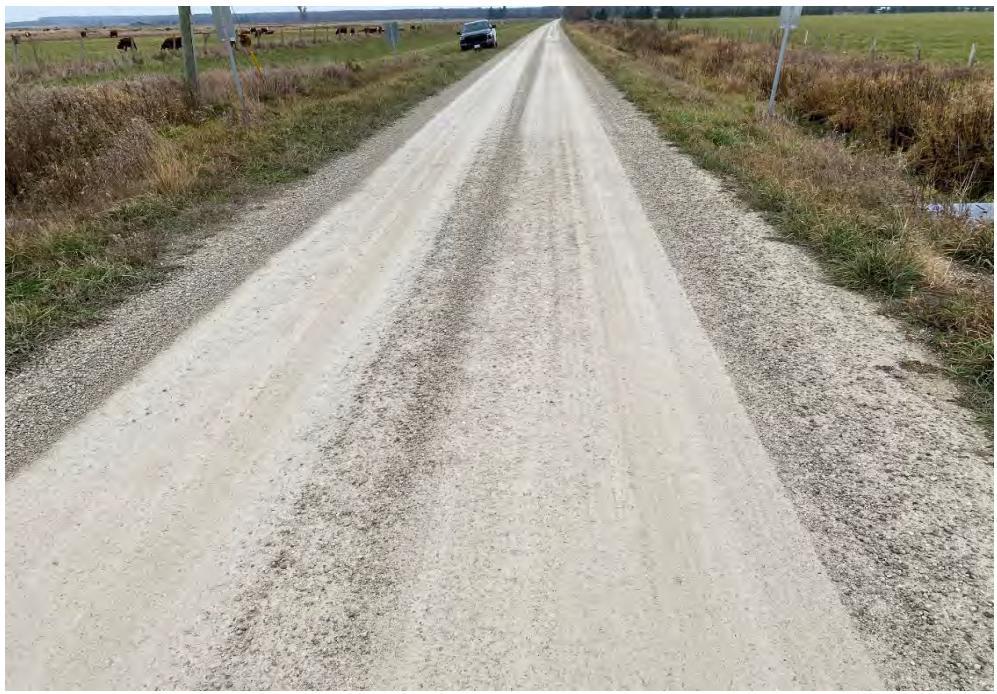
Element Group:	Decks		Length:				
Element Name:	Wearing Sur	face	Width:				
Location:			Height:				
Material:	Gravel		Count:				
Element Type:			Total Quantity:				
Environment:	Severe		Limited Insp'n:				
Protection System:	None						
Condition Data:	Units	Exc.	Good	Fair	Poor	Perform. Deficiencies	Maint. Needs
	%			100			Yes
Comments:	Minor wheel path ruttin	g and beginnii	ng stages of pot ho	les were ob	served.		
Recommended Work: None 6-10 Years 1-5 Years <a>      Grade the wearing surface annually.</a>

Photo 18-2: View of structure wearing surface
