#### MUNICIPALITY OF NORTHERN BRUCE PENINSULA

## 2024 STRUCTURE INSPECTION REPORT

FINAL PROJECT NO.: CA0043256.3165 DATE: MARCH 06, 2025

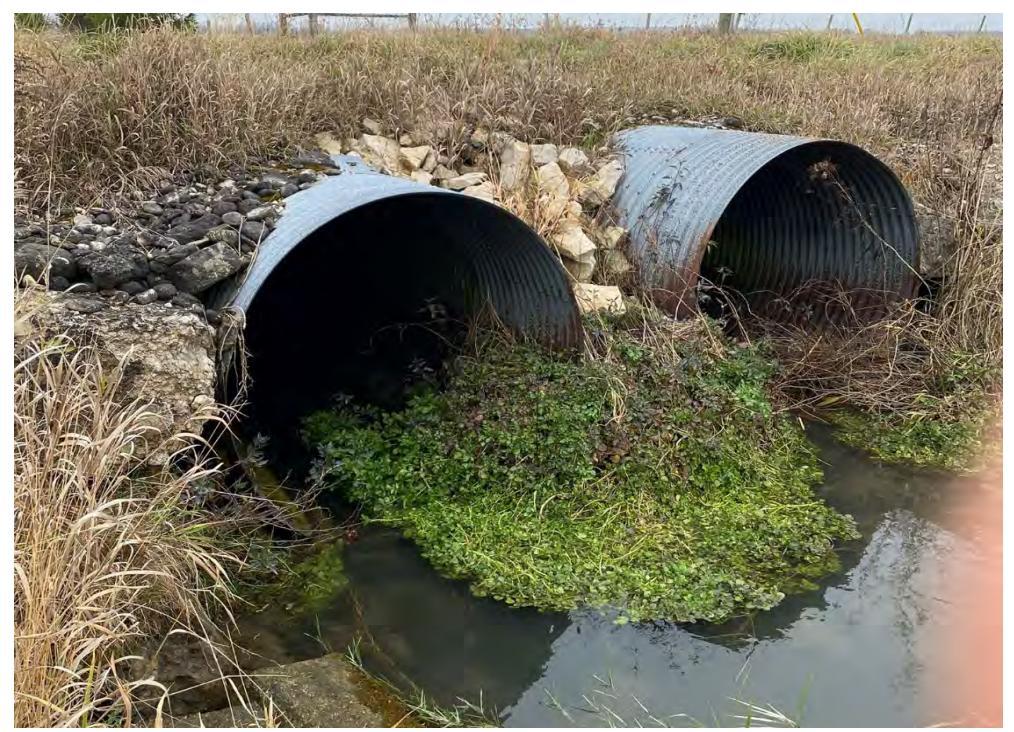
Element Group:	Culverts		Length:						
Element Name:	Inlet Component		Width:						
Location:	South En	d	Height:						
Material:	Stone and Rip	-Rap	Count:						
Element Type:			Total Quantity:						
Environment:	Moderate		Limited Insp'n:						
Protection System:	None								
Condition Data:	Units	Exc.	Good	Fair	Poor	Perform. Deficiencies	Maint. Needs		
	%			80	20	Yes	Yes		
<b>Comments:</b> Minor erosion observed around the pipes at the inlet. Heavy vegetation buildup at the inlet. Moderate corrosion of the barrel at the water line with no section loss.									
Recommended Wor	<b>k:</b> None Repair erosion and pla	6-10 Years ce rip rap slop	1-5 Years be protection. Clear	< 1 Year vegetation	Urgent to restore f	low.

Photo 18-3: View of culvert inlet components

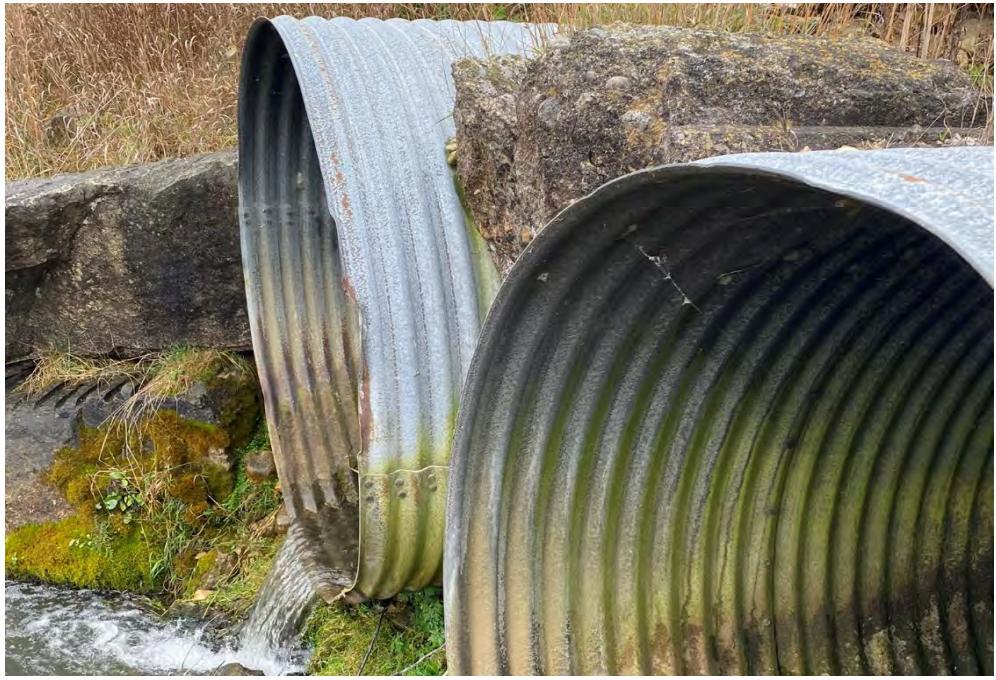
Element Group:	Culverts		Length:						
Element Name:	Outlet Components		Width:						
Location:	North End	d	Height:						
Material:	Stone and Rip	o-Rap	Count:						
Element Type:	-		Total Quantity:						
Environment:	Moderate		Limited Insp'n:						
Protection System:	None								
Condition Data:	Units	Exc.	Good	Fair	Poor	Perform. Deficiencies	Maint. Needs		
	%			50	50	Yes	Yes		
Comments: Large rocks (blocks) and rip-rap protect the embankment. There is a void between the pipes, a scour developing at the culvert end, and a void beneath the culvert ends. Medium corrosion with no section loss was observed at the waterline.   Recommended Work: None 6-10 Years 1-5 Years < 1 Year

Photo 18-4: View of culvert outlet components

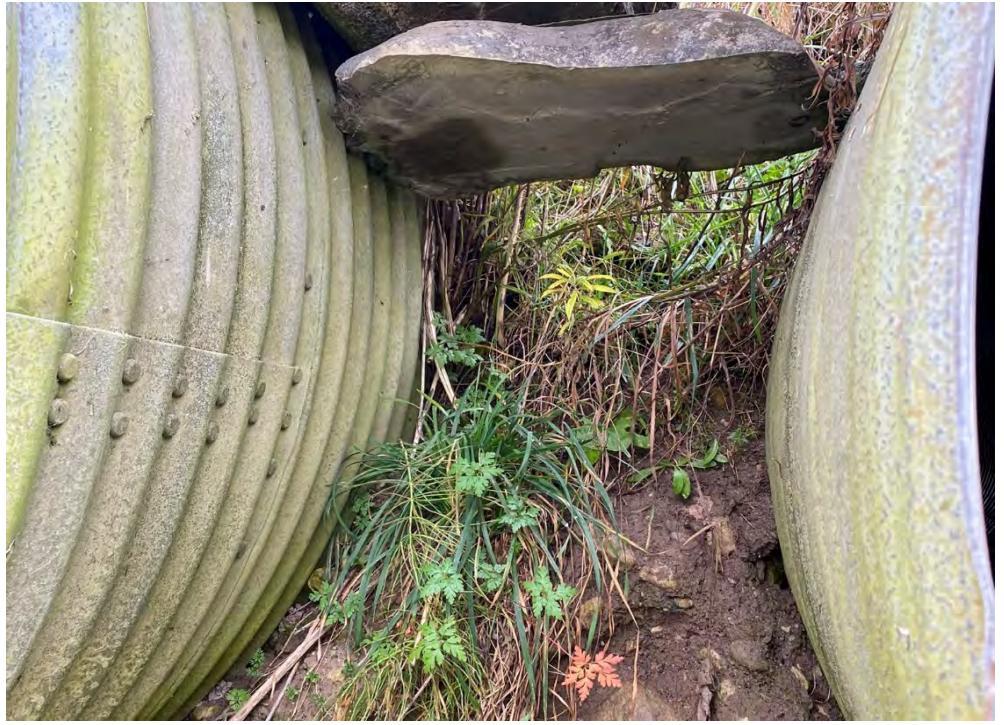
Photo 18-5: View of erosion and voids between culverts at outlet

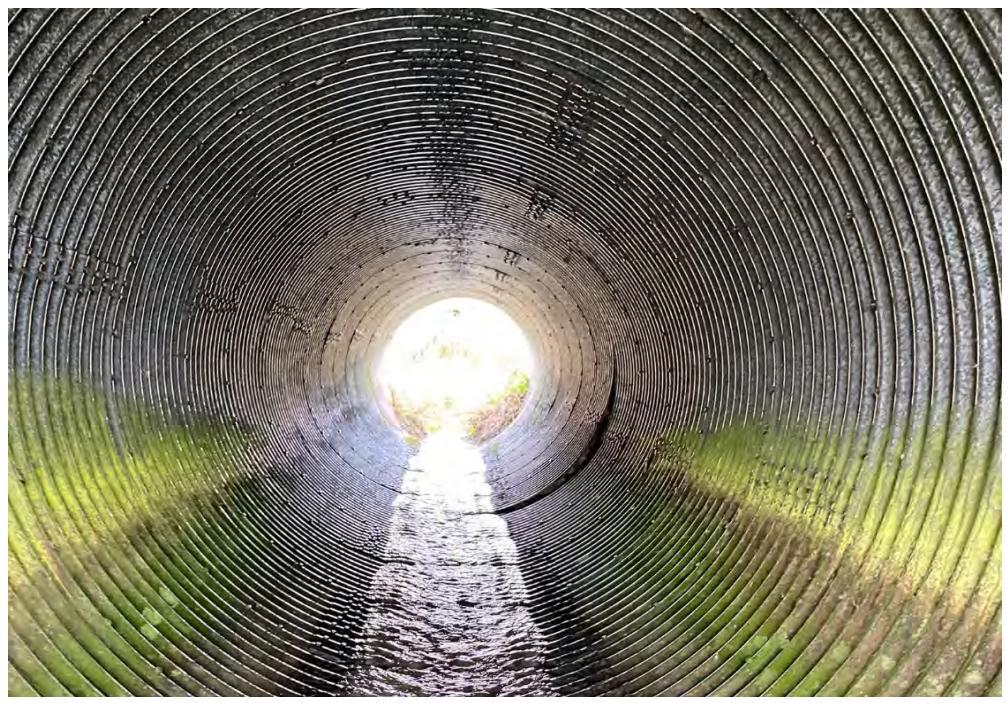
Photo 18-6: View of east culvert barrel

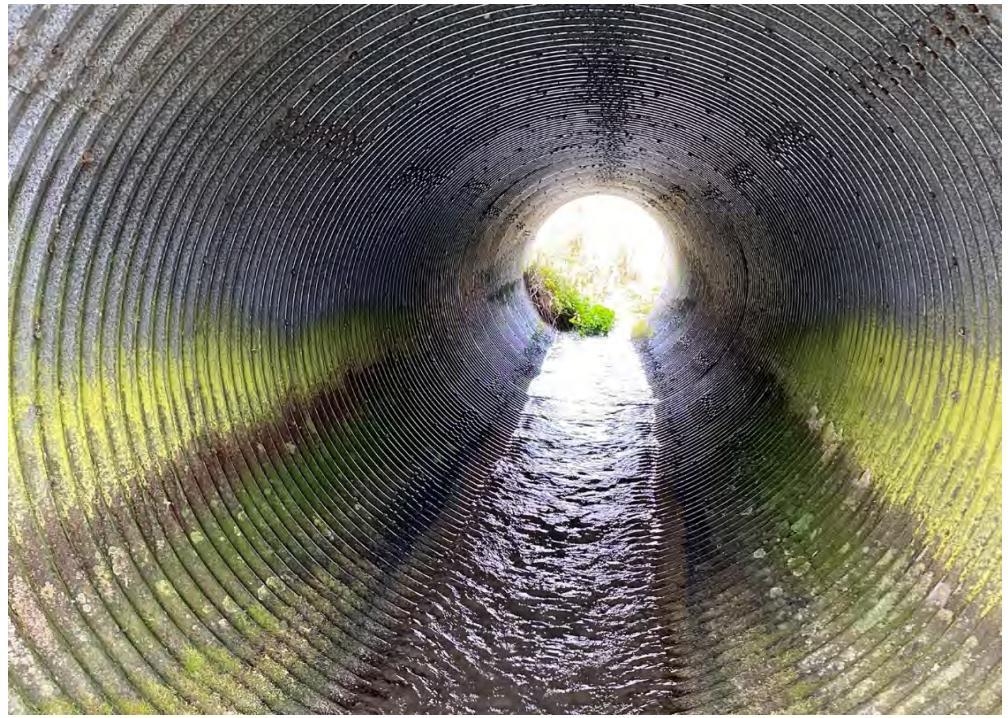
Photo 18-7: View of west culvert barrel

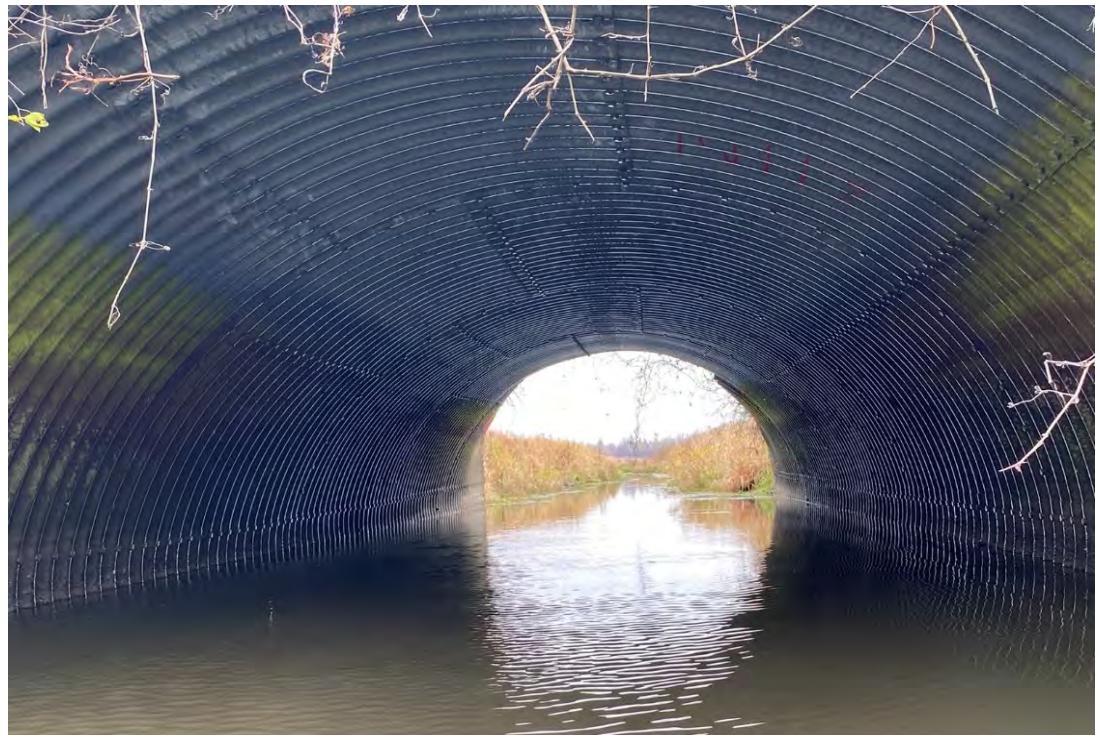
Photo 19-4: View of culvert barrel interior

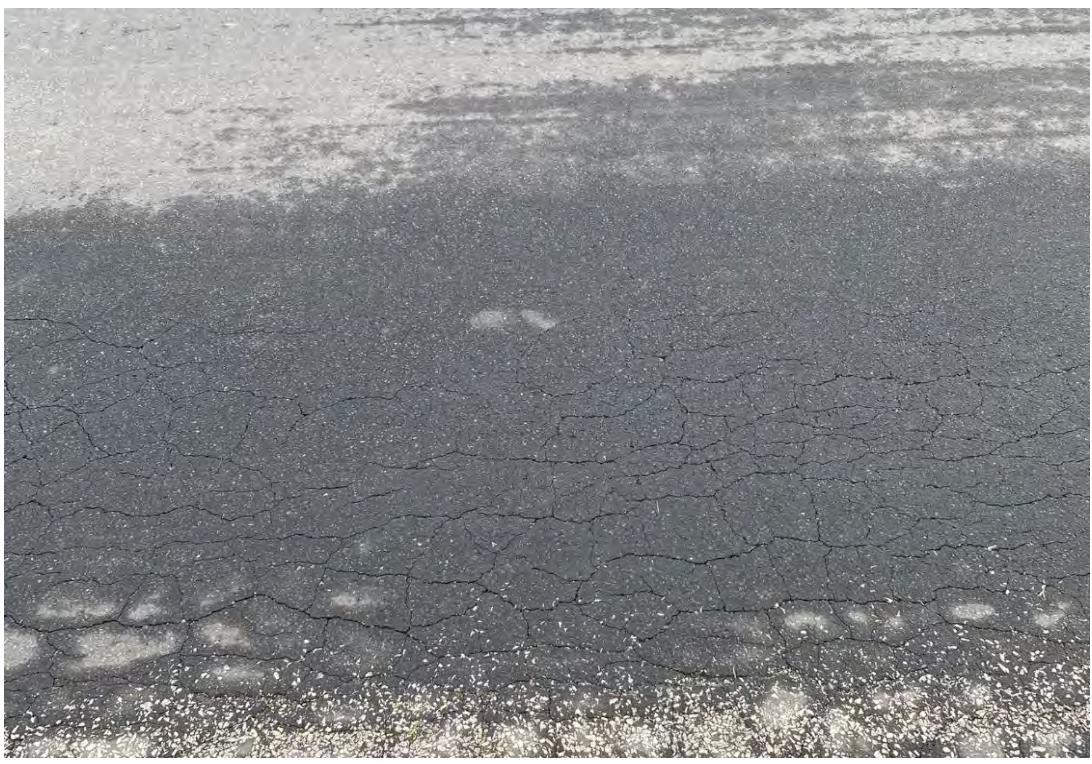
Element Group:	Approache	es	Length:						
Element Name:	Wearing Sur	face	Width:						
Location:	Each End	t	Height:						
Material:	Asphalt		Count:						
Element Type:			Total Quantity:						
Environment:	Severe		Limited Insp'n:						
Protection System:		None							
	Units	Exc	Good	Fair	Poor	Perform.	Maint.		
Condition Data:	01110	L70.	0000	i an	1 001	Deficiencies	Needs		
	%			100					
Comments:	Mild to moderate alligation	tor cracking ol	bserved throughou	it.					
Recommended Work	: None	6-10 Years	1-5 Years	< 1 Year	Urgent

Photo 19-6: View of wearing surface

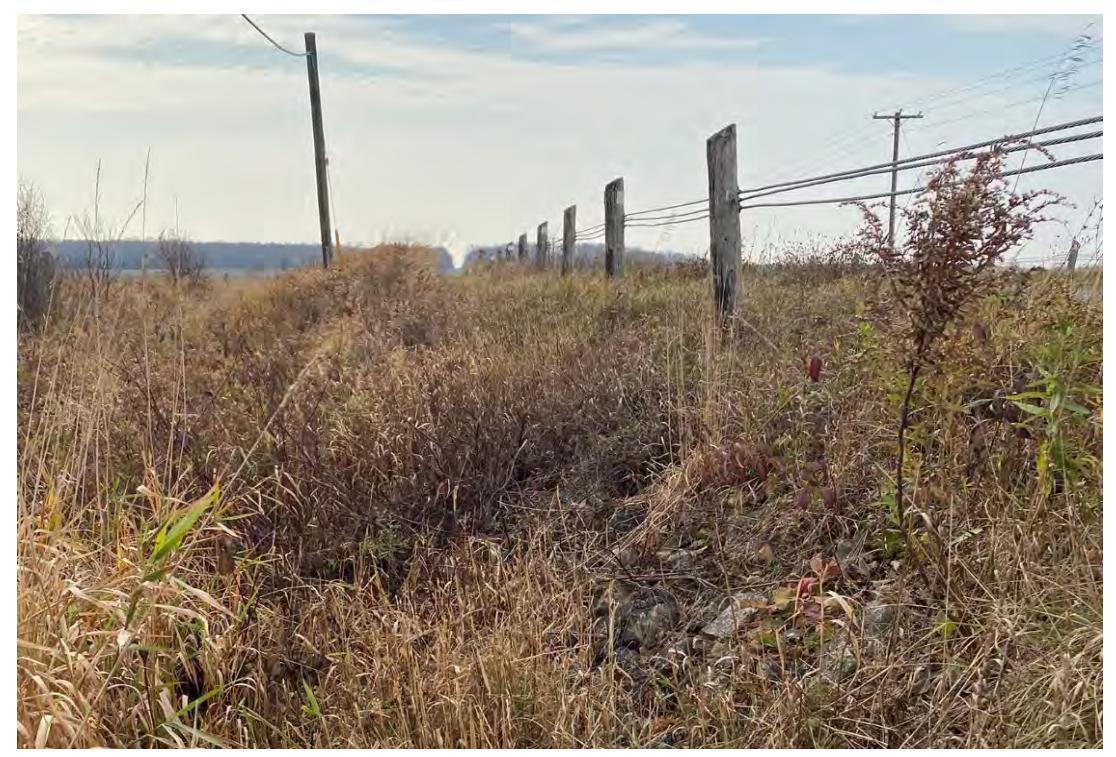
Photo 19-7: View of barrier protection
