MUNICIPALITY OF NORTHERN BRUCE PENINSULA

2022 STRUCTURE INSPECTION REPORT

FINAL
PROJECT NO.: 201-01605-00
DATE: APRIL 03, 2023

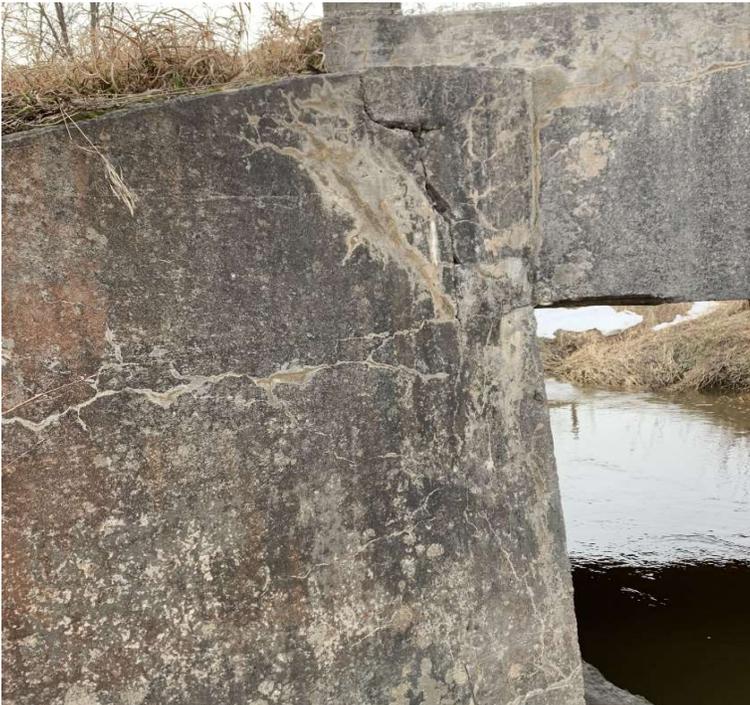
Photo 1-5: Wingwall deterioration (typ)

Element Group:	Abutments		Length:	3.05			
Element Name:	Wingwalls		Width:				
Location:			Height:	1.83			
Material:	Concrete		Count:	4			
Element Type:			Total Quantity:	22.32 m ²			
Environment:	Moderate		Limited Insp'n:				
Protection System:							
Condition Data:	Units	Exc.	Good	Fair	Poor	Perform. Deficiencies	Maint. Needs
	%			11.16	11.16		Yes
Comments:	Surface spalling & cracking was observed at each wingwall.						
Recommended Work:	None 6-10 Years <input type="checkbox"/> 1-5 Years <input checked="" type="checkbox"/> < 1 Year Urgent Repair all poor concrete, clean reinforcing steel, and replace concrete.

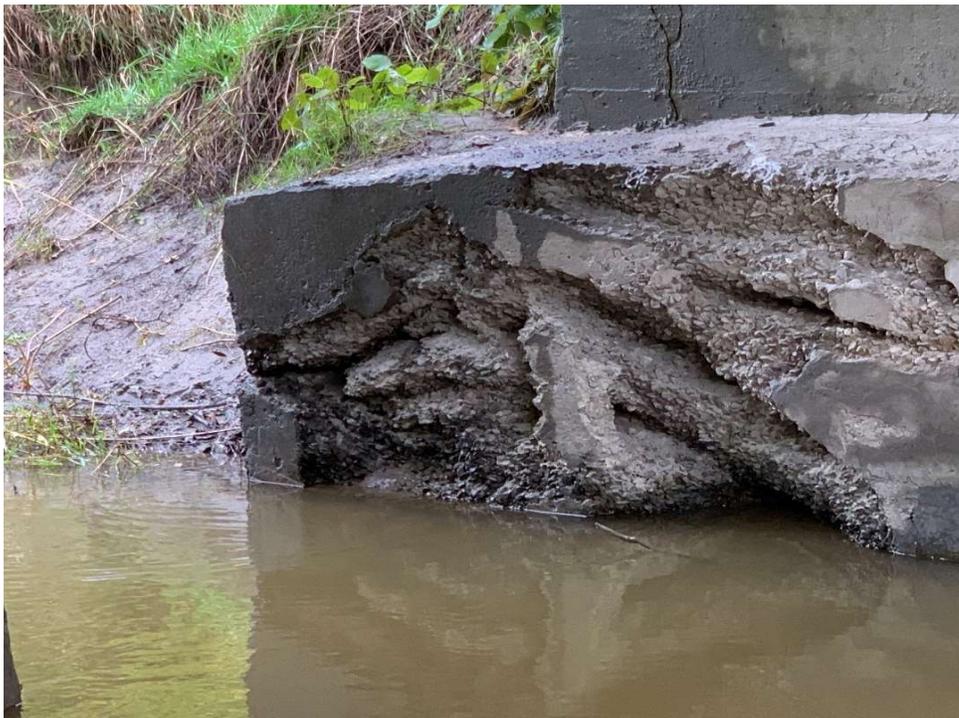
Photo 1-7 - Embankment erosion behind south footing and abutment (Sept. 24, 2020)

Element Group:	Embankments & Streams		Length:				
Element Name:	Embankments		Width:				
Location:			Height:				
Material:	Earth / Stone		Count:				
Element Type:			Total Quantity:	6			
Environment:	Moderate		Limited Insp'n:				
Protection System:							
Condition Data:	Units	Exc.	Good	Fair	Poor	Perform. Deficiencies	Maint. Needs
	Each			4	2	Yes	Yes
Comments:	Stone and well vegetated Earth embankments with some erosion observed along the back of the wingwall.						
Recommended Work:	None 6-10 Years <input checked="" type="checkbox"/> 1-5 Years < 1 Year Urgent Stabilize the eroded slopes by adding rip rap and/or rock protection.

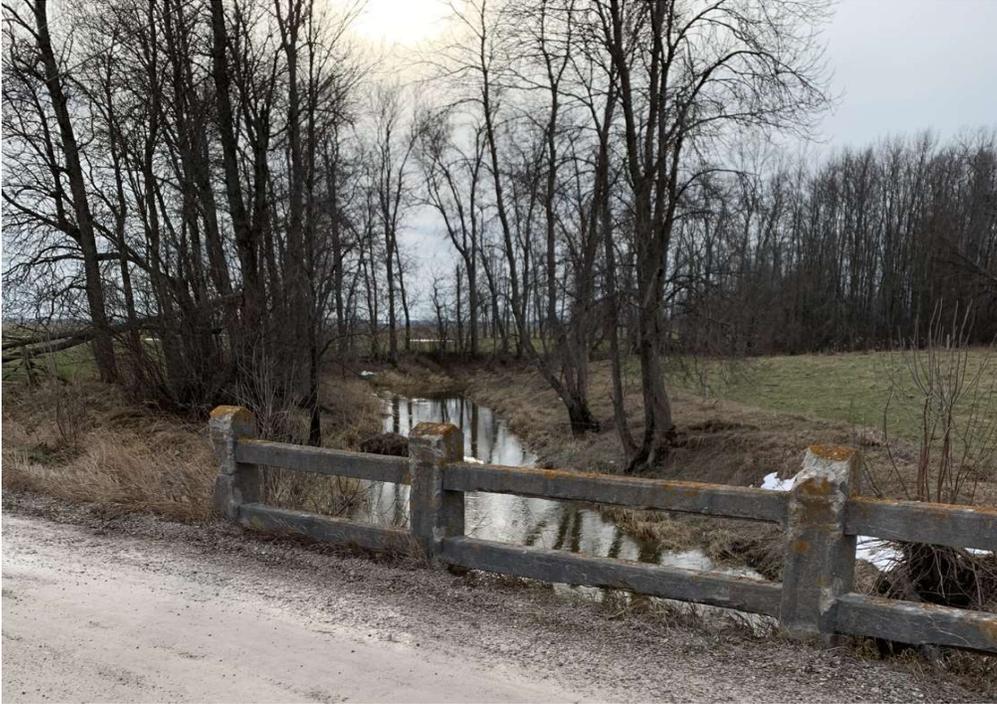
Photo 1-10 - View of watercourse upstream

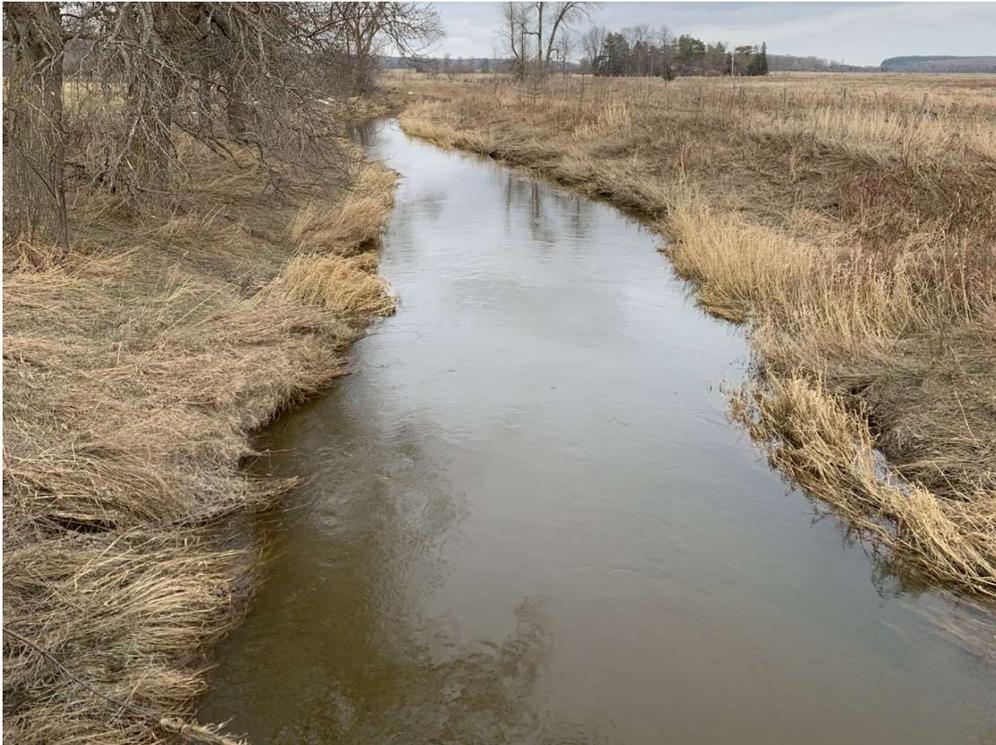
Photo 1-11- View of watercourse downstream

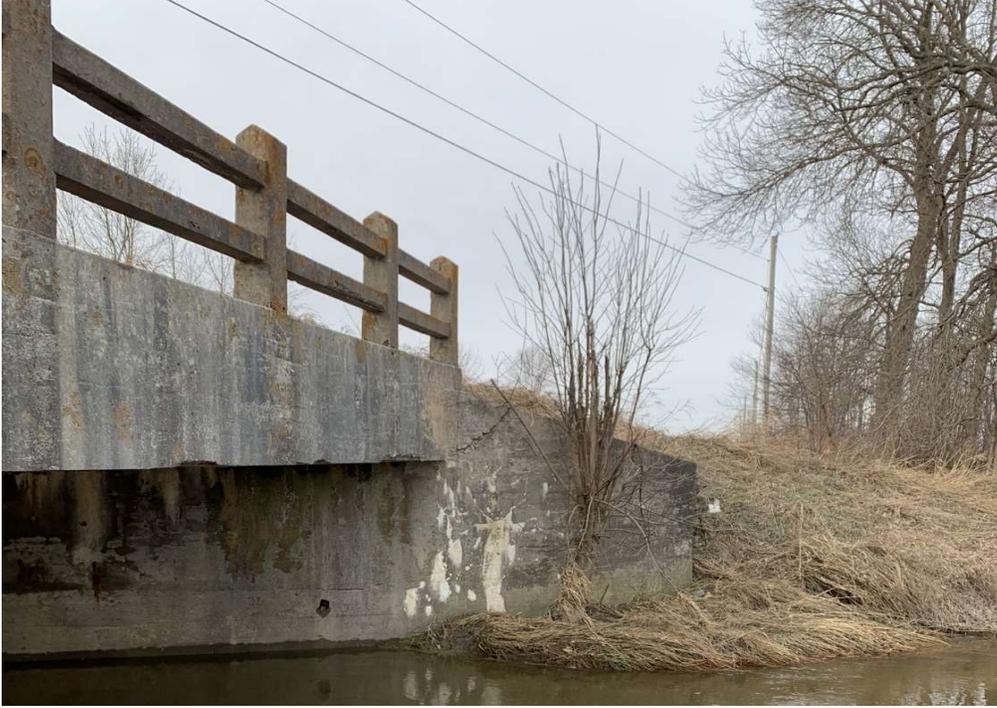
Photo 1-12 - Abutment wall drain and wingwall

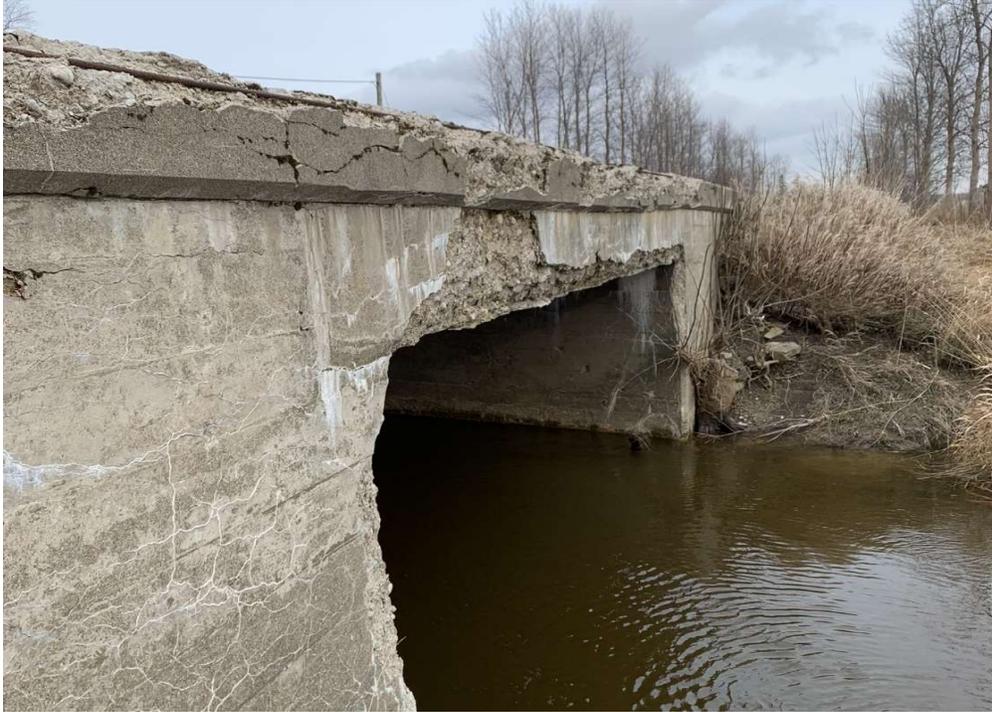
Photo 2-4: West abutment and south exterior soffit

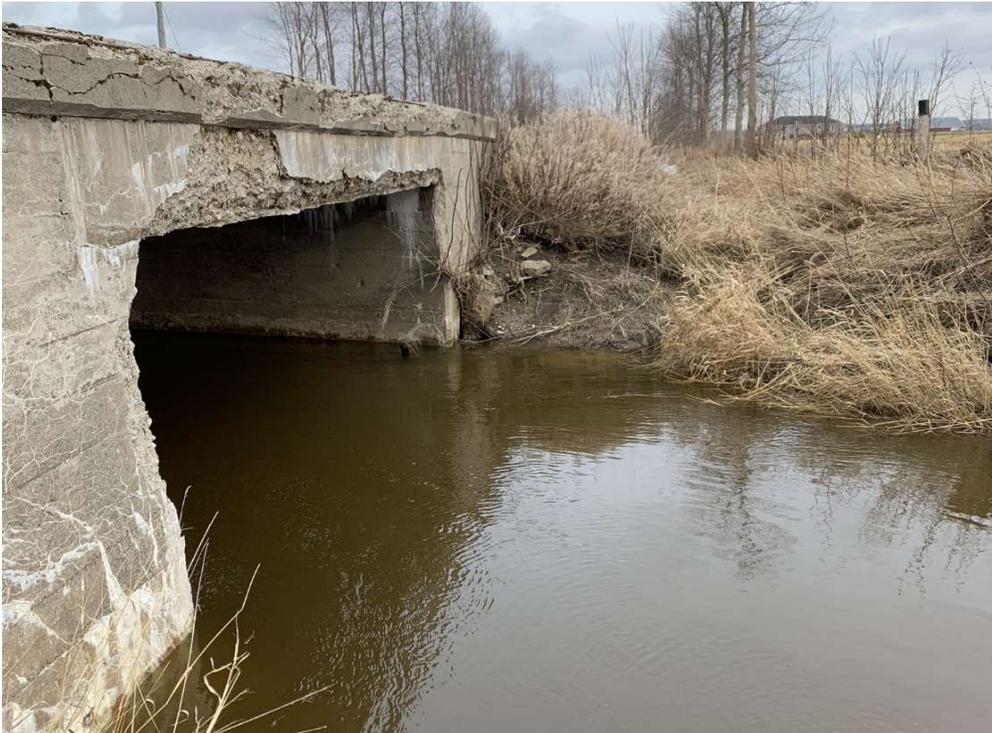
Photo 2-5: Structure elevation, wingwalls, exterior curb and soffit

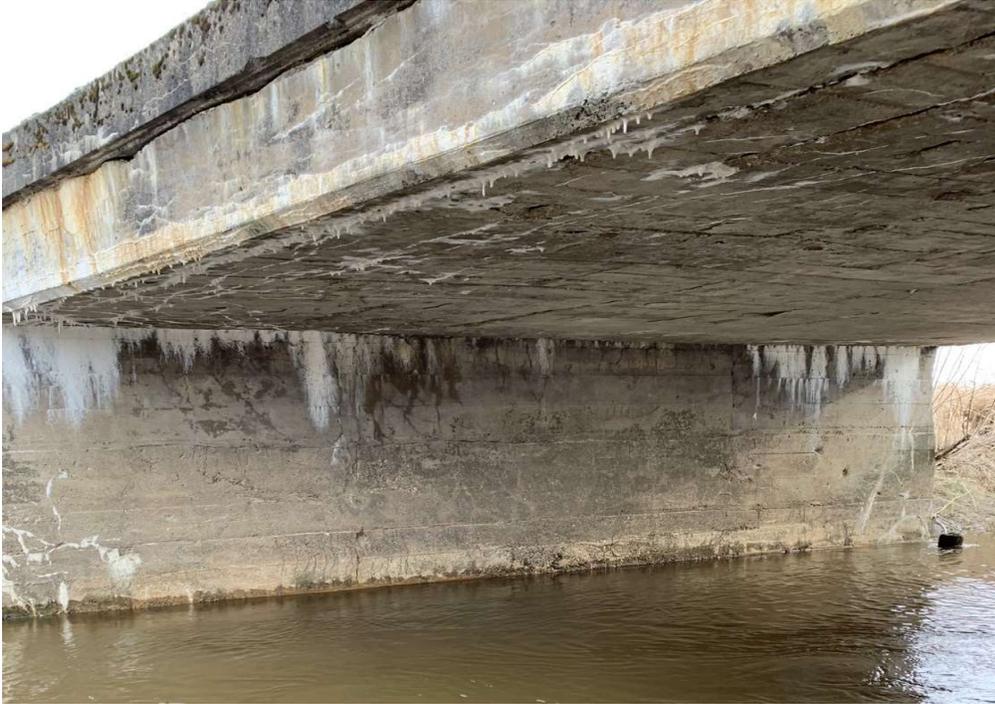
Photo 2-6: Extreme efflorescence at joints

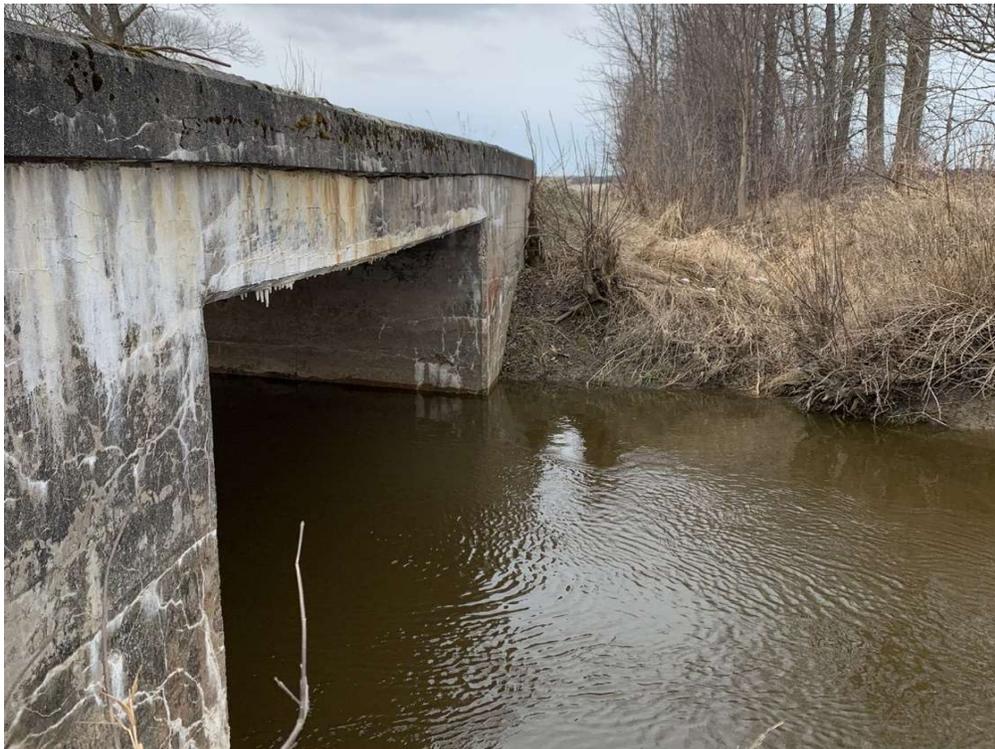
Photo 2-7: Erosion at structure footing, efflorescence of wingwall (typ)

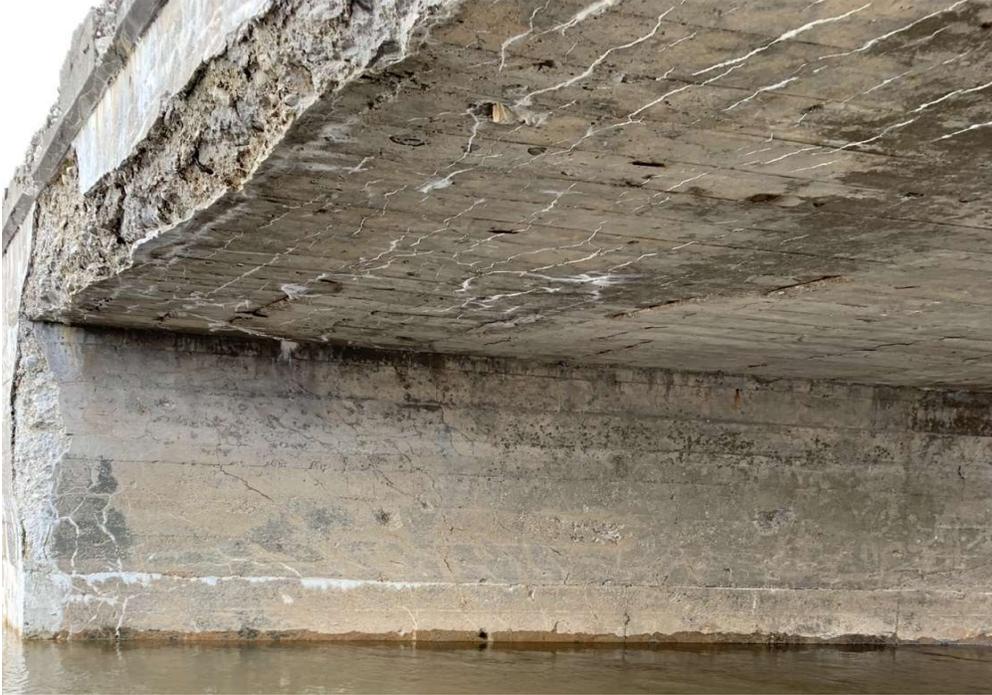
Photo 2-8: Delamination of soffit

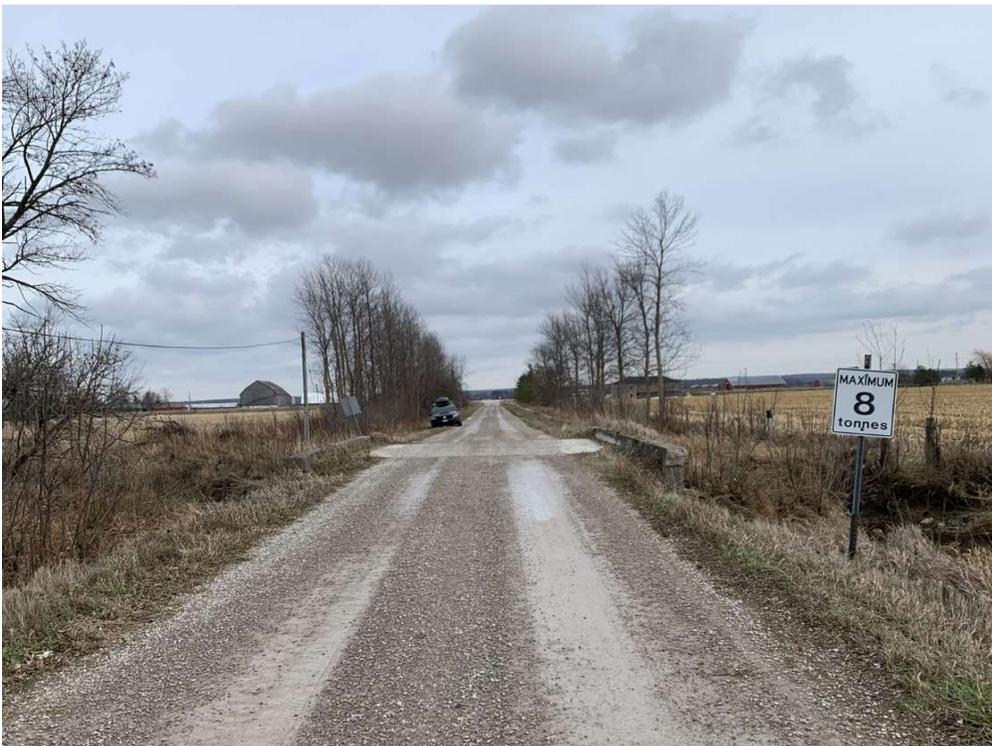
Photo 2-9: Load limit posting

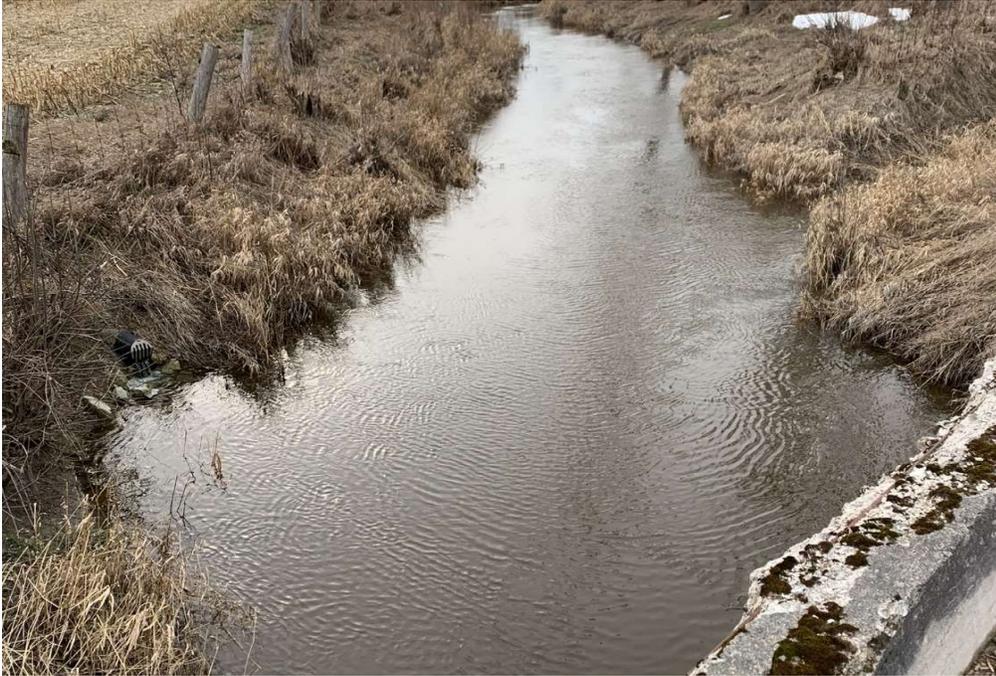
Photo 2-10: View of watercourse upstream

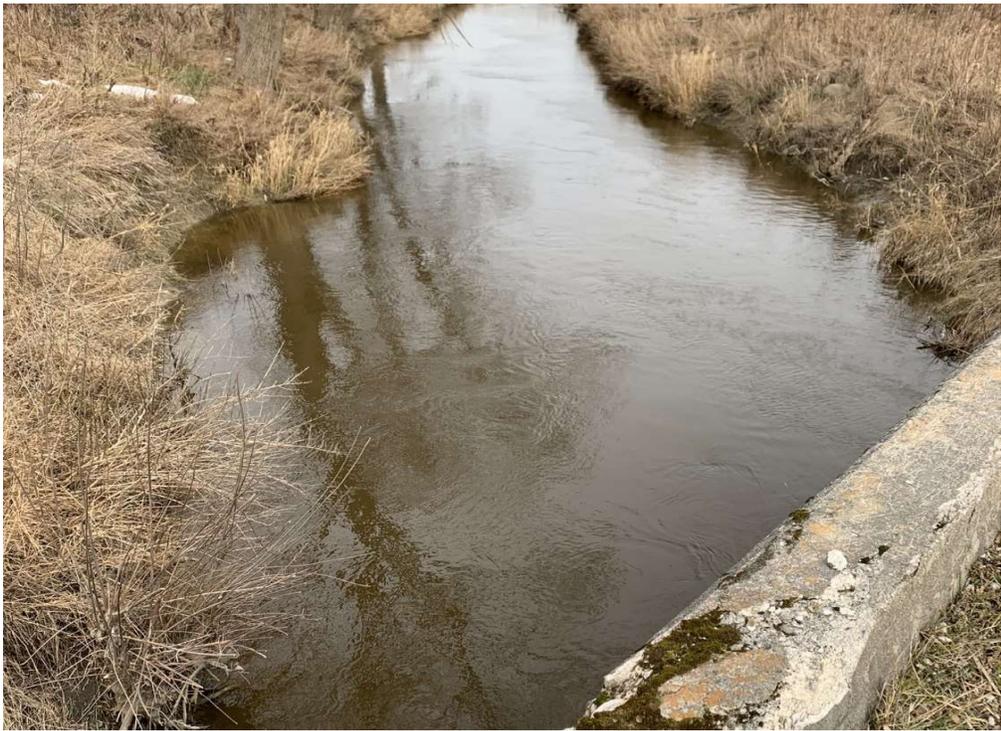
Photo 2-11: View of watercourse downstream

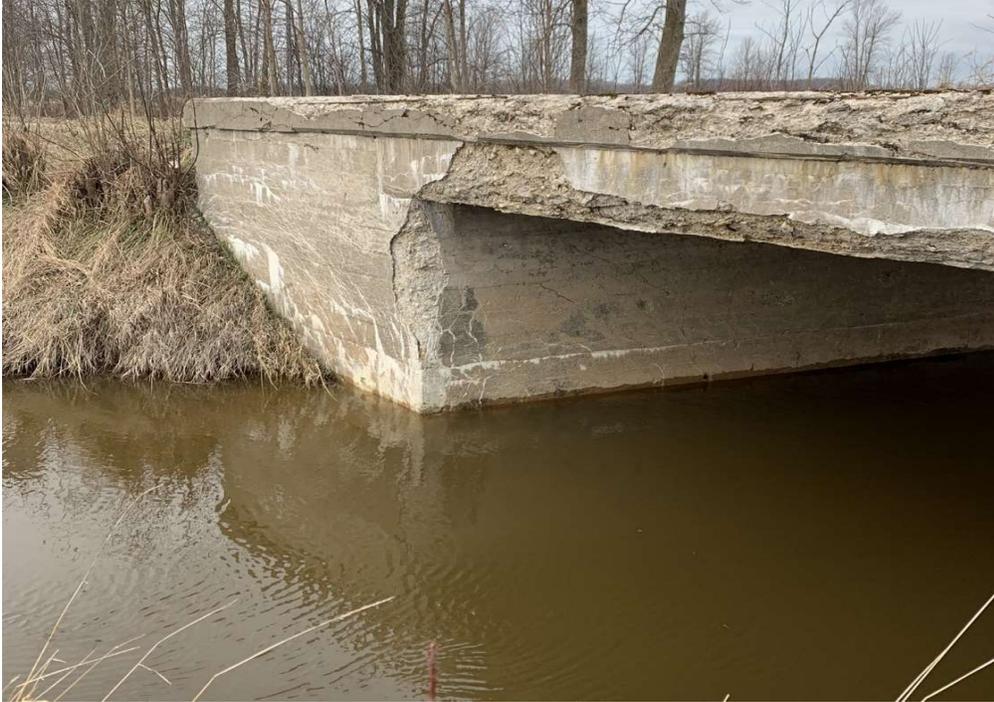
Photo 2-12: Wingwall, abutment wall and exterior soffit delamination.

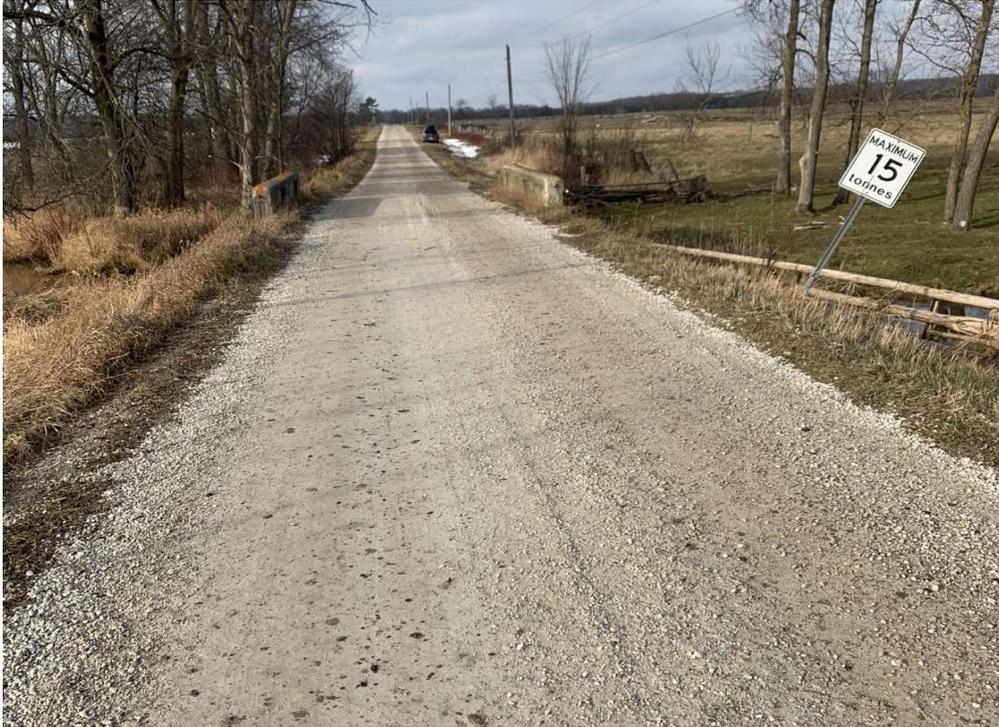
Photo 3-2: View of structure from the south approach

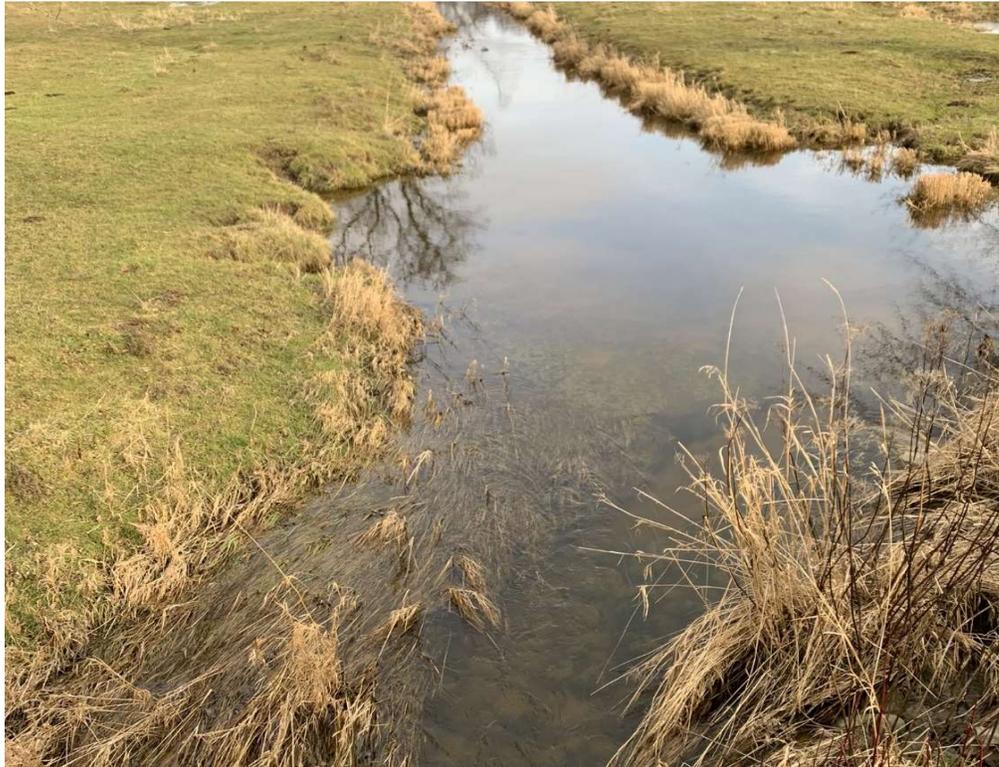
Photo 3-3: View of upstream watercourse

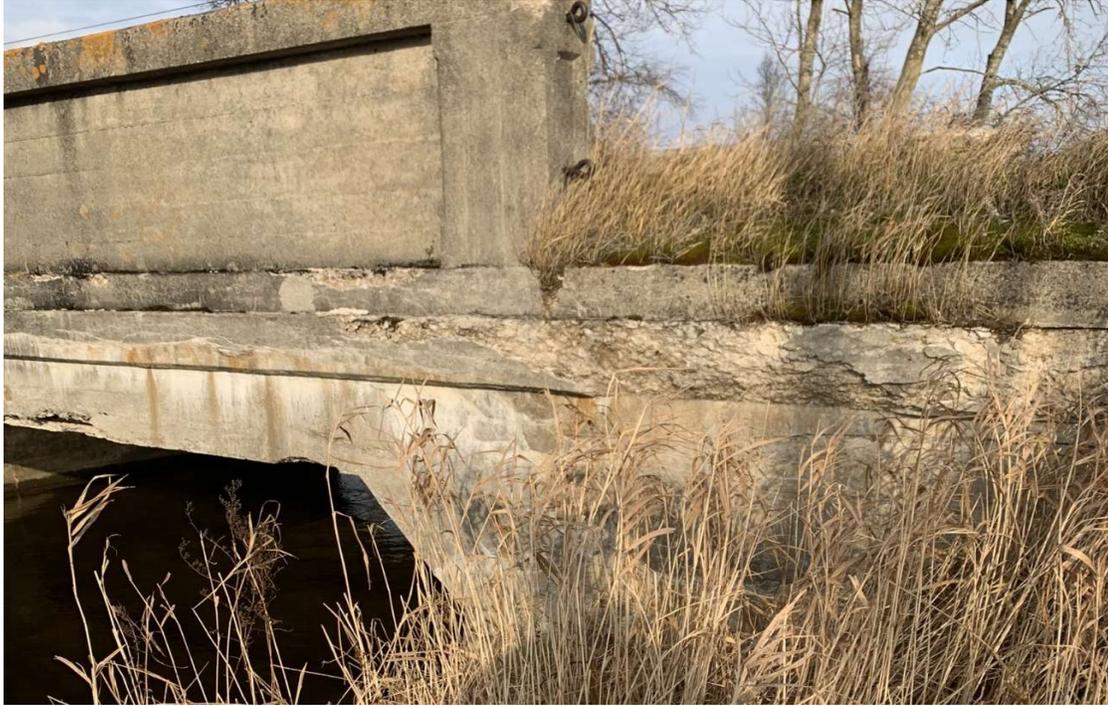
Photo 3-6: East structure elevation, exterior girder and barrier wall

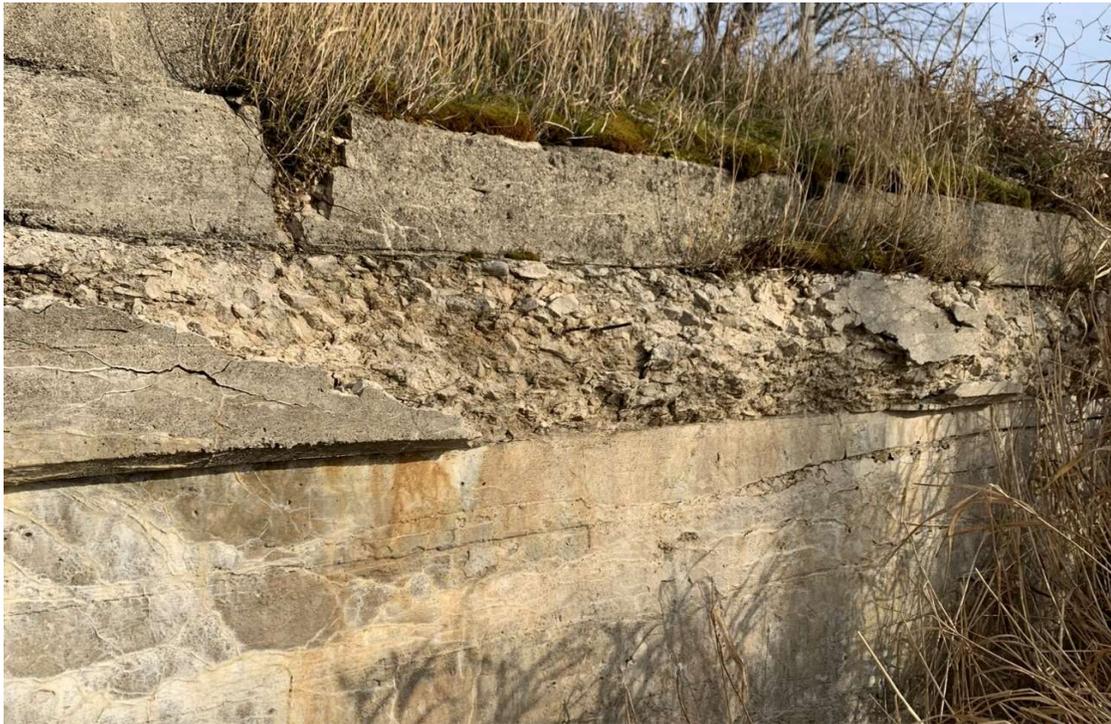
Photo 3-7: Wingwall and exterior curb (typical)

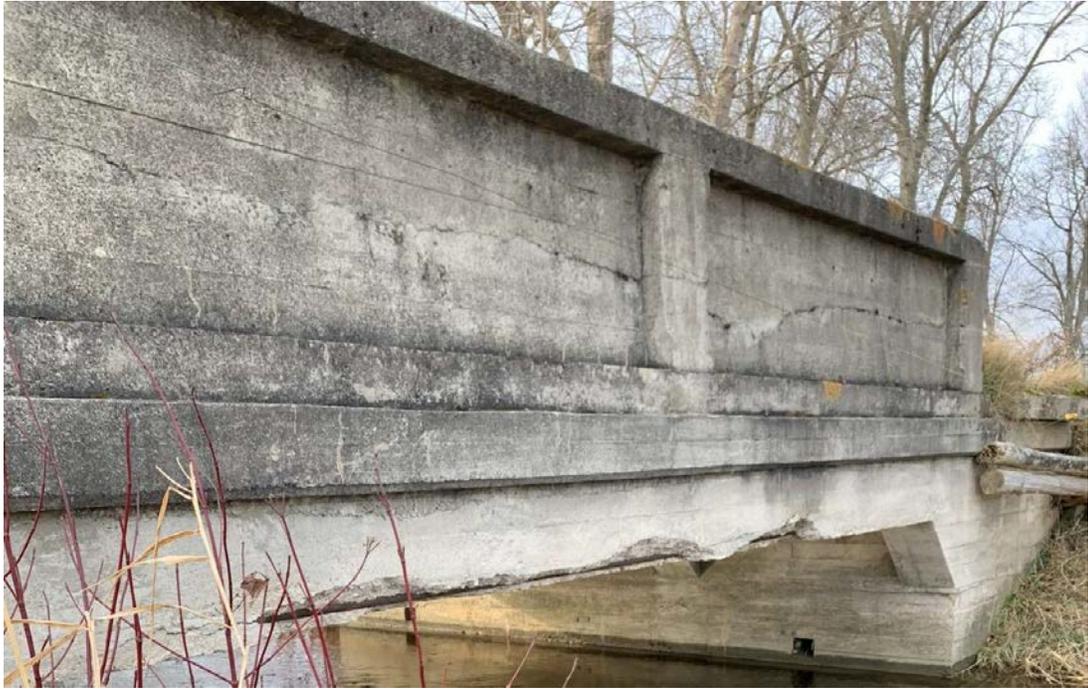
Photo 3-10: View of west structure elevation, exterior girder and barrier wall

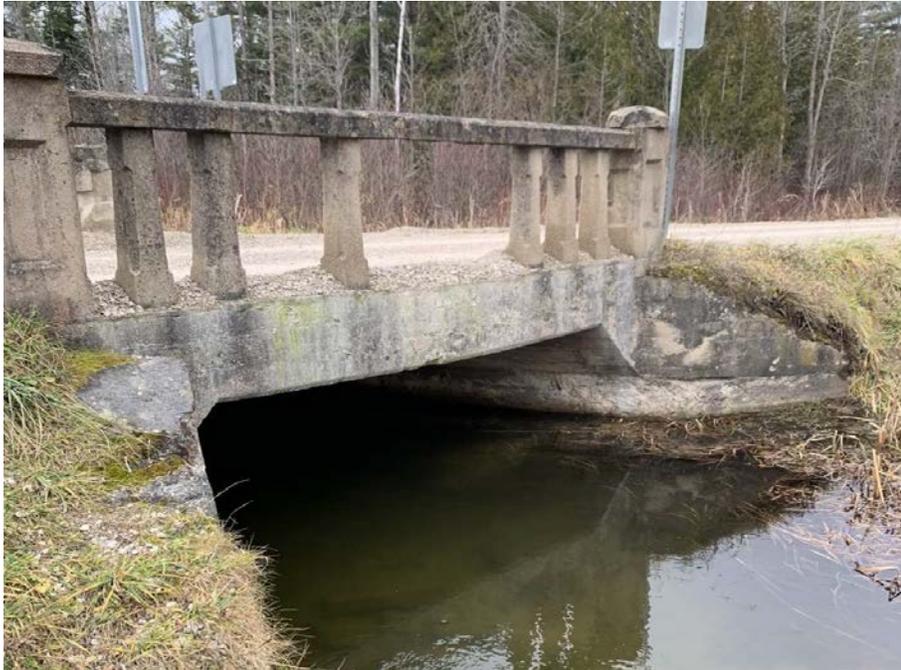
Photo 4-2: View of east structure elevation, wingwalls, exterior curb and barrier

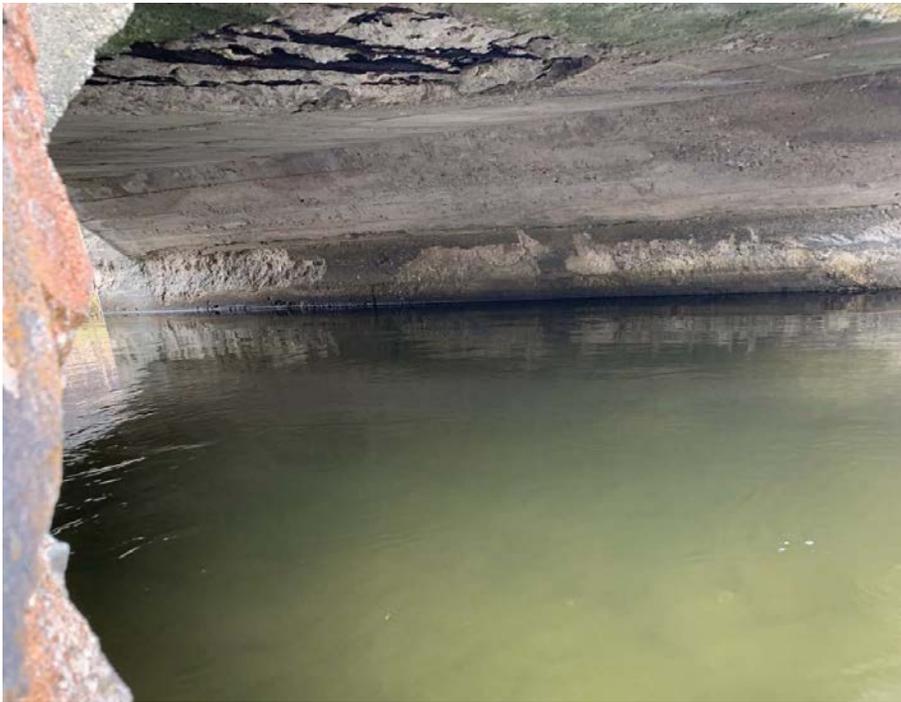
Photo 4-3: View of soffit and abutment wall

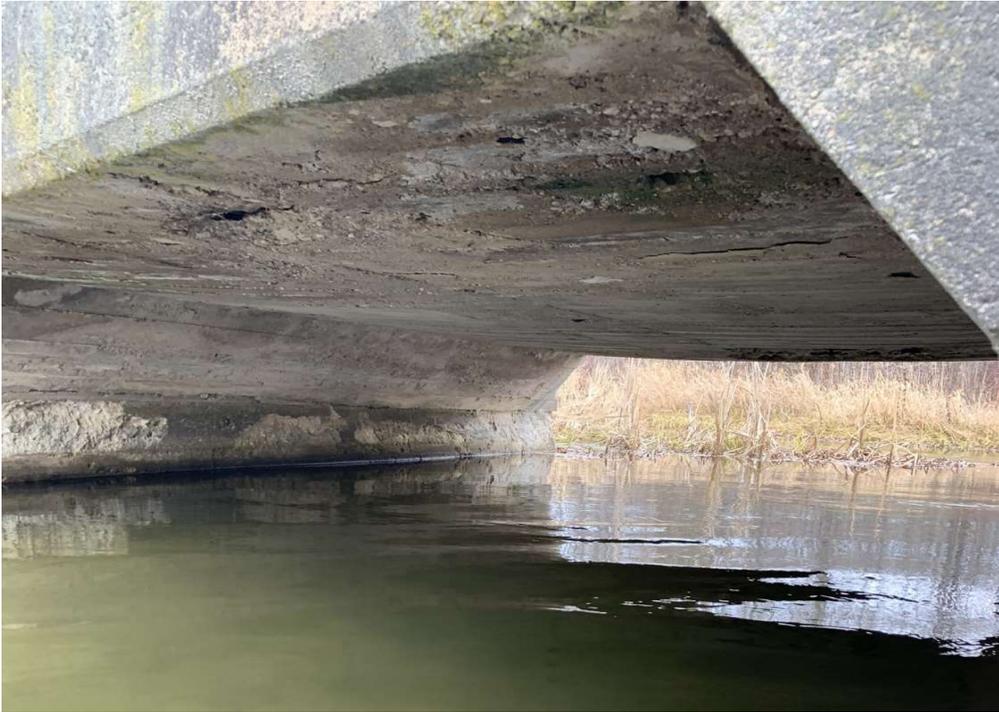
Photo 4-4: View of soffit

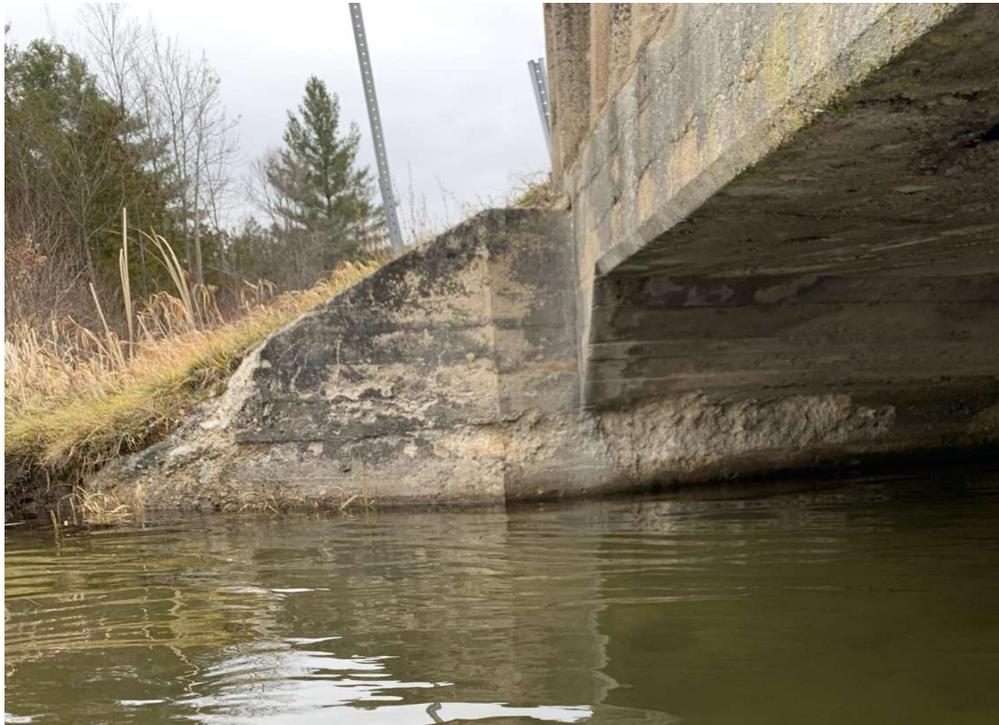
Photo 4-6: View of south abutment wall

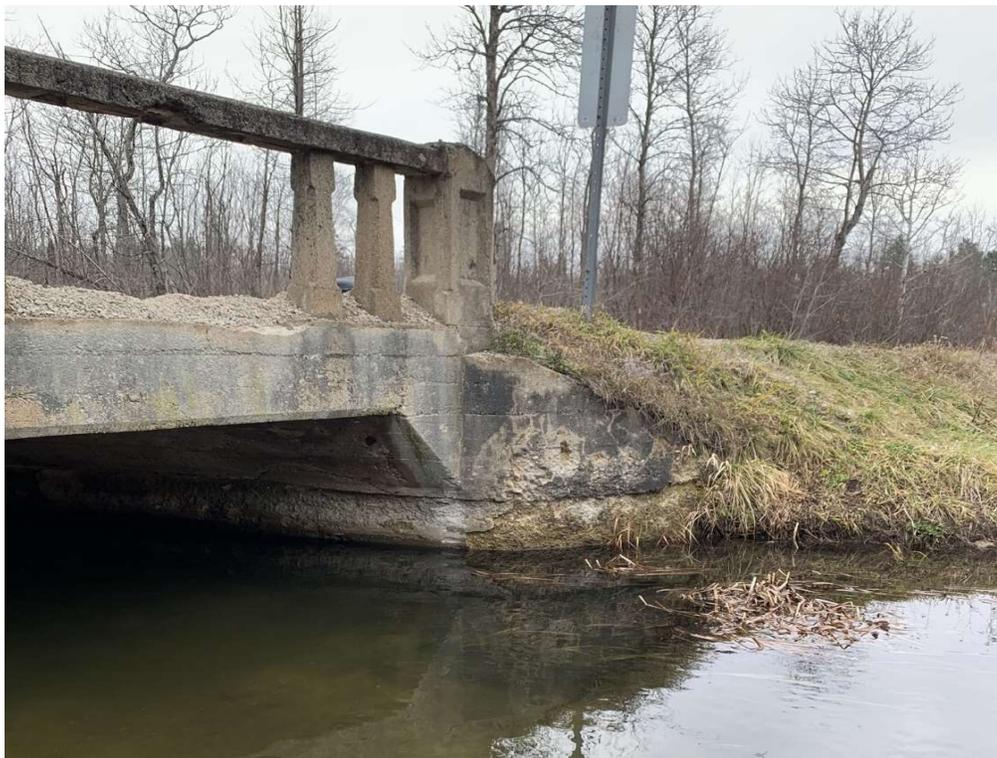
Photo 4-7: View of west structure elevation, exterior soffit, curb and barrier

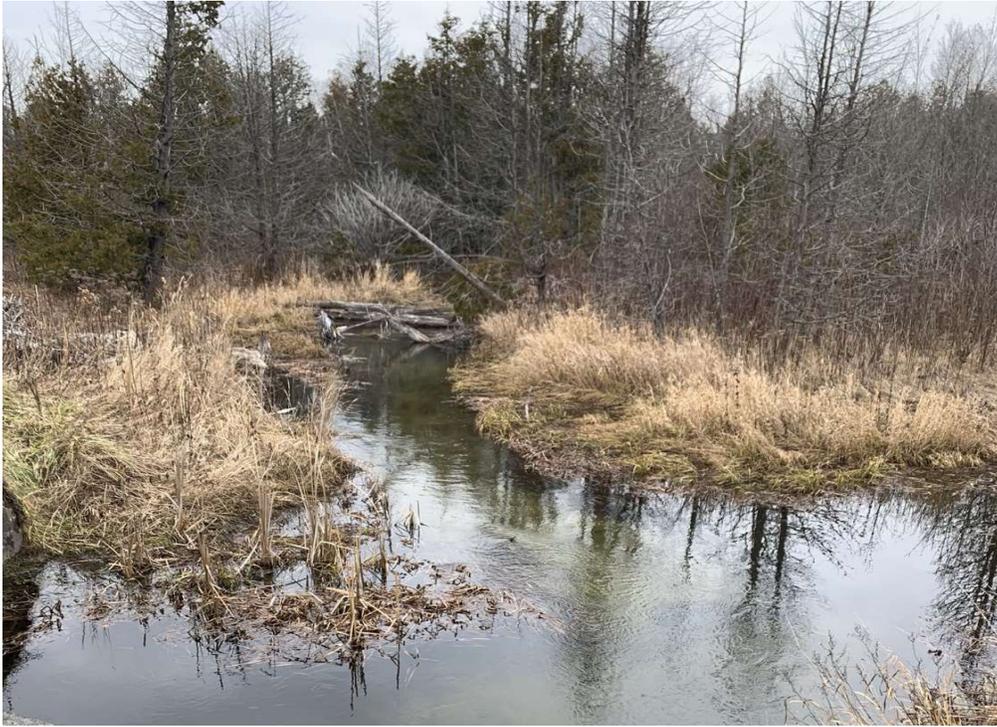
Photo 4-8: View of watercourse upstream

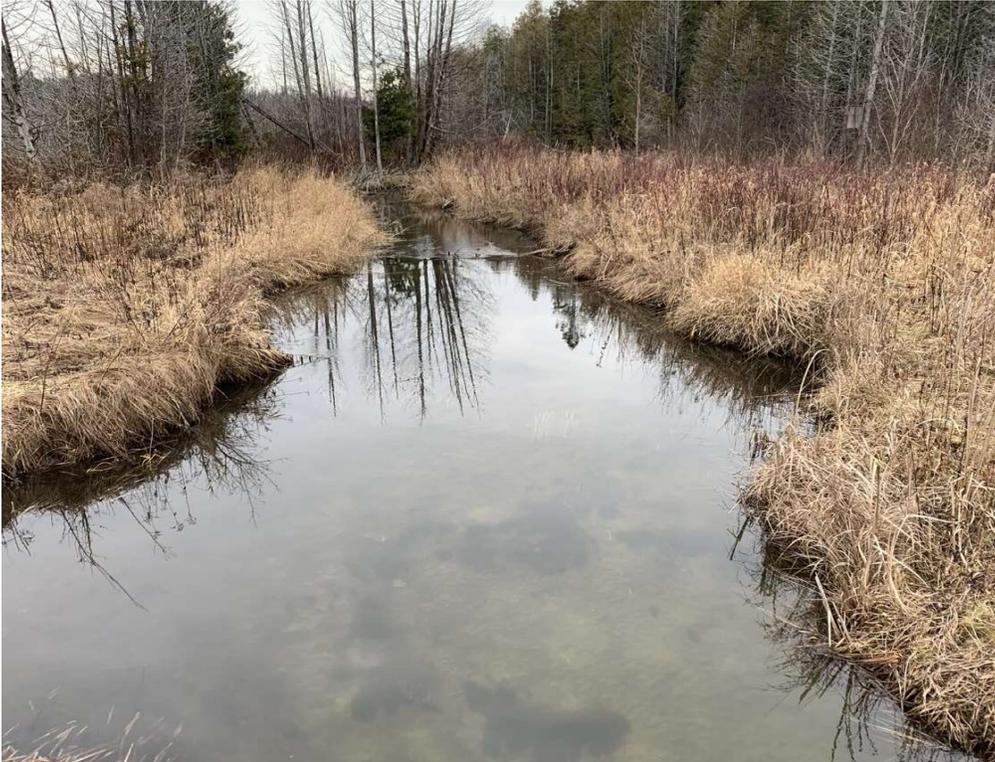
Photo 4-9: View of watercourse downstream

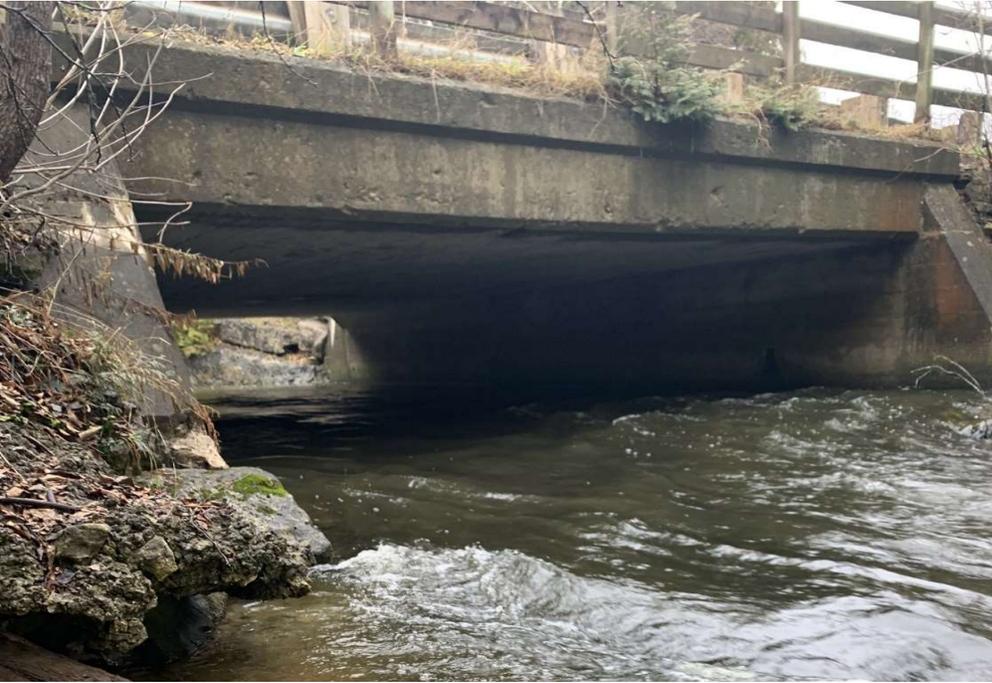
Photo 5-2: View of south structure elevation, exterior curb and soffit, wingwalls and slope protection

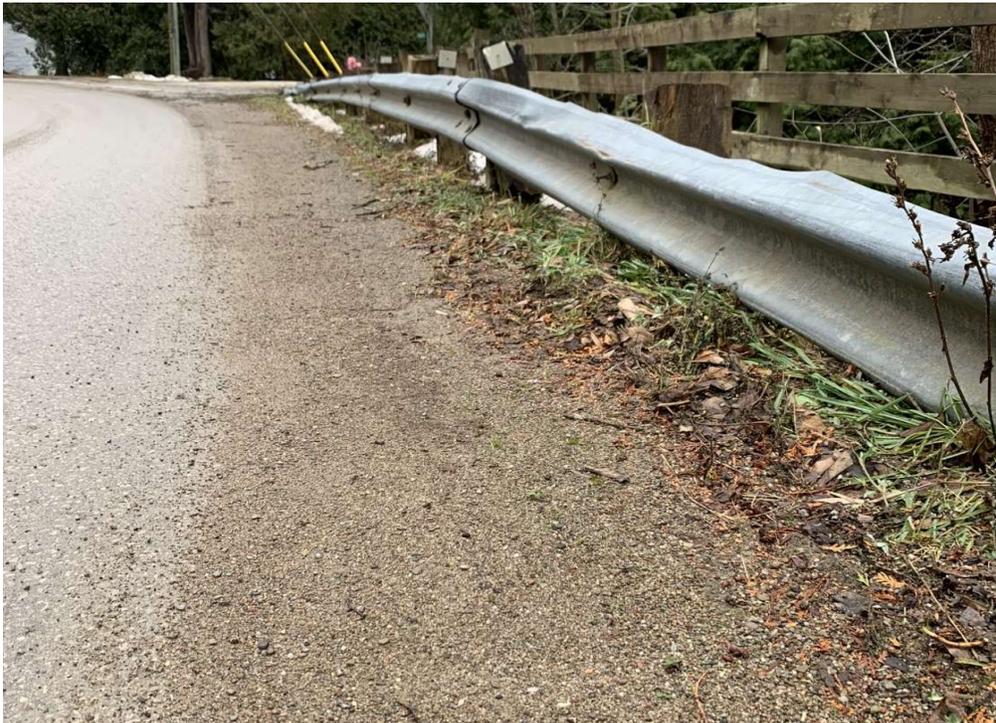
Photo 5-5: Pedestrian (south side only) and structure barrier (typ)

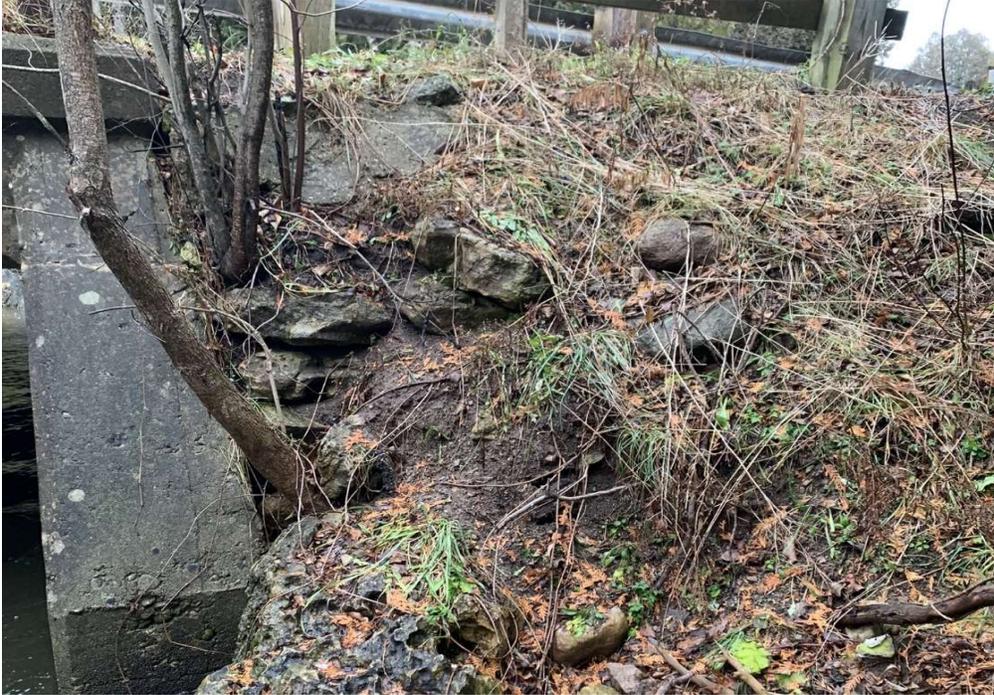
Photo 5-6: Southeast structure embankment erosion

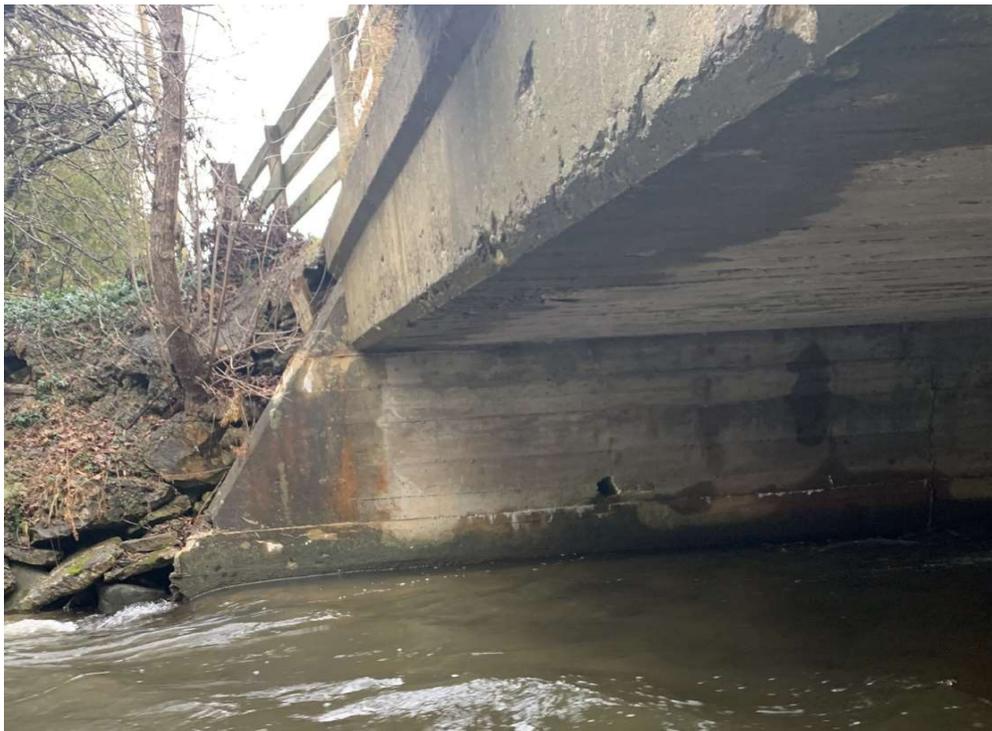
Photo 5-7: View of structure exterior soffit and curb

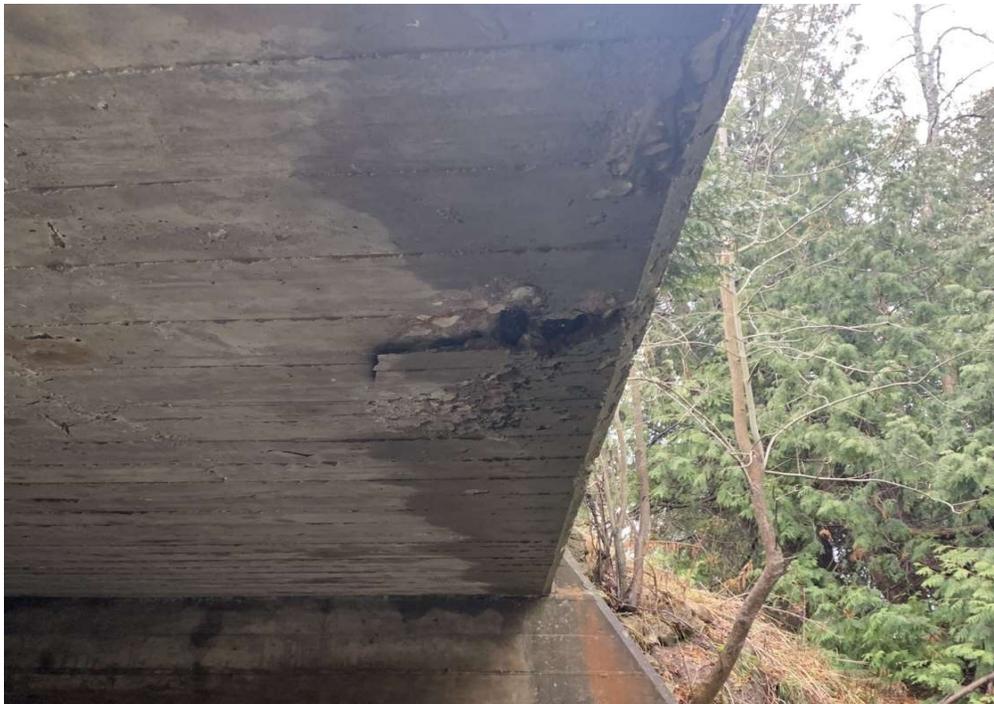
Photo 5-8: View of structure soffit
