MUNICIPALITY OF NORTHERN BRUCE PENINSULA

2022 STRUCTURE INSPECTION REPORT

FINAL
PROJECT NO.: 201-01605-00
DATE: APRIL 03, 2023

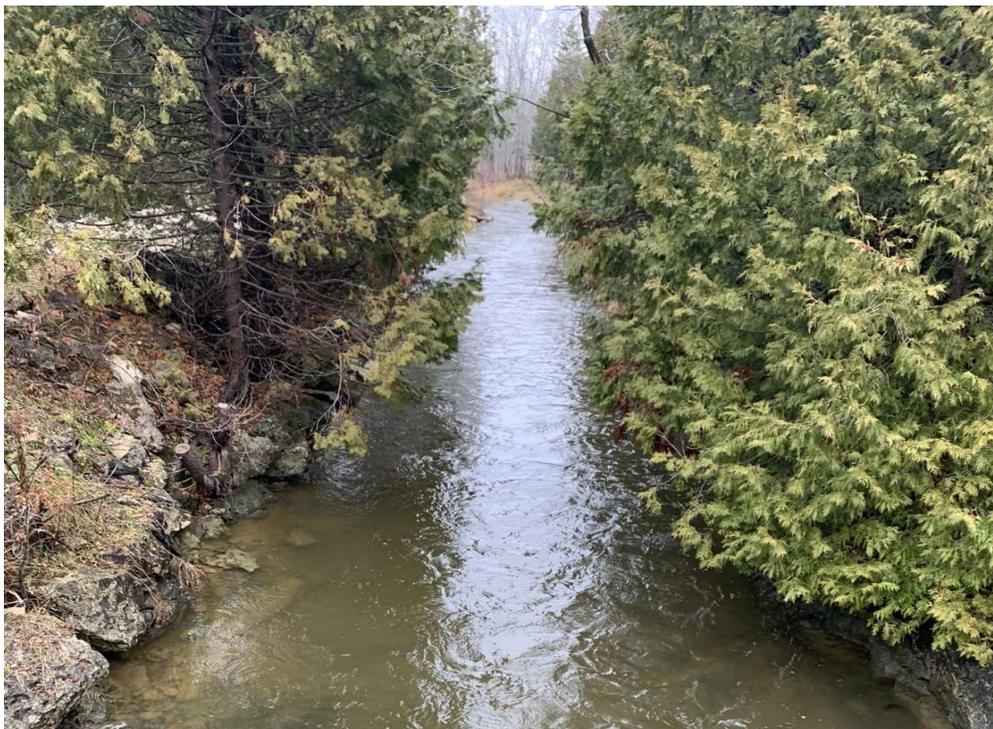
Photo 5-9: View of upstream watercourse

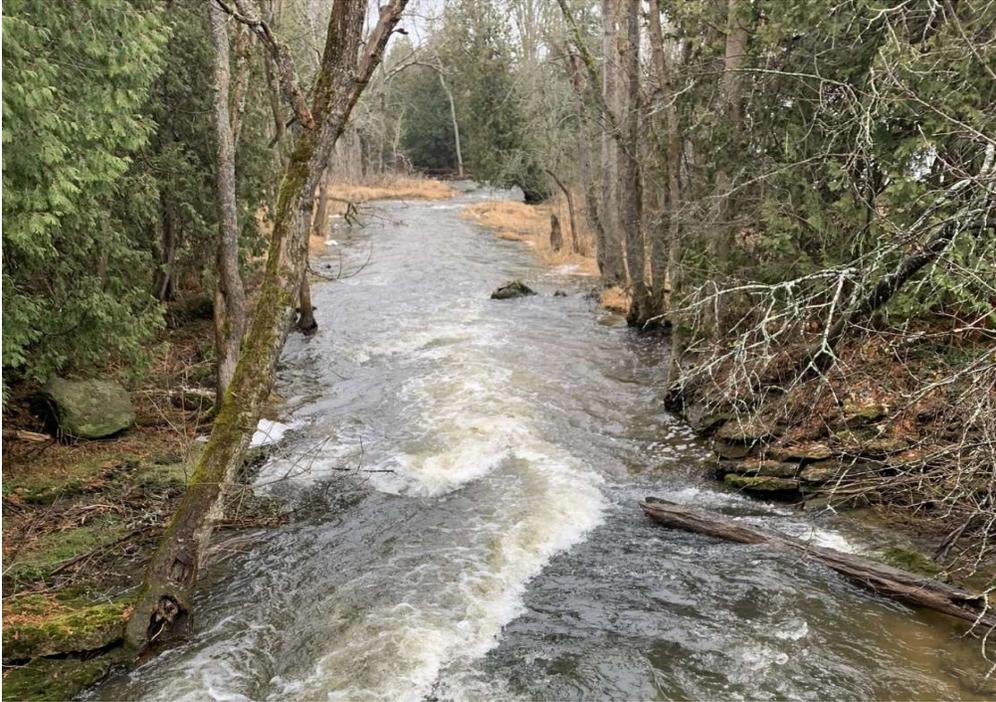
Photo 5-10: View of downstream watercourse

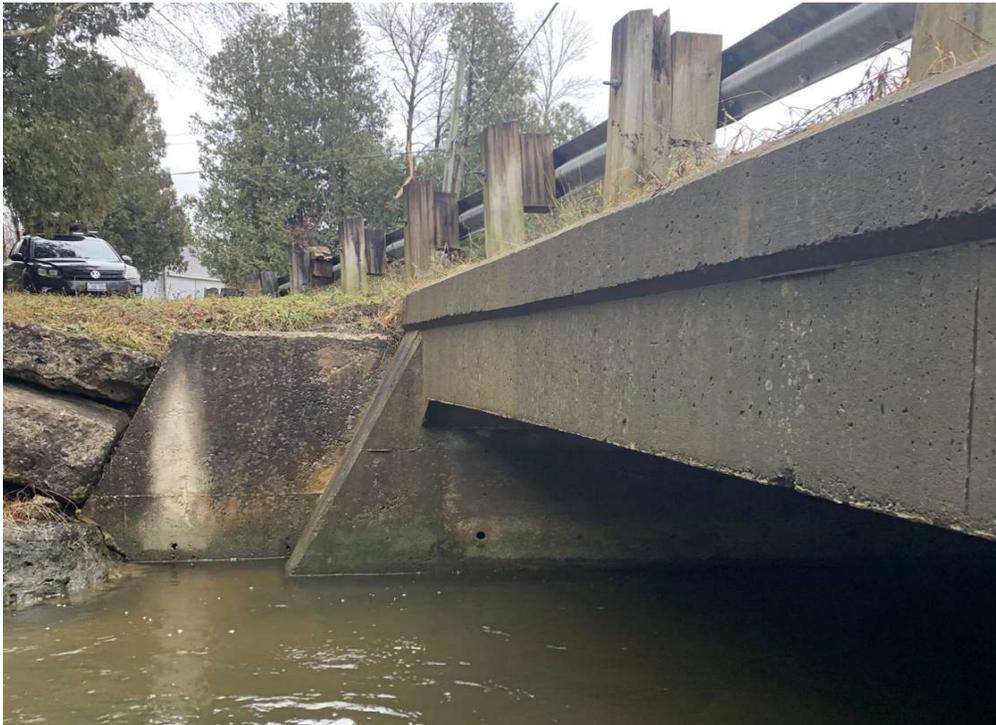
Photo 5-11: View of north structure elevation, exterior curb and soffit and northwest wingwall

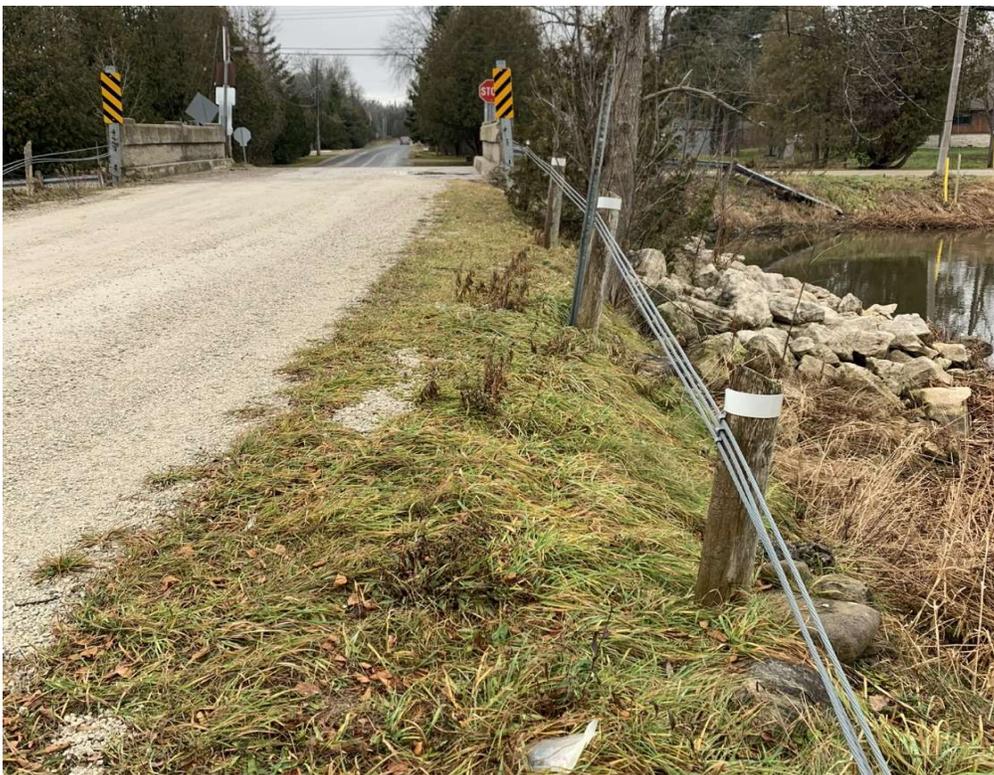
Photo 6-3: View of structure from south approach

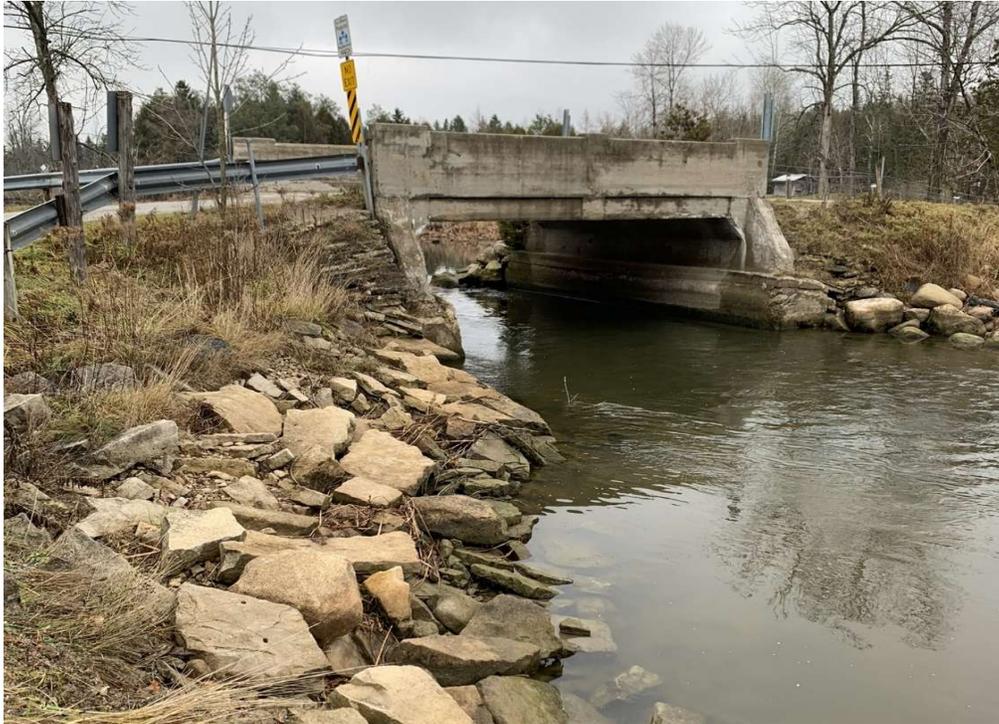
Photo 6-4: View of west structure elevation, slope protection and exterior of parapet wall

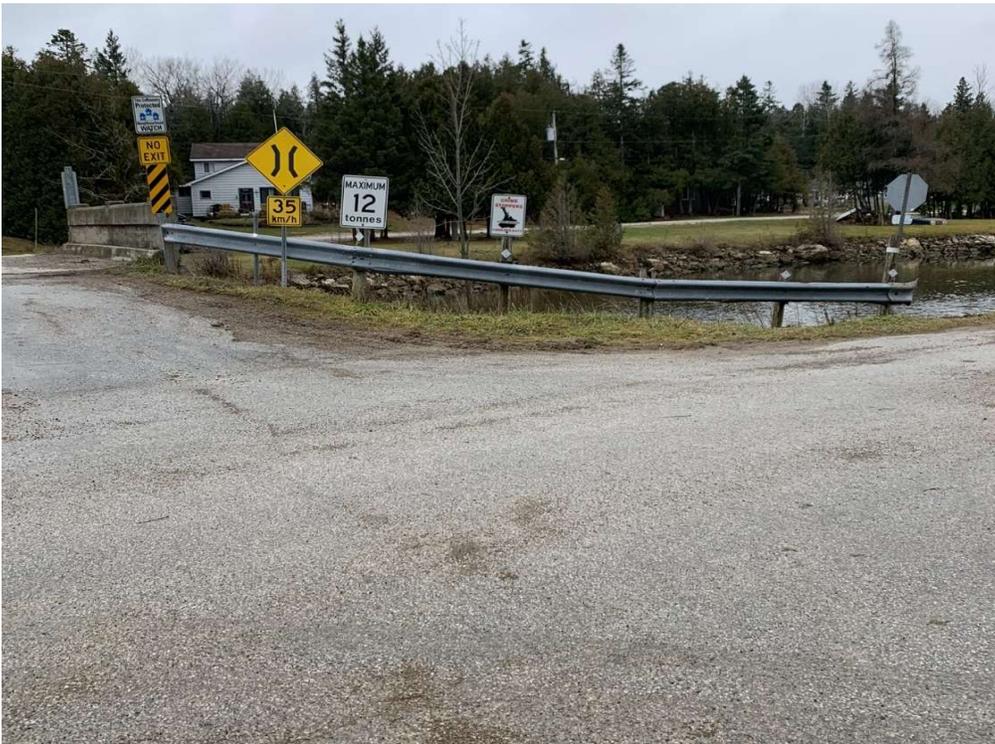
Photo 6-5: View of approach barrier flex beam and wood posts

Element Group:	Approaches		Length:				
Element Name:	Guiderail		Width:				
Location:			Height:				
Material:	Steel/Timber		Count:				
Element Type:	3 - Cable and Flex Beam		Total Quantity:				
Environment:	Severe		Limited Insp'n:				
Protection System:	Galvanized						
Condition Data:	Units	Exc.	Good	Fair	Poor	Perform. Deficiencies	Maint. Needs
	%			25	75	Yes	Yes
Comments:	The configuration of the flex beam on the north side of the structure does not meet Code. There are missing intermediate posts, improper connections to the structure parapet walls, and lack end protection. The 3-cable guiderail on the south approach is set too high, the cable is loose, several posts are broken, and the structure connection is not to code.						
Recommended Work:	None 6-10 Years <input type="checkbox"/> 1-5 Years <input checked="" type="checkbox"/> < 1 Year Urgent Upgrade the north approach barrier protection and structure connection to meet current code. Replace the 3-cable south side barrier with flex beam.

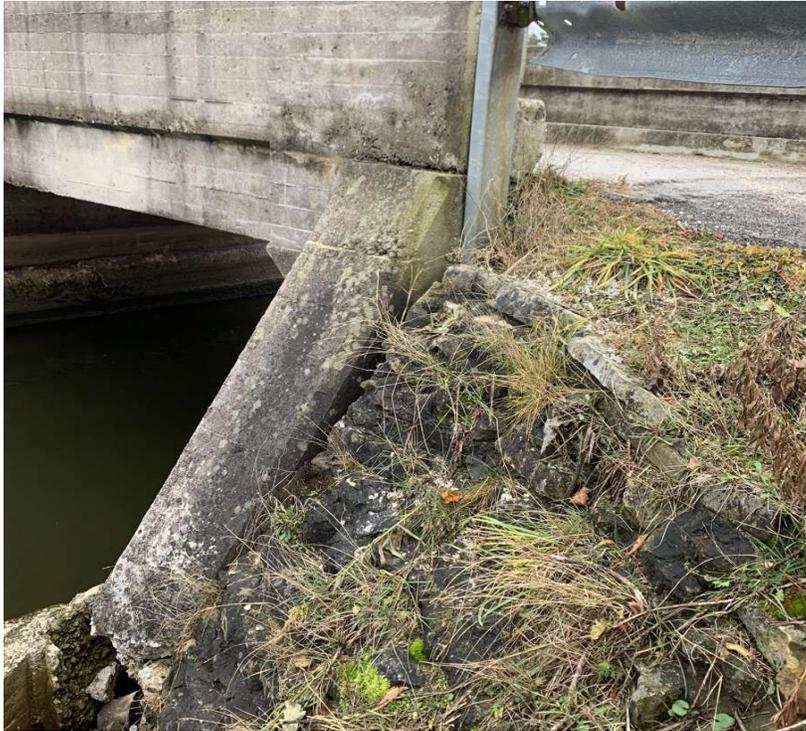
Photo 6-6: View of west structure elevation, wingwalls, exterior curb and parapet wall

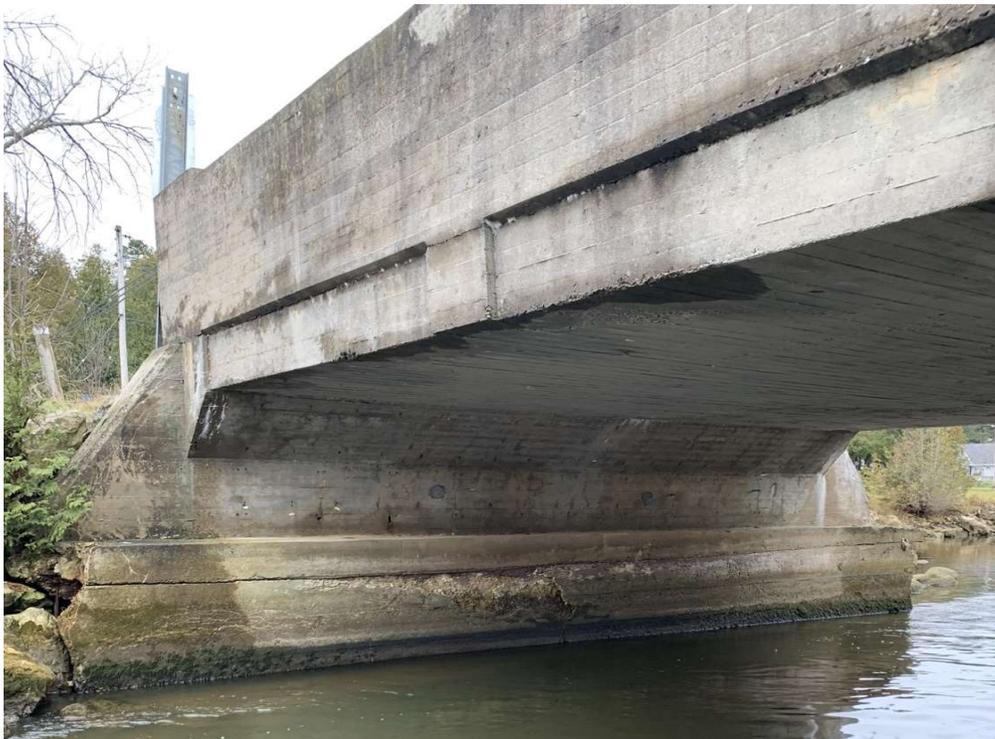
Photo 6-7: View of structure soffit and footing/abutment wall.

Element Group:	Abutments		Length:				
Element Name:	Abutment Walls		Width:	7.8			
Location:			Height:	0.64			
Material:	Concrete		Count:	2			
Element Type:			Total Quantity:	9.98 m ²			
Environment:	Moderate		Limited Insp'n:				
Protection System:							
Condition Data:	Units	Exc.	Good	Fair	Poor	Perform. Deficiencies	Maint. Needs
	m ²			8.98	1		
Comments:	Surface cracking & spalling observed throughout the abutment walls.						
Recommended Work:	None 6-10 Years <input checked="" type="checkbox"/> 1-5 Years < 1 Year Urgent Remove all poor concrete, clean reinforcing steel, and replace concrete.

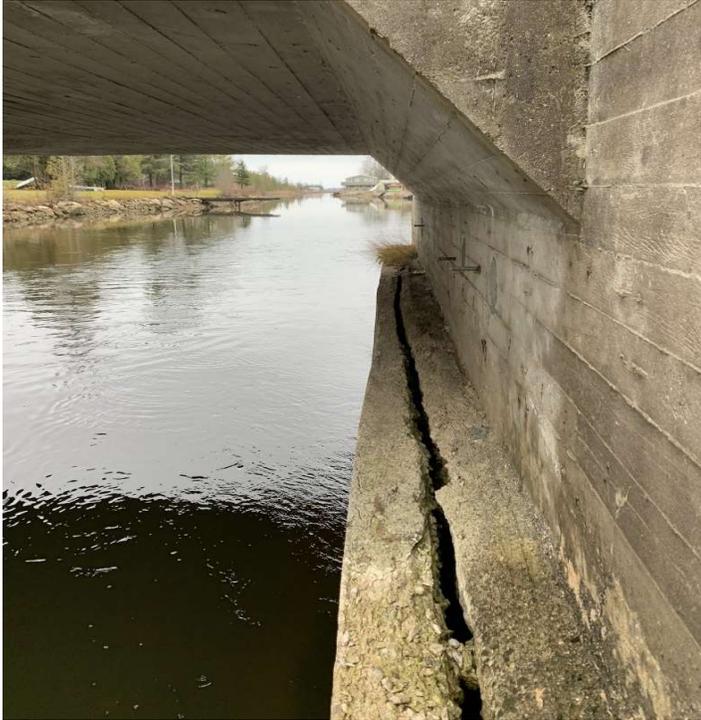
Photo 6-8: View of foundation crack/separation and abutment wall

Element Group:	Foundations		Length:				
Element Name:	Foundation (below ground level)		Width:	9.5			
Location:			Height:	0.85			
Material:	Concrete		Count:	2			
Element Type:			Total Quantity:	16.15			
Environment:	Moderate		Limited Insp'n:				
Protection System:							
Condition Data:	Units	Exc.	Good	Fair	Poor	Perform. Deficiencies	Maint. Needs
	m ²				16.15	Yes	
Comments:	Footings are exhibiting severe spalling and delamination. Both footings are severely split longitudinally throughout, and are separating from the abutment walls. Damaged inlet wingwalls allowing water to flow through cracked sections causing concrete erosion and undermining the structure. Concrete between separation is very soft and unstable.						
Recommended Work:	None 6-10 Years 1-5 Years < 1 Year <input type="checkbox"/> Urgent <input checked="" type="checkbox"/>						
	Replace wingwalls and repair damaged/undermined footings to prevent further erosion and complete loss of structure stability.

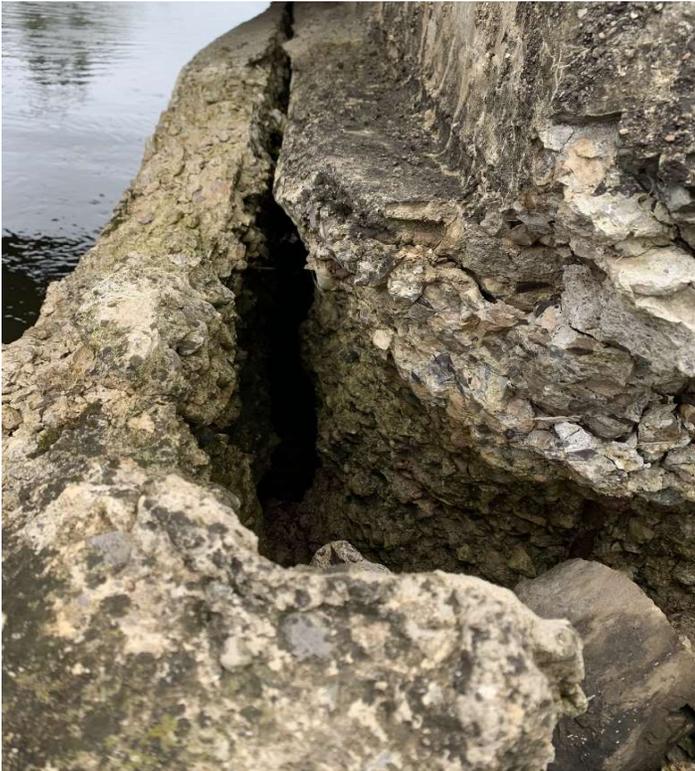
Photo 6-9: Foundation separation and concrete erosion.

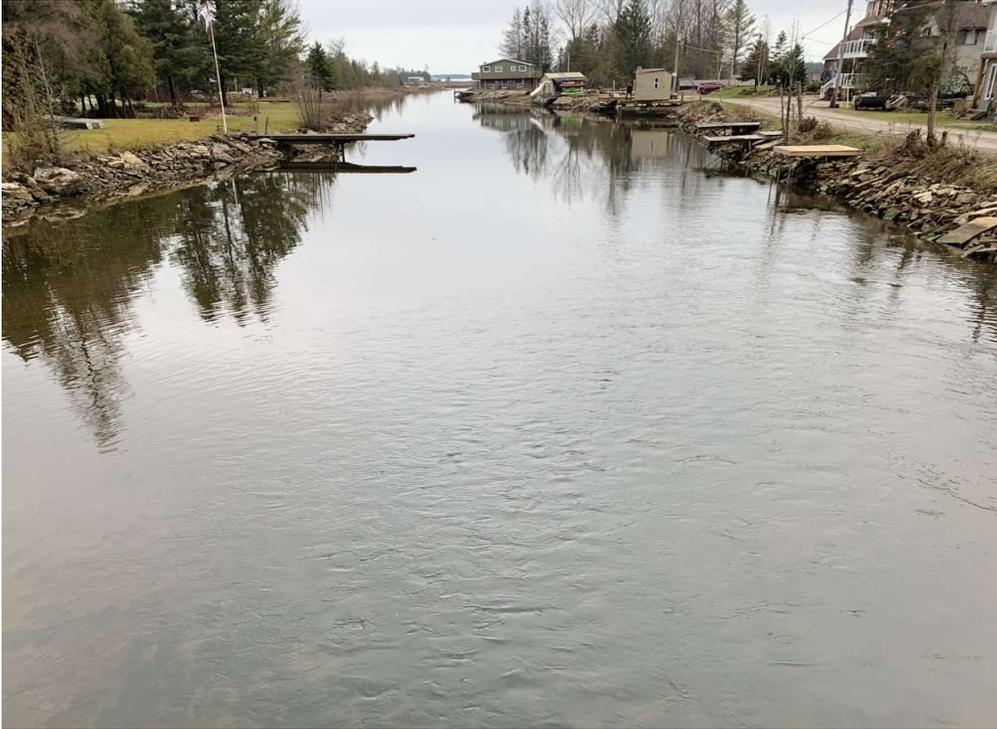
Photo 6-10: View of watercourse downstream

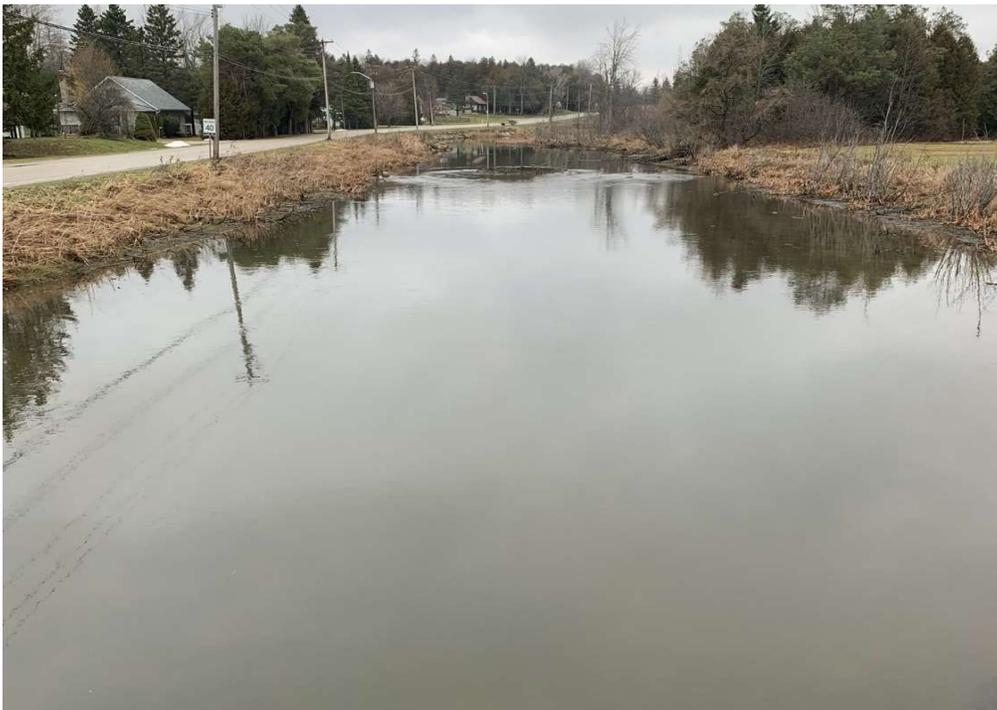
Photo 6-11: View of watercourse upstream

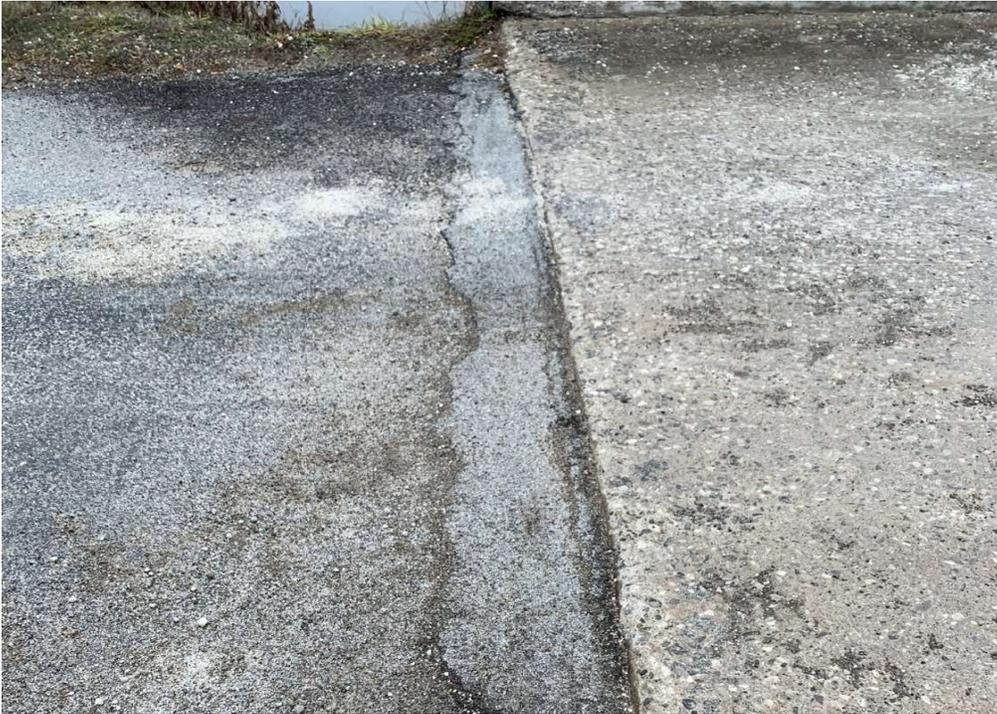
Photo 6-14: View of wearing surface

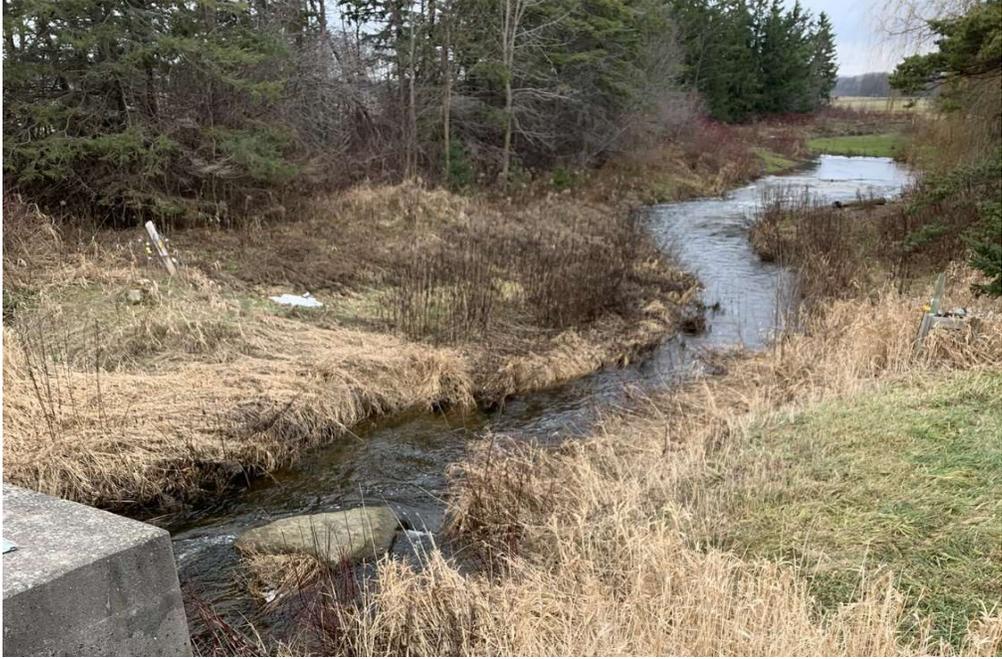
Photo 7-2: View of watercourse upstream and upstream culvert end

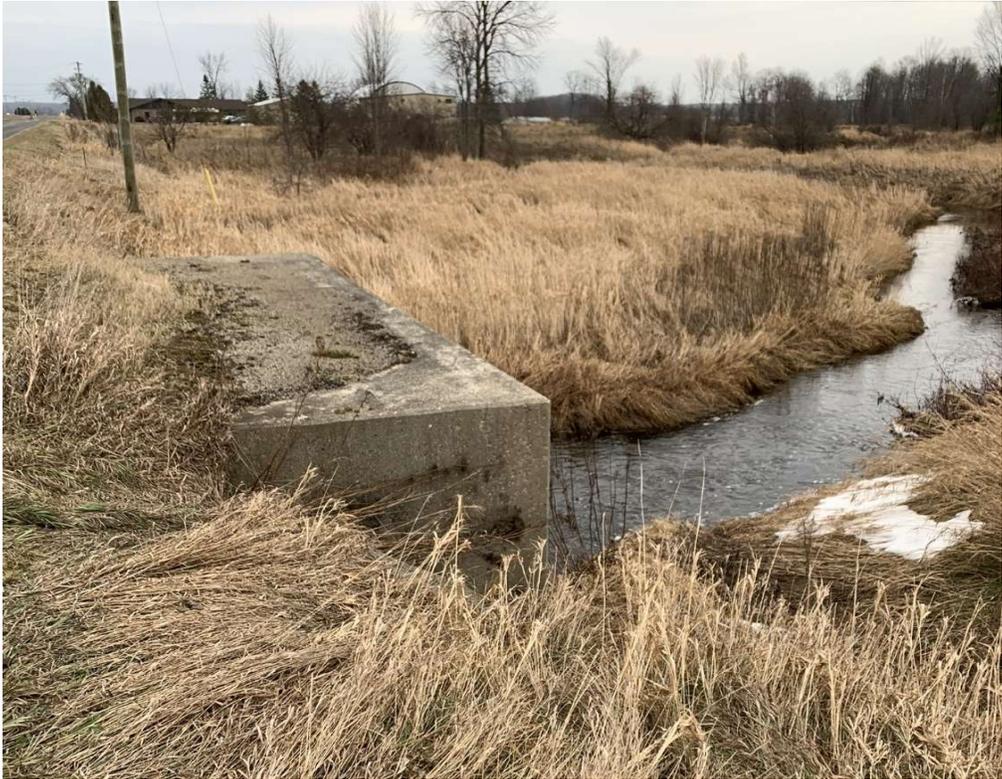
Photo 7-3: View of watercourse downstream and downstream culvert end

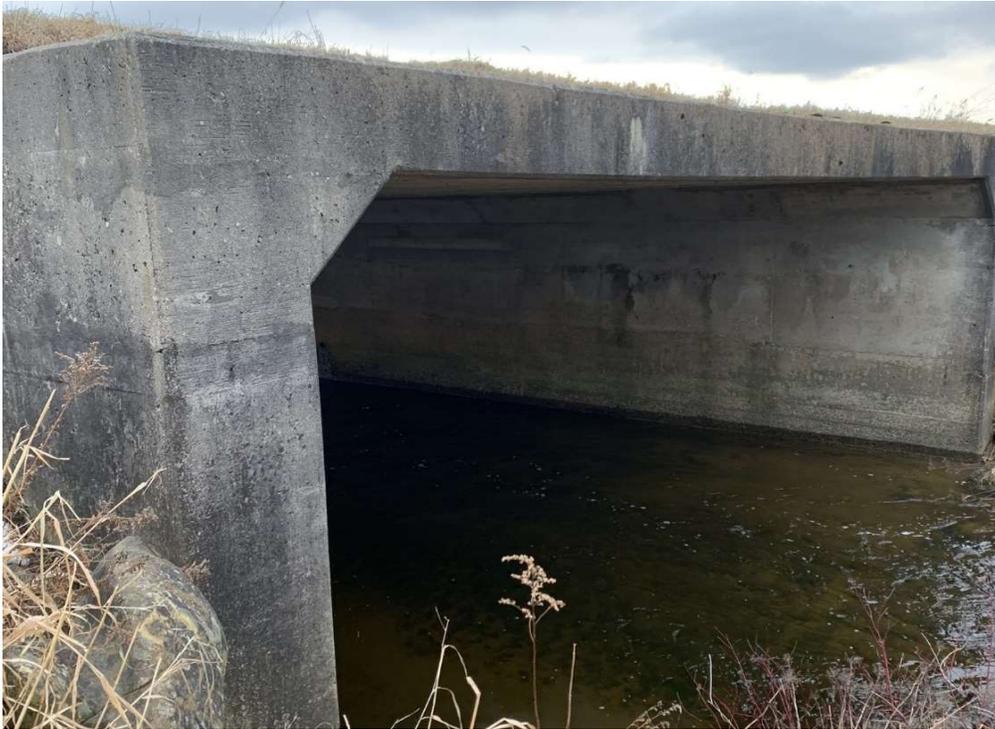
Photo 7-4: Structure Elevation

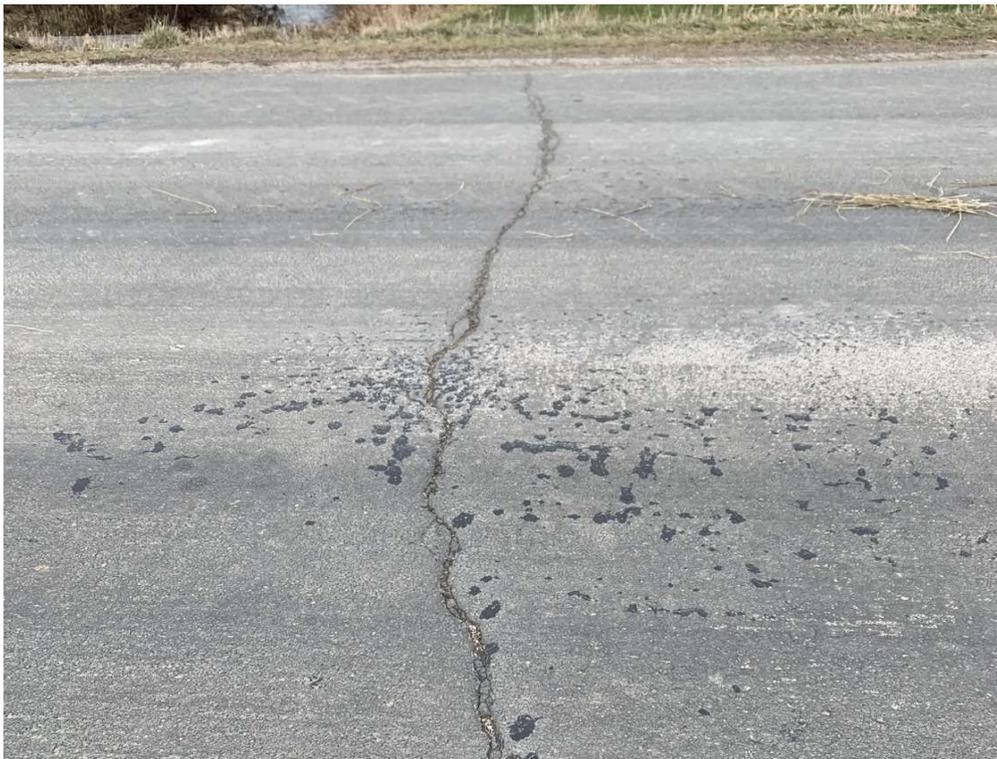
Photo 7-5: Wearing Surface

Element Group:	Approaches		Length:				
Element Name:	Wearing Surface		Width:				
Location:	Each End		Height:				
Material:	Asphalt		Count:				
Element Type:			Total Quantity:				
Environment:	Severe		Limited Insp'n:				
Protection System:	None						
Condition Data:	Units	Exc.	Good	Fair	Poor	Perform. Deficiencies	Maint. Needs
	%		70	25	5		
Comments:	Slight settlement was observed at the deck ends. Alligator cracking observed along edge of eastbound lane. Transverse crack 5m east of deck.						
Recommended Work:	None		<input checked="" type="checkbox"/> 6-10 Years	1-5 Years	< 1 Year	Urgent	
	Repair road base prior to next scheduled road resurfacing.

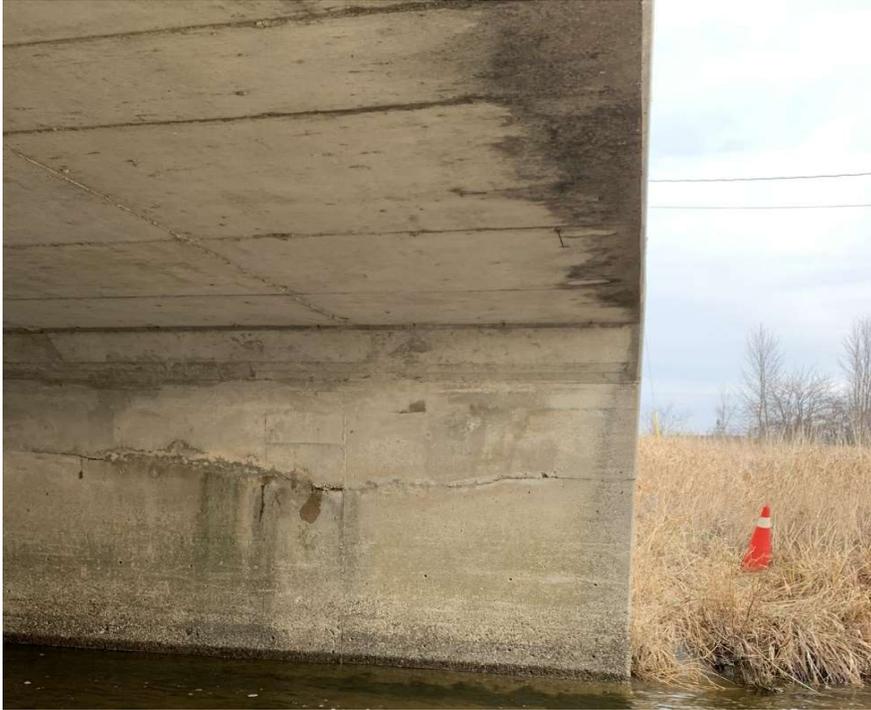
Photo 7-6: View of soffit and abutment walls

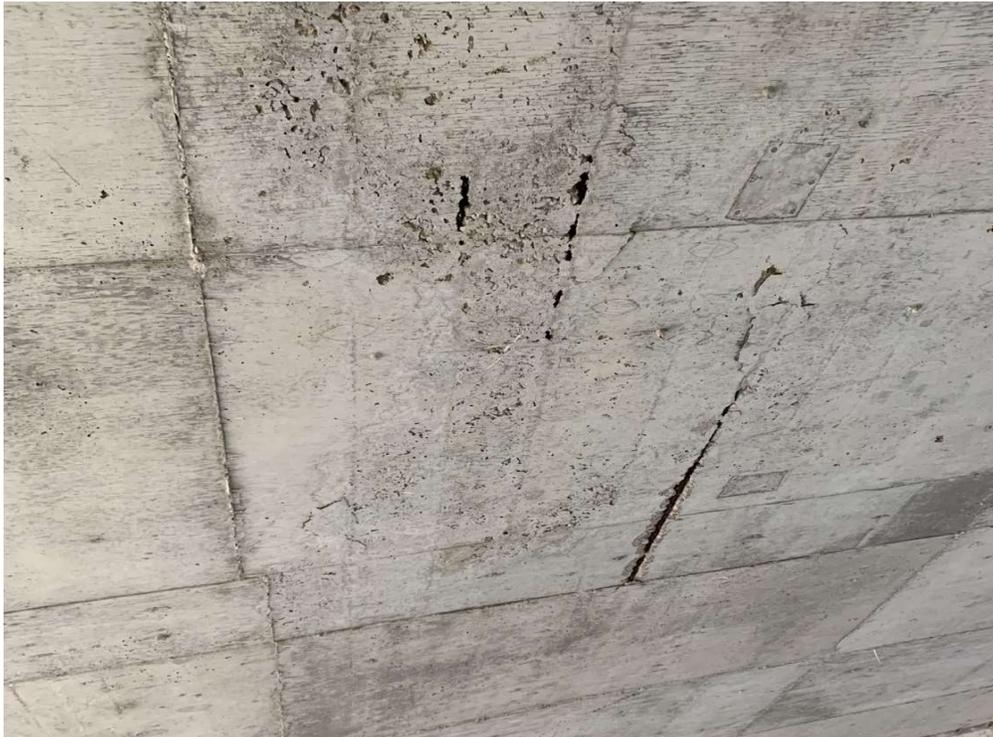
Photo 7-7: View of soffit

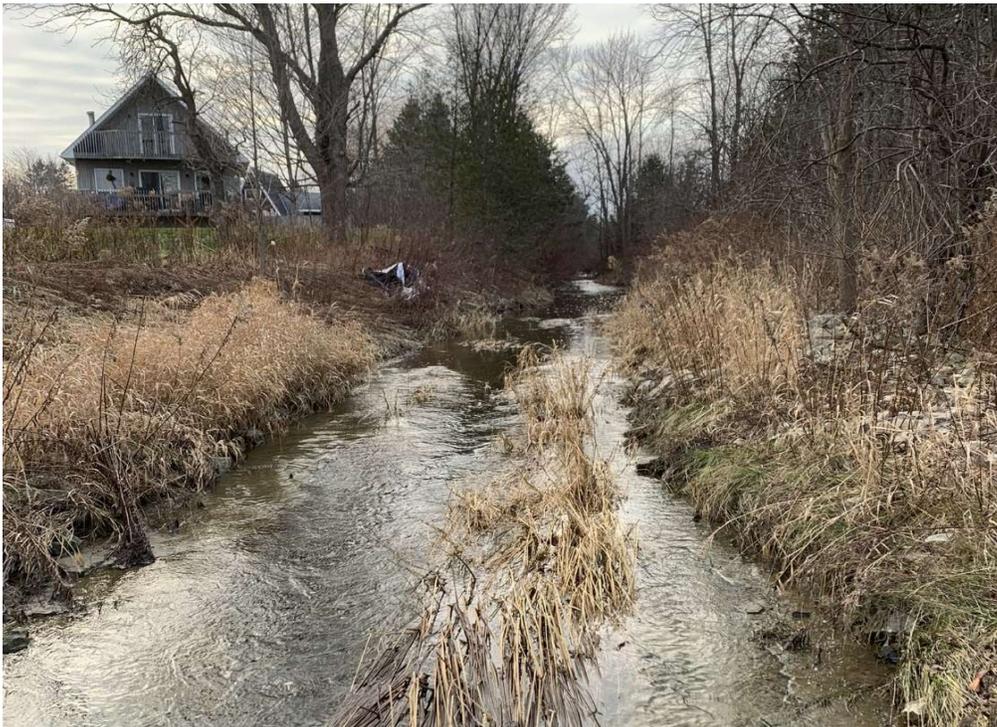
Photo 8-3: View of watercourse upstream

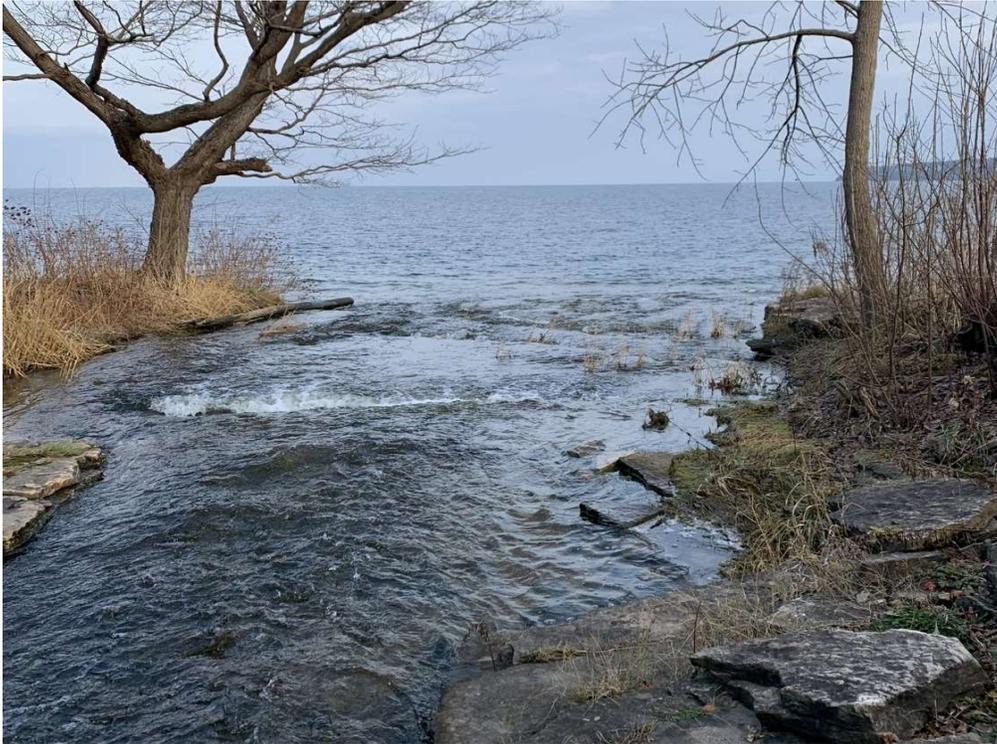
Photo 8-5: View of watercourse downstream

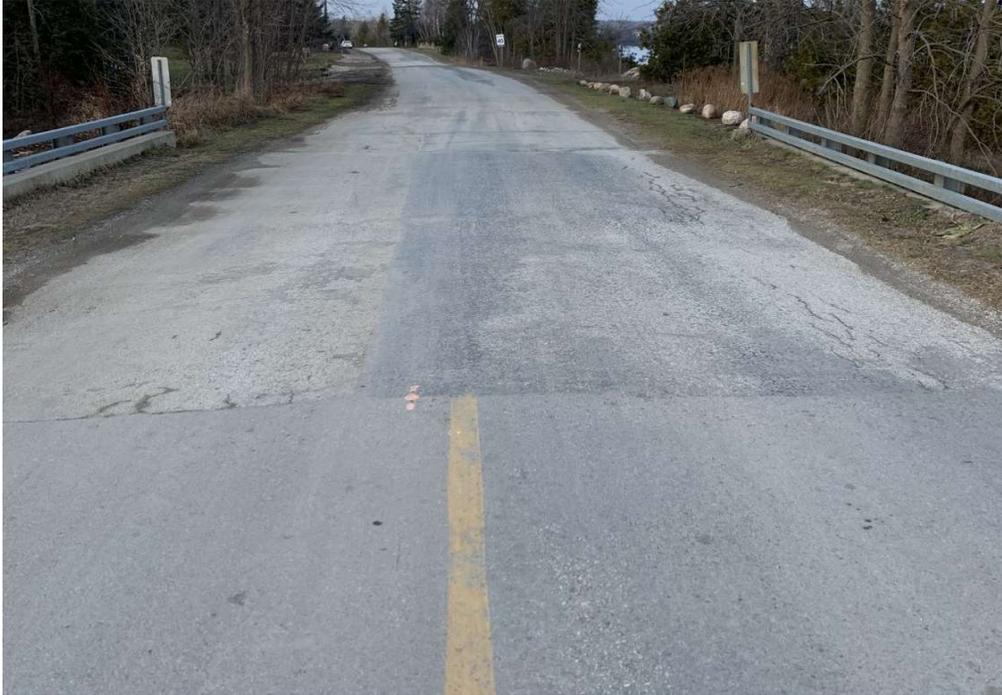
Photo 8-6: View of structure approach and deck wearing surface

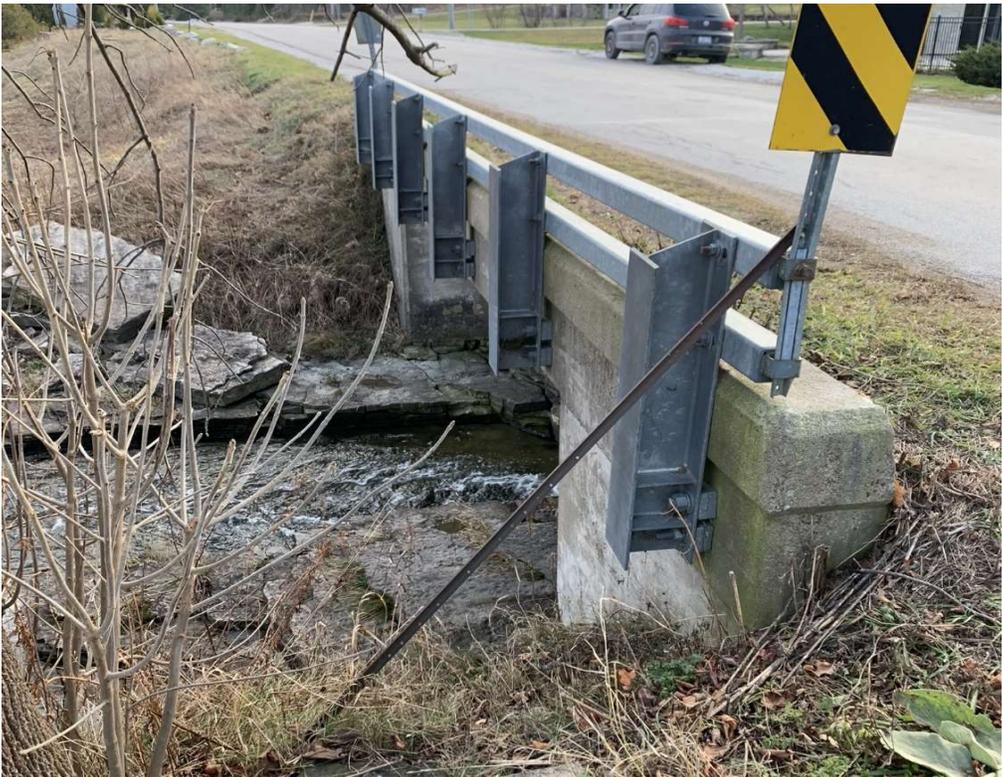
Photo 8-7: View of east structure elevation, wingwalls, exterior soffit and curb

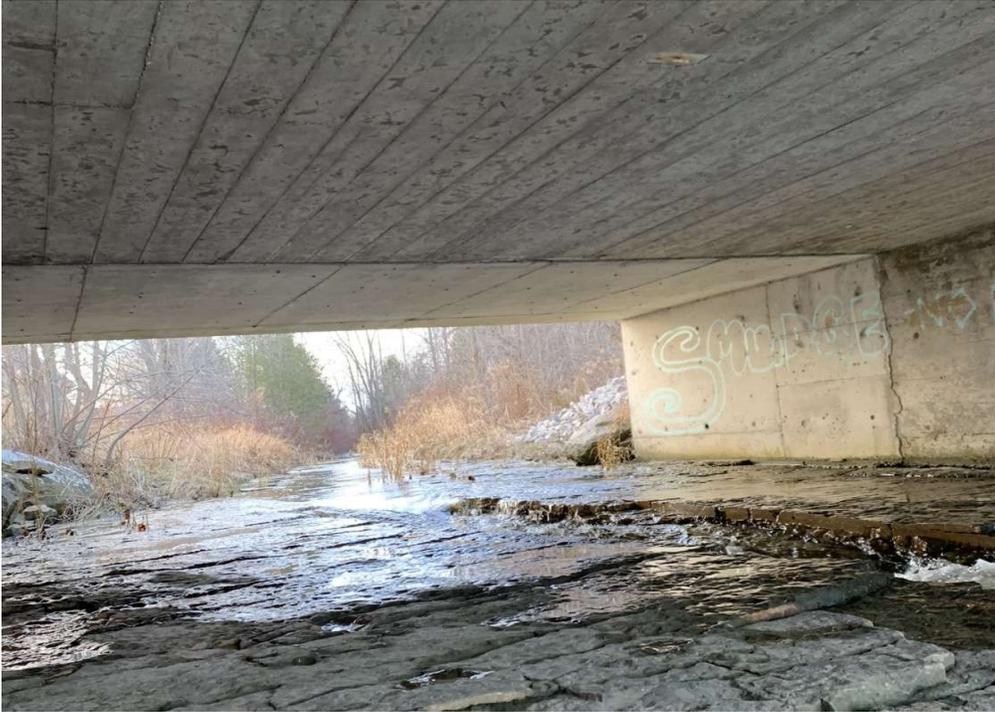
Photo 8-8: View of north abutment wall and bedrock streambed

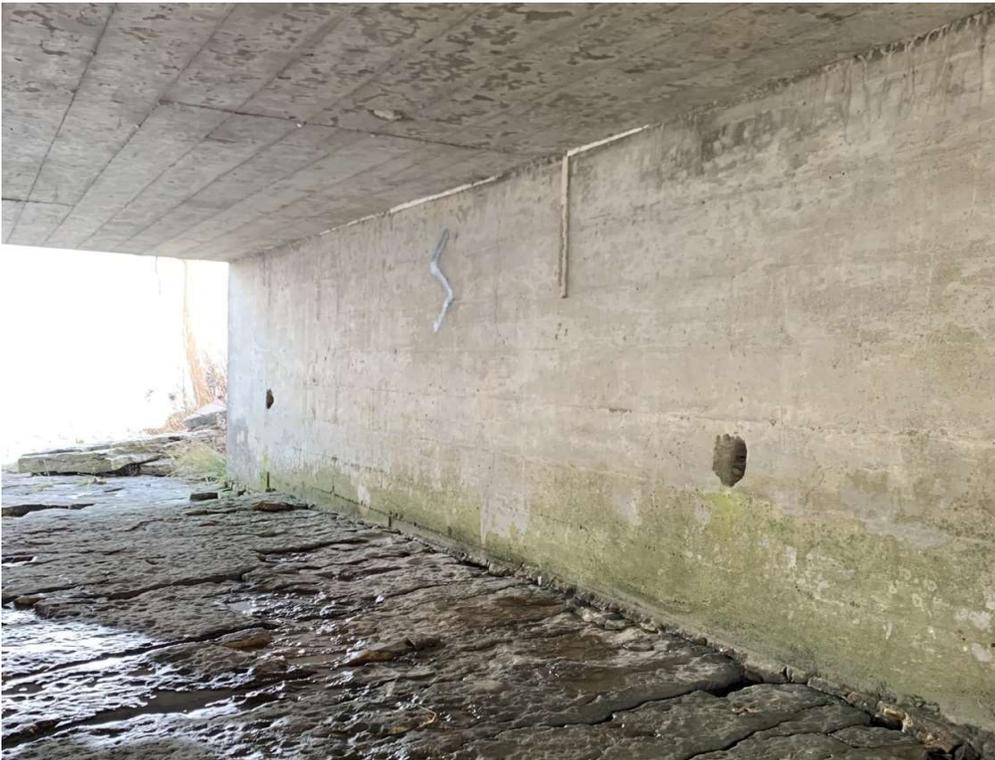
Photo 8-9: View of south abutment wall and soffit

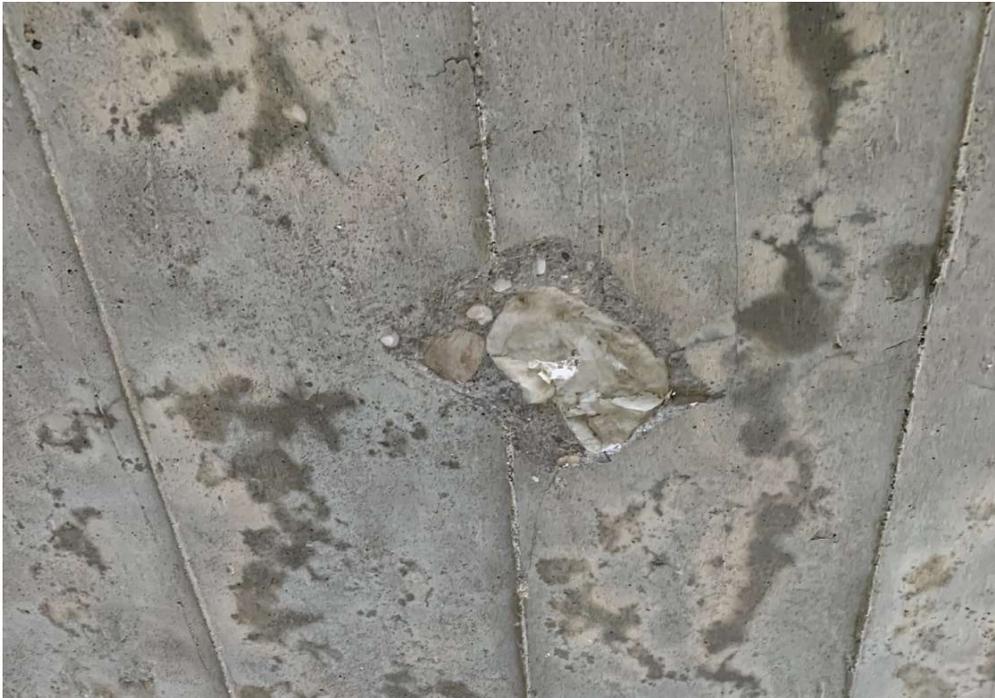
Photo 8-10: View of structure soffit

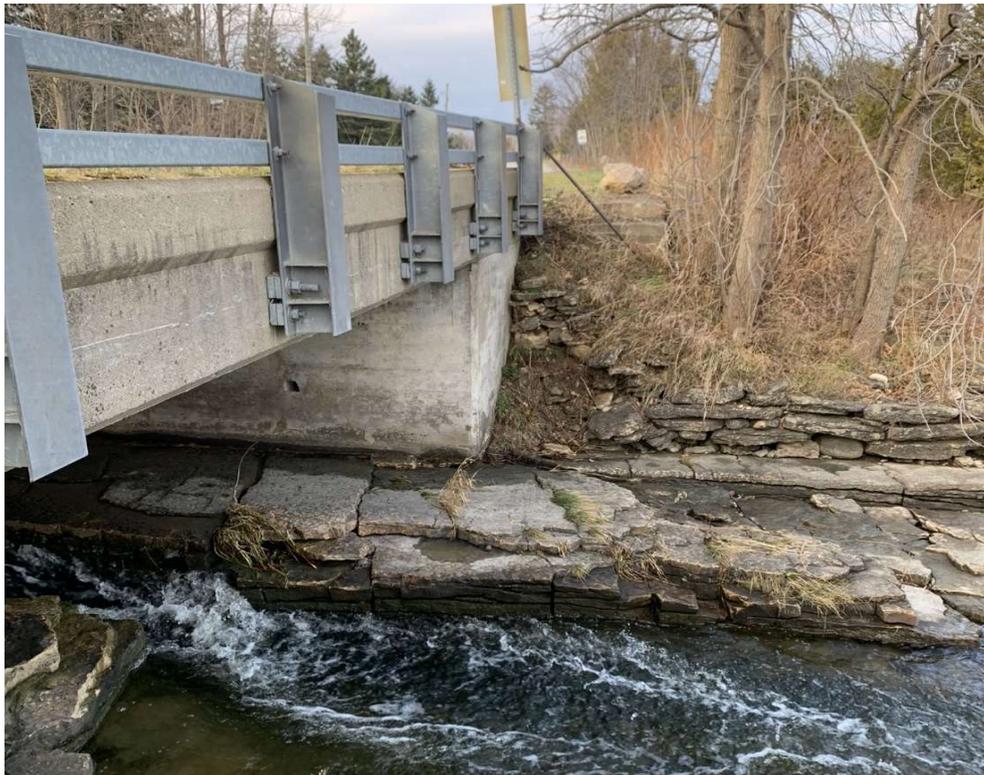
Photo 8-11: View of structure elevation, exterior barrier protection, curb and soffit

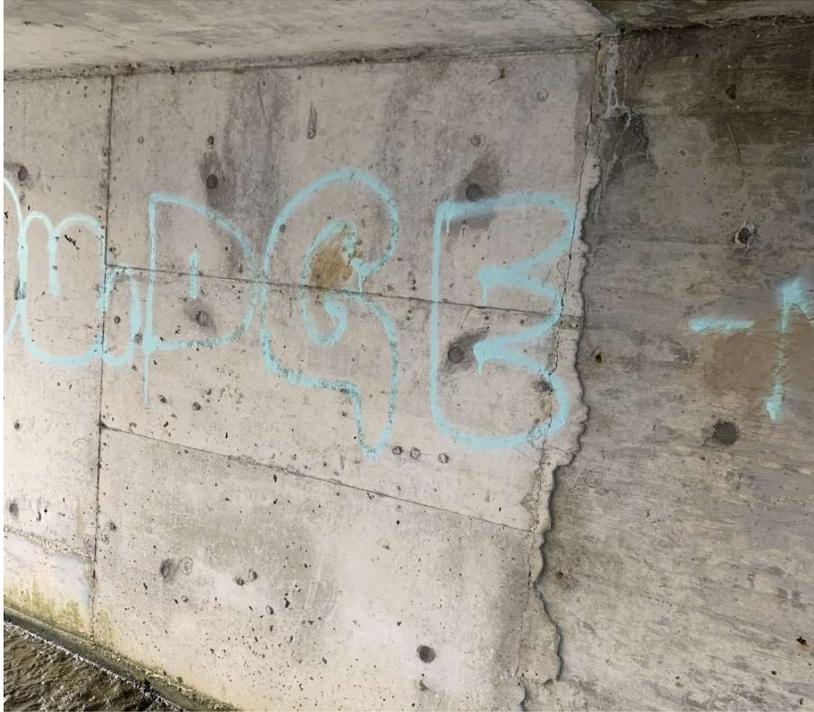
Photo 8-12: View of abutment wall

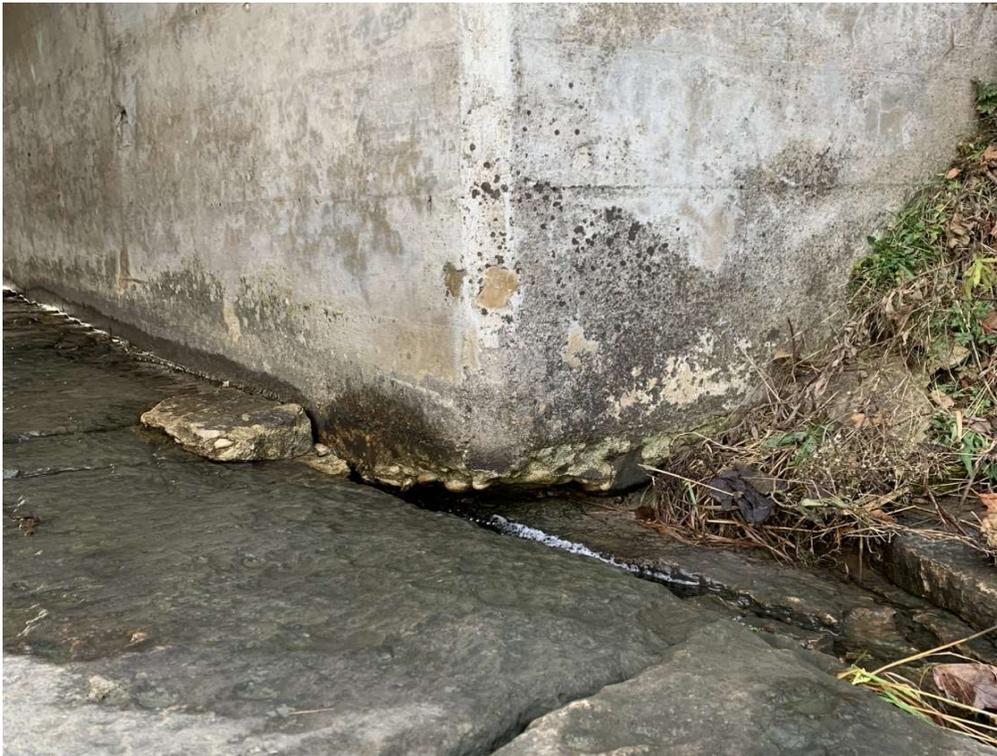
Photo 8-13: View of wingwall

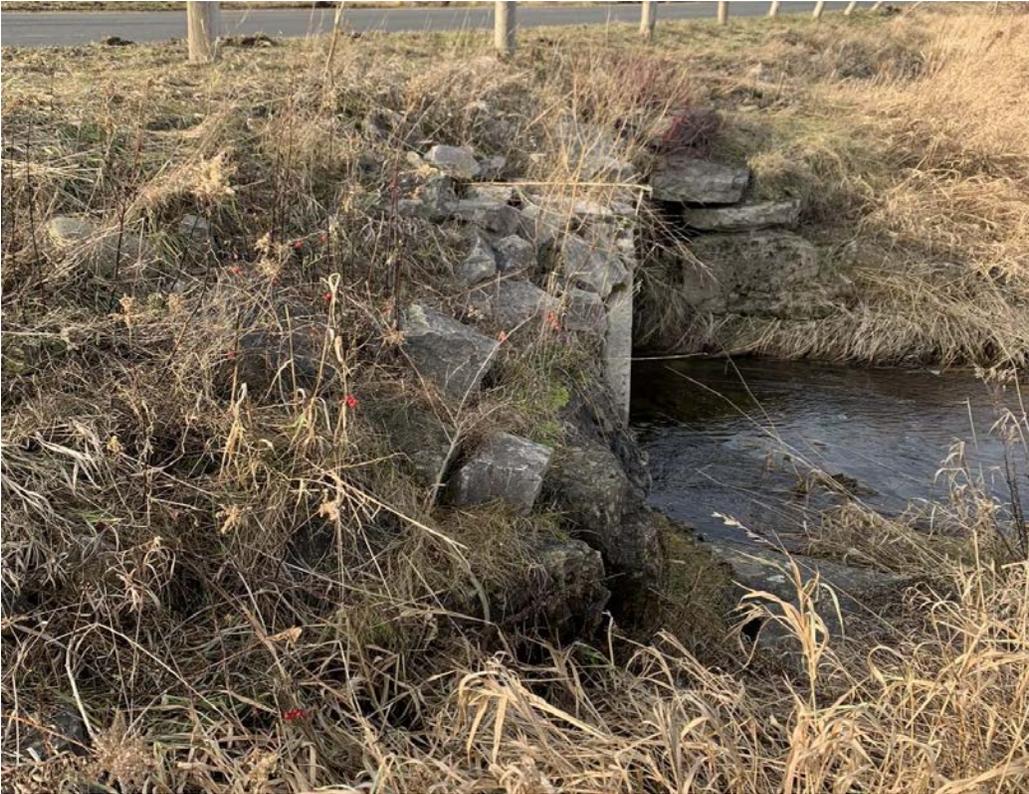
Photo 9-2 - View of structure inlet elevation and embankment
