MUNICIPALITY OF NORTHERN BRUCE PENINSULA

2022 STRUCTURE INSPECTION REPORT

FINAL
PROJECT NO.: 201-01605-00
DATE: APRIL 03, 2023

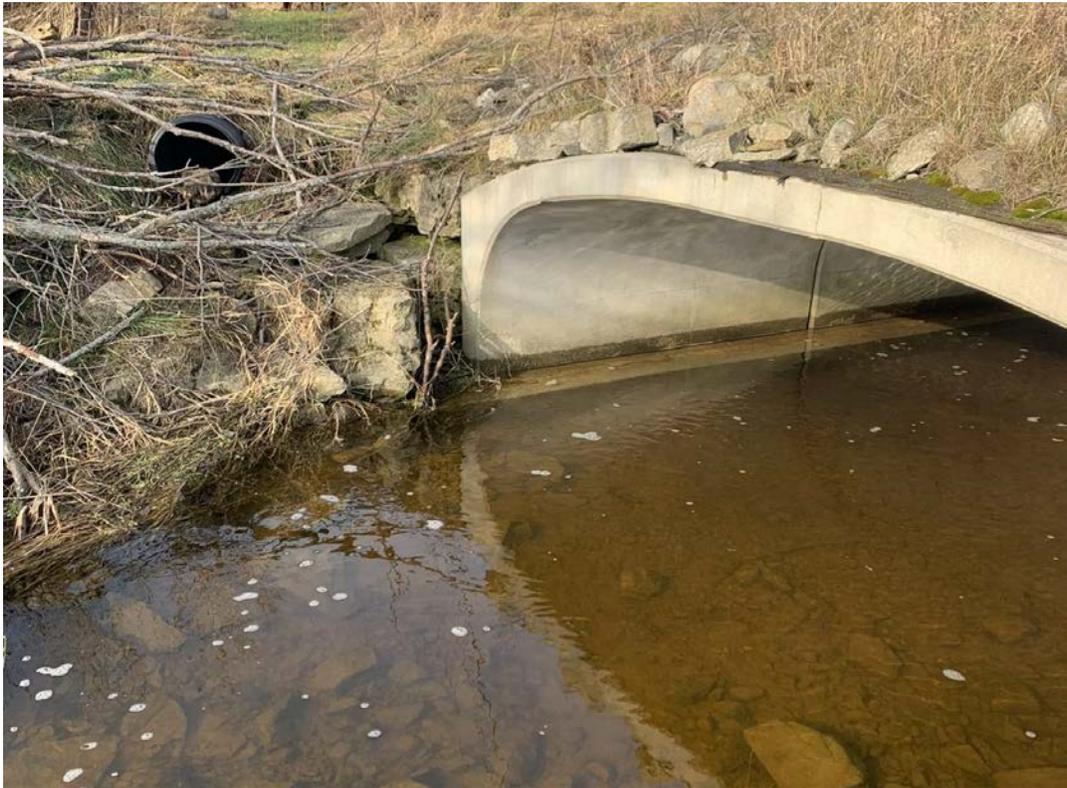
Photo 9-3 - View of structure outlet elevation and embankments

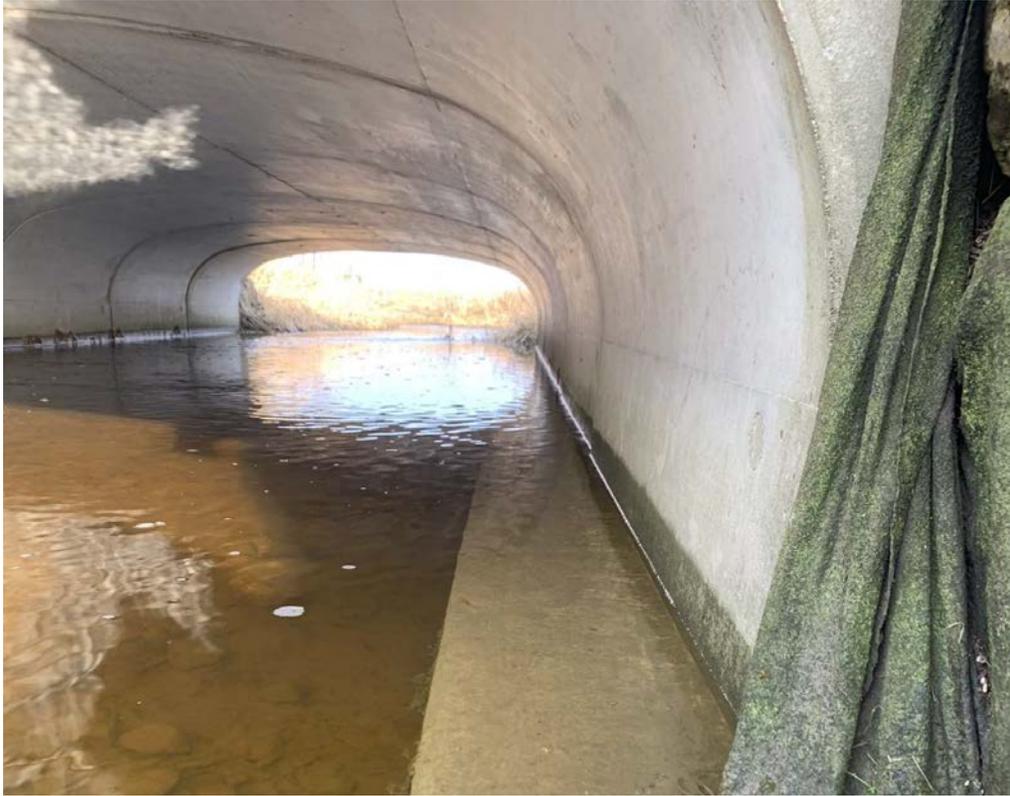
Photo 9-4 - View of pipe arch soffit and walls

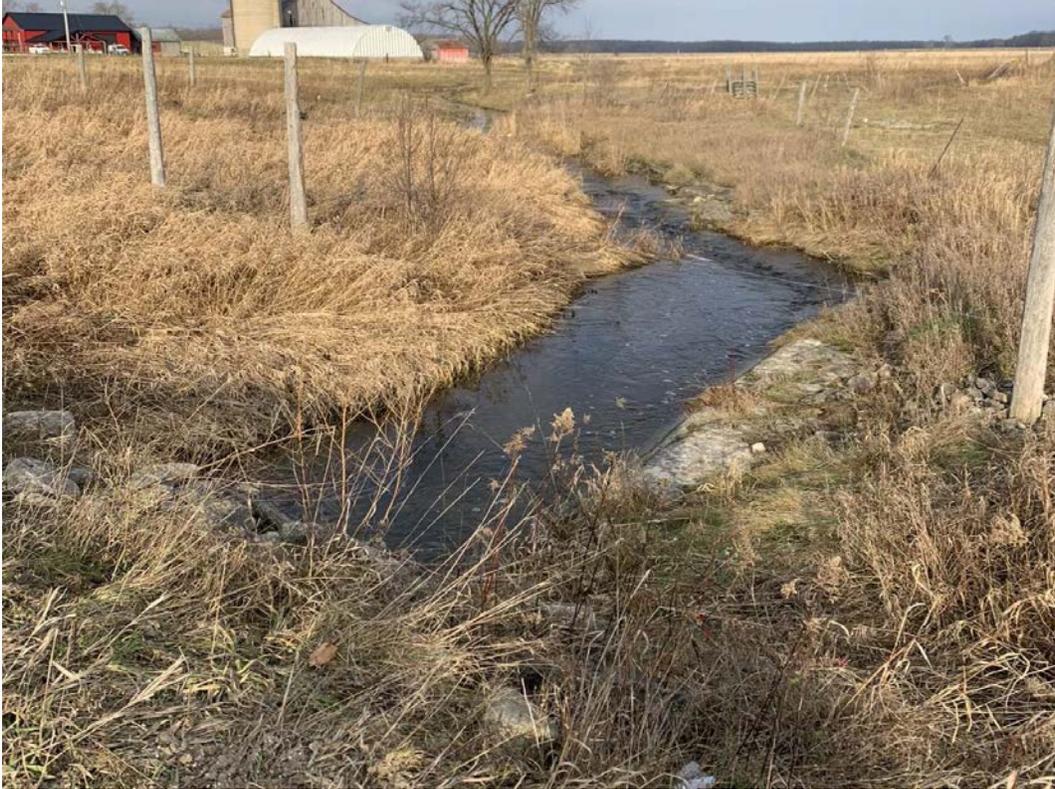
Photo 9-6 - View of watercourse upstream

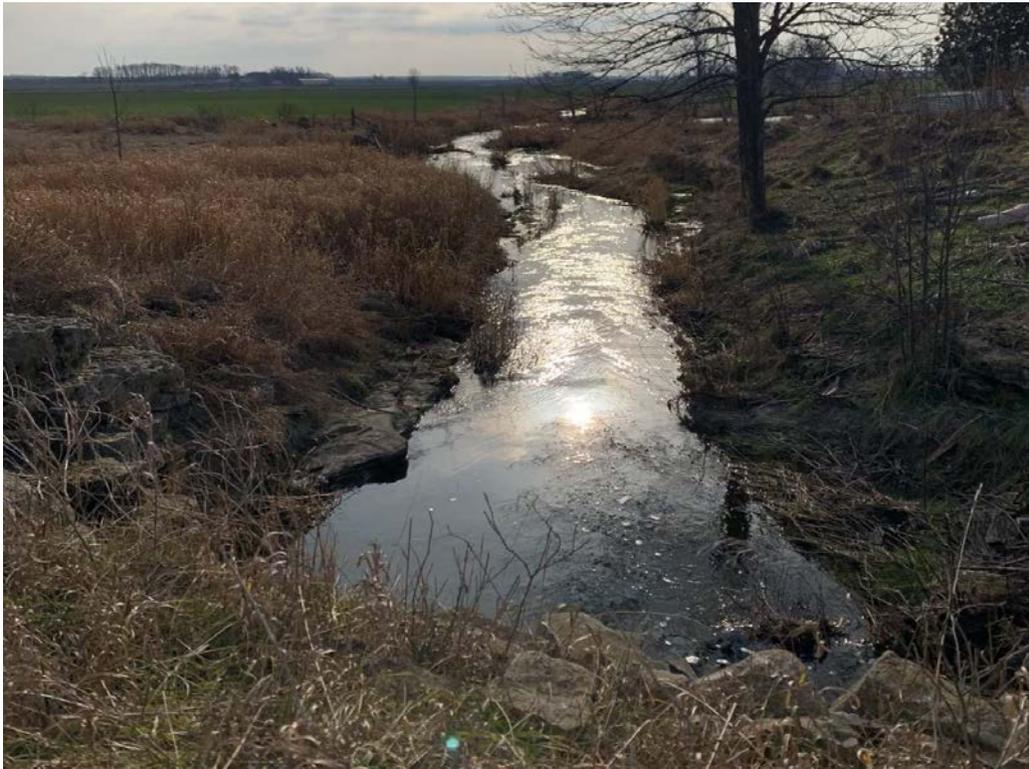
Photo 9-7 - View of watercourse downstream

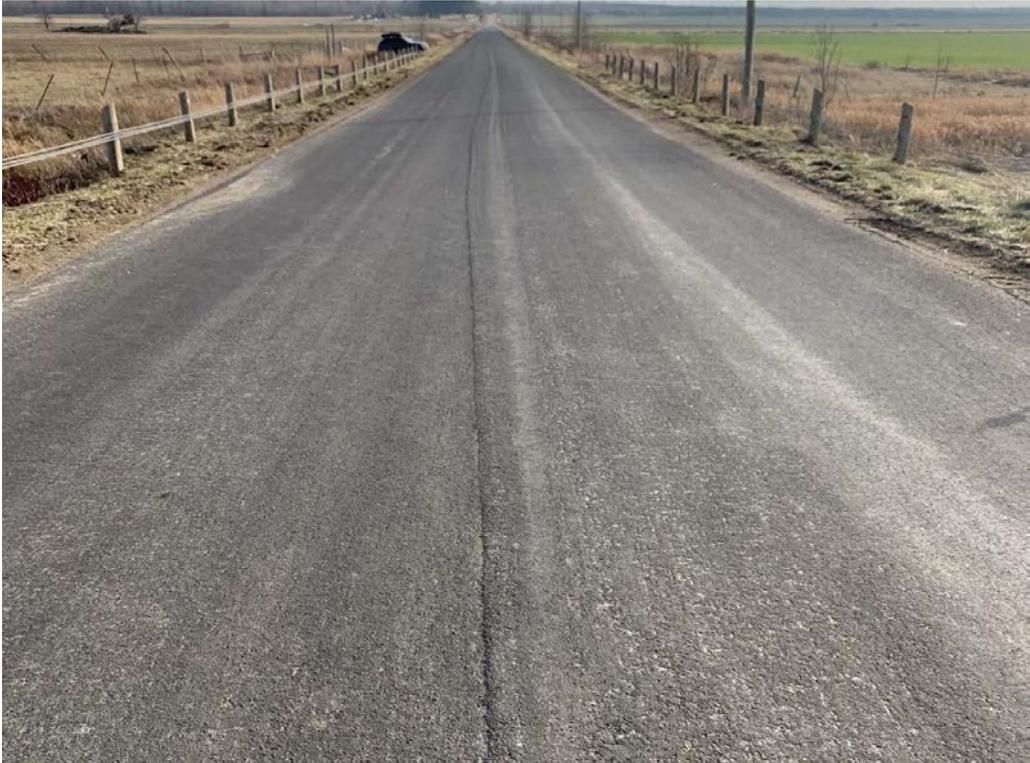
Photo 9-9 - View of structure wearing surface from approaching perspective

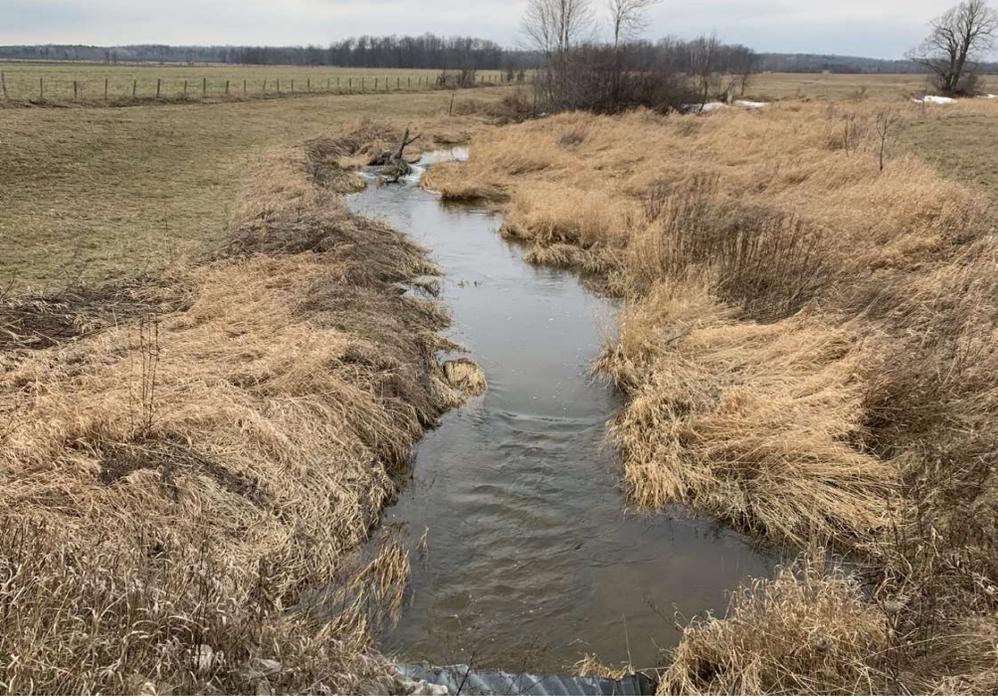
Photo 10-2: View of watercourse upstream and inlet component

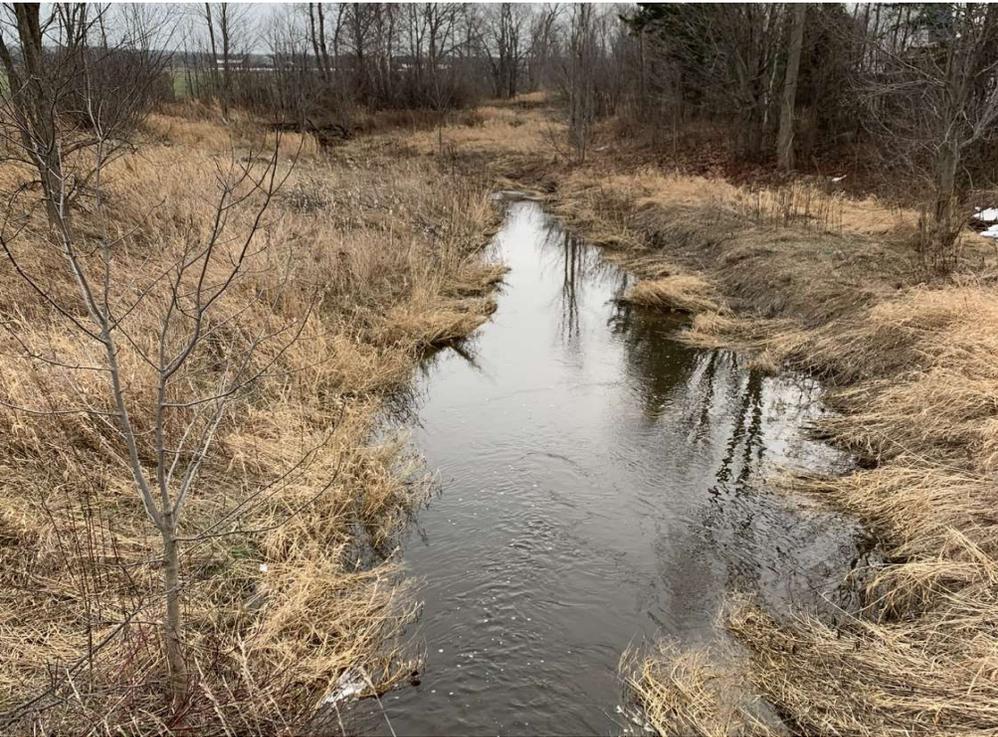
Photo 10-3: View of watercourse downstream

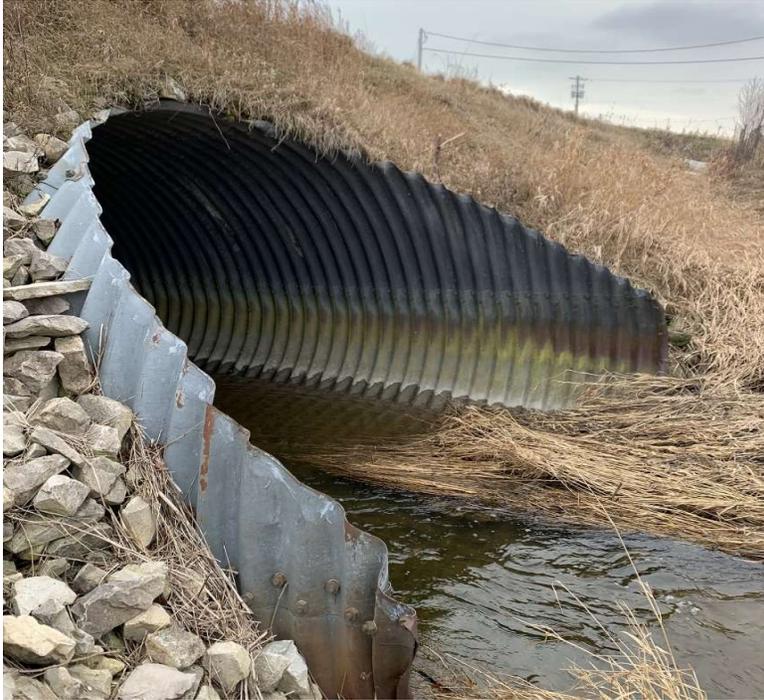
Photo 10-4: View of culvert barrel in elevation

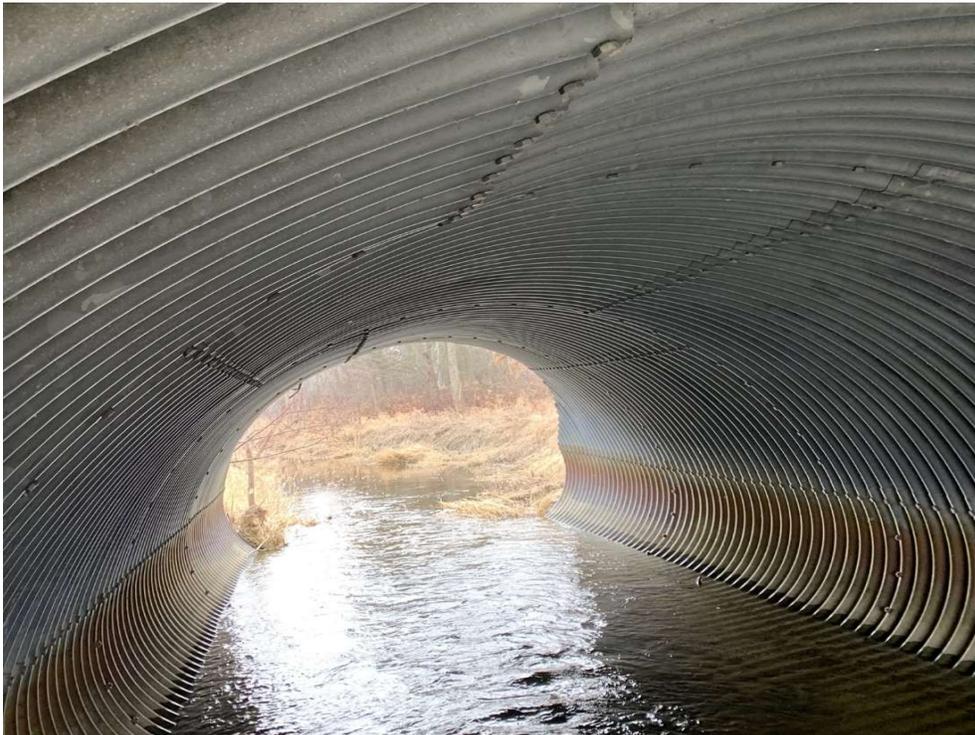
Photo 10-5: View of interior culvert barrel

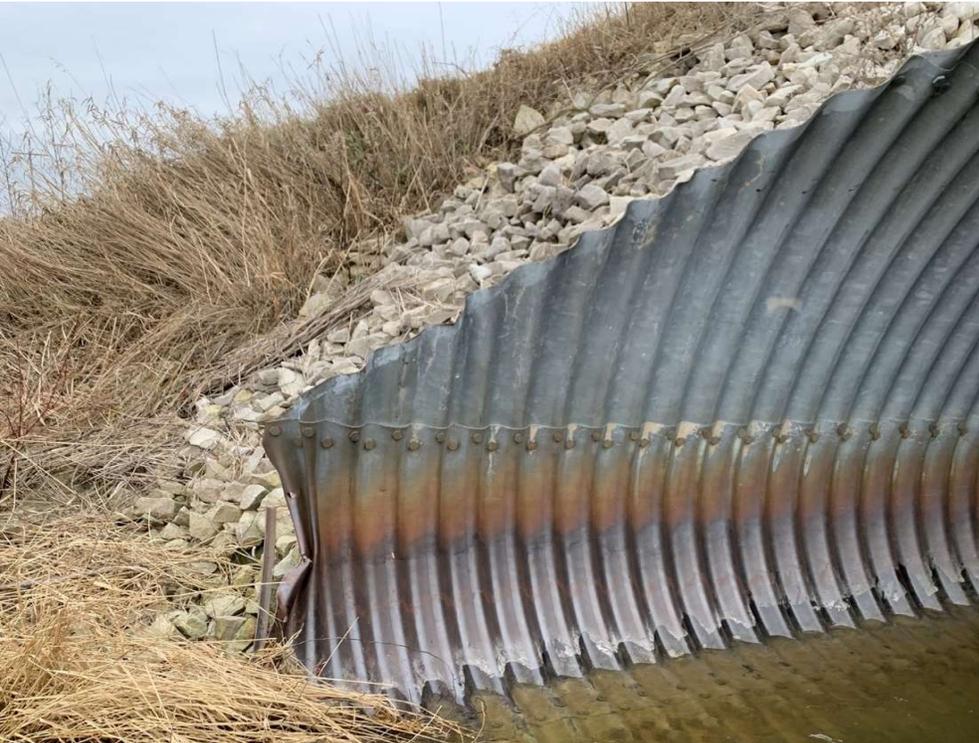
Photo 10-7: View of embankment and culvert inlet interior

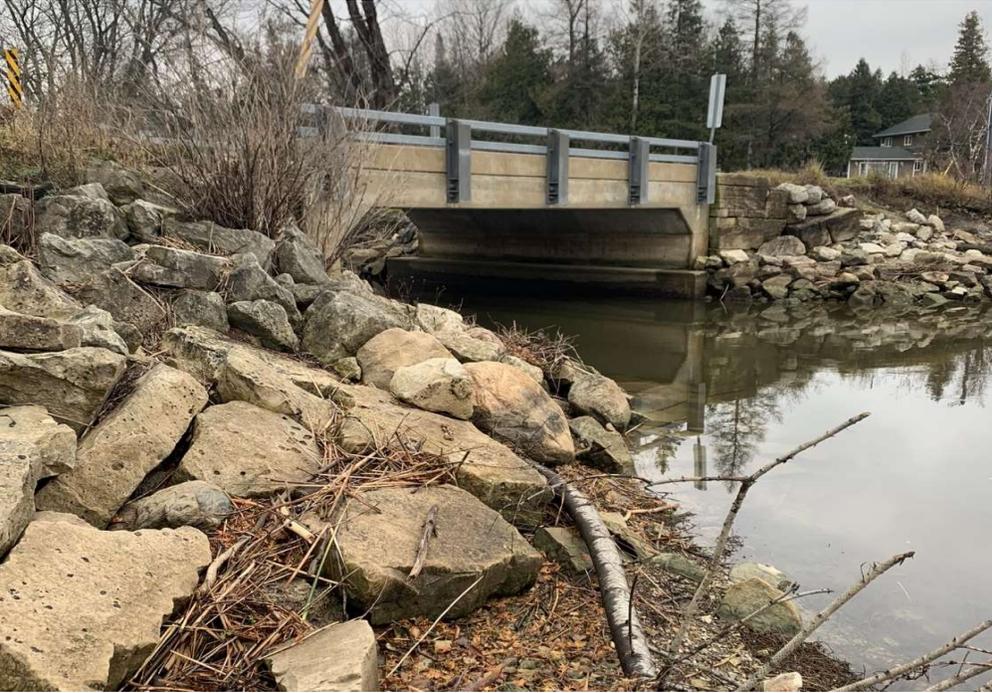
Photo 11-2: View of east structure elevation, exterior soffit, barrier and embankments

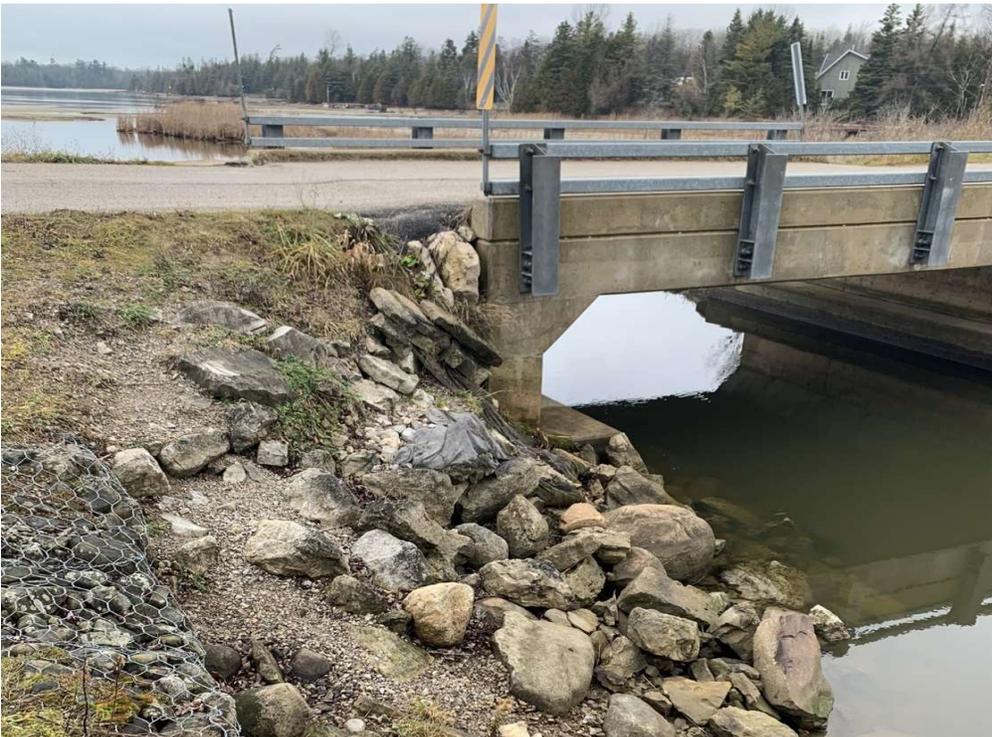
Photo 11-3: View of exterior barrier protection, soffit and wingwalls

Element Group:	Barriers		Length:				
Element Name:	Railing Systems		Width:				
Location:			Height:				
Material:	Steel		Count:				
Element Type:	Box Beam		Total Quantity:				
Environment:	Severe		Limited Insp'n:				
Protection System:							
Condition Data:	Units	Exc.	Good	Fair	Poor	Perform. Deficiencies	Maint. Needs
	%		95	5		Yes	
Comments:	There is currently no approach protection in place and the ends of the structure barrier pose a vehicular hazard. The structure barrier is code deficient (does not meet height requirements) and has no pedestrian/cyclist handrail. Minor corrosion of the galvanized railing has started.						
Recommended Work:	<input type="checkbox"/> None		<input type="checkbox"/> 6-10 Years	<input checked="" type="checkbox"/> 1-5 Years	<input type="checkbox"/> < 1 Year	<input type="checkbox"/> Urgent	
	Install bridge and approach barrier protection to Code.

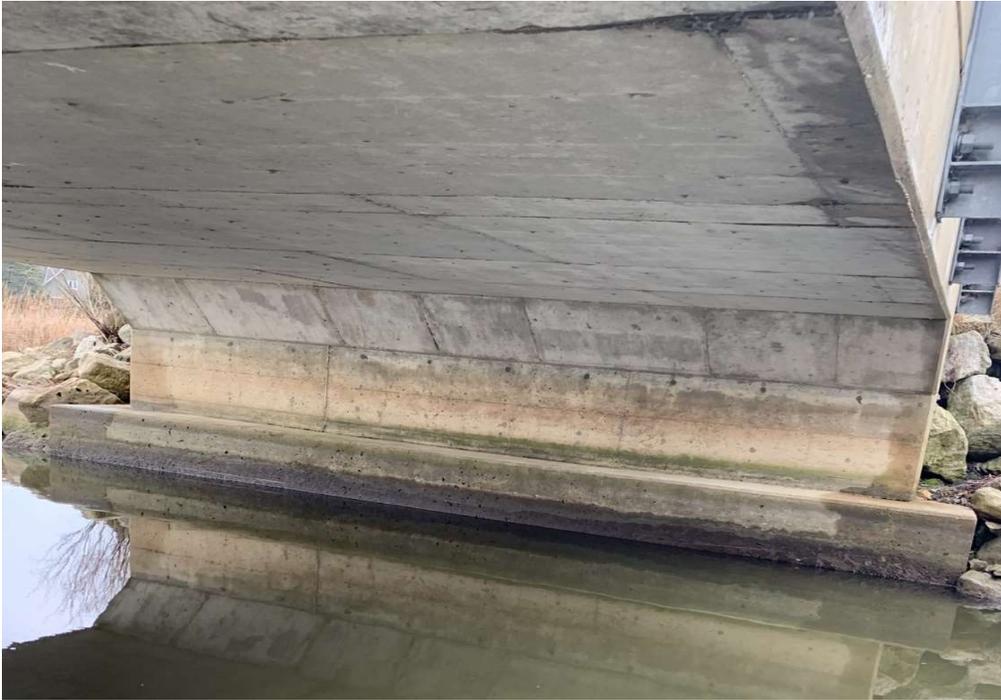
11-4: View of structure soffit

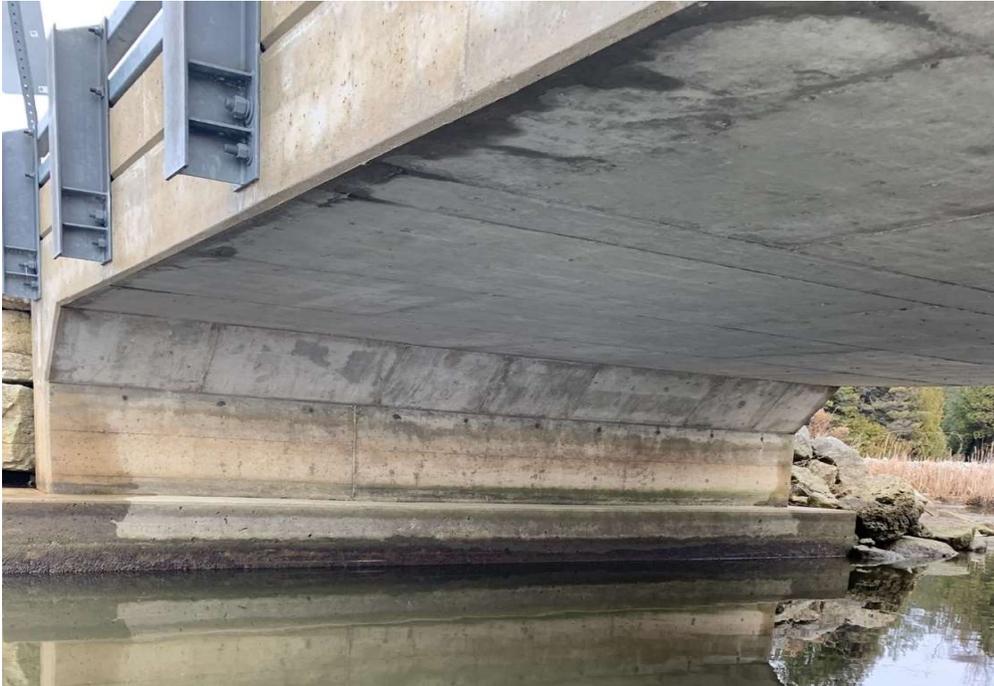
11-6: View of north abutment wall and soffit

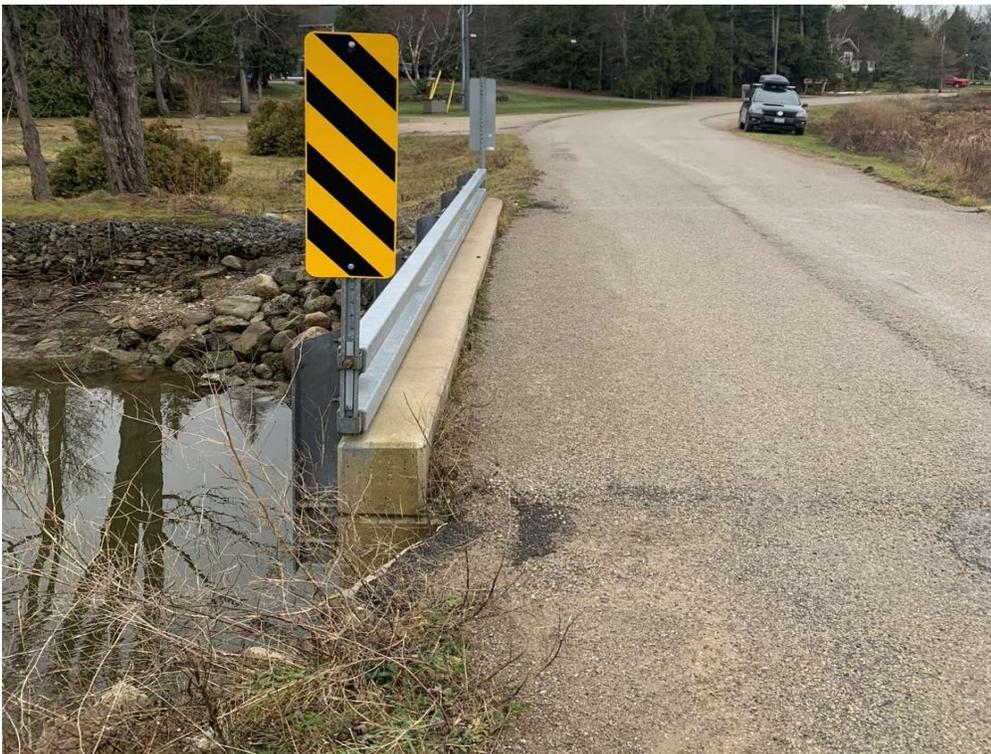
11-7: View of structure wearing surface, barrier protection and end hazard signage

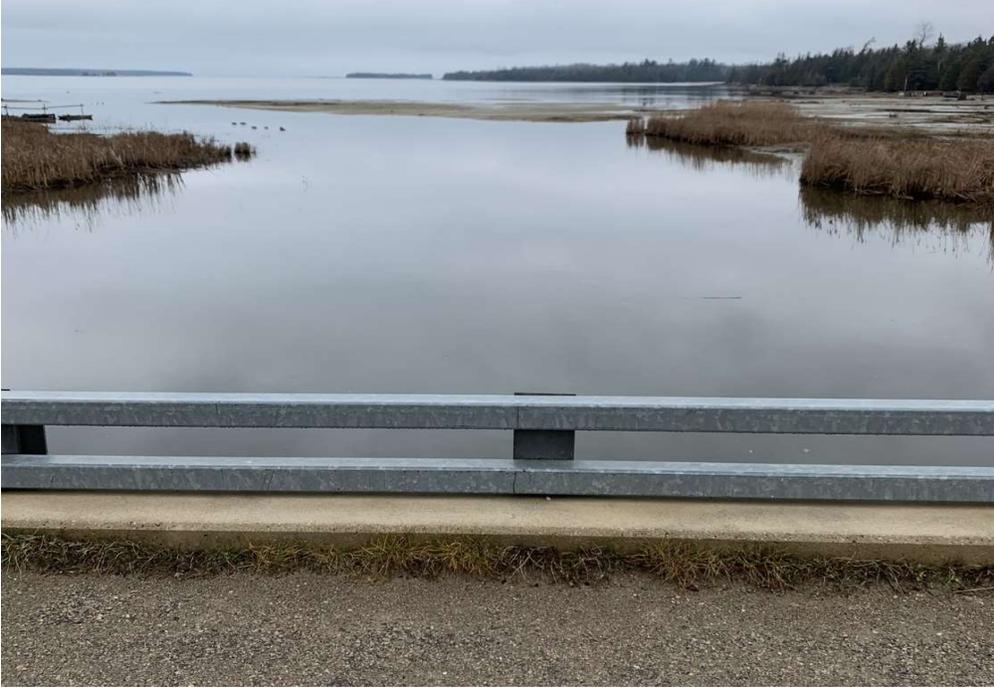
11-8: View of watercourse downstream

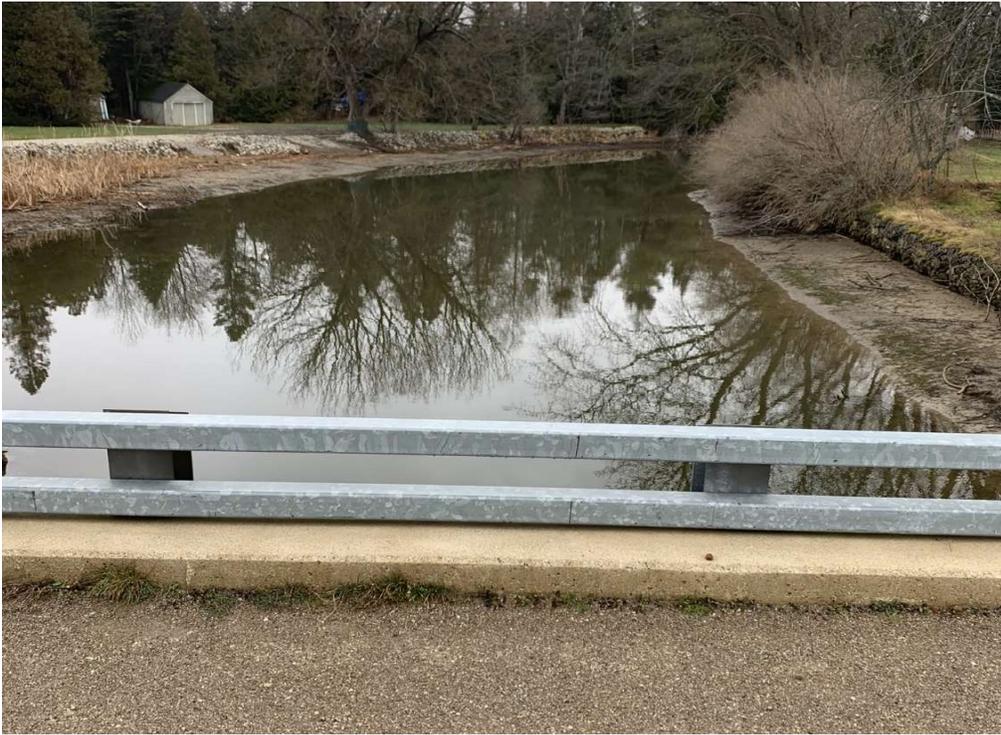
11-7: View of watercourse upstream

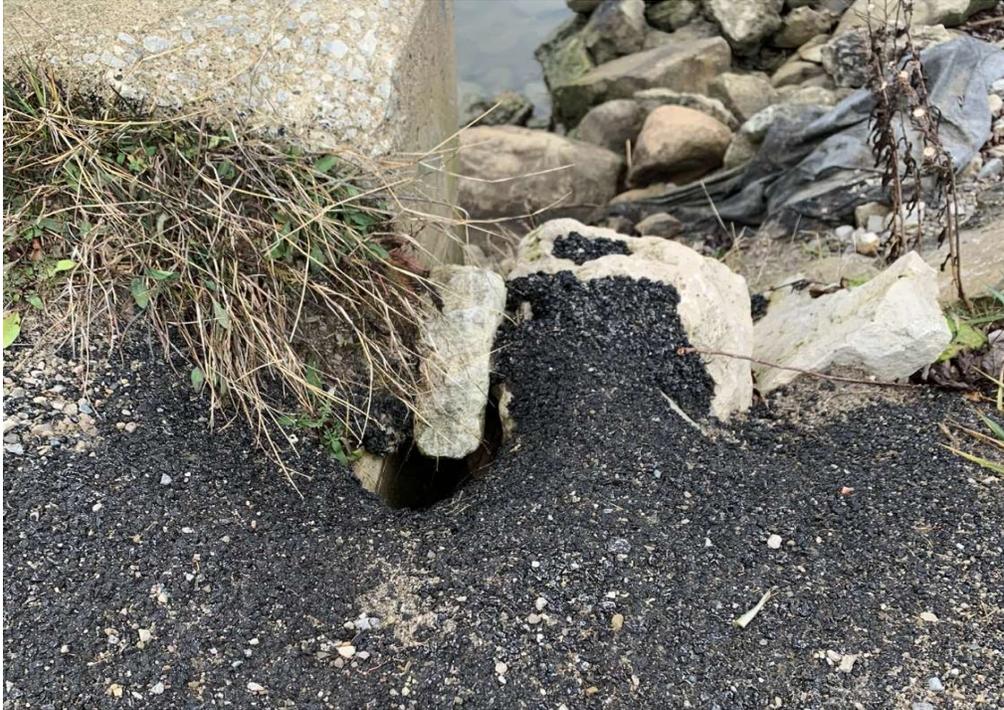
11-10: Minor erosion at the northwest structure quadrant

Element Group:	Embankments & Streams		Length:				
Element Name:	Embankments		Width:				
Location:			Height:				
Material:	Earth / Stone		Count:	4			
Element Type:			Total Quantity:	4			
Environment:	Moderate		Limited Insp'n:				
Protection System:							
Condition Data:	Units	Exc.	Good	Fair	Poor	Perform. Deficiencies	Maint. Needs
	Each			3	1		
Comments:	The slopes are stone and vegetated earth. The southeast quadrant has erosion and failure of the geotextile and rock protection. The southwest quadrant has minor erosion of the embankment.						
Recommended Work:	None 6-10 Years <input checked="" type="checkbox"/> 1-5 Years < 1 Year Urgent Repair all erosion and place new geotextile and rip rap/rock slope protection.

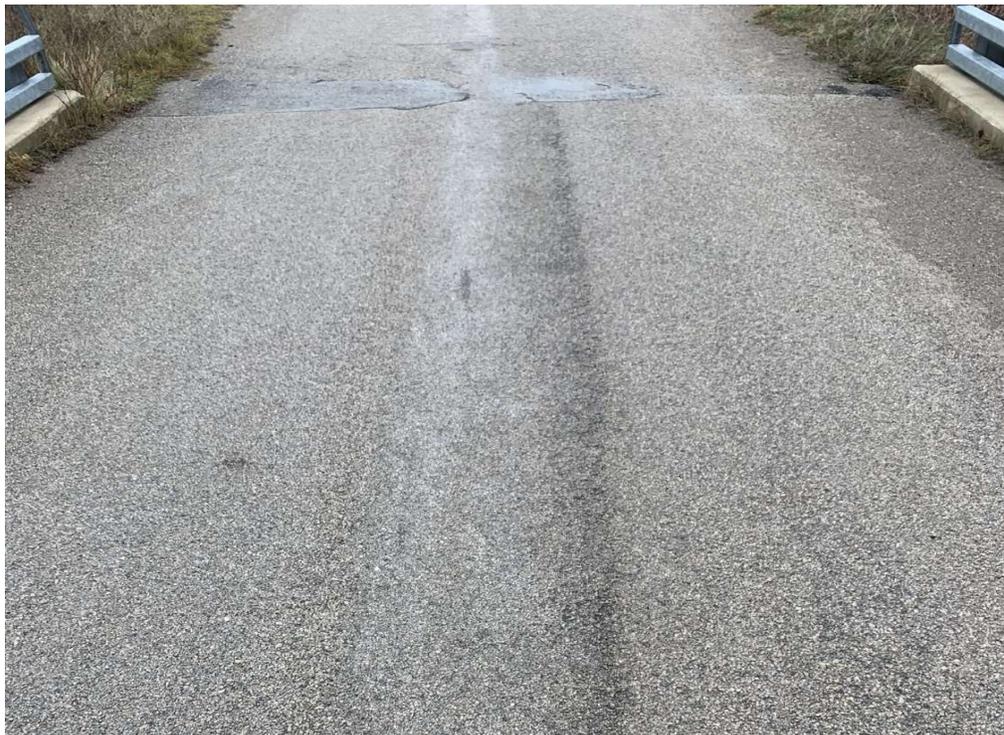
11-11: Structure wearing surface

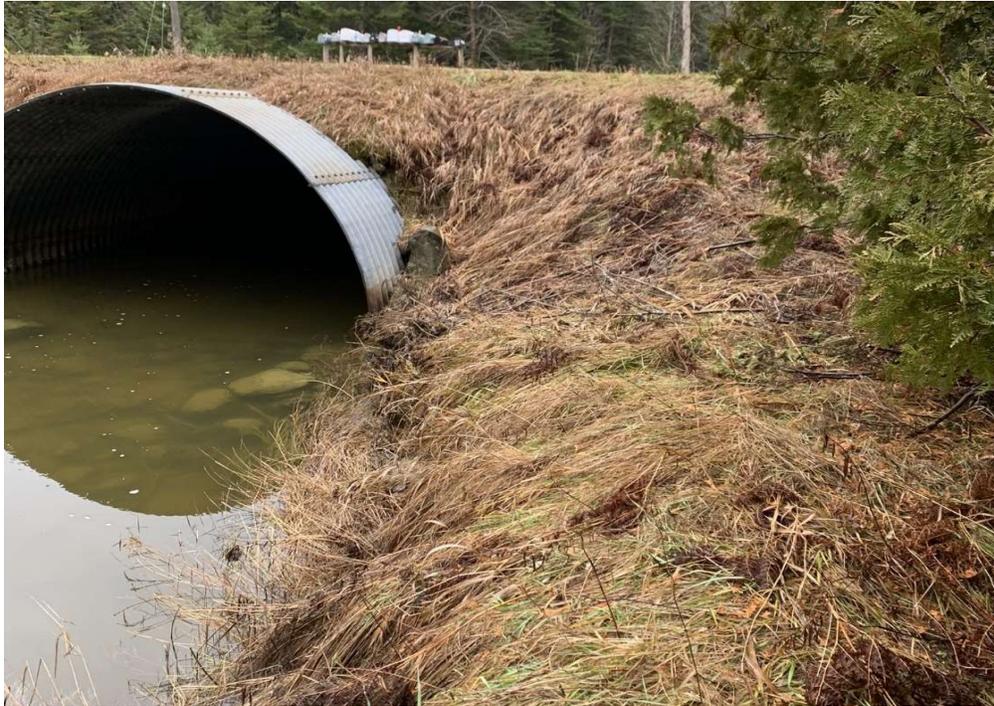
Photo 12-2: View of culvert inlet in elevation (north perspective)

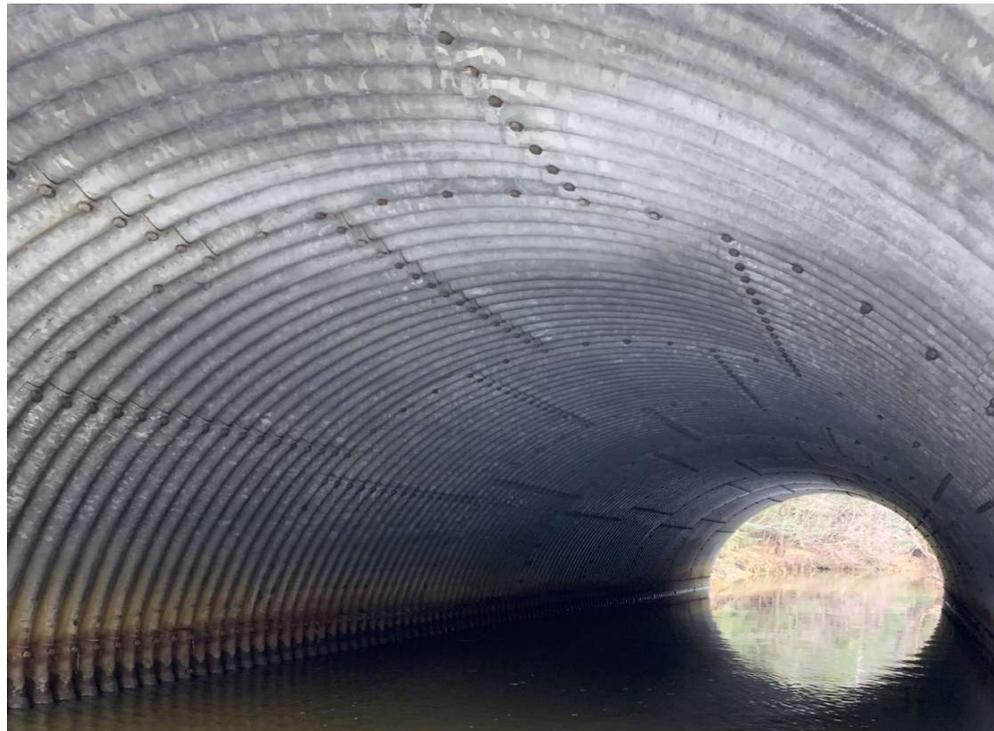
Photo 12-3: View of culvert barrel interior

Element Group:	Culvert		Length:				
Element Name:	Barrel		Width:				
Location:			Height:				
Material:	Steel		Count:				
Element Type:	Pipe Arch		Total Quantity:				
Environment:	Moderate		Limited Insp'n:				
Protection System:	Galvanized						
Condition Data:	Units	Exc.	Good	Fair	Poor	Perform. Deficiencies	Maint. Needs
	%		40	50	10	Yes	
Comments:	Deformations are visible at the obvert, with corrosion and swelling near the water level. Section loss is 10% at most.						
Recommended Work:	None 6-10 Years <input checked="" type="checkbox"/> 1-5 Years < 1 Year Urgent Monitor the deformations and section loss.

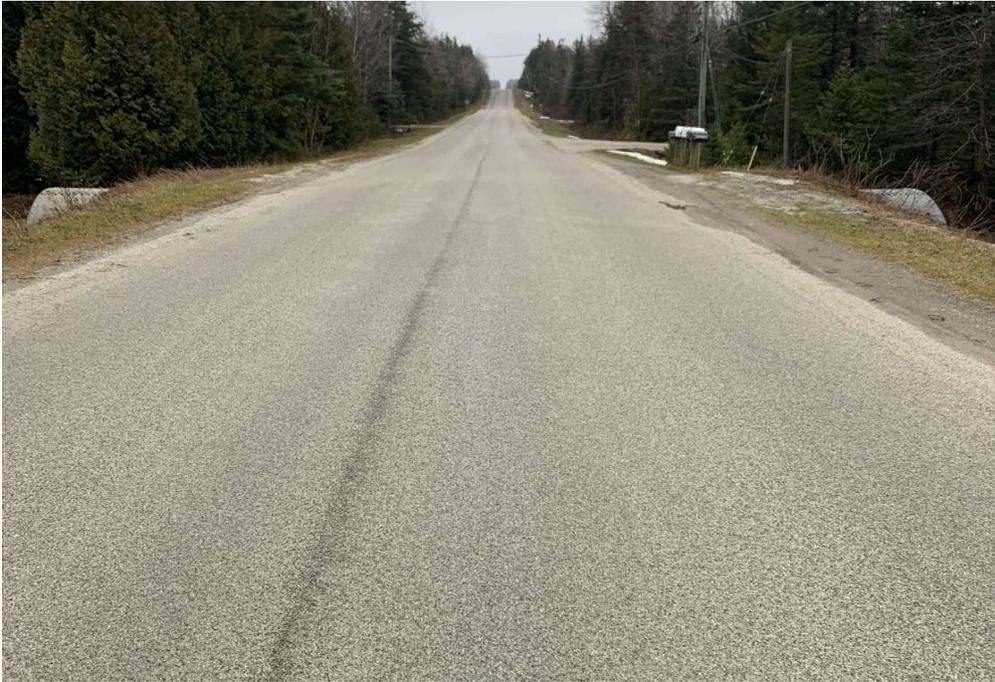
Photo 12-4: View of surface treatment wearing surface

Element Group:	Decks		Length:				
Element Name:	Wearing Surface		Width:				
Location:			Height:				
Material:	Surface Treatment		Count:				
Element Type:			Total Quantity:				
Environment:	Severe		Limited Insp'n:				
Protection System:	None						
Condition Data:	Units	Exc.	Good	Fair	Poor	Perform. Deficiencies	Maint. Needs
	%		75	25			
Comments:	The surface treatment wearing surface is in good to fair condition with minor settlement and wheel path rutting observed.						
Recommended Work:	None <input type="checkbox"/> 6-10 Years <input checked="" type="checkbox"/> 1-5 Years <input type="checkbox"/> < 1 Year <input type="checkbox"/> Urgent Replace the surface treatment with road resurfacing.

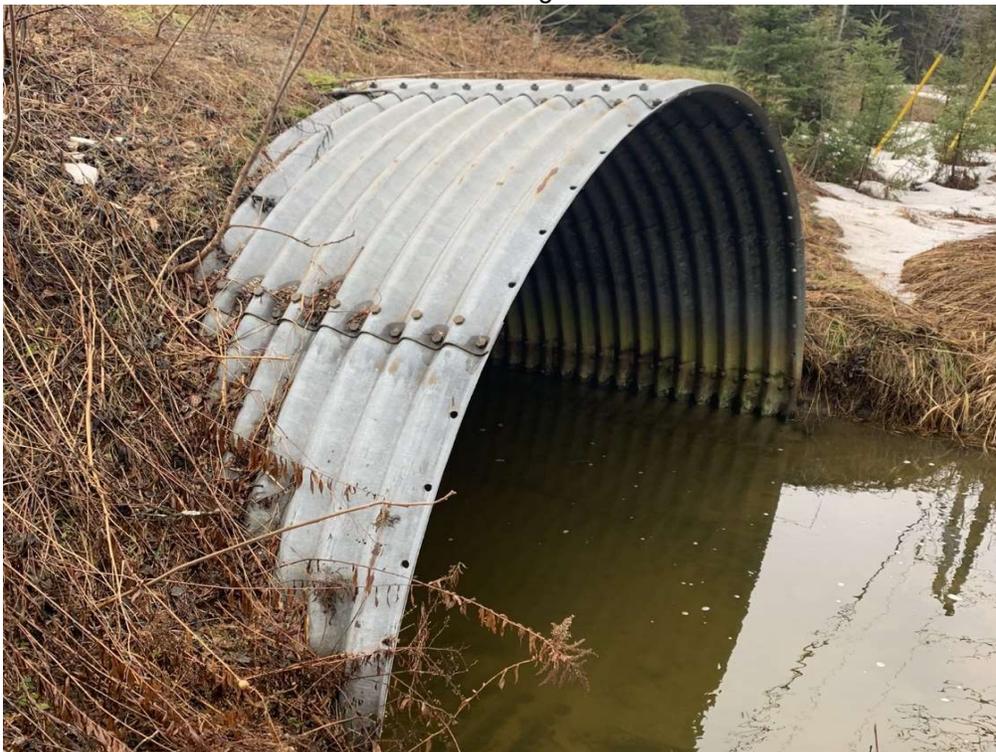
Photo 12-5: View of culvert outlet

Element Group:	Culverts		Length:				
Element Name:	Outlet Components		Width:				
Location:	West End		Height:				
Material:	Stone and Earth		Count:				
Element Type:			Total Quantity:				
Environment:	Moderate		Limited Insp'n:				
Protection System:	None						
Condition Data:	Units	Exc.	Good	Fair	Poor	Perform. Deficiencies	Maint. Needs
	%		30	60	10	Yes	Yes
Comments:	Some of the rip rap and rock slope protection has failed.						
Recommended Work:	None 6-10 Years <input checked="" type="checkbox"/> 1-5 Years < 1 Year Urgent Replace the missing stones and rip-rap.

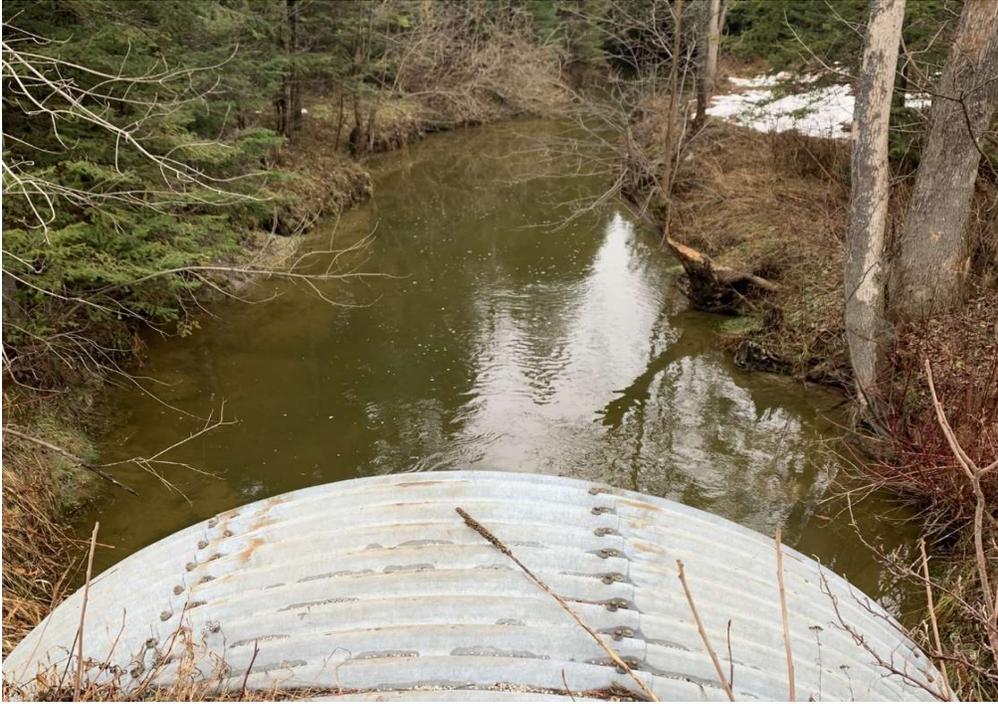
Photo 12-6: View of watercourse downstream

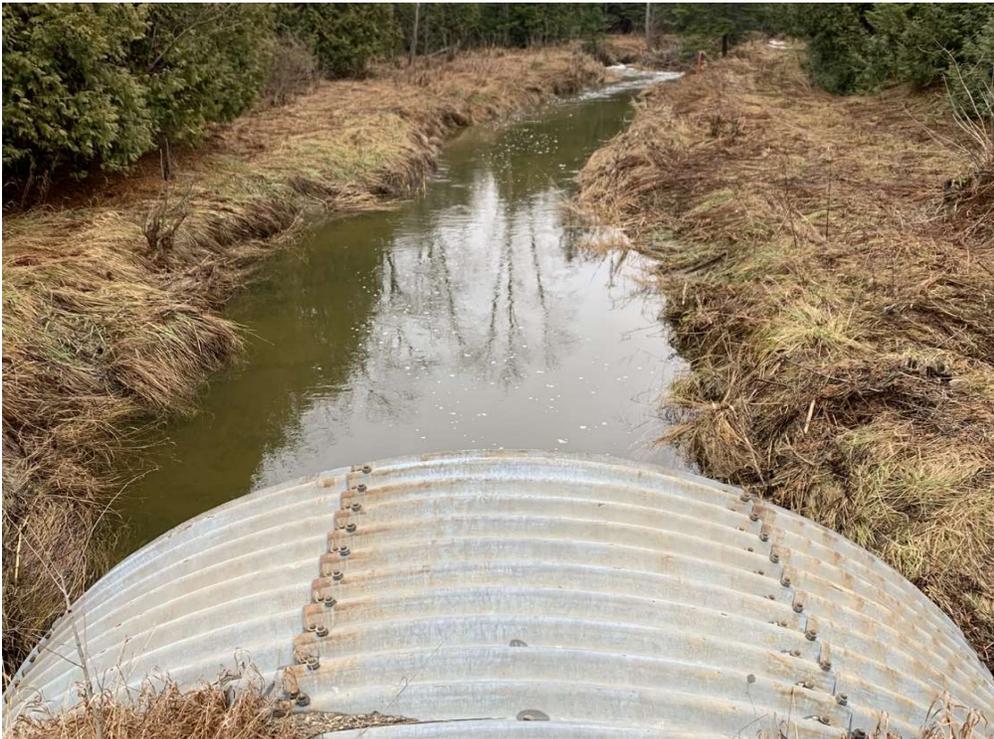
Photo 12-7: View of watercourse upstream

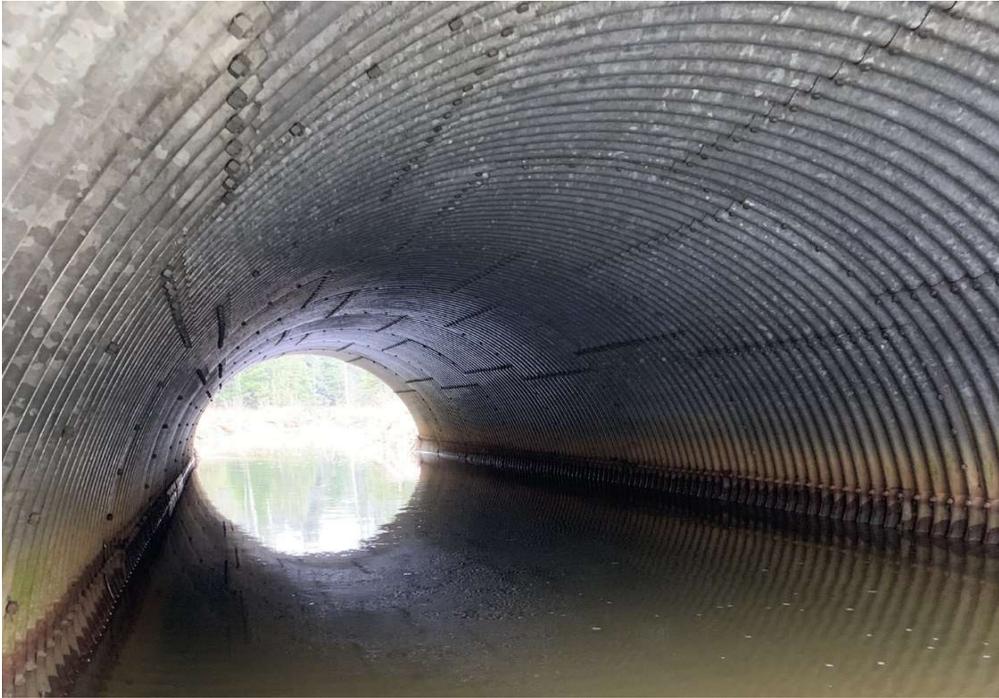
Photo 12-8: View of culvert barrel interior

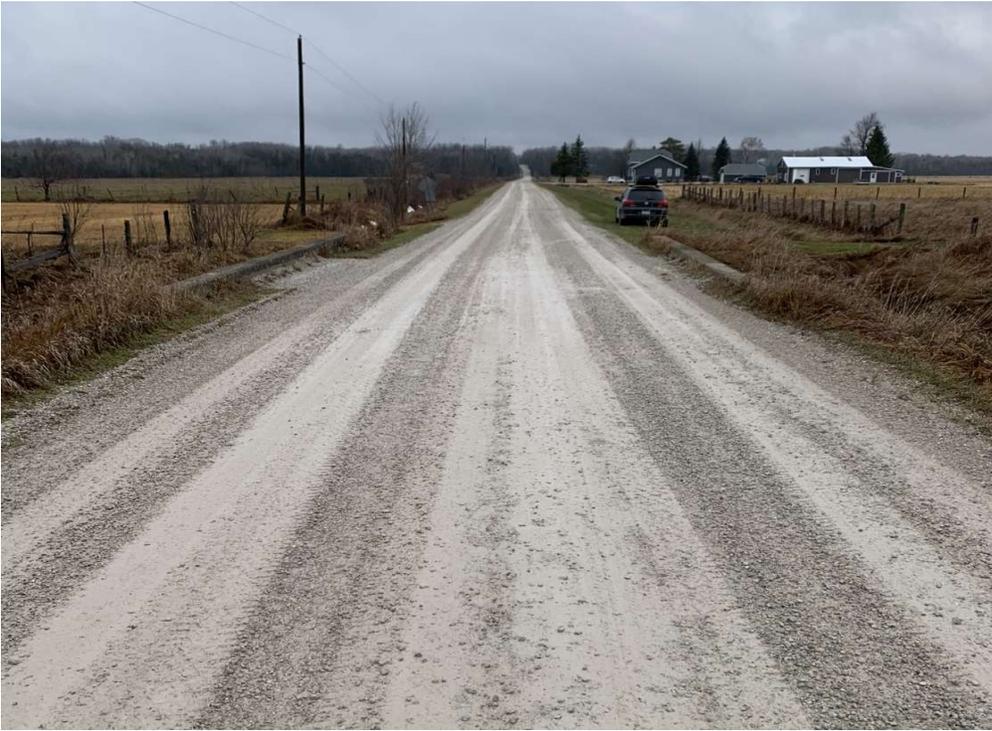
Photo 13-2: View of structure from the south approach

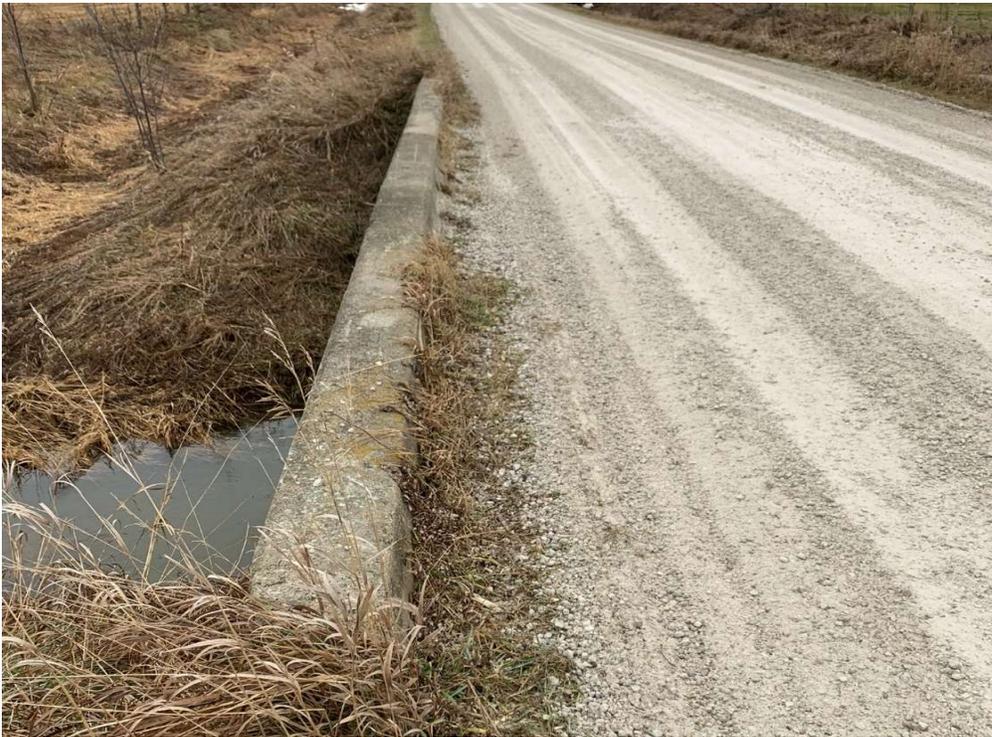
Photo 13-3: View of curb

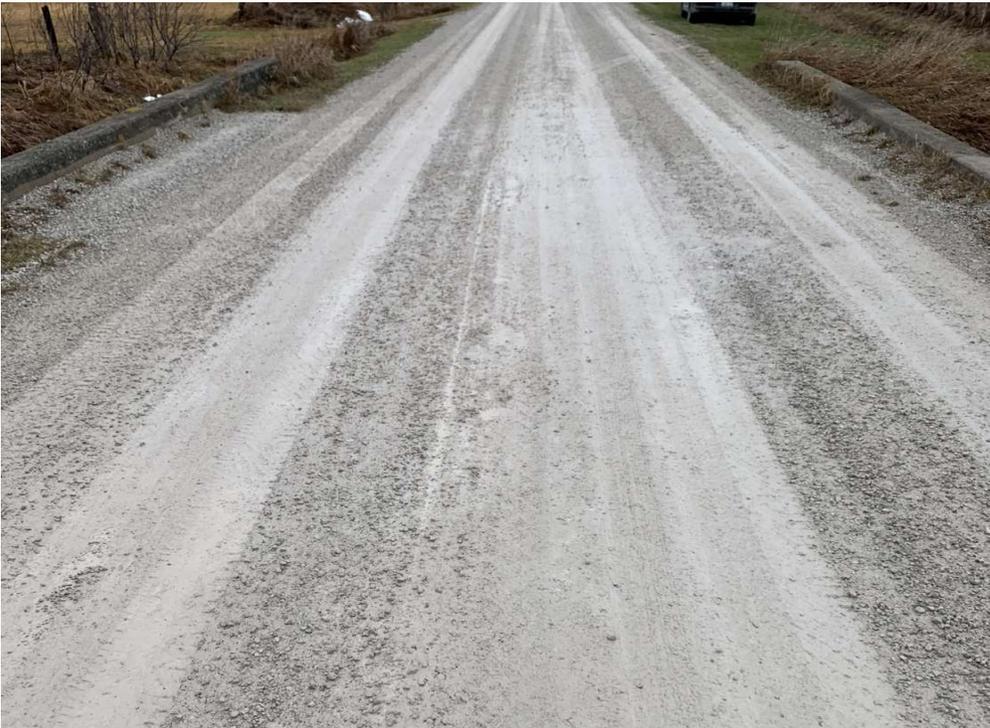
Photo 13-4: Approach and structure wearing surface

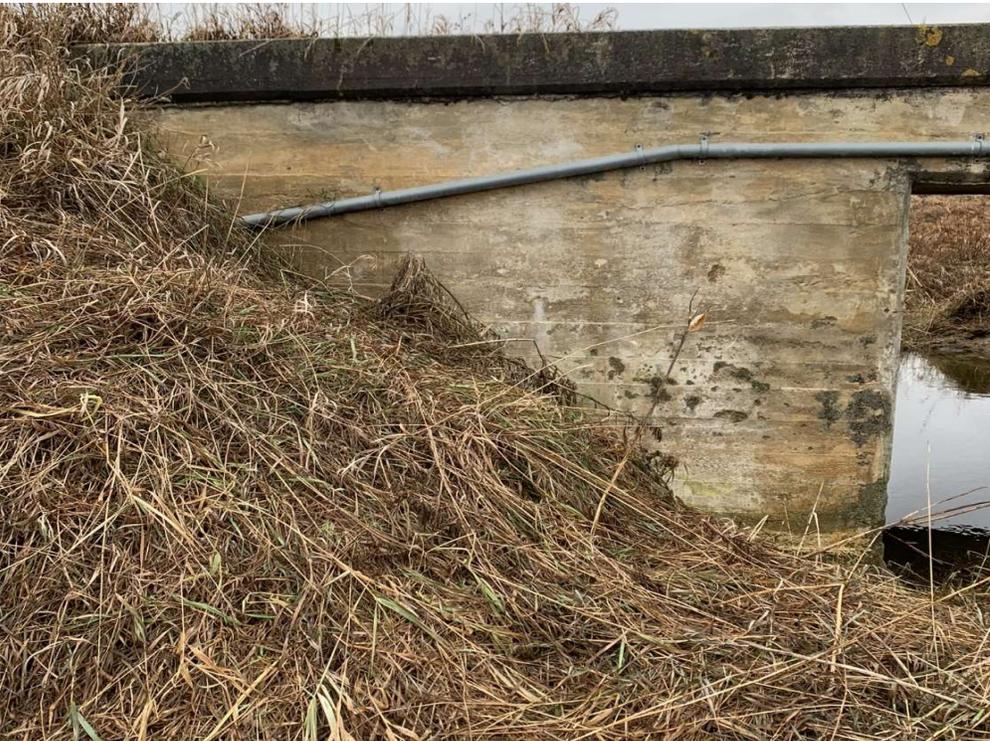
Photo 13-5: Southwest structure wingwall (typical)
