MUNICIPALITY OF NORTHERN BRUCE PENINSULA

2022 STRUCTURE INSPECTION REPORT

FINAL
PROJECT NO.: 201-01605-00
DATE: APRIL 03, 2023

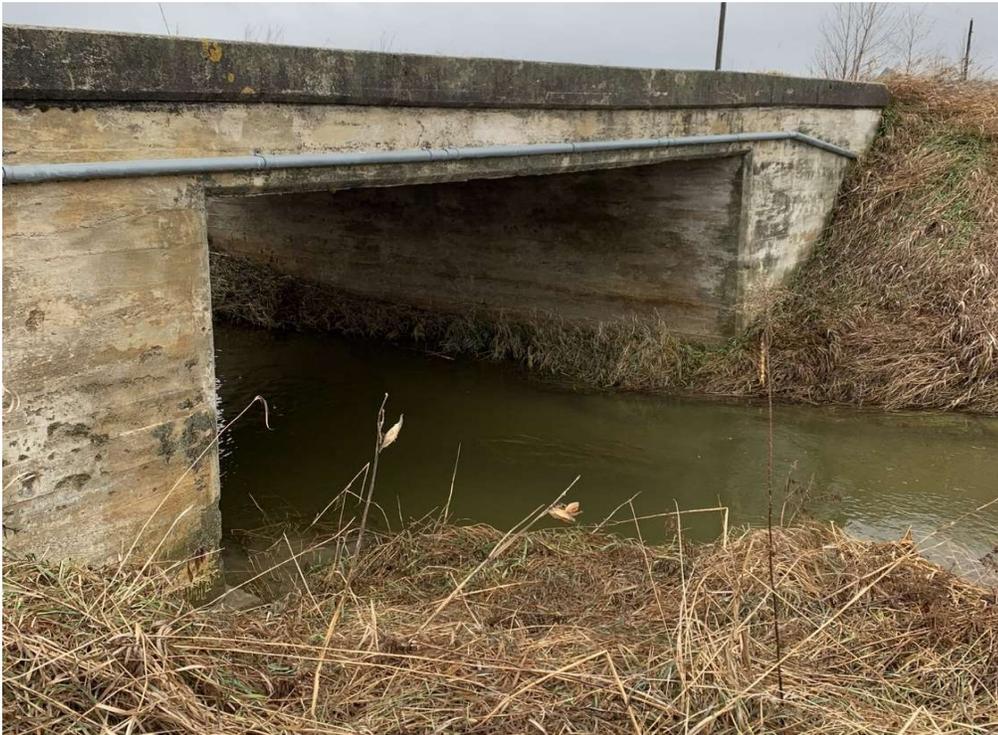
Photo 13-6: View of east structure elevation, exterior soffit and north abutment wall

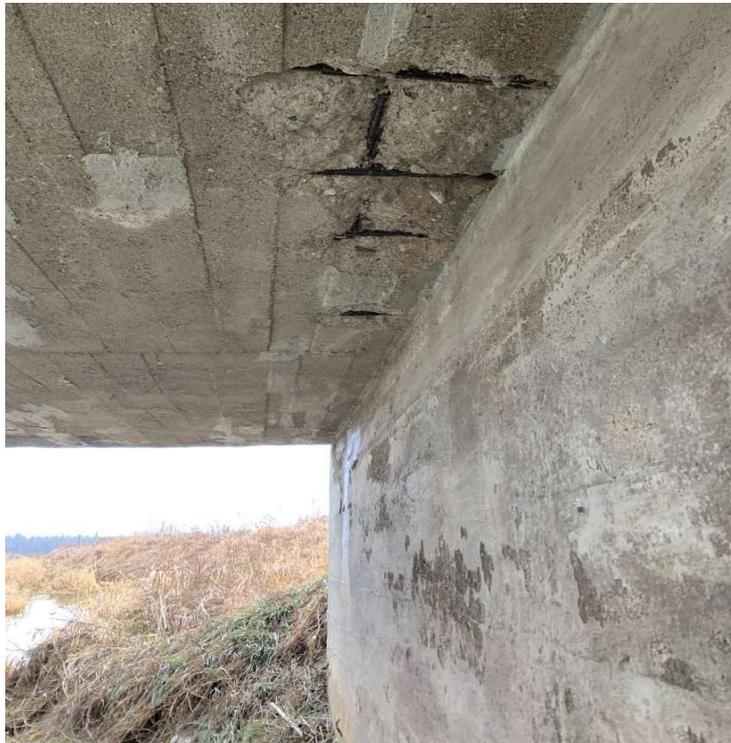
Photo 13-7: View of structure soffit and north abutment wall

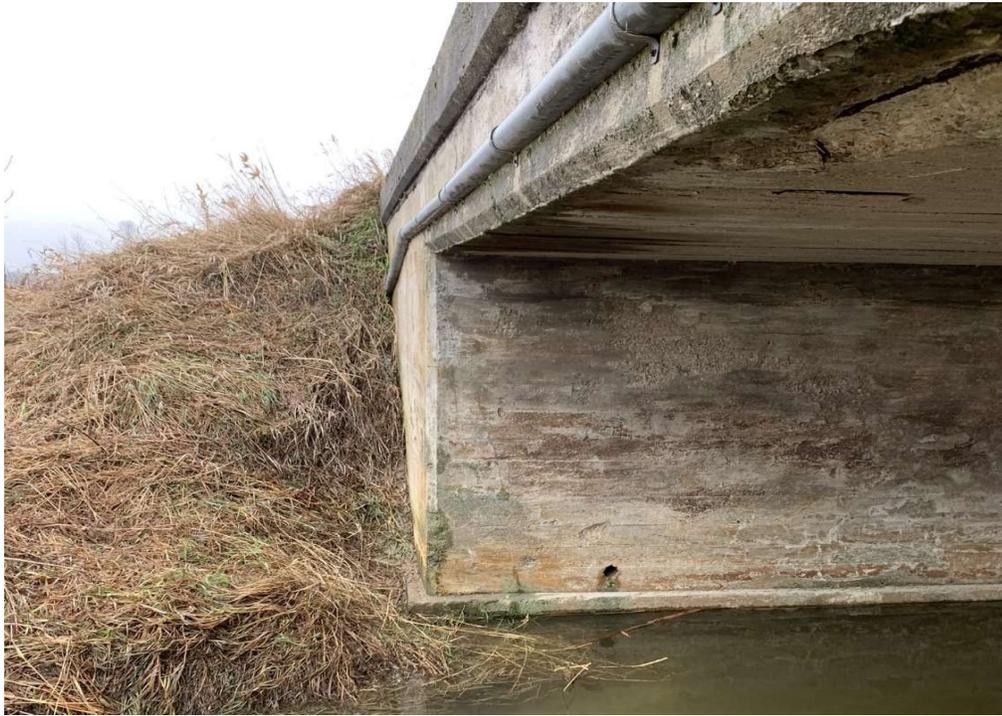
Photo 13-8: View of south abutment wall and exposed footing

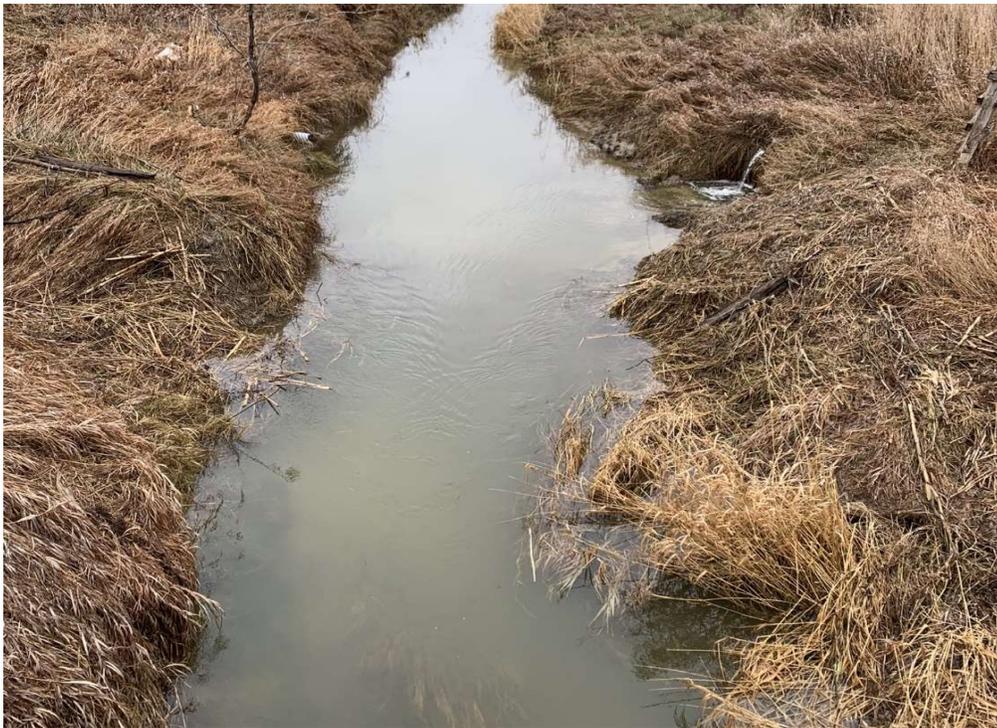
Photo 13-9: View of watercourse upstream

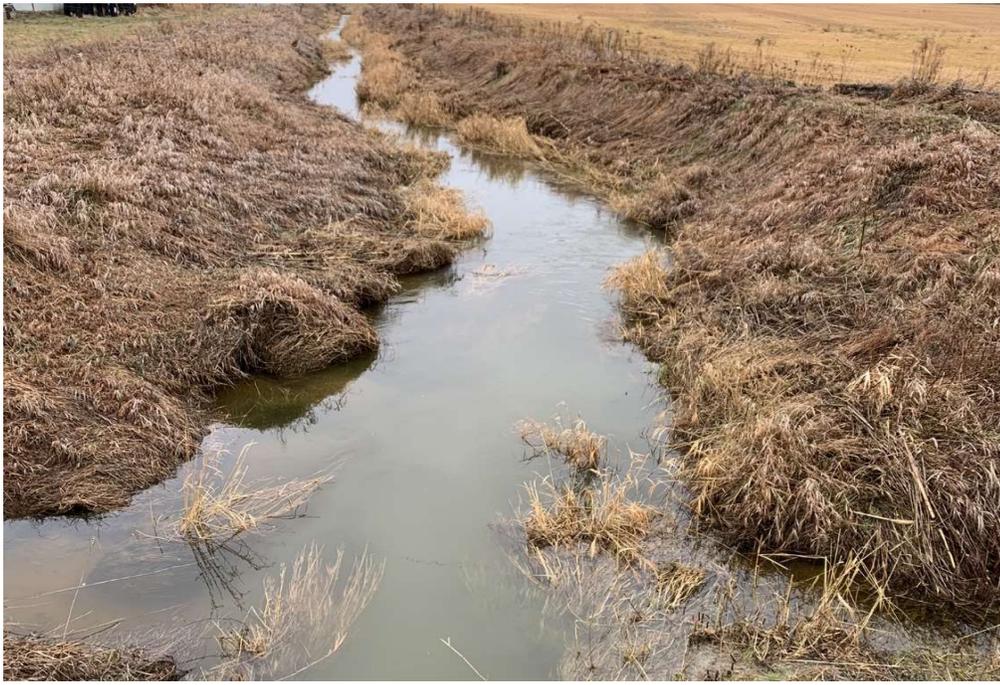
Photo 13-10: View of watercourse downstream

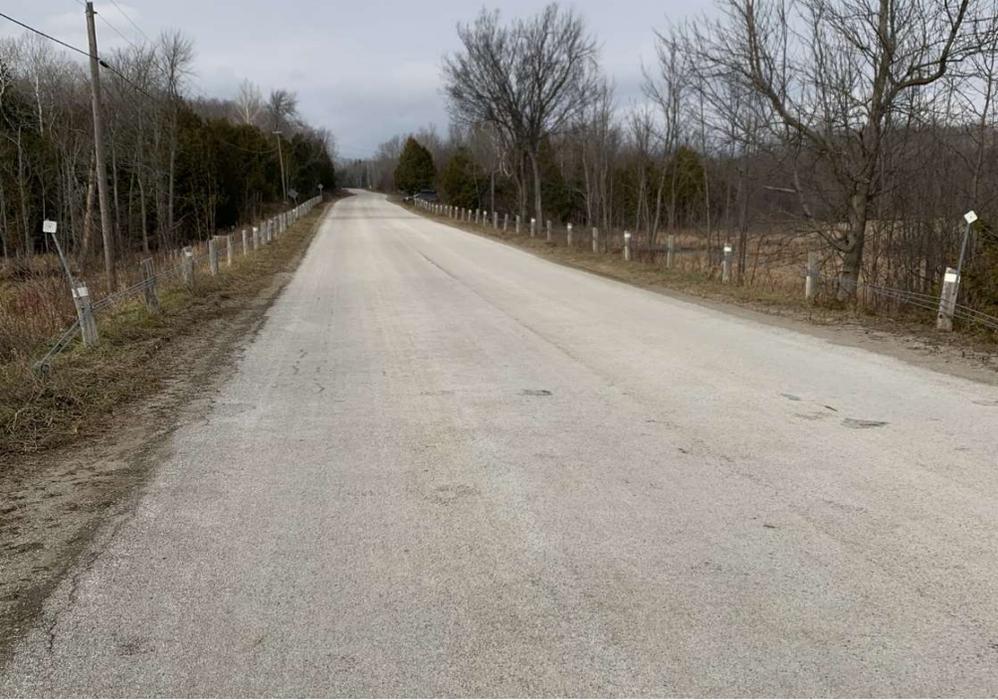
Photo 14-2: View of structure wearing surface

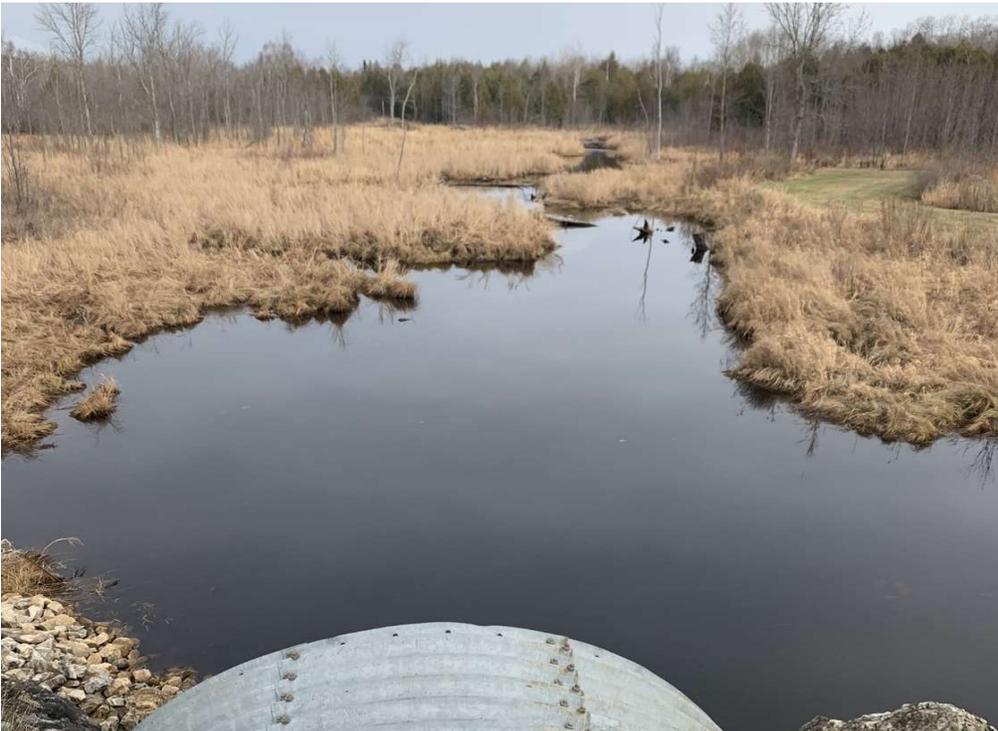
Photo 14-3: View of watercourse downstream

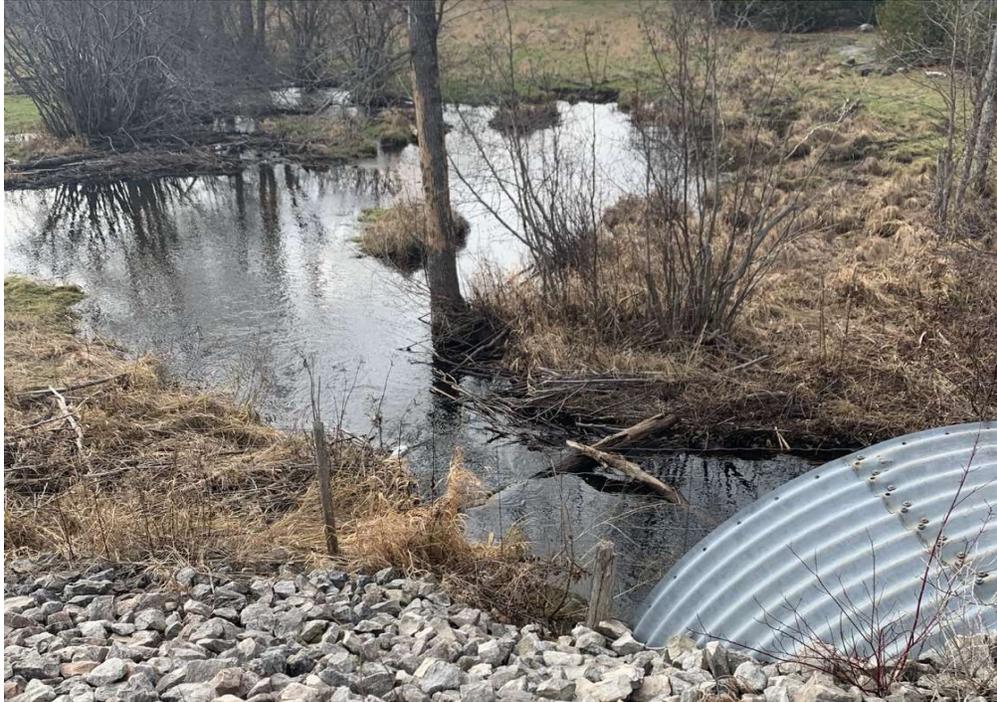
Photo 14-4: View of watercourse upstream

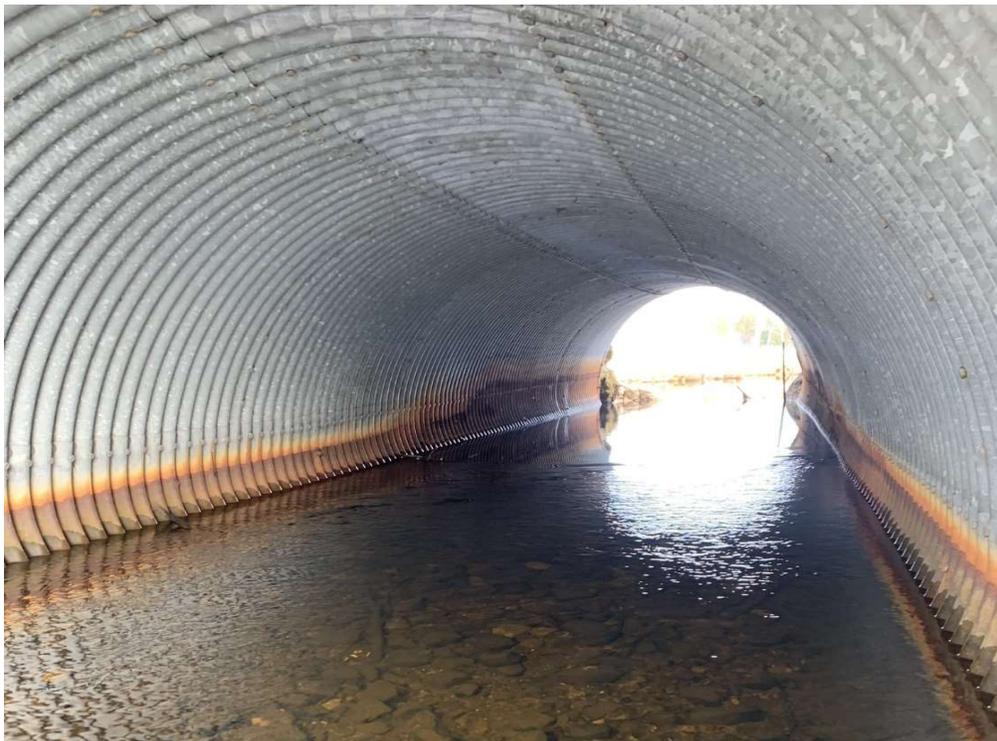
Photo 14-5: View of culvert barrel interior, obvert

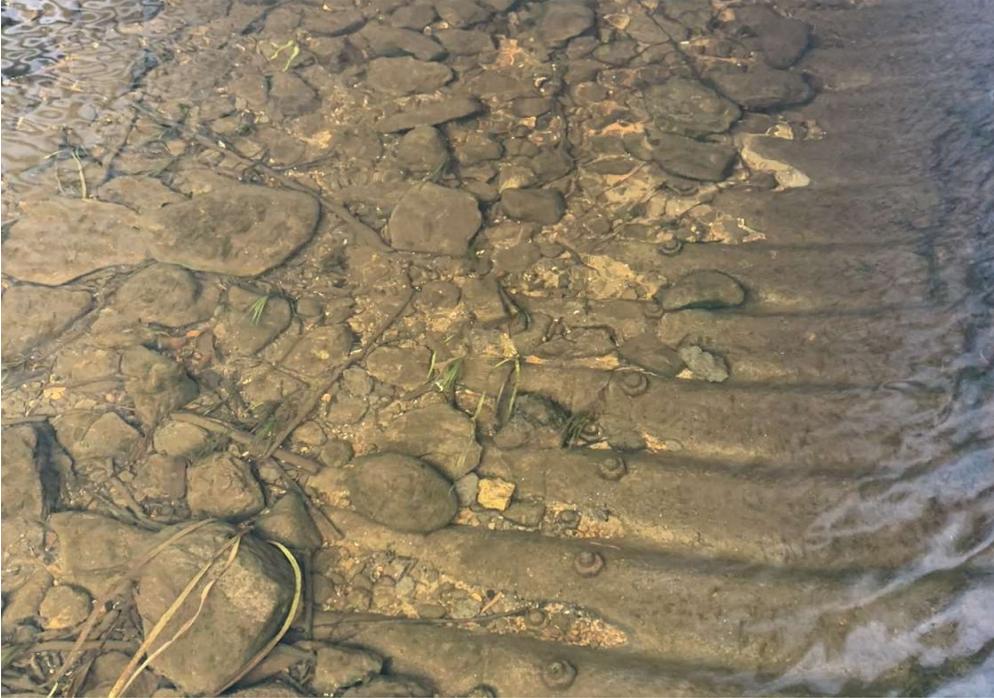
Photo 14-6: View of culvert barrel interior

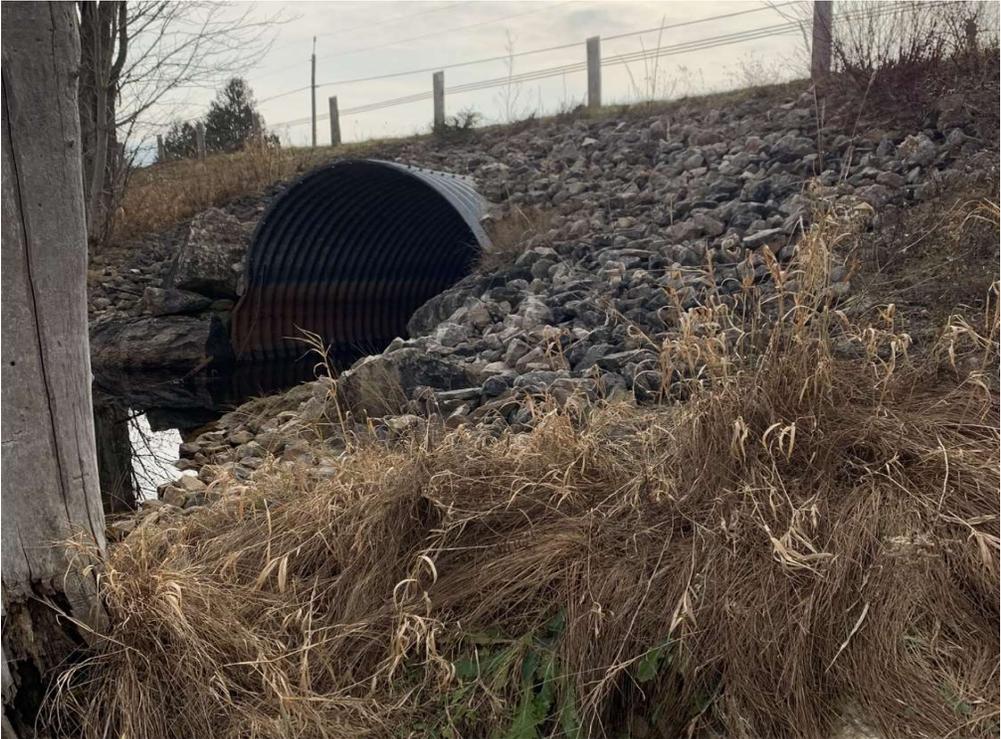
Photo 14-7: View of slope protection

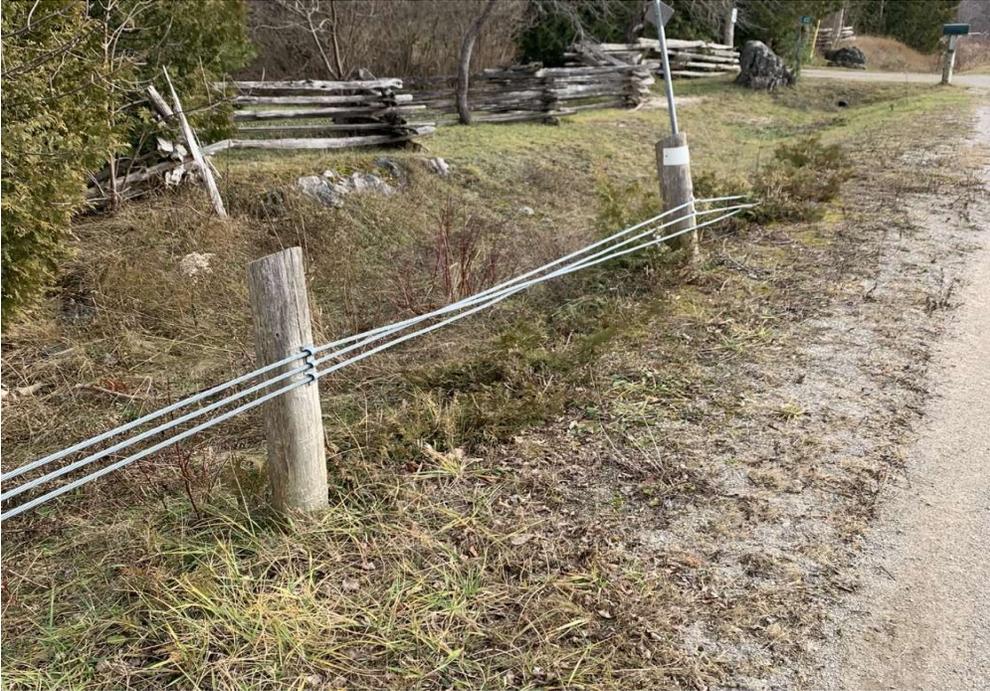
Photo 14-8: View of barrier (typical)

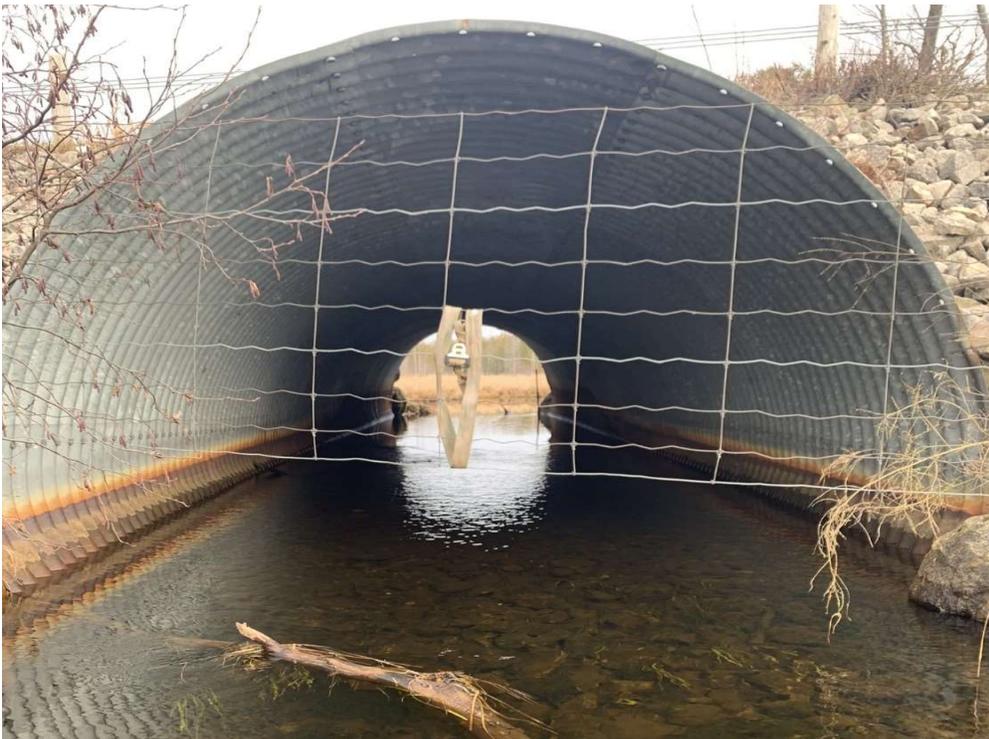
Photo 14-9: View of culvert interior

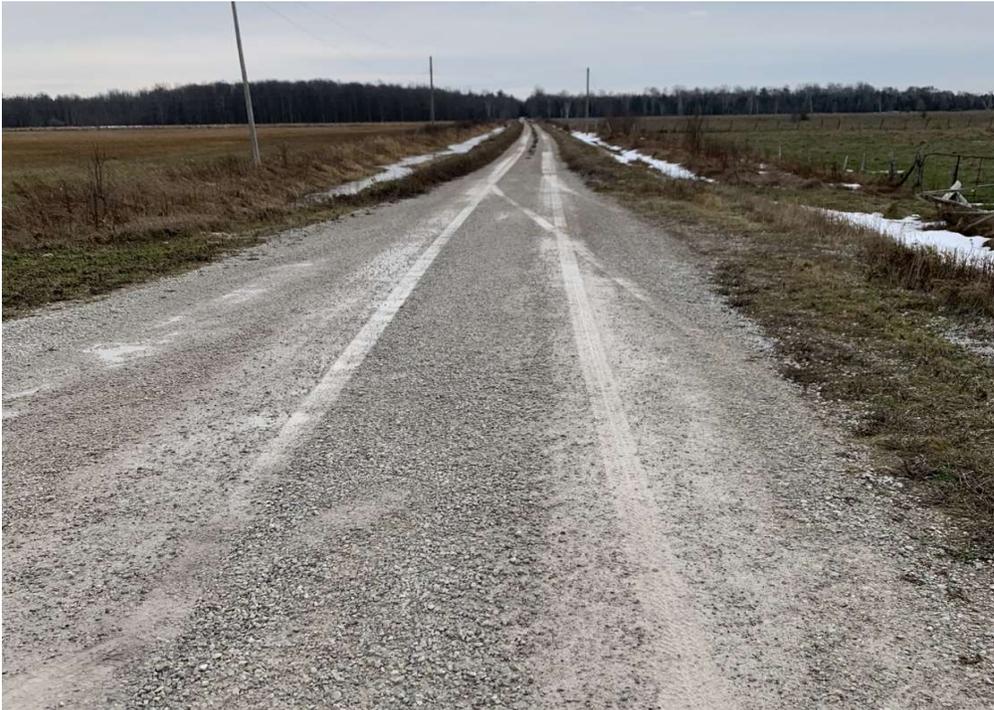
Photo 15-2: View of approach and structure wearing surface

Element Group:	Decks		Length:				
Element Name:	Wearing Surface		Width:				
Location:			Height:				
Material:	Gravel		Count:				
Element Type:			Total Quantity:				
Environment:	Severe		Limited Insp'n:				
Protection System:	Wearing Surface						
Condition Data:	Units	Exc.	Good	Fair	Poor	Perform. Deficiencies	Maint. Needs
	%			100		Yes	Yes
Comments:	The granular wearing surface is uneven and requires grading to achieve drainage.						
Recommended Work:	None		6-10 Years	1-5 Years	<input checked="" type="checkbox"/> < 1 Year	Urgent	
	Grade annually and clear vegetation from shoulders.

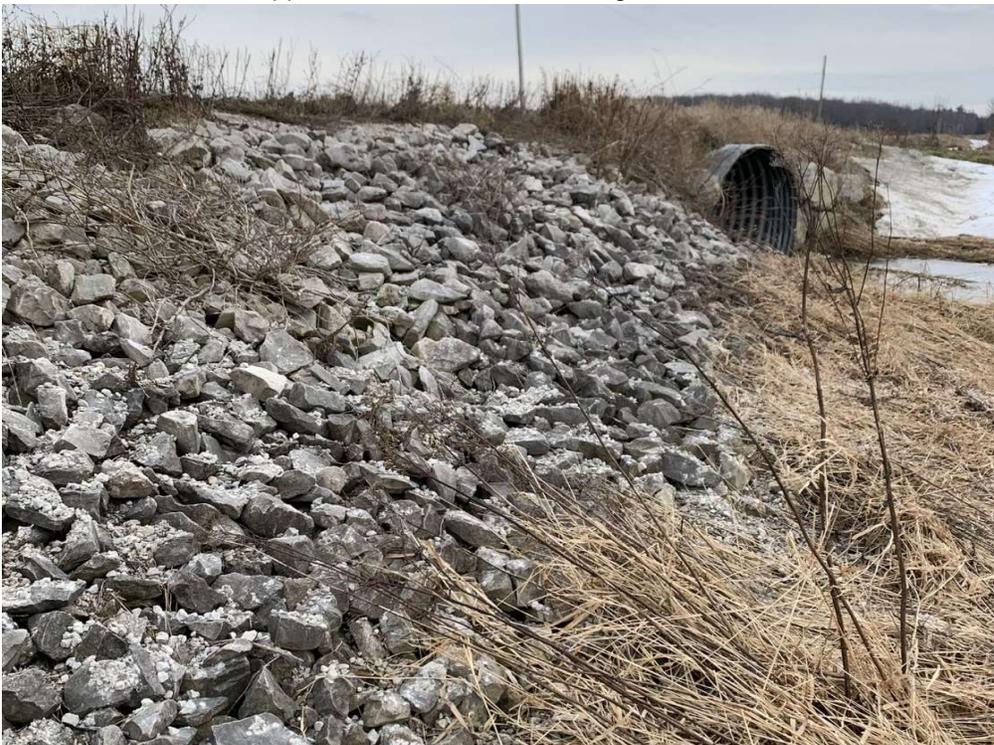
Photo 15-3: Rock protection at inlet end

Element Group:	Culverts		Length:				
Element Name:	Inlet Component		Width:				
Location:	East End		Height:				
Material:	Stone and Earth		Count:				
Element Type:			Total Quantity:				
Environment:	Moderate		Limited Insp'n:				
Protection System:	None						
Condition Data:	Units	Exc.	Good	Fair	Poor	Perform. Deficiencies	Maint. Needs
	%		100				
Comments:	The low level CSP pipe culvert is partially submerged underwater. There is some observed erosion of the embankments at the culvert inlet.						
Recommended Work:	None		6-10 Years	1-5 Years	<input checked="" type="checkbox"/> < 1 Year	Urgent	
	Repair erosion and add rip-rap slope protection.

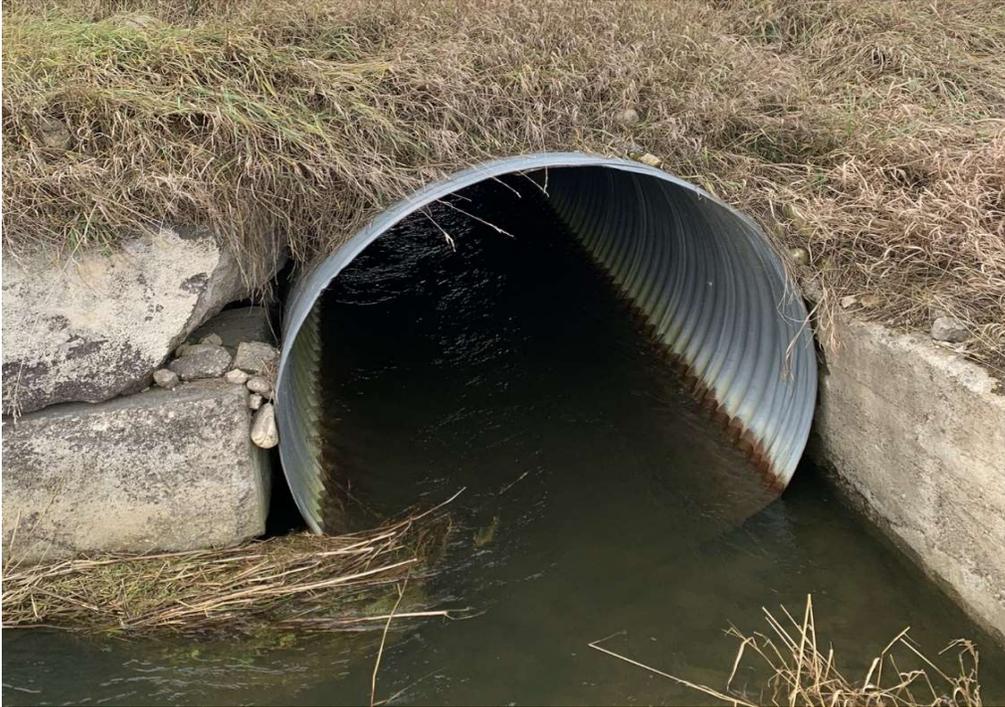
Photo 15-4: View of west culvert end

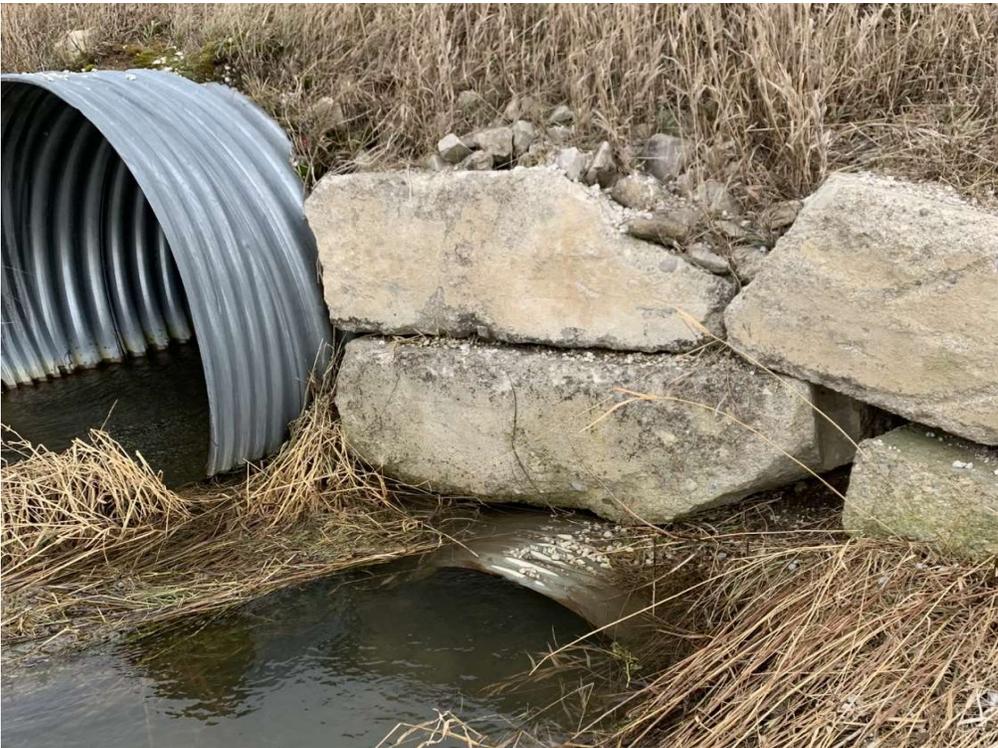
Photo 15-5: View of east culvert end

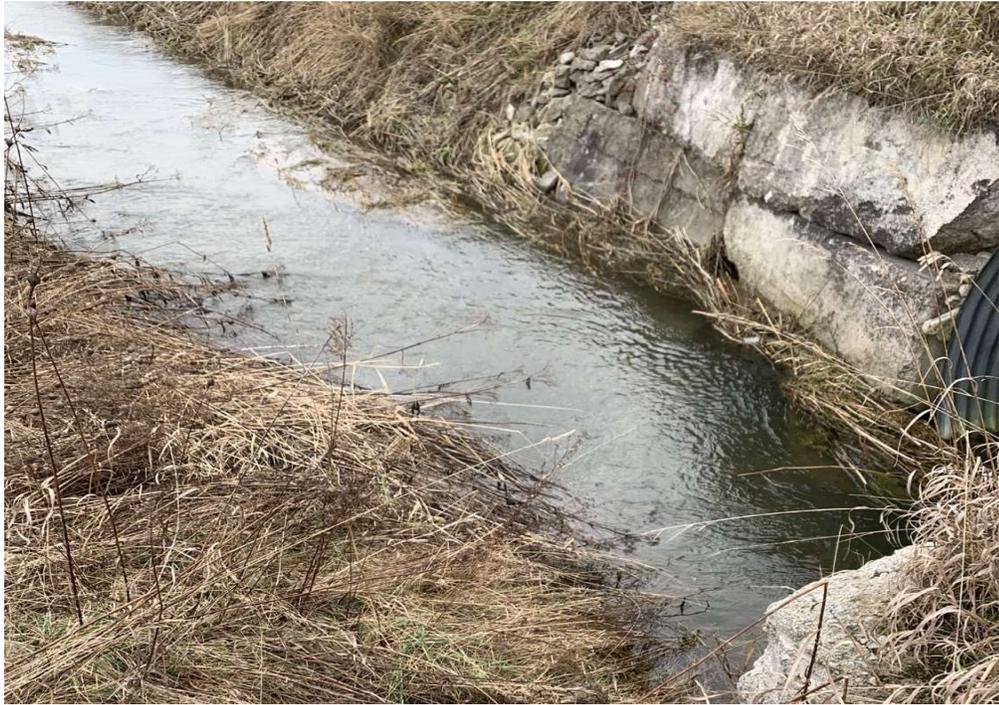
Photo 15-6: View of watercourse downstream

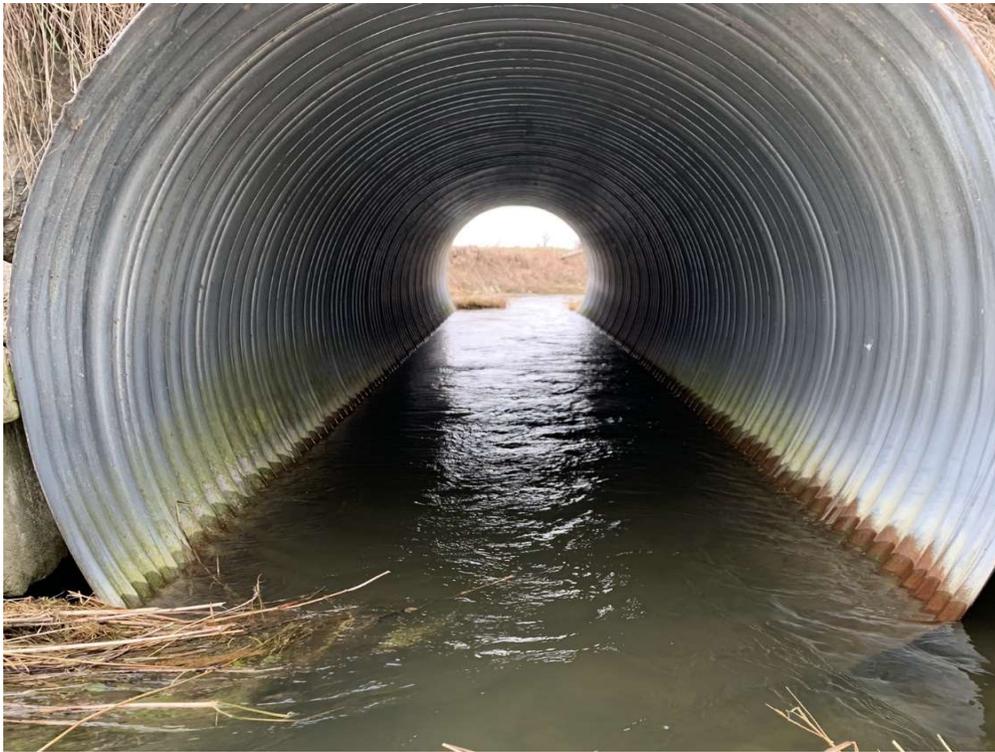
Photo 15-7: View of culvert barrel interior

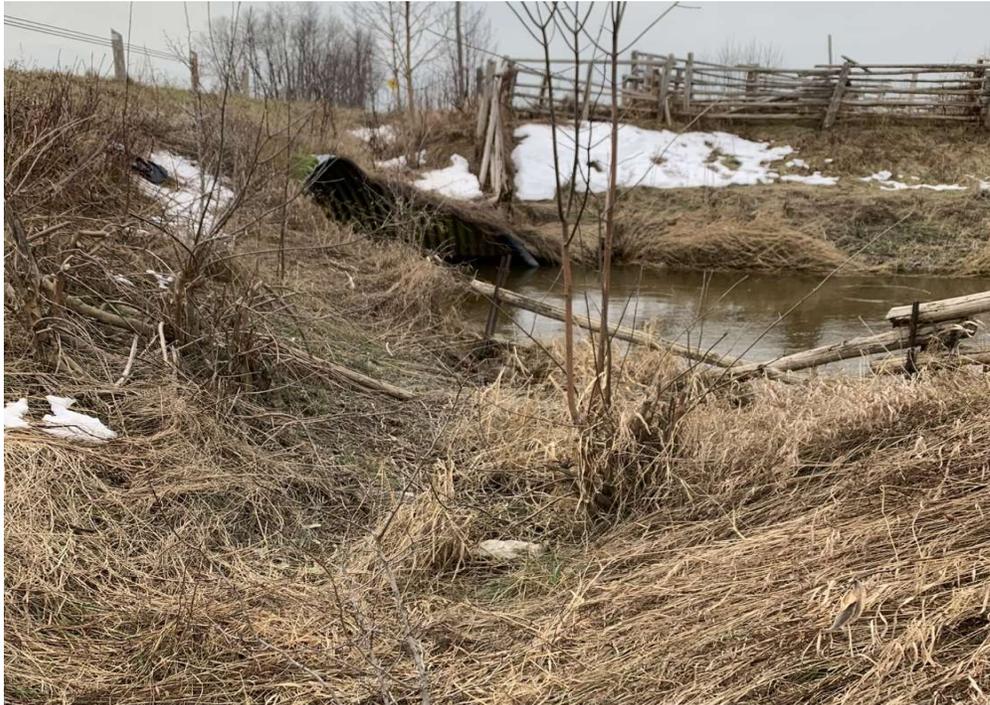
Photo 16-2: View of culvert barrel in elevation (outlet end)

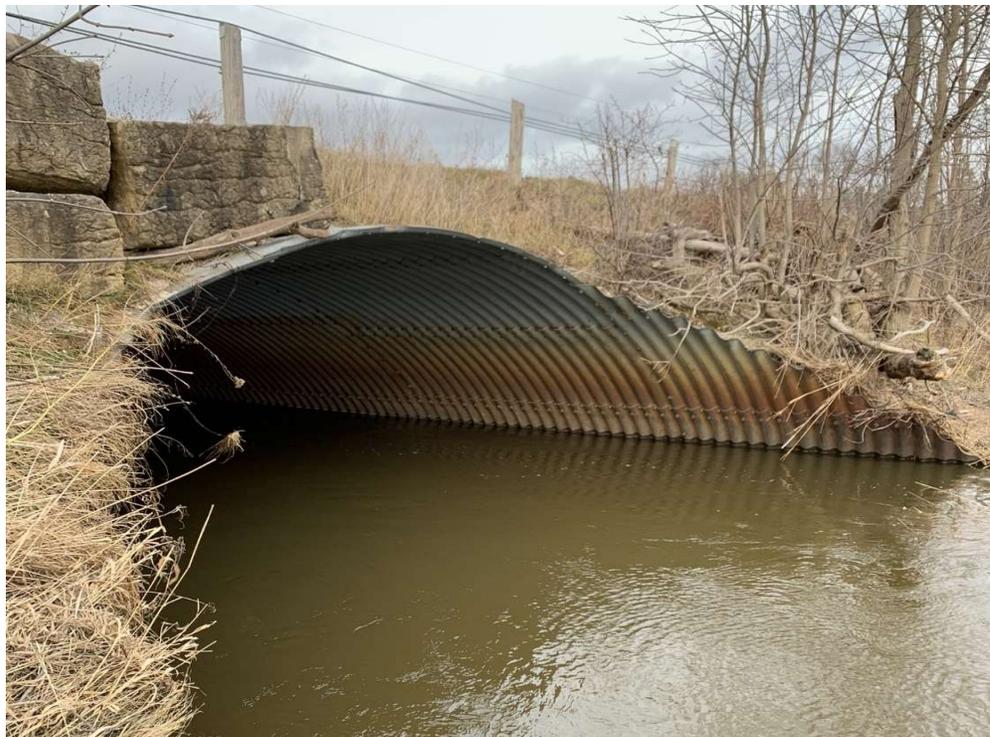
Photo 16-3: View of culvert barrel in elevation (inlet end)

Element Group:	Culverts		Length:				
Element Name:	Inlet Component		Width:				
Location:	South End		Height:				
Material:	Stone		Count:				
Element Type:	Stone Head Wall		Total Quantity:				
Environment:	Moderate		Limited Insp'n:				
Protection System:	None						
Condition Data:	Units	Exc.	Good	Fair	Poor	Perform. Deficiencies	Maint. Needs
	%		50	40	10	Yes	Yes
Comments:	Some erosion was observed under the large block stones protecting the south slope.						
Recommended Work:	None <input type="checkbox"/> 6-10 Years <input checked="" type="checkbox"/> 1-5 Years <input type="checkbox"/> < 1 Year <input type="checkbox"/> Urgent Place additional stone blocks and rip-rap. Remove the debris at the inlet.

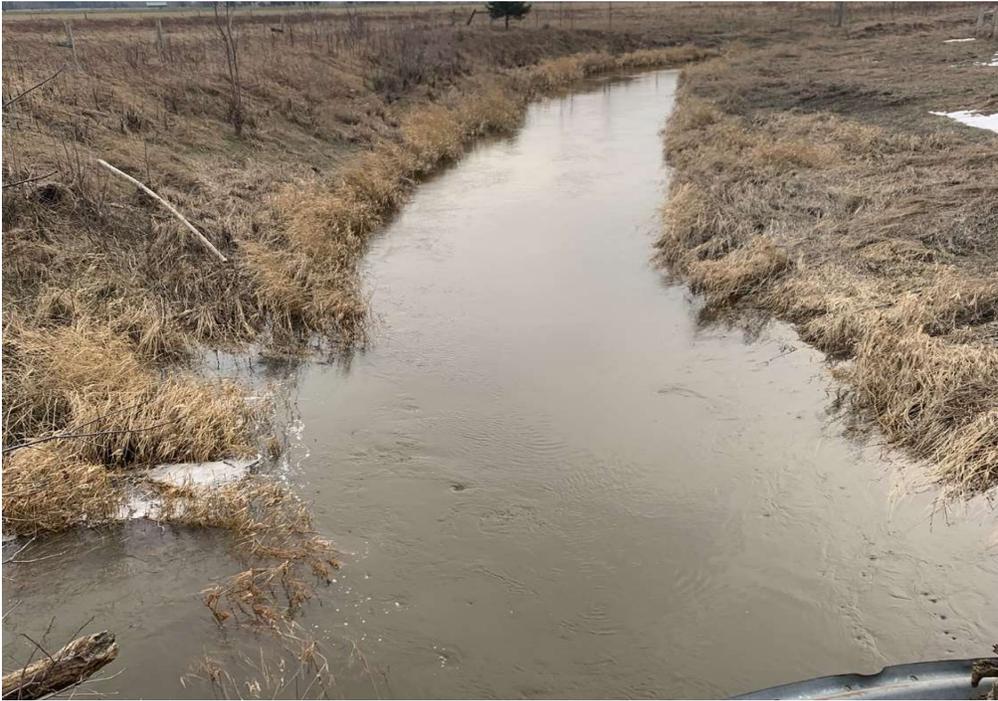
Photo 16-4: View of watercourse upstream

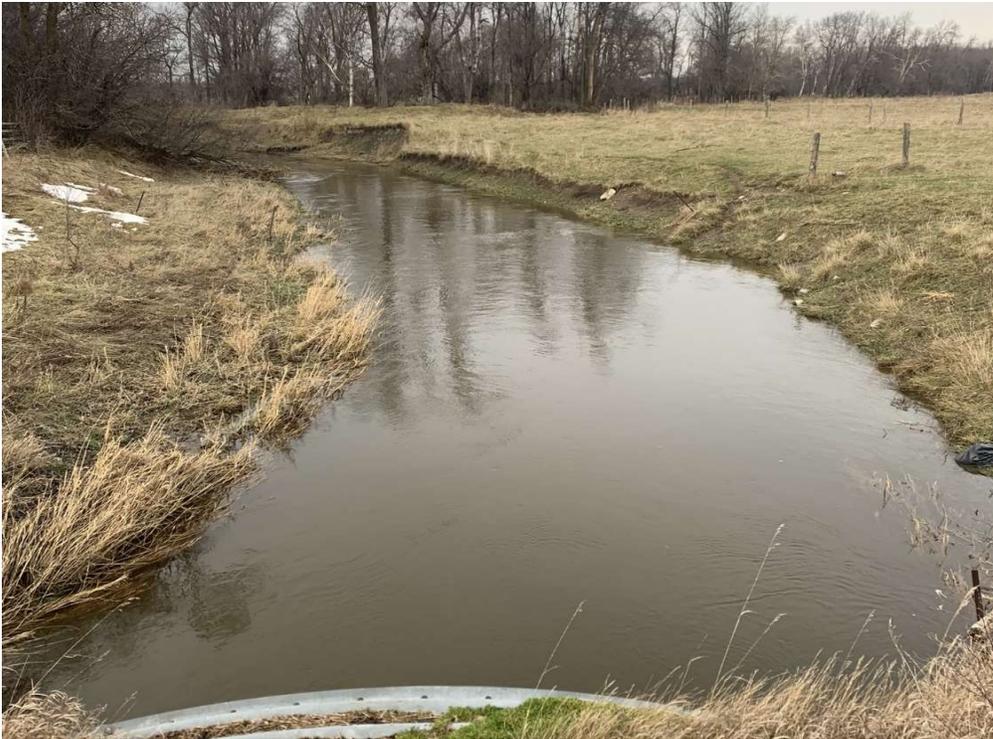
Photo 16-5: View of watercourse downstream

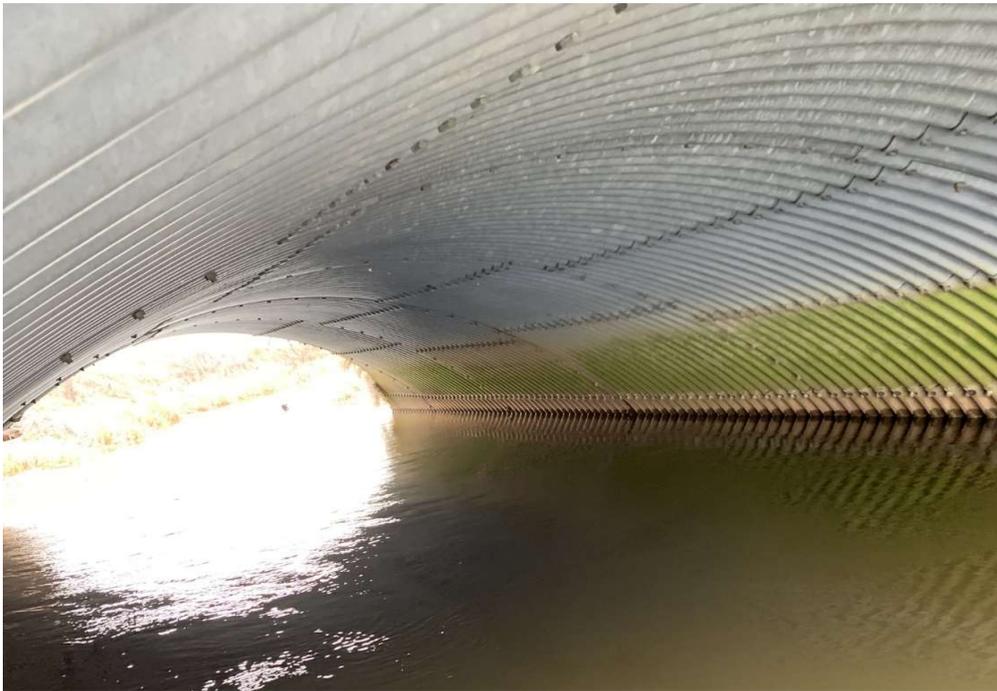
Photo 16-6: Culvert barrel interior

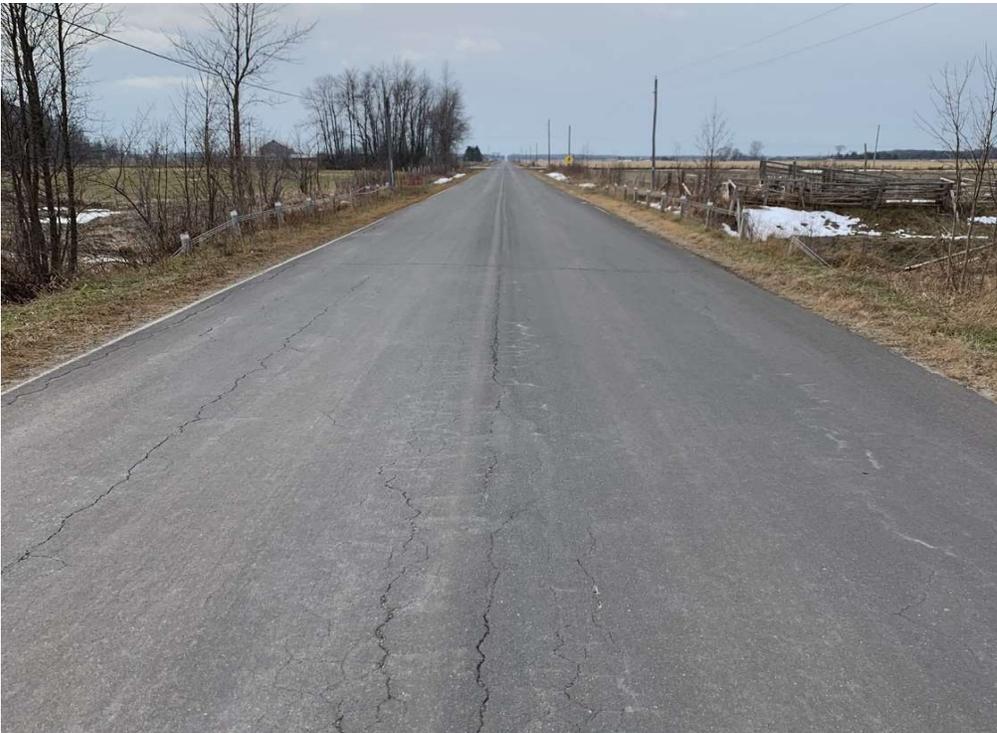
Photo 16-7: View of structure from approach

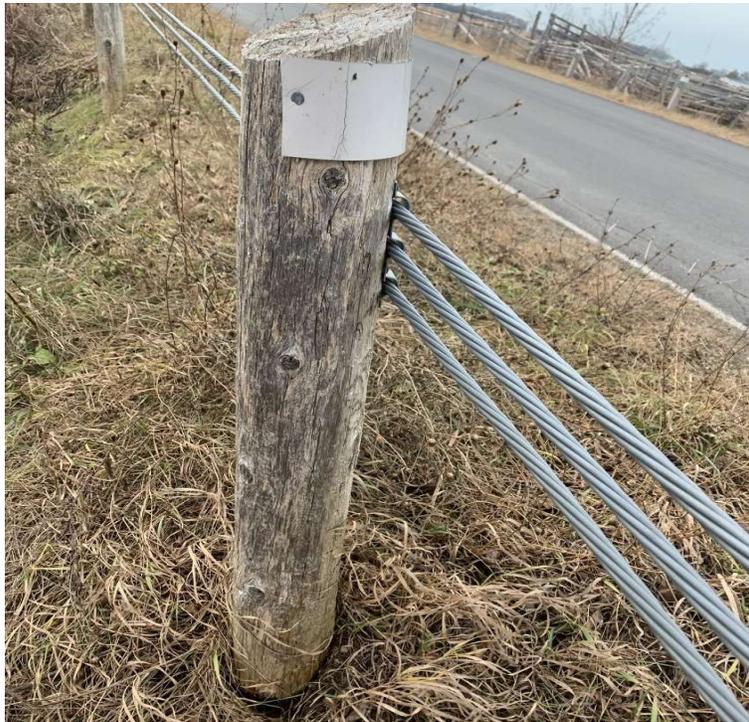
Photo 16-9: Wooden post (typical)

Element Group:	Barriers		Length:				
Element Name:	Barrier		Width:				
Location:	Each Side		Height:				
Material:	Steel/Wood		Count:	20 posts - 3 cable			
Element Type:	3-Cable Guiderail		Total Quantity:				
Environment:	Severe		Limited Insp'n:				
Protection System:	None						
Condition Data:	Units	Exc.	Good	Fair	Poor	Perform. Deficiencies	Maint. Needs
	Ea.		20			Yes	Yes
Comments:	The three cable guide barrier is in fair overall condition. Some of the wooden posts are experiencing moderate rot and should be replaced for vehicle safety. Loose cable on south side.						
Recommended Work:	None <input type="checkbox"/> 6-10 Years <input type="checkbox"/> 1-5 Years <input checked="" type="checkbox"/> < 1 Year <input type="checkbox"/> Urgent Replace the rotten barrier posts. Re-attach and tighten loose cables.

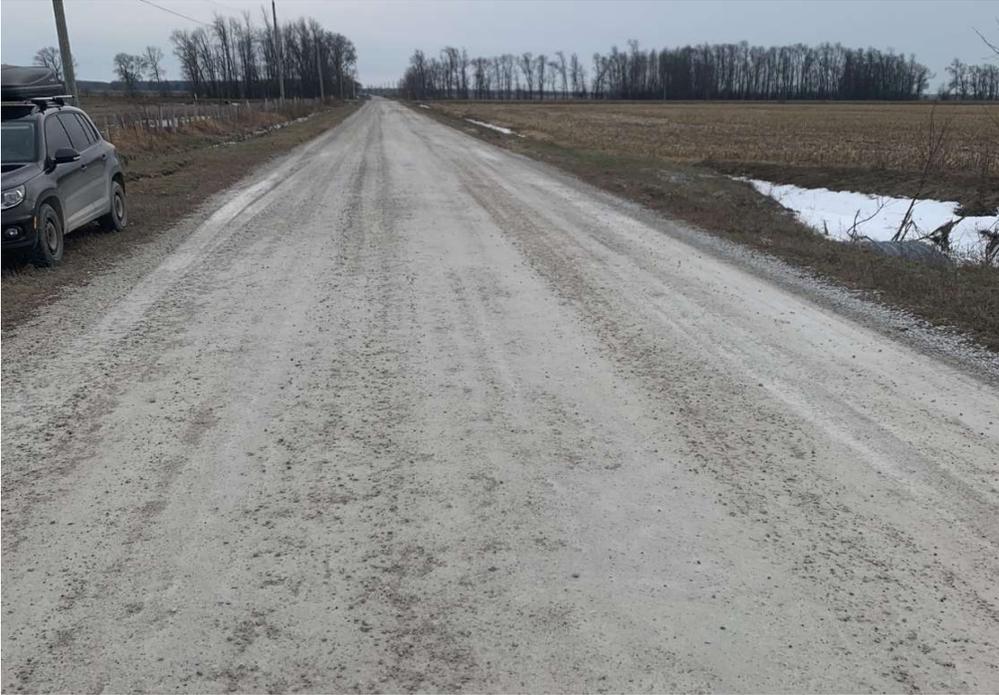
Photo 17-2: View of structure and approach wearing surface

Element Group:	Decks		Length:				
Element Name:	Wearing Surface		Width:				
Location:			Height:				
Material:	Gravel		Count:				
Element Type:			Total Quantity:				
Environment:	Severe		Limited Insp'n:				
Protection System:	None						
Condition Data:	Units	Exc.	Good	Fair	Poor	Perform. Deficiencies	Maint. Needs
	%			85	15	Yes	Yes
Comments:	Some wheel path rutting was observed. Grade the wearing surface annually.						
Recommended Work:	None 6-10 Years		1-5 Years	<input checked="" type="checkbox"/> < 1 Year	Urgent		
	Grade the wearing surface annually.

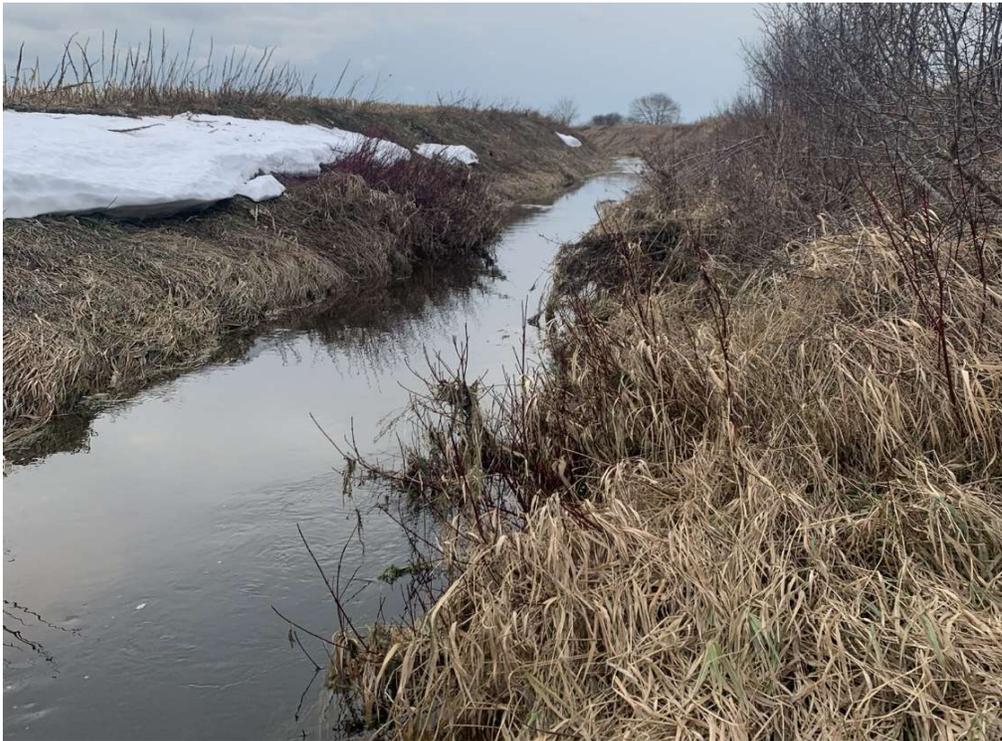
Photo 17-3: View of watercourse upstream

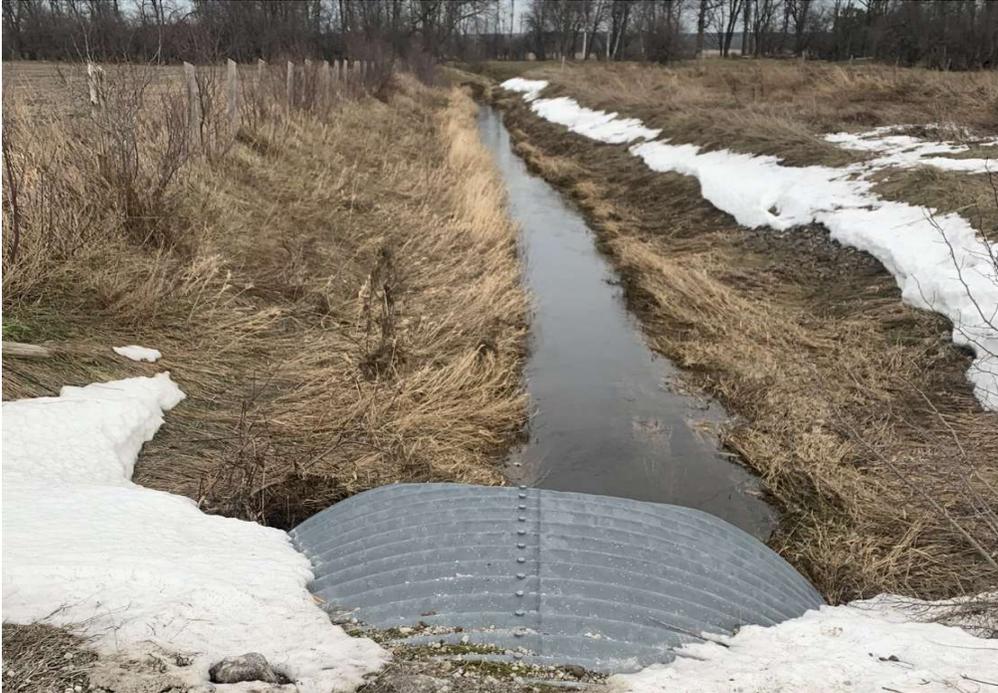
Photo 17-4: View of watercourse downstream and outlet culvert end

Element Group:	Culverts		Length:				
Element Name:	Outlet Components		Width:				
Location:	West End		Height:				
Material:	Stone and Earth		Count:				
Element Type:	Stone and Steel Culvert		Total Quantity:				
Environment:	Moderate		Limited Insp'n:				
Protection System:	None						
Condition Data:	Units	Exc.	Good	Fair	Poor	Perform. Deficiencies	Maint. Needs
	%			100			Yes
Comments:	Minor erosion at corners.						
Recommended Work:	None		6-10 Years	<input checked="" type="checkbox"/> 1-5 Years	< 1 Year	Urgent	
	Place rip-rap slope protection.

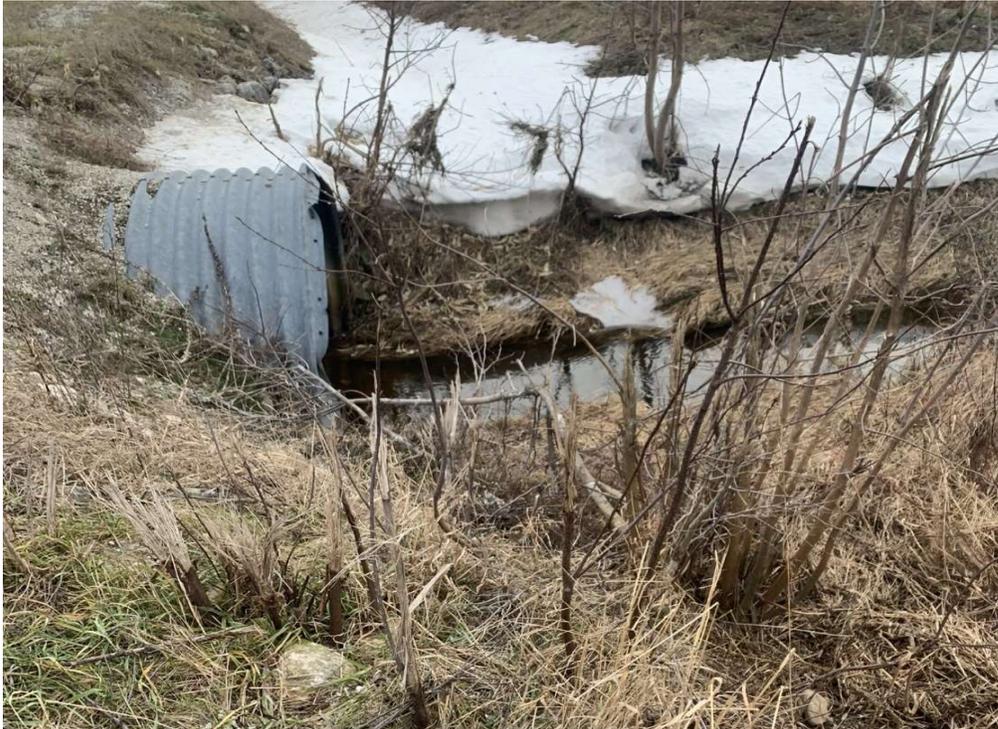
Photo 17-5: View of culvert in elevation and inlet components

Element Group:	Culverts		Length:				
Element Name:	Inlet Component		Width:				
Location:	End		Height:				
Material:	Stone and Earth		Count:				
Element Type:	Stone Head Wall and Steel Culvert		Total Quantity:				
Environment:	Moderate		Limited Insp'n:				
Protection System:	None						
Condition Data:	Units	Exc.	Good	Fair	Poor	Perform. Deficiencies	Maint. Needs
	%			100			Yes
Comments:	Minor erosion at corners.						
Recommended Work:	None 6-10 Years		1-5 Years	<input checked="" type="checkbox"/> < 1 Year	Urgent		
	Place rip-rap slope protection.
