MUNICIPALITY OF NORTHERN BRUCE PENINSULA

2022 STRUCTURE INSPECTION REPORT

FINAL
PROJECT NO.: 201-01605-00
DATE: APRIL 03, 2023

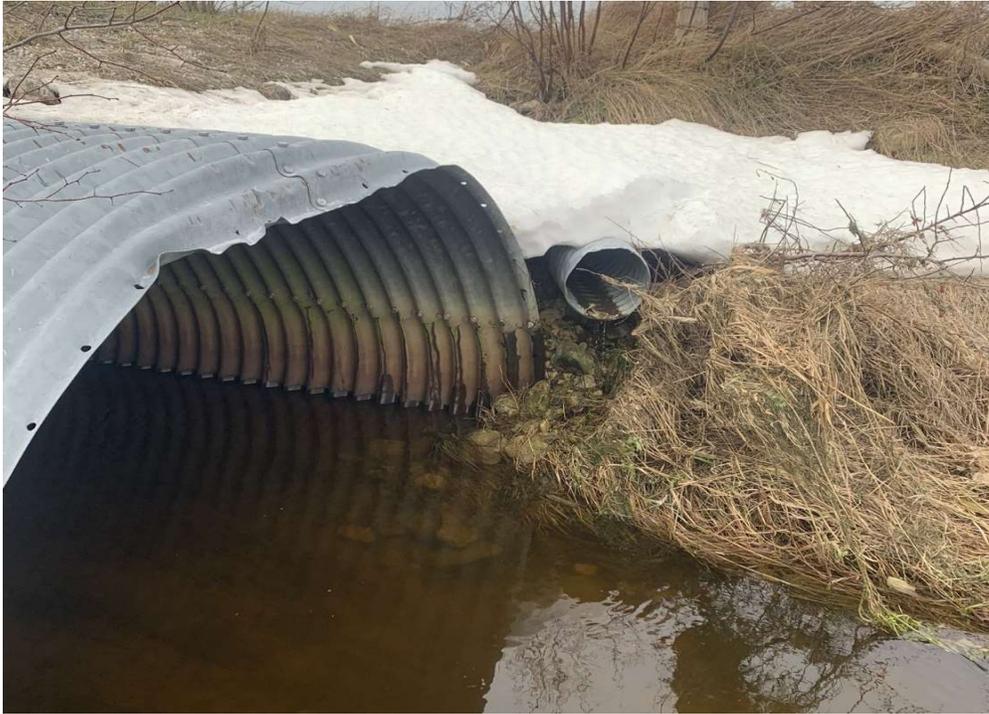
Photo 17-6: View of embankment

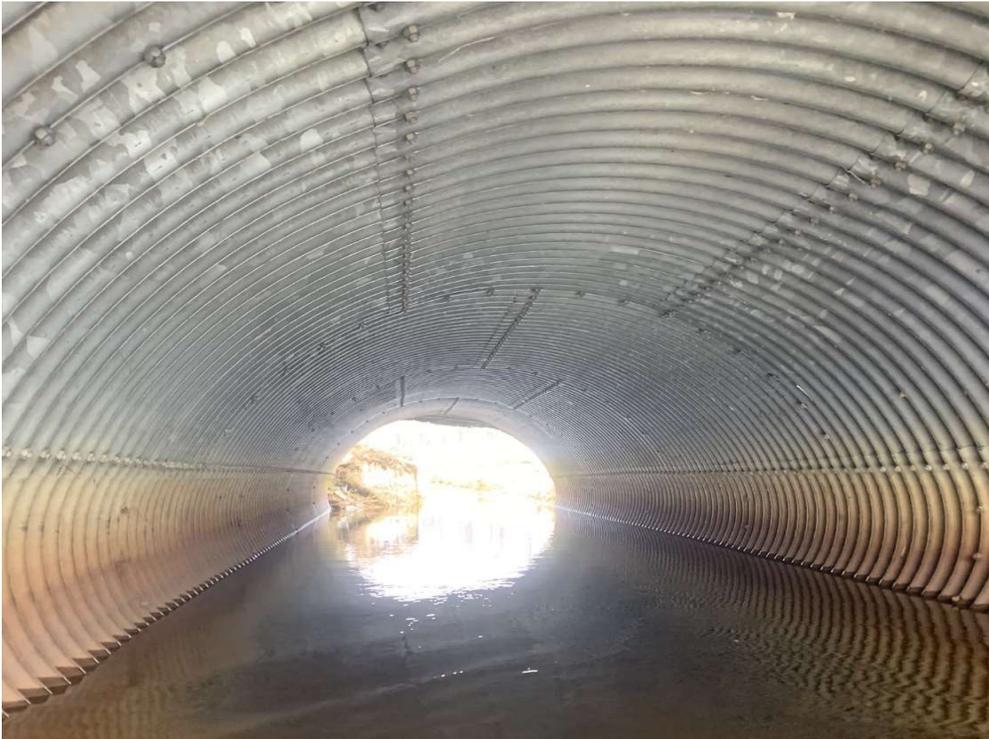
Photo 17-7: View of culvert barrel interior

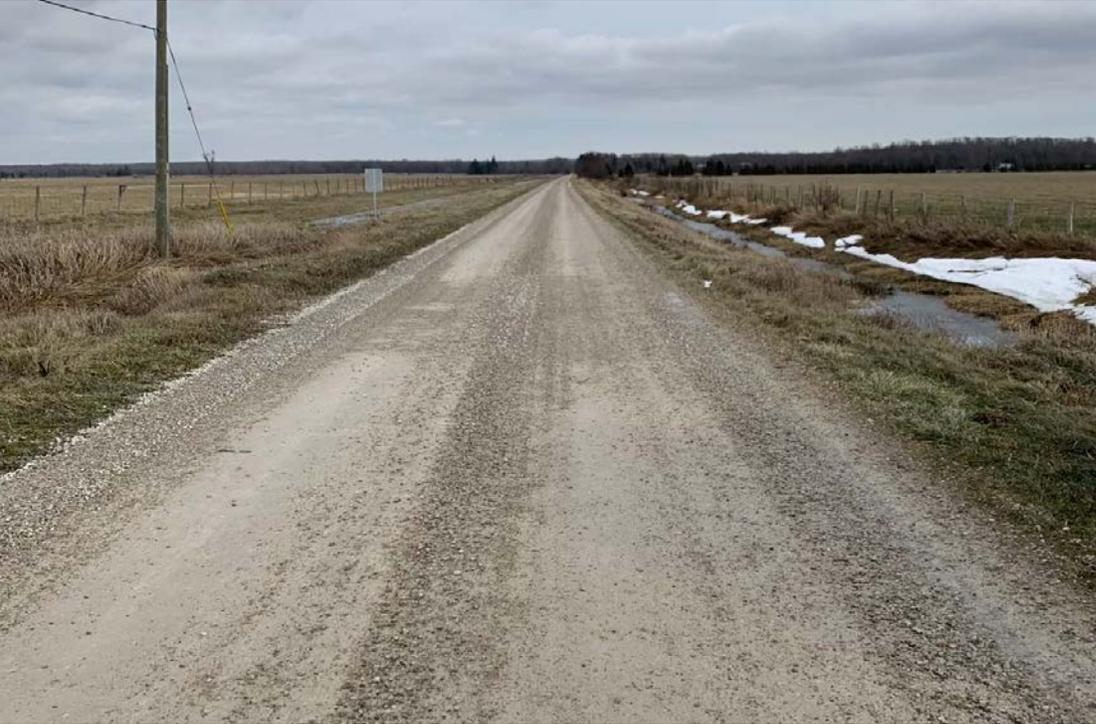
Photo 18-2: View of structure wearing surface

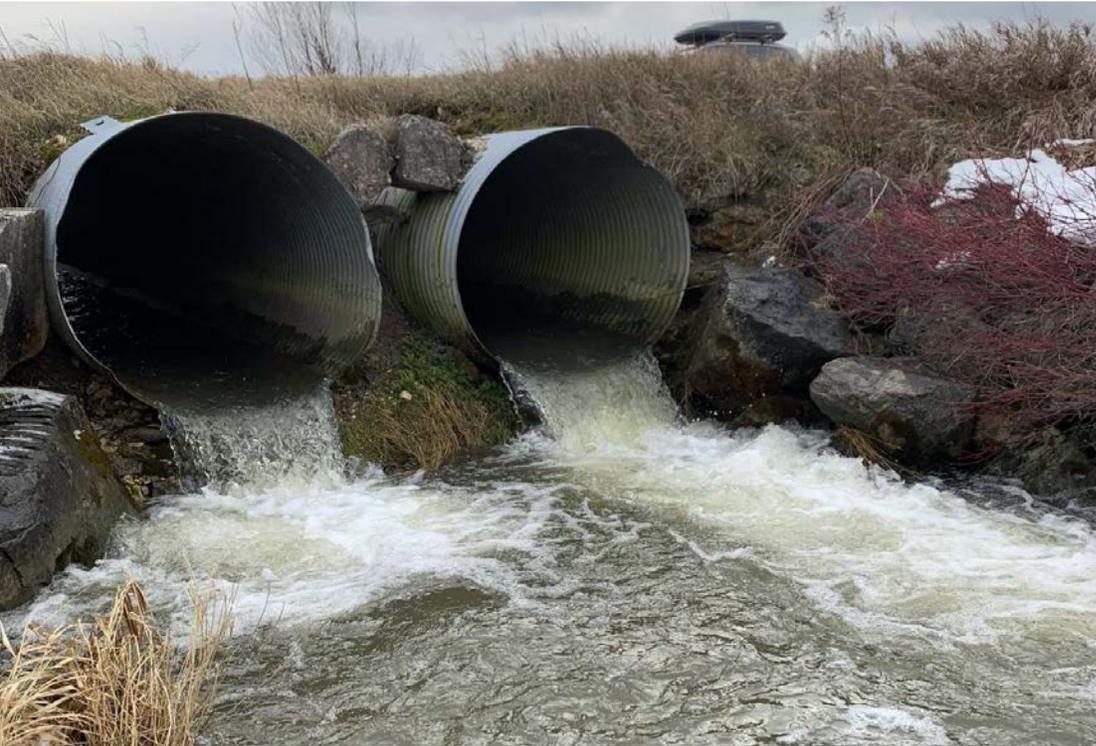
Photo 18-3: View of culvert in elevation and outlet end components

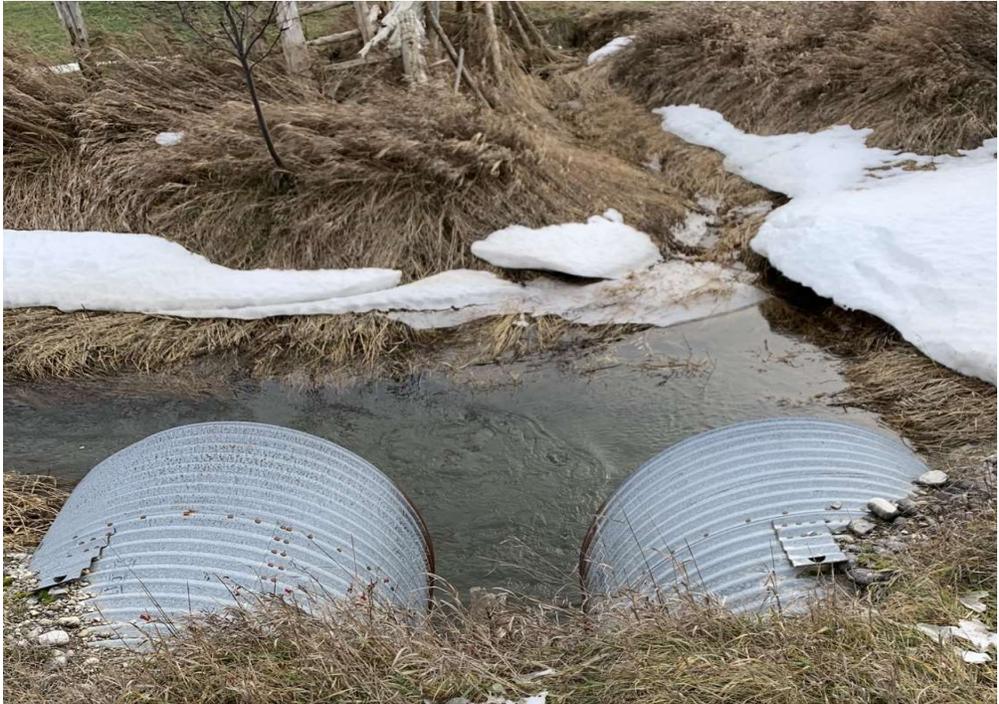
Photo 18-4: View of watercourse upstream and inlet ends

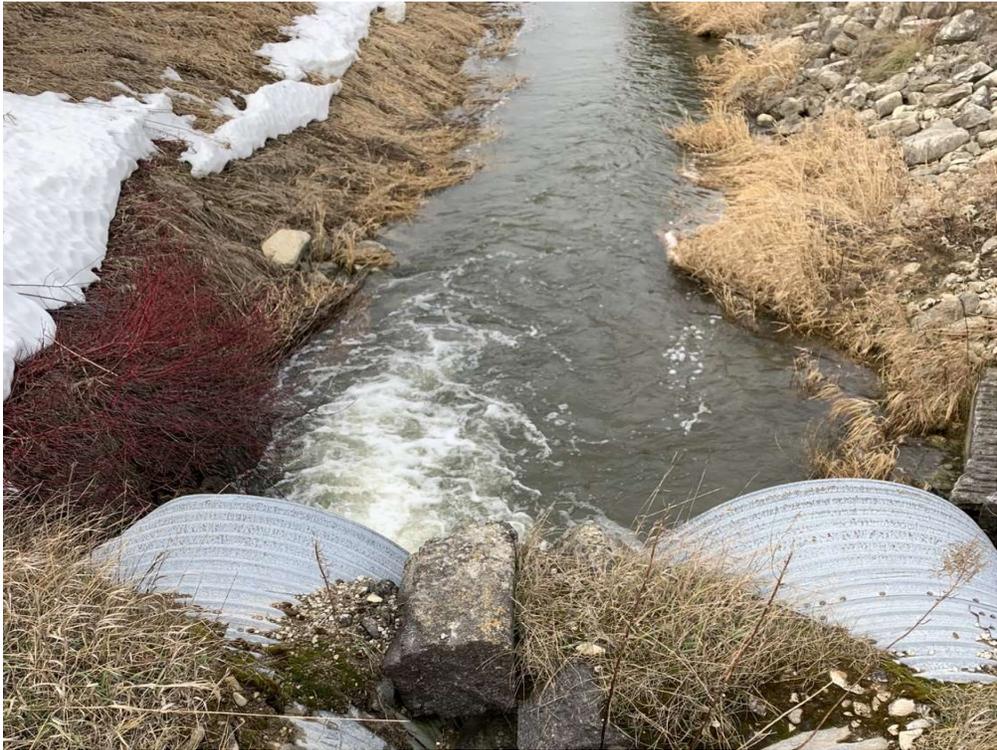
Photo 18-5: View of watercourse downstream and outlet culvert ends

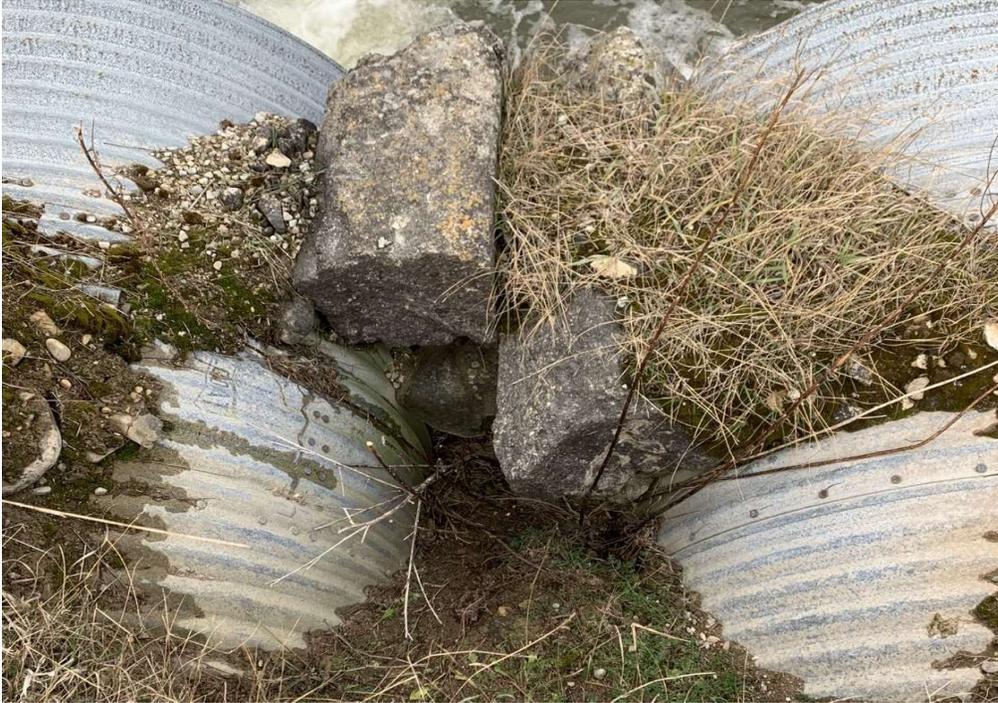
Photo 18-6: View of erosion of embankment and between pipes

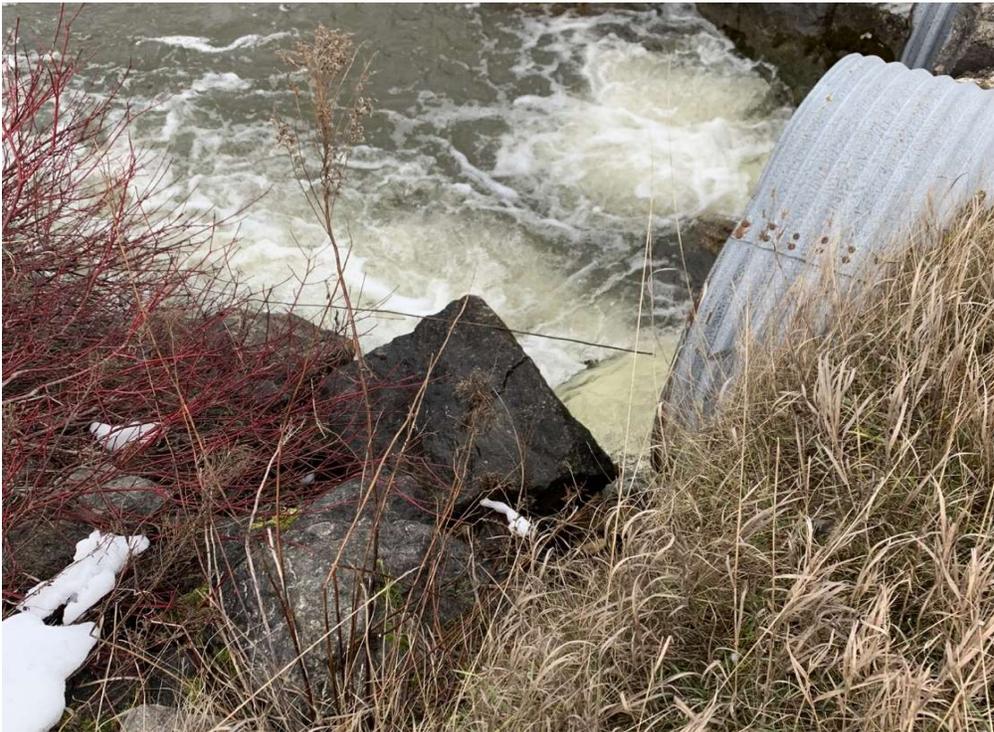
Photo 18-7: Erosion at the haunch of the outlet pipe

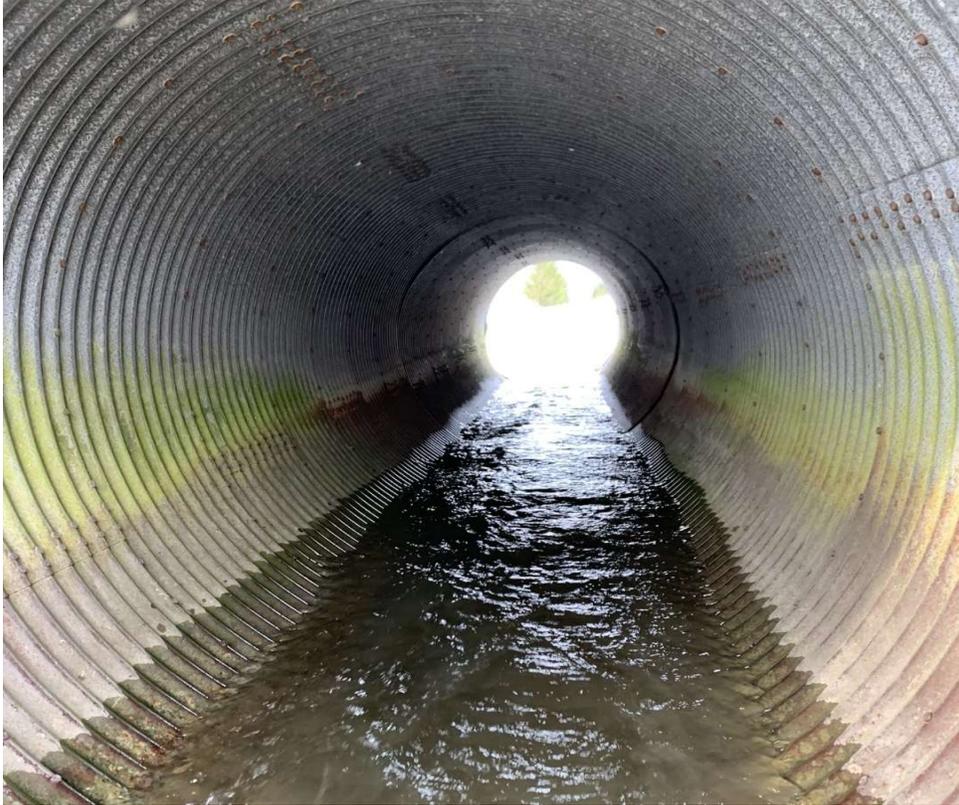
Photo 18-8: View of east culvert barrel interior

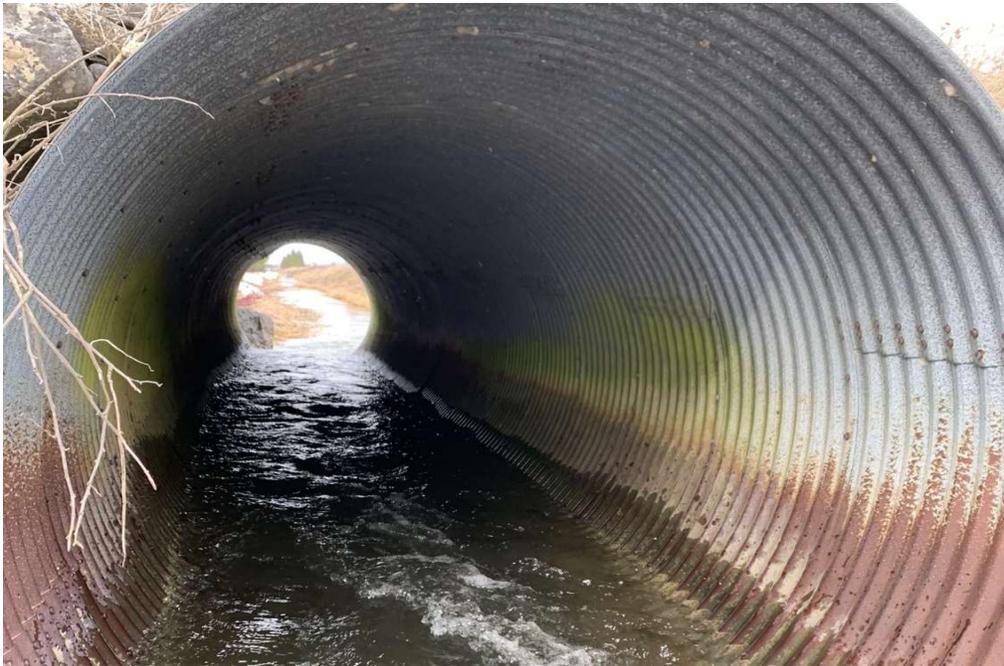
Photo 18-9: View of west culvert barrel interior

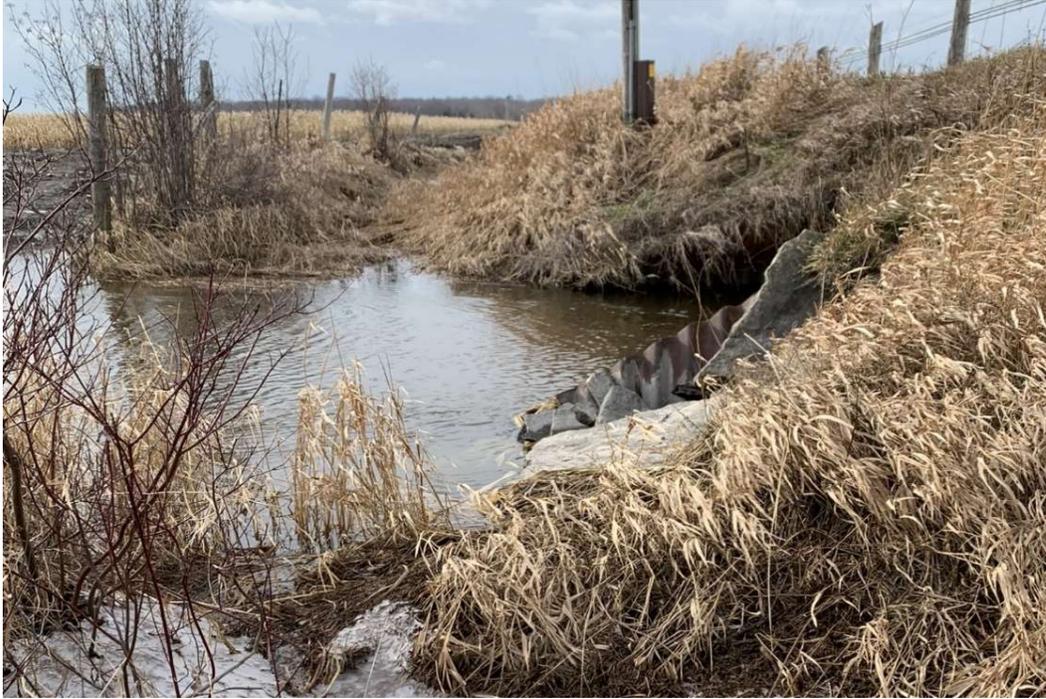
Photo 19-2: View of culvert in elevation and inlet components

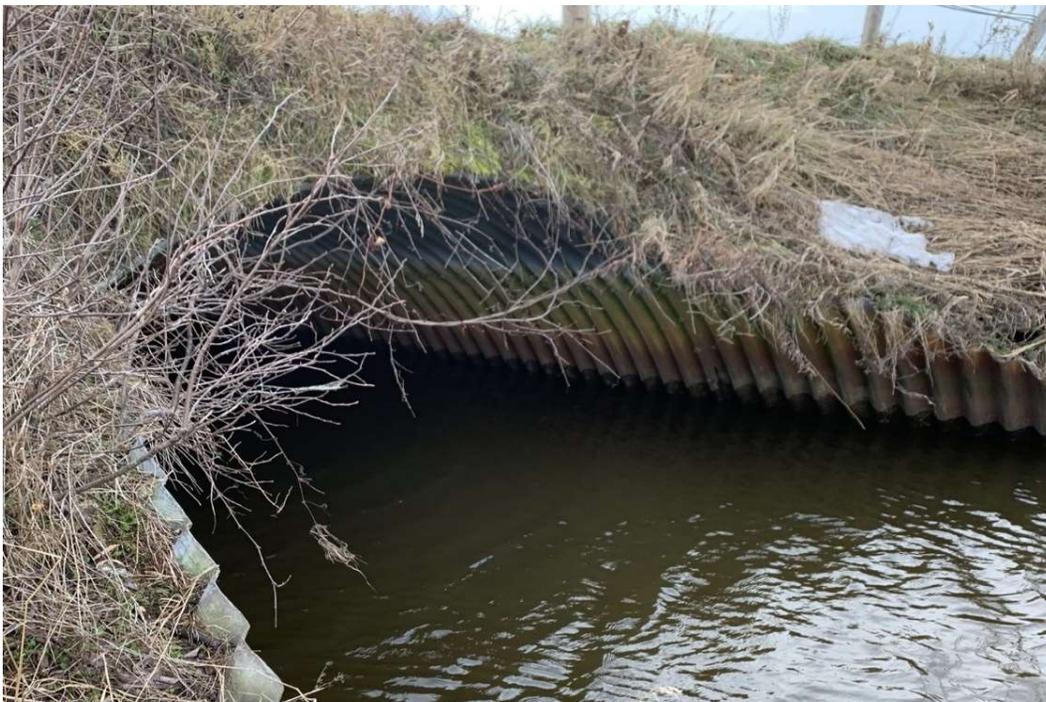
Photo 19-3: View of culvert in elevation and outlet components

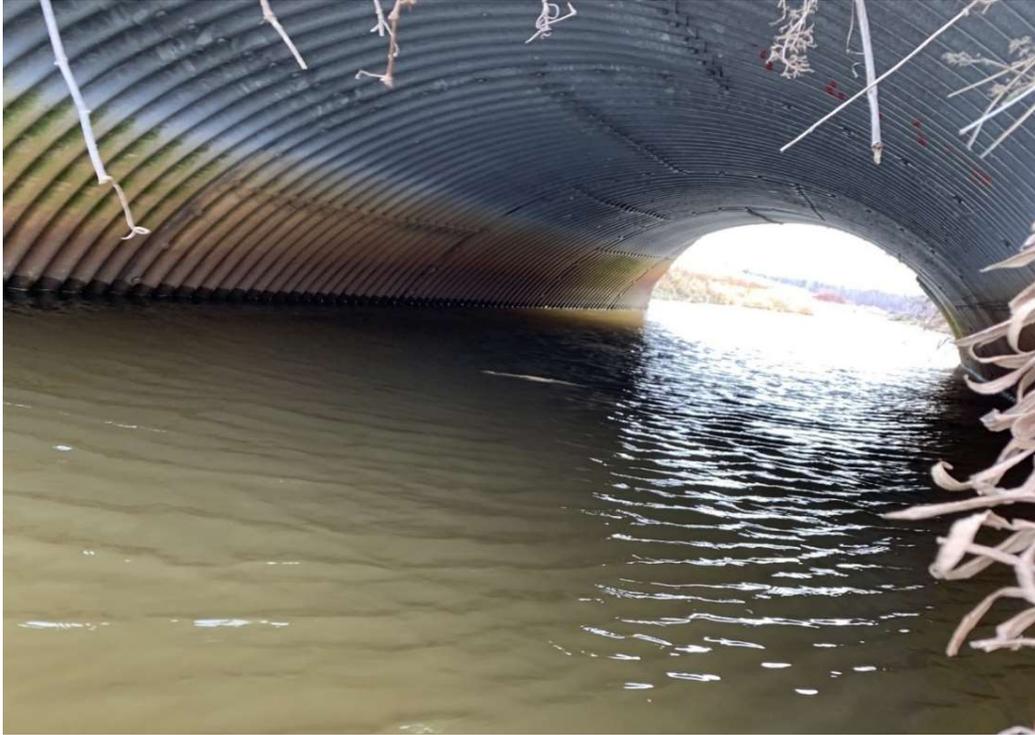
Photo 19-4: View of culvert barrel interior

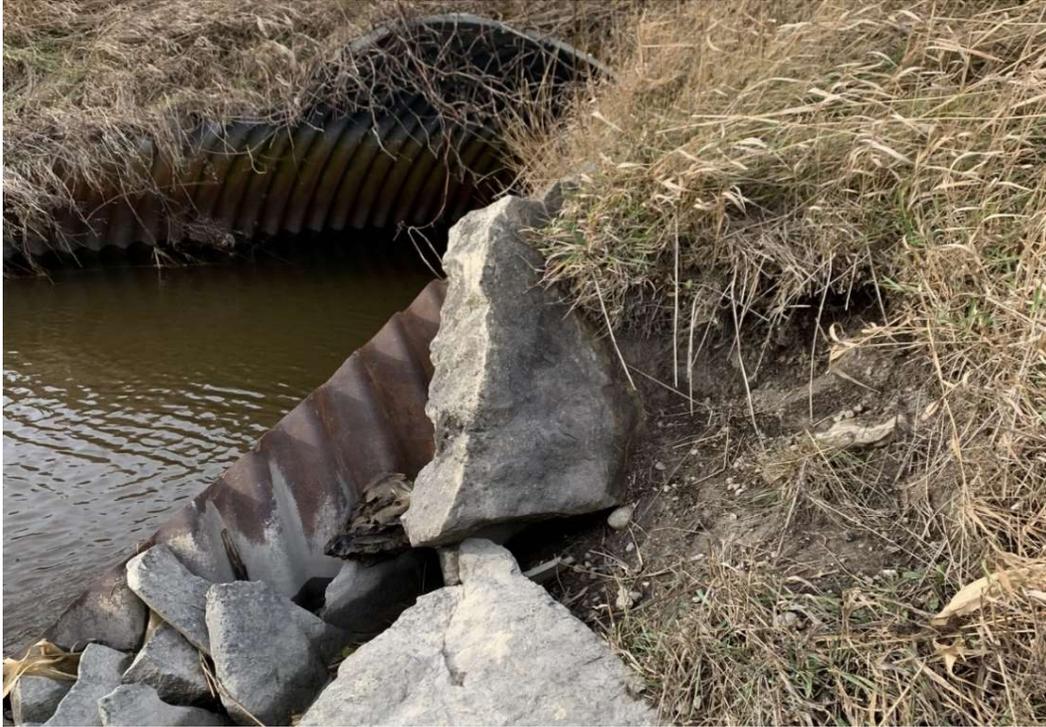
Photo 19-6: Structure embankment

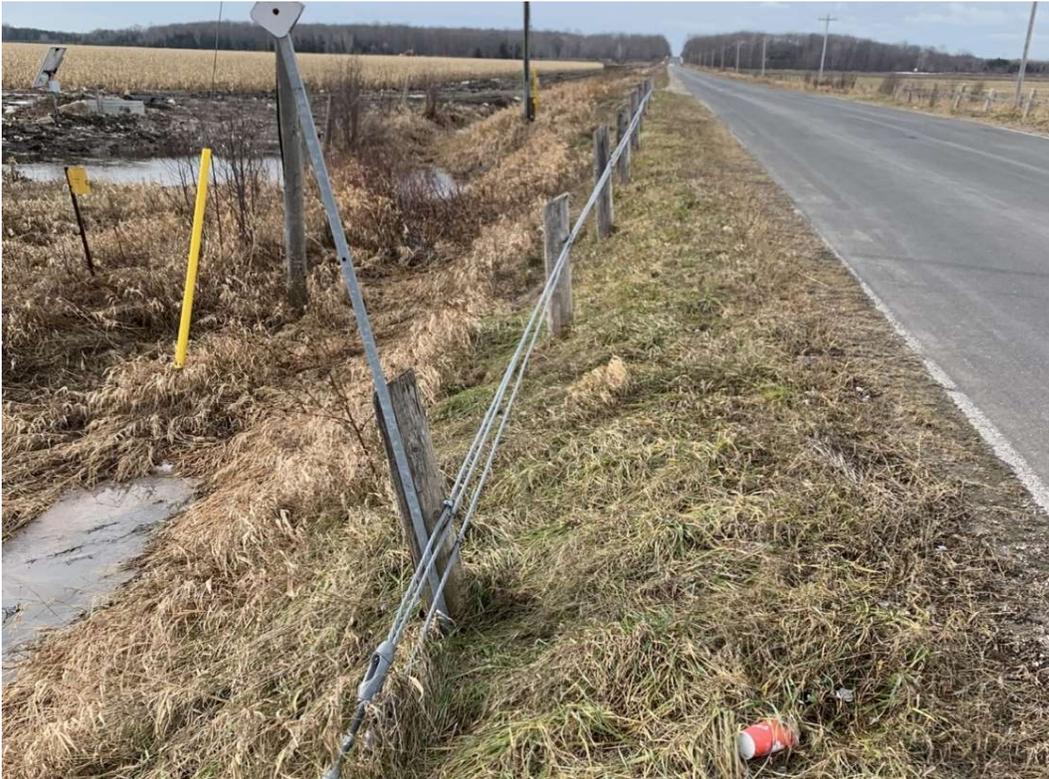
Photo 19-7: View of structure barrier protection (typical)

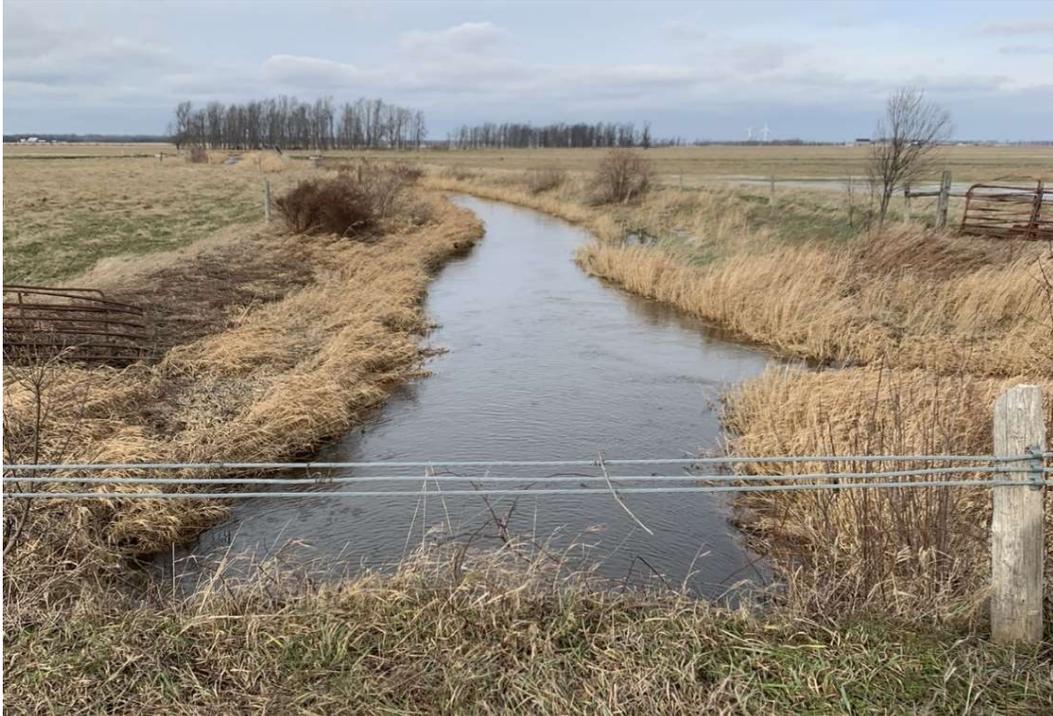
Photo 19-8: View of watercourse upstream

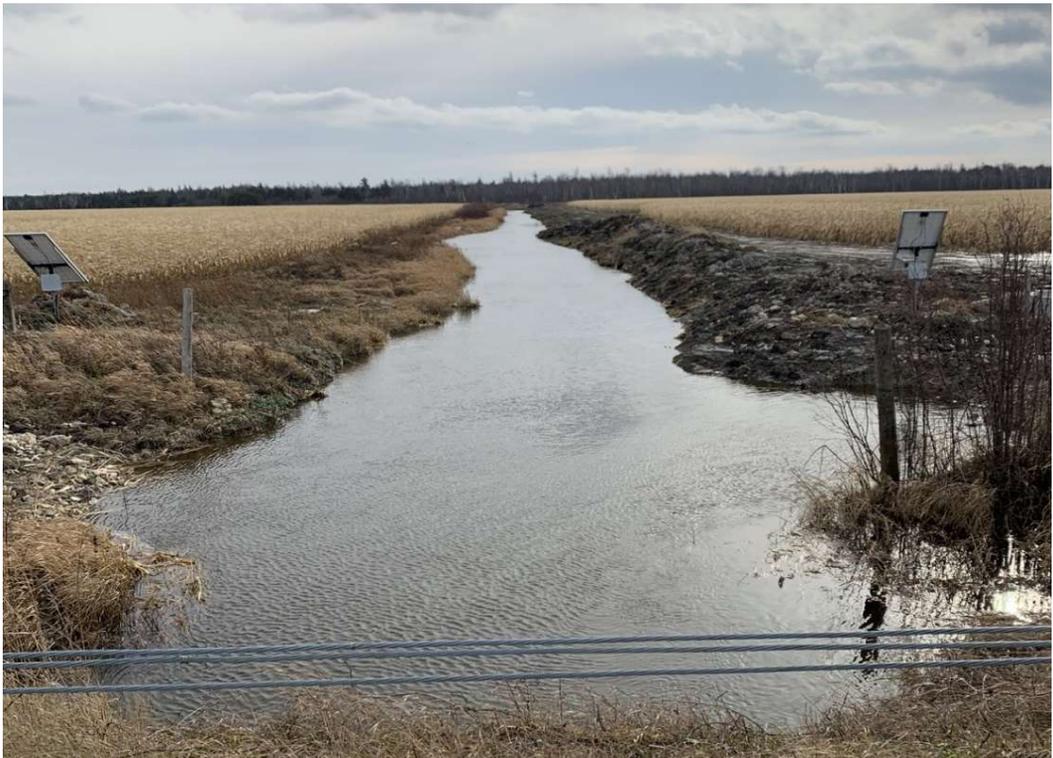
Photo 19-9: View of structure downstream

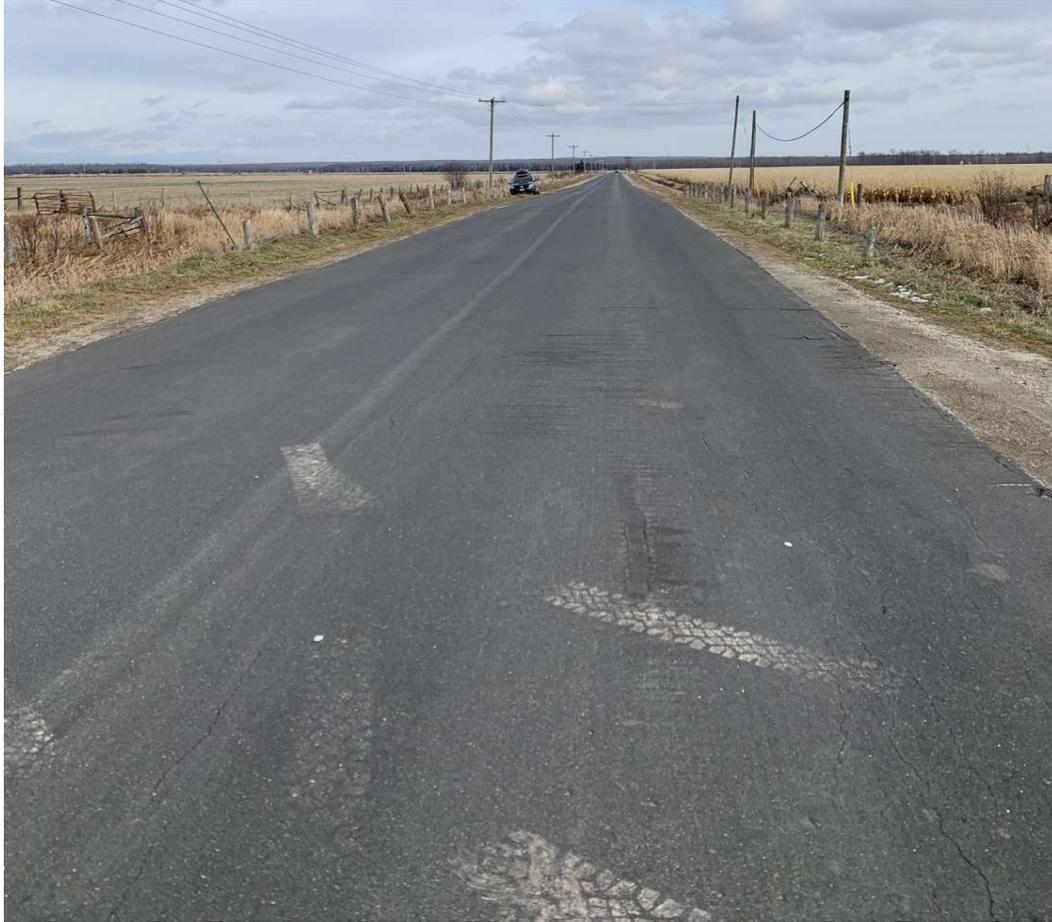
Photo 19-10: View of structure and approach wearing surface
